Central Belt Barrier Strategy - Workshop

24th November 2014

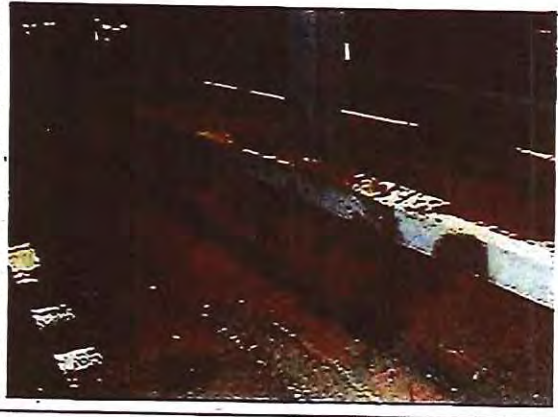
M8 Central Reserve – Between Junction 13 and 14 (Note High Mast in background)

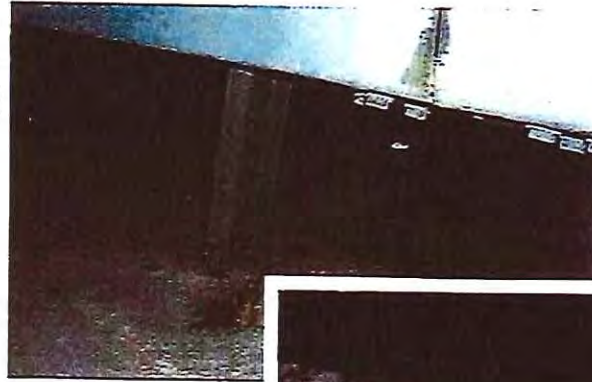
M8 Central Reserve – Between Junction 14 and 15

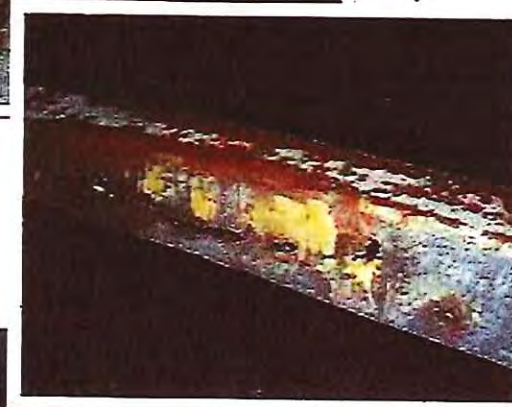
M8 Central Reserve – Between Junction 12 and 15

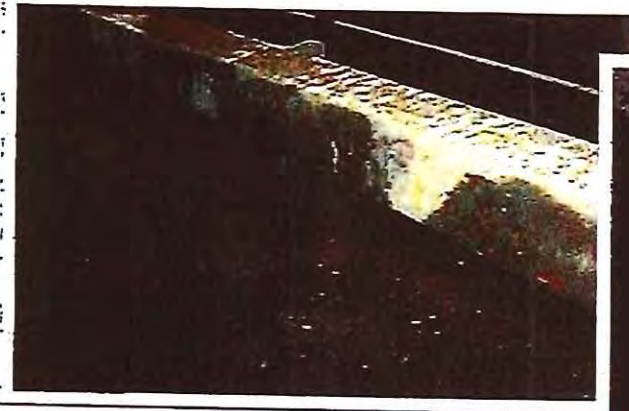
M8 Central Reserve – Between Junction 14 and 15

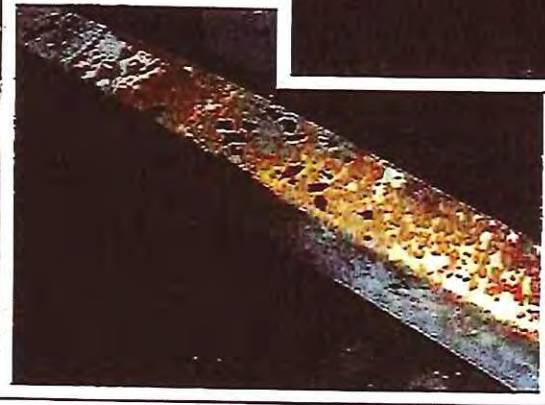
POOR - Evidence of obvious disintegration and perforations by corrosion, evidence of collapsed or collapsing beams and posts, clear failure of system.
