A83 Rest and Be Thankfull Loch Restil Vehicle Restraint System Investigation and Review

Scheme Ref: 16/NW/0901/033

April 2017

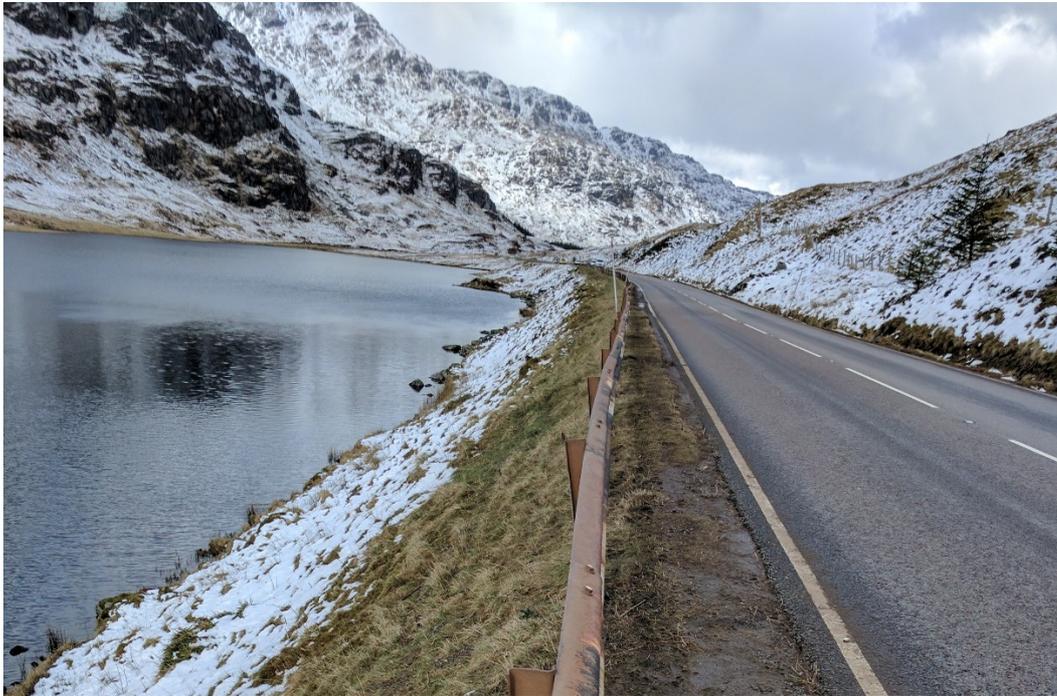
The site inspection confirmed that the barrier shown in Appendix A Photo 1 is a TCB system, installed to comply with N2 containment (1500kg vehicle, 70mph, 20° impact). The barrier has an adequate setback of 1200mm from the carriageway. The tensioning assembly appears to be in good condition, and the barrier appears to be tensioned sufficiently, although some of the bolts are at the ends of the slots. This is known as being 'slot bound' and results in not all beams being equally tensioned

The system is a NPSBS and would be categorised as N2W6 if installed as new under the current standard, however, the prevalence of many existing installations has meant that they are accepted as N2W5. Although the acquired rights aim to reduce the number of out of standard installations, there is only an available working width of 800mm. This is still 900mm less than 1700mm required by a W5 system in EN1317-2. Mounting height of 550mm from the carriageway is also below the standard of 610 ± 30 mm

There is corrosion to traffic face of barrier, although there are no sections where this has penetrated the full thickness or caused lamination of the material. The departure length, 8m past the hazard of the steep embankment, is less than the 30m beyond a hazard required in TD19/06.

The terminal ends are ramped P1 terminals which are no longer accepted in TD19/06 for national speed limit roads. These may overturn vehicles in the direction of the embankment and waterbody.

Manufacturing date stamping came into practise circa 1988 in line with BS5750. As there is no date stamp on the barrier it can be assumed to have been installed prior to this, which is in excess of the expected standard 20 year design life advised in TD19/06.

Photo 1: Steep embankment and closer proximity of waterbody in location currently protected by TCB (looking north @ Section 2 Ch.425).

The TCB barrier in Section 2, adjacent to Loch Restil, has previously been identified as in need of renewal due to corrosion of the barrier. As a result a barrier replacement has been programmed for this section in the 2017/18 routine maintenance programme. It is recommended that the increase in the length of protection, specified in this report is carried out simultaneously with the replacement. A further extension south toward Rest and Be Thankful should also be investigated at this time.

The replacement system installed adjacent to the loch is likely to be a Flexbeam+ system with Trend P4 terminals or similar products which are on the list of accepted VRS systems for UK highways [SHW Appendix SA1].

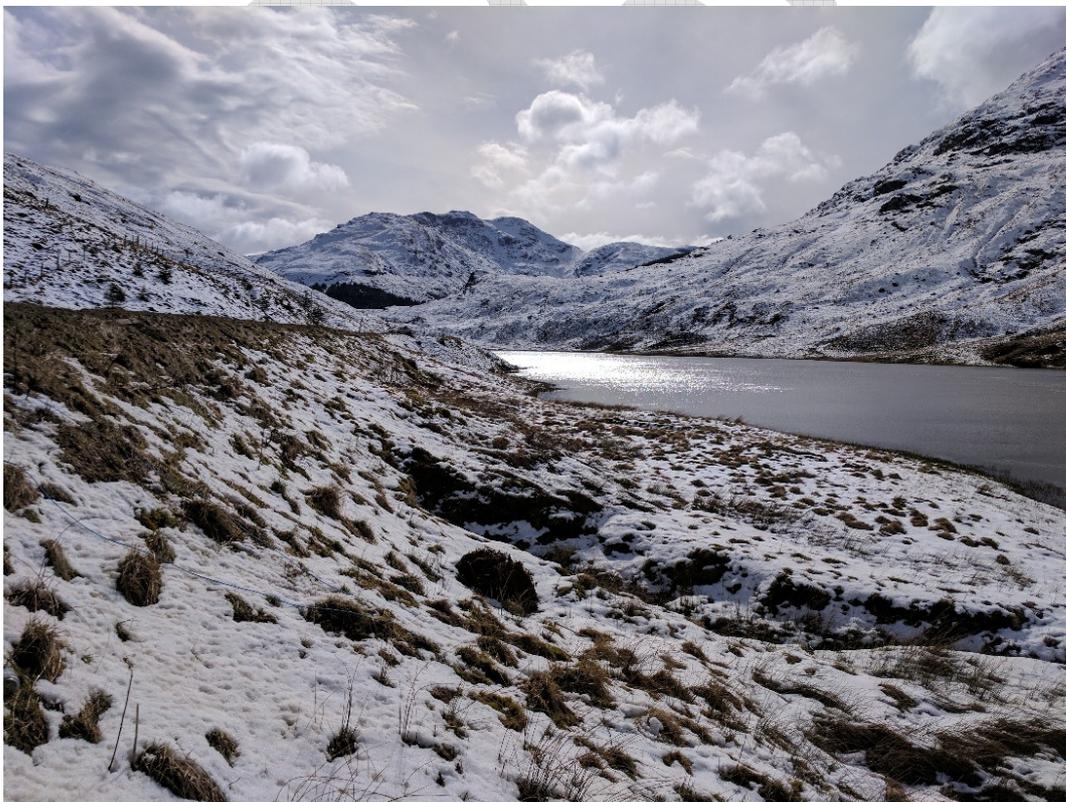
There are 2 small culverts in the embankment and the carriageway is setback 15.8m from the waterbody at the closest point (Ch.709).

There are tyre tracks down the embankment and police tape on a post at Ch.709 which is assumed to be the location of the accident on the 13th January 2017, there is no official record of the accident location. This is also the closest point of the water to the carriageway in Section 3 at an offset of 15.8m.

Photo 2: Minimum of 15.8m from carriageway to waterbody (looking south @ Section 3 Ch.680).

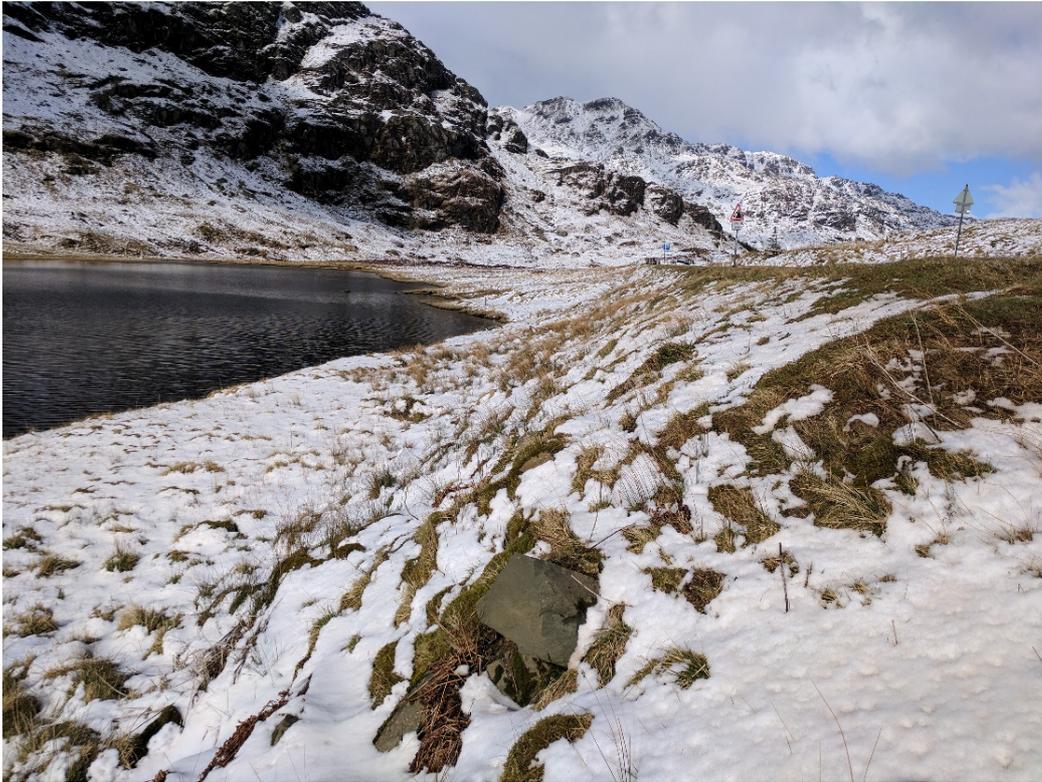
Photo 3: Minimum of 15.8m from carriageway to waterbody (looking north @ Section 3 Ch.680).

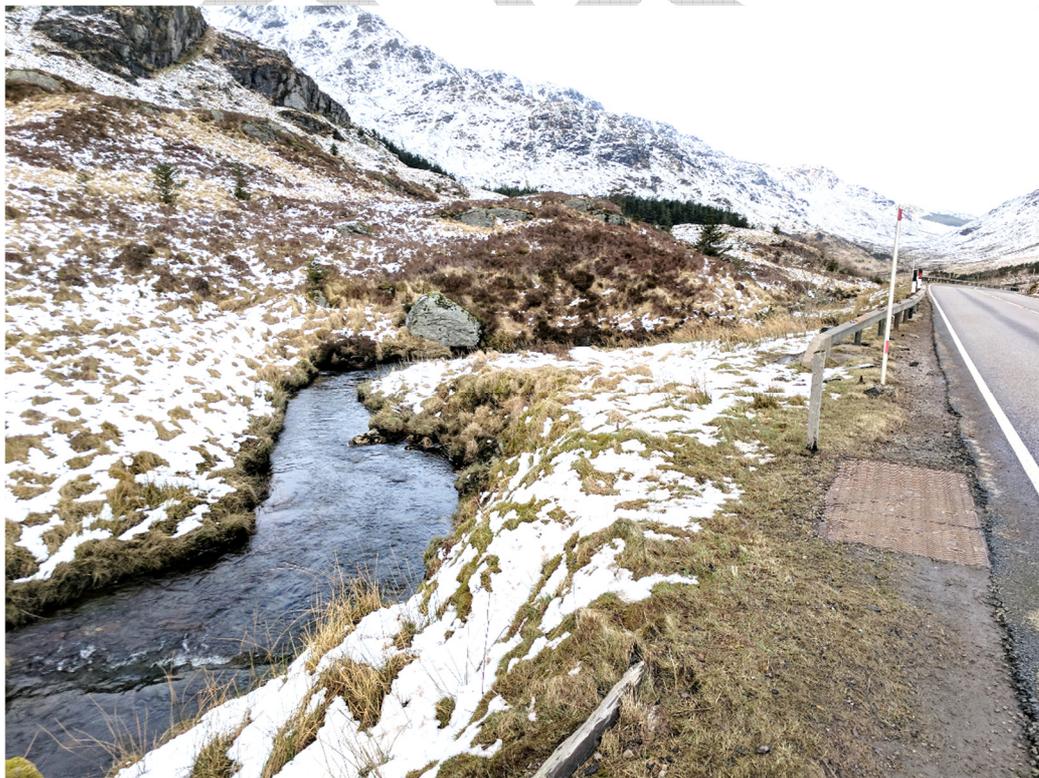
The working width available for this barrier is not sufficient to meet the standards set out in EN1317-2. The width from the traffic face to the water/embankment is only 800mm or less where there is limited space available as the carriageway crosses a small bridge at approximately Ch.1400. At this location a PSb of 600mm and a reduced working width of 250mm has been used. It is not known if a departure from standard was granted for this, however, the solution exhibits sound engineering sense based on TD19/85, the standard in place at the time of the design.

There is a risk of vehicles travelling north accessing the hazard from behind the approach terminal of the barrier as it does not extend 30m beyond the hazard of the steep embankment and watercourse as required in TD19/06. Likewise southbound traffic could face a similar risk if they cross over the road at the departure end although this does provide marginally better protection to the embankment and water. This risk is amplified by the sub-standard ramped P1 terminals which have the potential to flip the vehicle into the water hazard.

Photo 4: OBB Barrier approach length does not cover hazard (looking north @ Section 2 Ch.1285).

Although this barrier does not meet the required working width for a W5 system, this is not uncommon on the trunk road network. The barrier is generally in good condition and as such a replacement is not recommended at this time. An extension to the approach length shown in Appendix A Photo 4 is recommended with the addition of the appropriate P4 terminal. The possibility of closing the gap to another OBB barrier further north of this site should also be considered, although this may prove impractical due to the presence of public utilities.

The recommended extension to the barrier approach and departure lengths plus the appropriate P4 terminal upgrades to the existing OBB barrier in Section 6 are also recommended to be carried out as part of the routine maintenance scheme. Drawings showing the recommended barrier works have been included in Appendix E.
