# M9 Junction 2 NB Drainage Investigation

## M9 J2-3 NB Drainage

17/SE/0901/016/DOC-001

October 2017

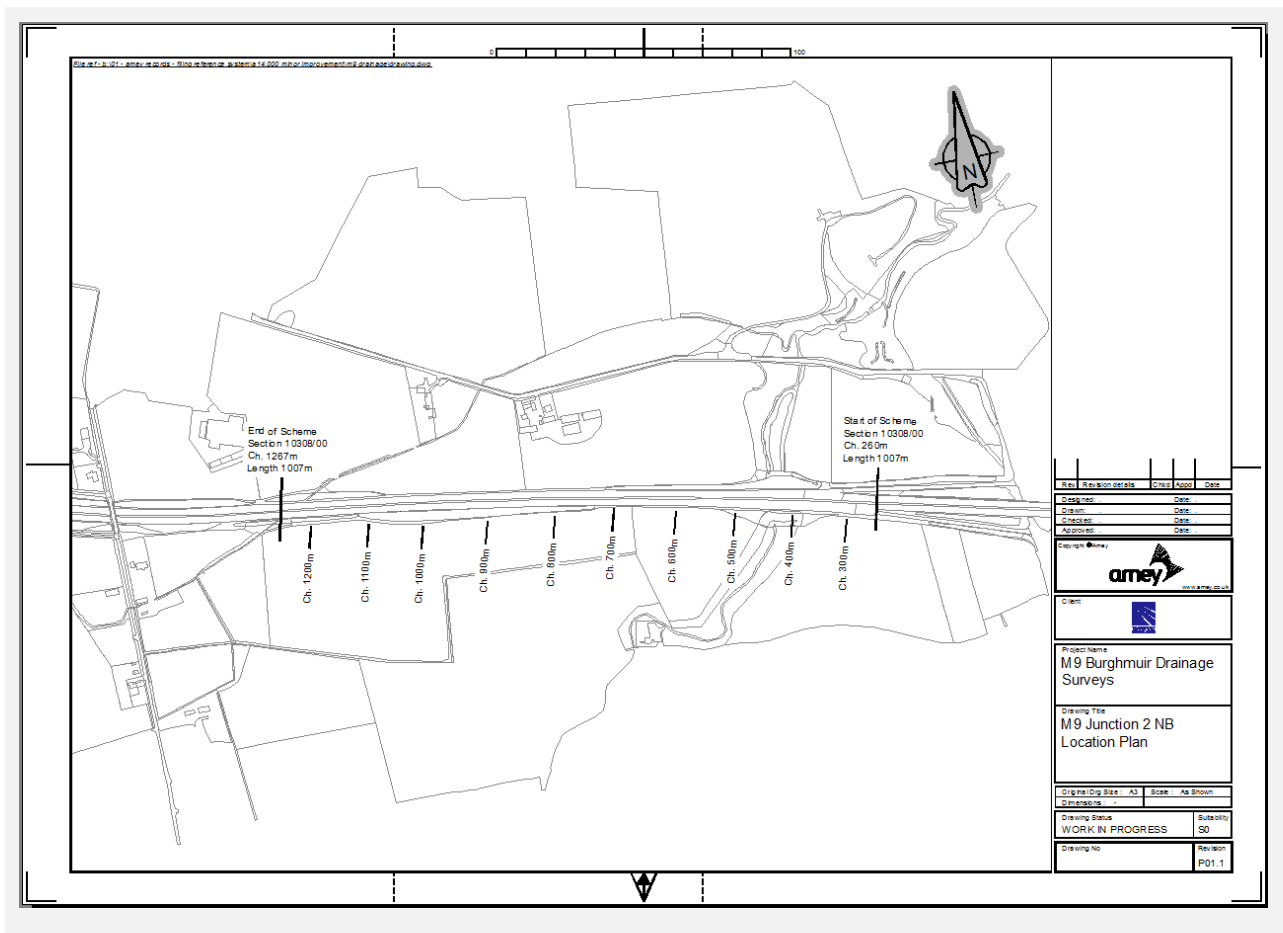
**Figure 2 - Detailed site investigation location plan.**

3.1.1 On site investigation including lifting of manhole covers to determine the size and condition of the carrier drains. Gullies were also inspected to ensure they were free running. During this inspection, it was noted that the majority of gullies within this section were side entry which historically does not catch the flow of surface water efficiently, due to the gradient and crossfall of the hardshoulder and carriageway.

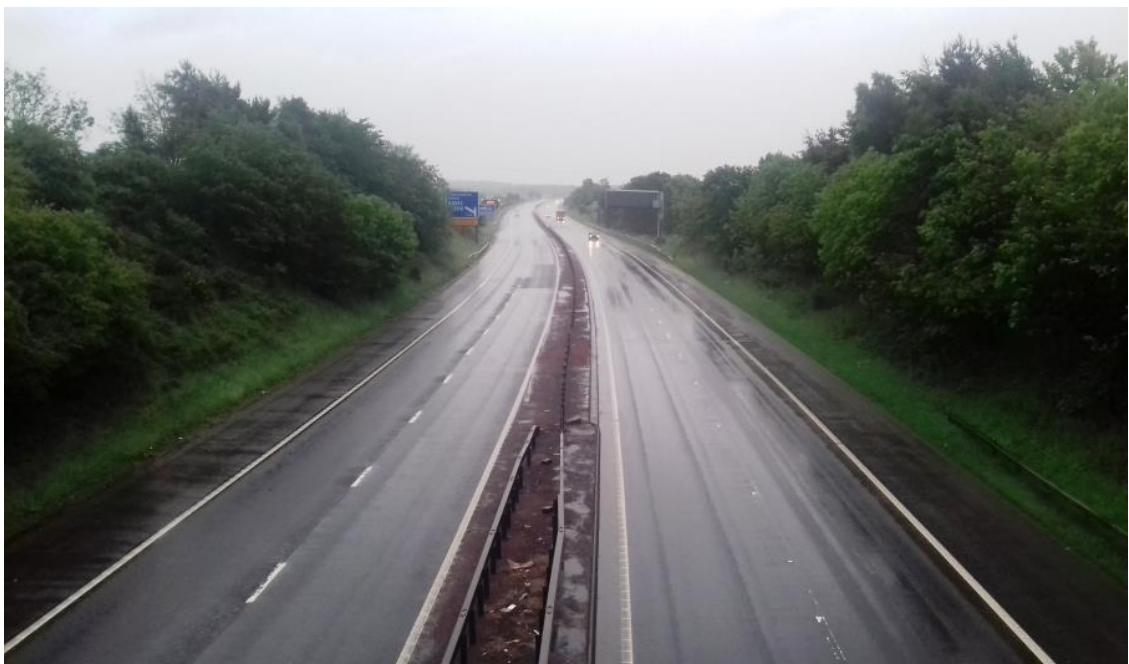
**Figure 3** – Example photos

- 4.1.1 The investigation confirmed that the drainage is functioning as it was designed and there were no blocked gullies found during the investigation.
- 4.1.2 The site inspection also confirmed that due to the positioning of the drainage, particularly the existence of the side entry gullies at certain locations, compromised the effectiveness of the drainage system.
- 4.1.3 At key points within this section of the M9 Motorway, at changes in the vertical alignment of the main carriageway the existing drainage provided does not ensure efficient catchment of the surface water. This allows the surface water to flow over both lanes of the main carriageway northbound.
- 4.1.4 This is determined as the prime cause of the accidents at this section of the M9 Motorway.

*Junction 2 looking SB* – Photo shows surface water flowing across the carriageway from the Northbound Hardshoulder.

- 5.1.1 The existing carriageway drainage within this section of the M9 Motorway, whilst fully functional is deemed to be inadequate due to the existence of side entry gullies at key locations where the carriageway alignment changes.

- 5.1.2 A separate Strategic Road Safety study concluded that the prime cause of accidents at this section of the M9 motorway were related to the flow of surface water across the carriageway.

- 5.1.3 At key points within this section of the M9 Motorway, at changes in the vertical alignment of the main carriageway the existing drainage provided does not ensure efficient catchment of the surface water. This allows the surface water to flow over both lanes of the main carriageway northbound.

- 5.1.4 In order to rectify the present drainage problem, it is proposed to undertake minor drainage alterations within this section of the M9 motorway. This proposal comprises of the removal of sections of existing kerb and side entry gullies to be replaced by filter drainage. This will ensure catchment of the surface water minimising the flow of surface water across the main carriageway. Gullies 18 to 25 will be removed and the filter drainage will replace this existing drainage which will ensure the catchment of the flow of the surface water.

- 5.1.5 It is recommended that this proposal to amend the existing drainage is taken forward via routine maintenance.
