**A83 Cairndow (HD28)**  
**Descriptions of defects listed within RMMS for these sections**

A83 Calrindow (HD28)  
HD28 Site Details

A83 Cairndow (HD28)  
Visual Condition Survey

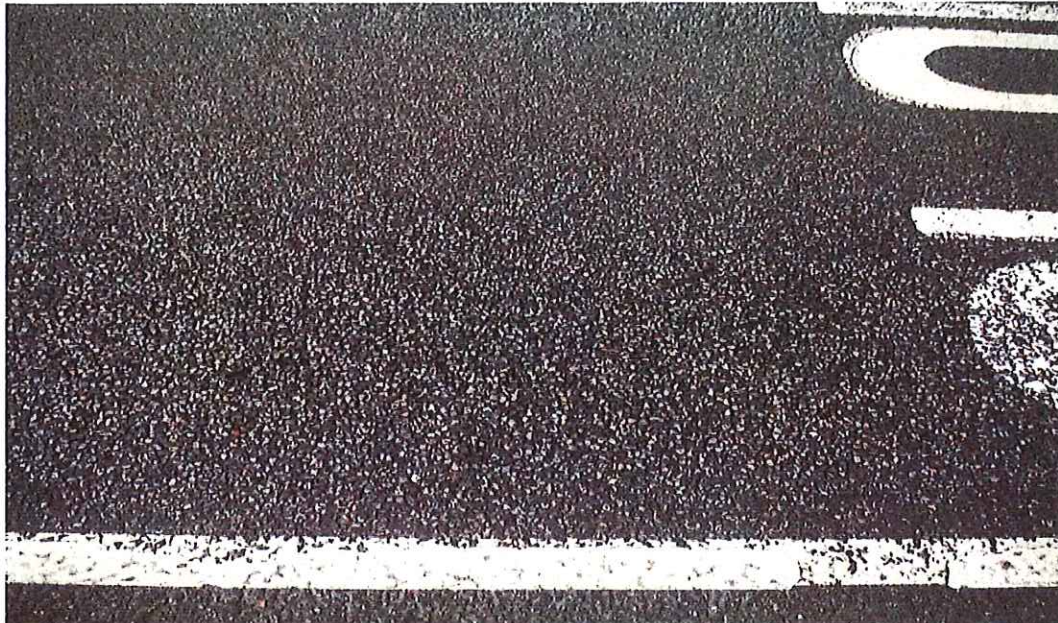
Photo 7: A83 Cairndow (HD28). Section 16520/05 CH1520. Photo detailing rutting, cracking to the nearside wheeltracks CL1.

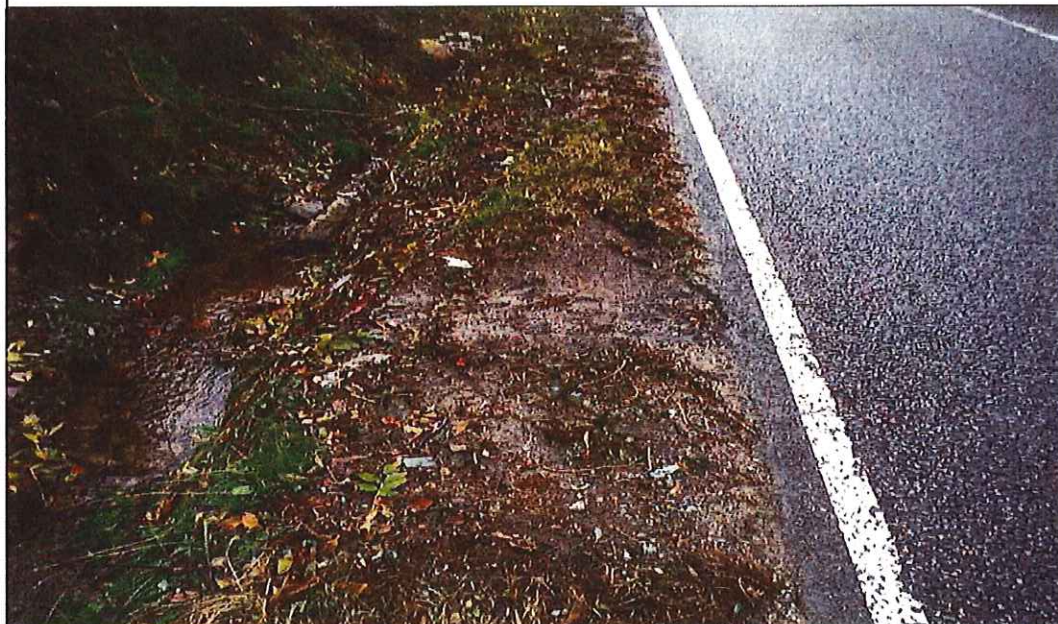
Photo 8: A83 Cairndow (HD28). Section 16520/05 CH1710. Photo detailing drainage ditch, possible with heavy rain for water to flood over the carriageway contributing to increased skid risk.

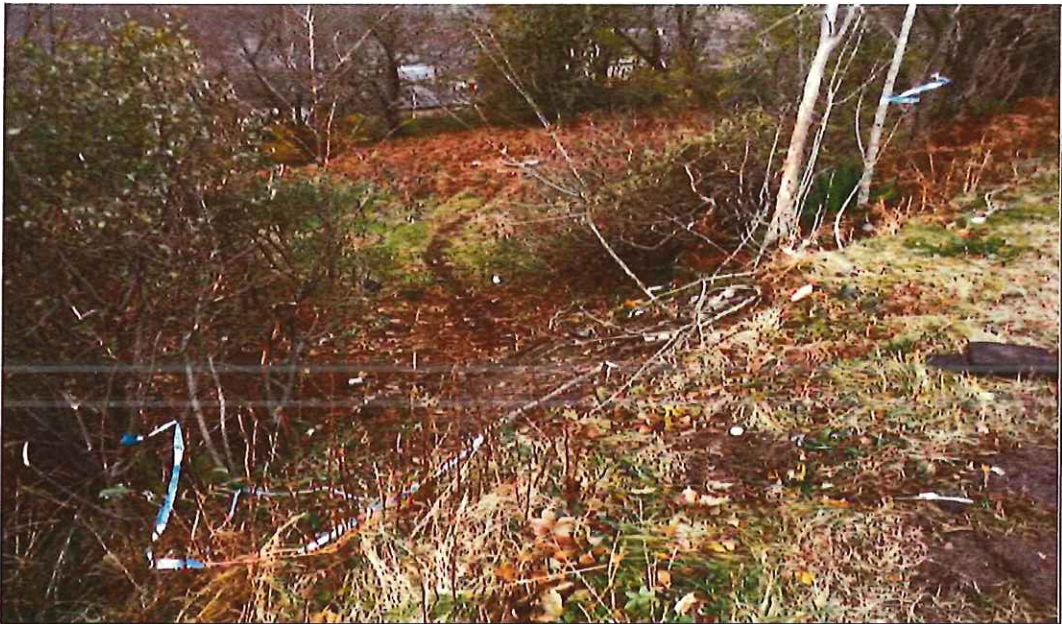
Photo 9: A83 Cairndow (HD28), Section 16520/05 CH1780. Photo detailing accident of to the nearside CL1. Approx 20m beyond current safety barrier in place, and 20m beyond HD28 secondary site identified for treatment.

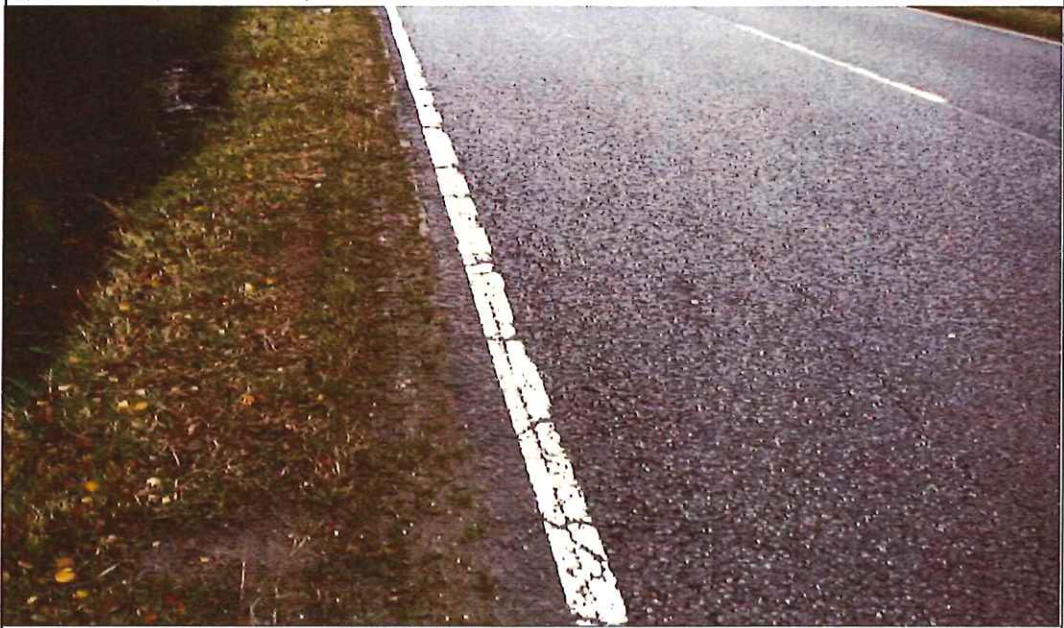
Photo 10: A83 Cairndow (HD28), Section 16520/05 CH1800. Photo detailing cracking to the nearside edge CR1.

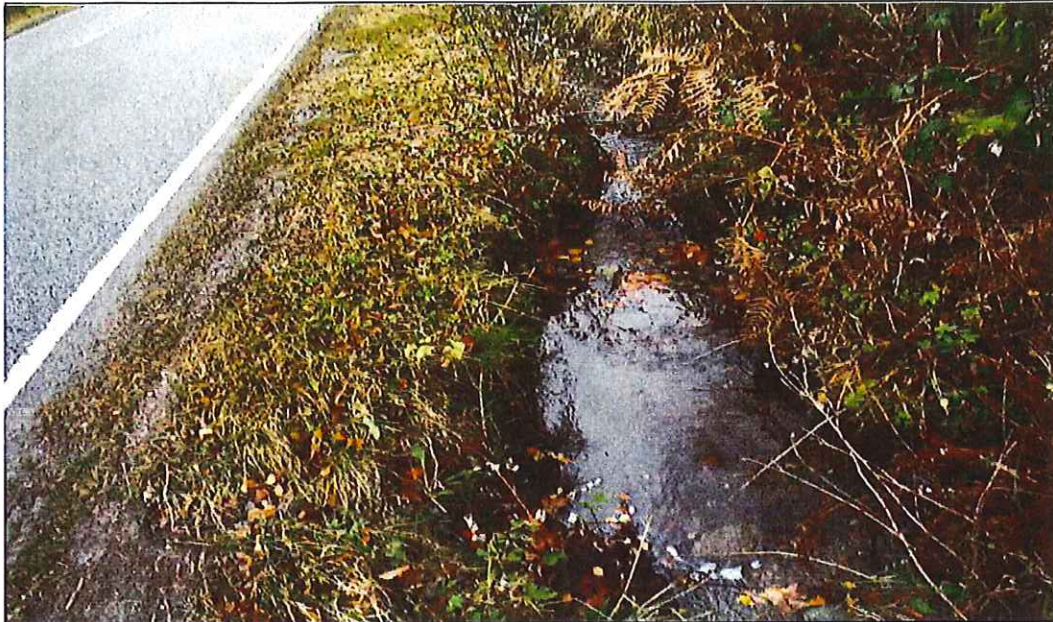
Photo 11: A83 Cairndow (HD28). Section 16520/05 CH1820. Photo detailing drainage ditch, possible with heavy rain for water to flood over the carriageway contributing to increased skid risk.

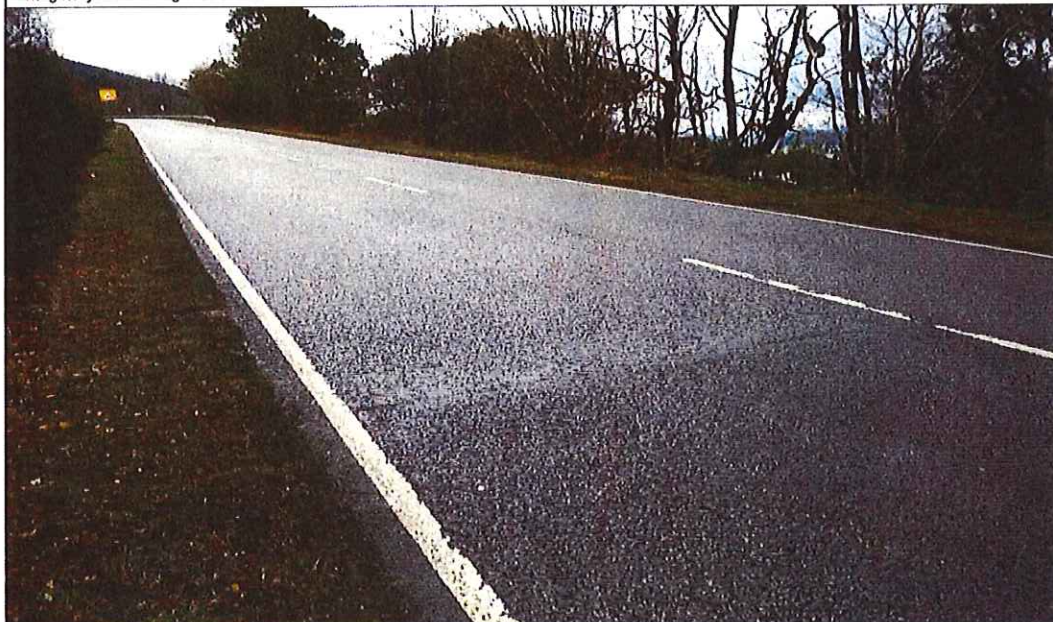
Photo 12: A83 Cairndow (HD28). Section 16520/05 CH1872. Photo detailing construction joint marking the end of scheme. Photo looking back into scheme. Safety barrier can be seen ending CR1. At design stage, looking to extend the barrier to account for recent accidents.
