| Document: 4GNW-F261 | Form<br>Statement of Intent | |

## 4th Generation Term Contract for Management and Maintenance of the Scottish Trunk Road Network

### North West Unit

Statement of Intent for: *A83 Cairndow (HD28)*  
 Scheme Identification: *IRIS Ref 16NW0104007*  
 SOI Version: *Version 1.0*

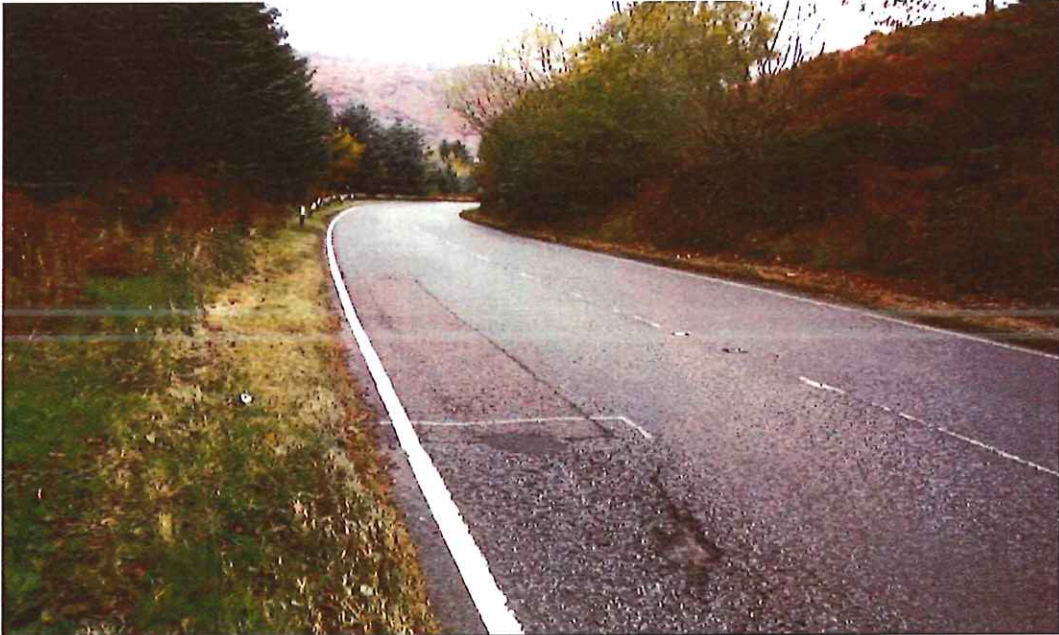
Photo 1: A83 Cairndow (HD28). Section 16520/05 CH1220. Photo detailing rulling/ pothole forming in the nearside wheel tracks CL1 at the start of scheme extents.

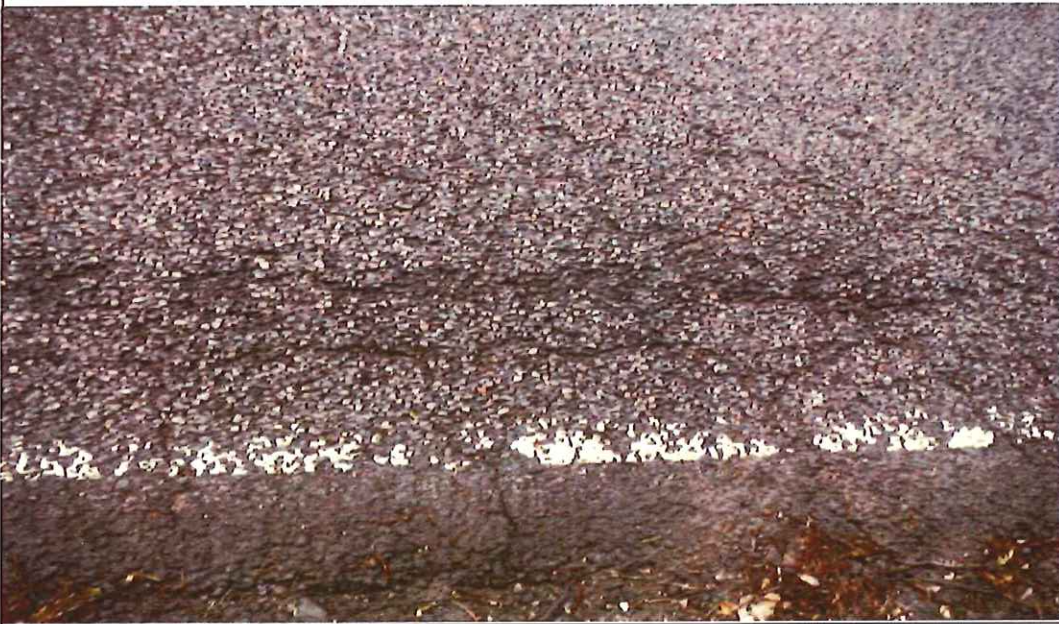
Photo 2: A83 Cairndow (HD28). Section 16520/05 CH1255. Photo detailing cracking by nearside carriageway edge CL1.

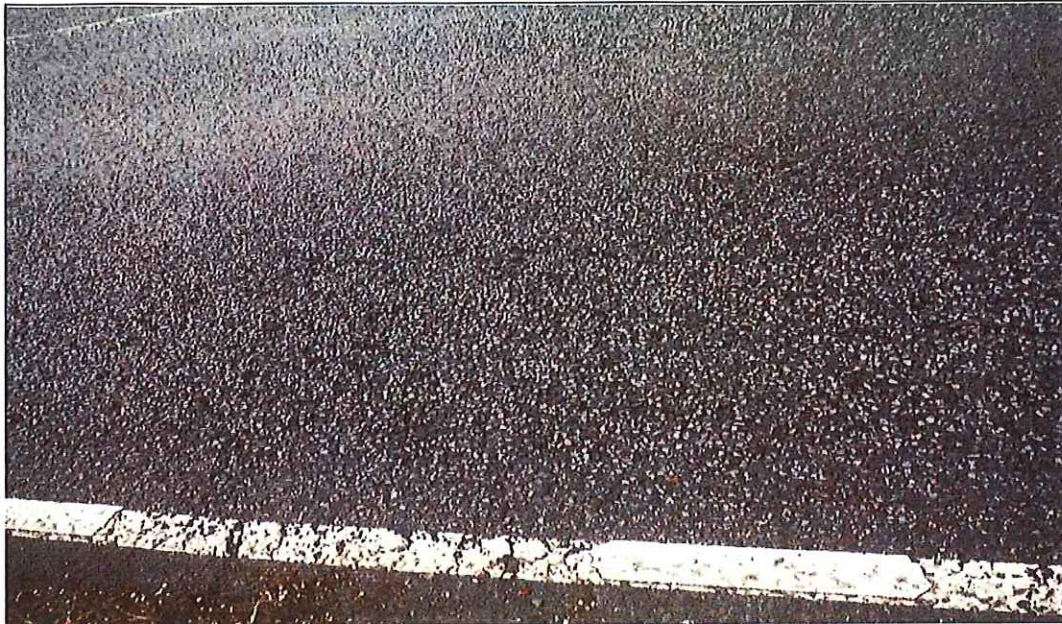
Photo 3: A83 Cairndow (HD28). Section 16520/05 CH1350. Photo detailing open texture of the surface course, nearside wheel tracks CR1. This is prominent throughout the scheme surface area.

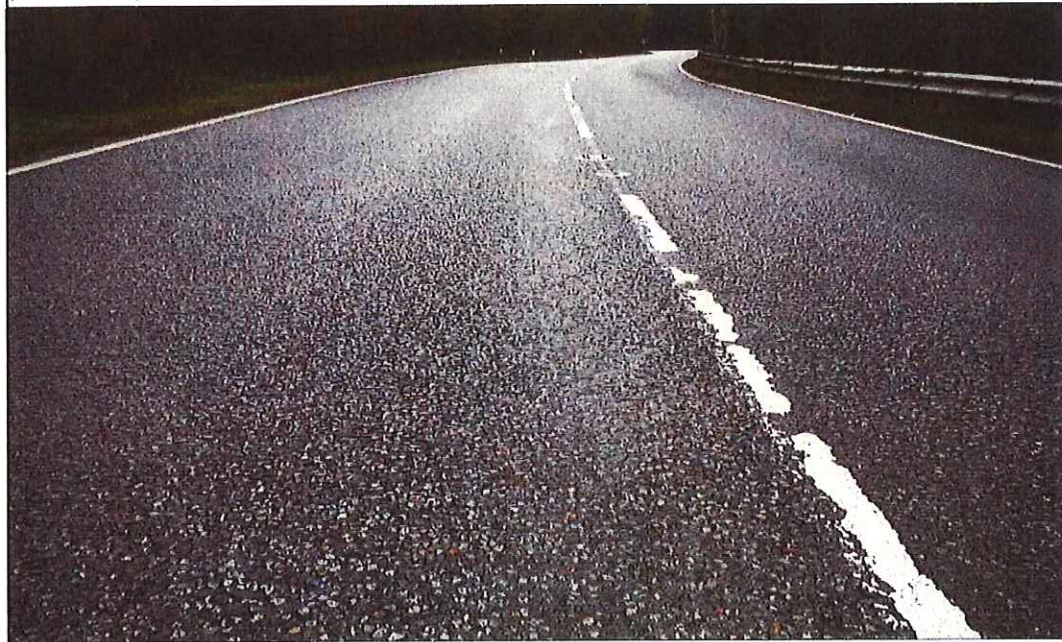
Photo 4: A83 Cairndow (HD28). Section 16520/05 CH1370. Photo detailing polishing to the surface, open texture also in evidence.

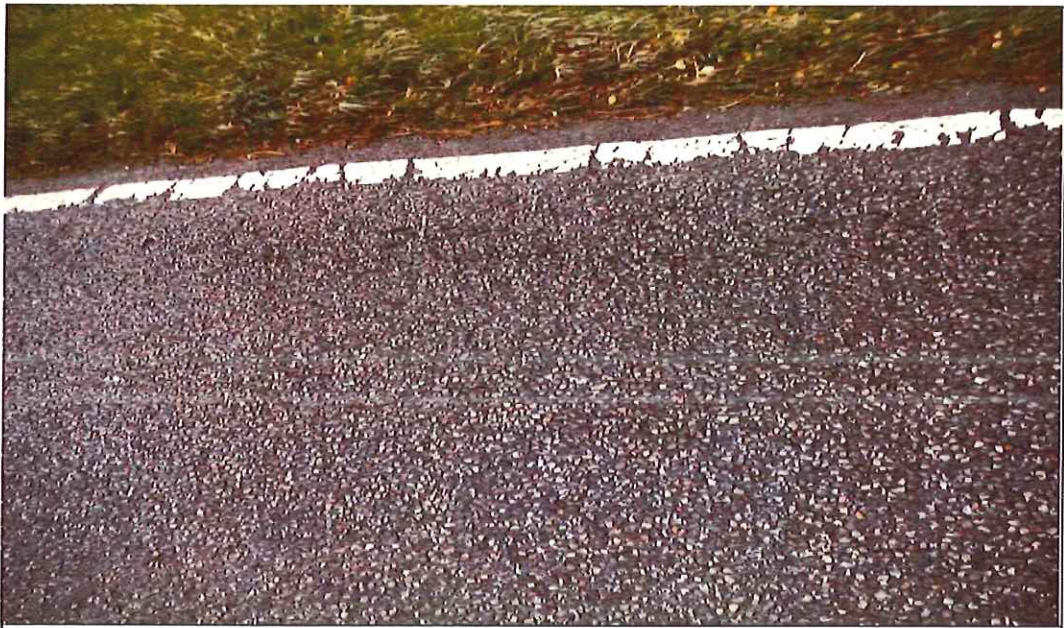
Photo 5: A83 Cairndow (HD28). Section 16520/05 CH1370. Photo detailing localised depression and cracking CR1.

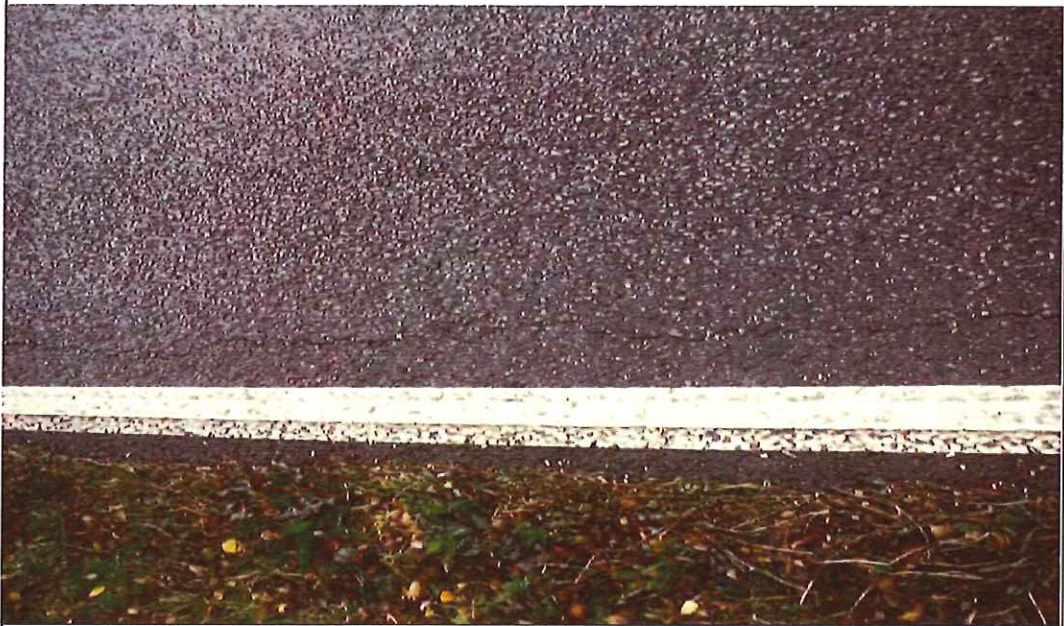
Photo 6: A83 Cairndow (HD28). Section 16520/05 CH1400. Photo detailing edge cracking CL1.
