**AWPR
A944
SOUTH KINGSWELL ROUNDABOUT
AND ASSOCIATED ROADS
ABERDEEN**

STAGE 3 ROAD SAFETY AUDIT
(SPA Ref No: 4021)

Roads Authority: TRANSPORT SCOTLAND

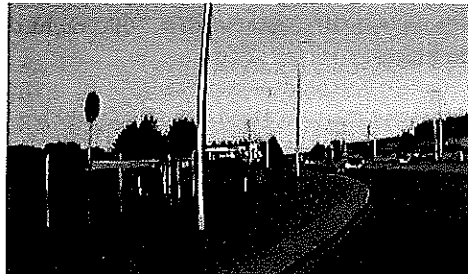
- A944 East Bound Redundant 40 MPH and national speed limit sign to be removed from north verge.

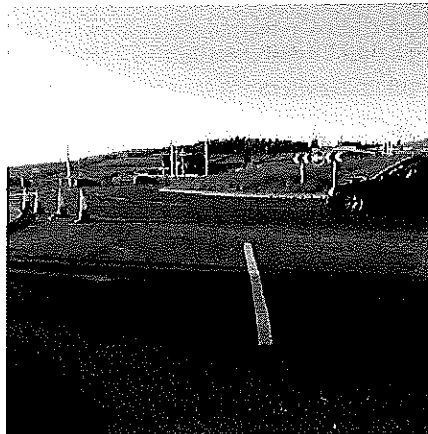
3.2.1 Problem

Location: A90 Northbound merge to South Kingswell Roundabout

Summary: Incorrect Roundabout geometry can result in an increase in accidents with vehicles leaving the carriageway onto the central hub.

It was noted on site that the centre line carriageway markings on the A90 northbound diverge appeared to have been laid non – tangential to the central hub.

The alignment of the entry lanes could cause driver to misjudge their entry and cause collisions with the central hub

It recommended that the designer reviews the layout of the centre lining on the A90 northbound diverge.

If necessary, the lining should be adjusted to ensure that they are tangential to the hub.

Recommendation accepted. The road centreline will be reviewed on site and adjusted if necessary.

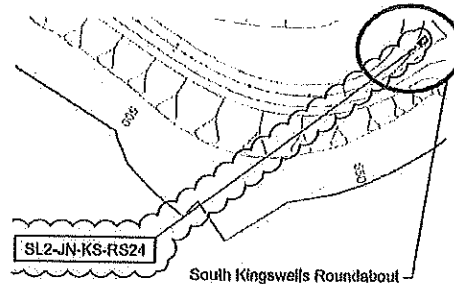
3.5.2 Problem

Location: A944 South Kingswell Roundabout / Kingsford Gairnlea Road
Drawing(s): N/A
Summary: Lack of definition of roadside features can result in an increase in late braking and sudden manoeuvre type accidents.

It was noted that on the splitter island on A944 South Kingswell Roundabout / Kingsford Gairnlea Road no bollard had been provided at the interface of the circulatory carriageway and the exit arm

There was no permanent signing provided on the splitter island although the design provides for a bollard with left aspect for northbound traffic approaching the roundabout on the Kingsford Gairnlea Road. Temporary direction signs are currently provided on the splitter island.

It is normally the case that where an illuminated fingerpost sign is provided that there is no requirement for a bollard.

It is recommended that a bollard with blank face be provided between the circulatory carriageway and the Kingsford Gairnlea Road. It is further recommended that the as designed bollard be provided on the splitter island for northbound traffic.

In addition, it is recommended that the designer reviews to need to provide a fingerpost direction sign on the splitter island.

Recommendation accepted. A bollard with a blank face will be provided between the circulatory carriageway and the Kingsford Gairnlea Road. We can also confirm that the bollard on the splitter island for northbound traffic will also be provided as per the design.

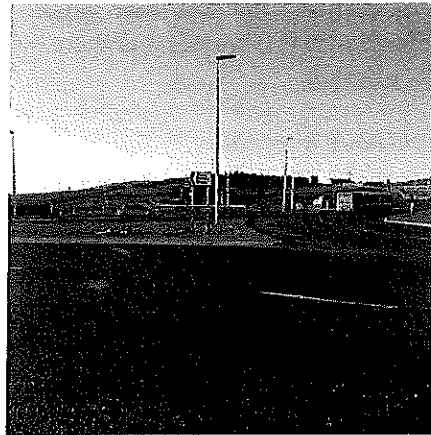
3.5.3 Problem

Location: A944 South Kingswell Roundabout / A944 Westbound exit arm
Drawing(s): N/A
Summary: Lack of definition of roadside features can result in an increase in late braking and sudden manoeuvre type accidents.

It was noted that on the splitter island on A944 South Kingswell Roundabout / A944 westbound exit arm no bollard had been provided at the interface of the circulatory carriageway and the exit arm

A permanent non – illuminated fingerpost sign had been provided on the splitter island.

It is normally the case that where an illuminated fingerpost sign is provided that there is no requirement for a bollard.

It was mentioned on site that the sign seen in the picture opposite had already been struck by a vehicle.

It is recommended that a bollard with blank face be provided between the circulatory carriageway and the A944 westbound exit arm.

Recommendation accepted. A bollard with a blank face will be provided between the circulatory carriageway and the A944 Westbound exit arm.

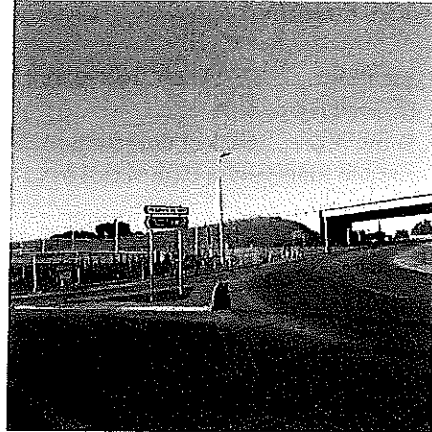
3.5.4 Problem

Location: A944 South Kingswell Roundabout / C93C Clintery to Kingsford Road.
Drawings: N/A
Summary: Lack of definition of roadside features can result in an increase in late braking and sudden manoeuvre type accidents.

It was noted that, on the splitter island on A944 South Kingswell Roundabout / C93C Clintery to Kingsford Road exit arm, no bollard had been provided at the interface of the circulatory carriageway and the exit arm

A permanent non – illuminated fingerpost sign had been provided on the splitter island.

It is normally the case that where an illuminated fingerpost sign is provided that there is no requirement for a bollard.

It is recommended that a bollard with blank face be provided between the circulatory carriageway and the C93C Clintery to Kingsford Road exit arm. A second bollard should also be provided on the southbound approach to the circulatory carriageway.

Recommendation accepted. A bollard with a blank face will be provided between the circulatory carriageway and the C93C Clintery to Kingsford Road exit arm. A second bollard will also be provided on the southbound approach to the circulatory carriageway.

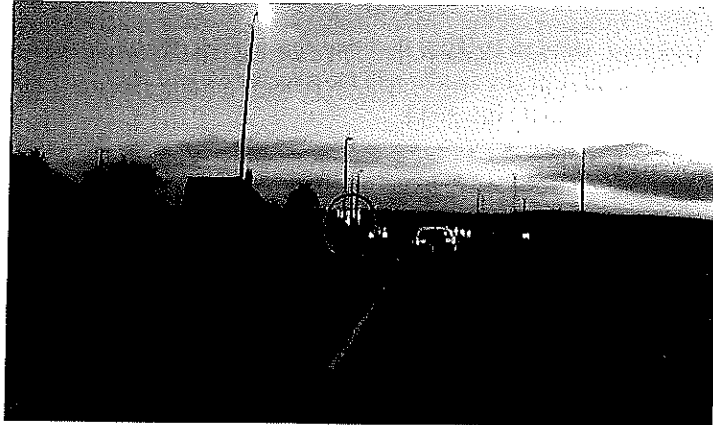
3.5.7 Problem

Location: A944, westbound approach to roundabout

Summary: The obscuring of sign legends can lead to drivers having difficulty interpreting the road layout ahead.

It was noted that the ADS on the westbound A944 on the approach to the roundabout was slightly obscured by the boundary wall of the private house on the southside of the A944.

It is recommended that if practical and possible that the height of the sign be adjusted to improve visibility to the lower legends.

Recommendation not accepted. We have undertaken a review of the sign, post and foundation design and it is not possible to increase the mounting height of the sign face. As the sign face is slightly obscured by the boundary wall but still becomes clearly visible, it is proposed to retain the sign in its current position.
