**A83 TARBET – CAMPBELTOWN TRUNK ROAD**

**STRONE POINT REALIGNMENT**

**ROAD SAFETY AUDIT RESPONSE REPORT**

**STAGE: 3**

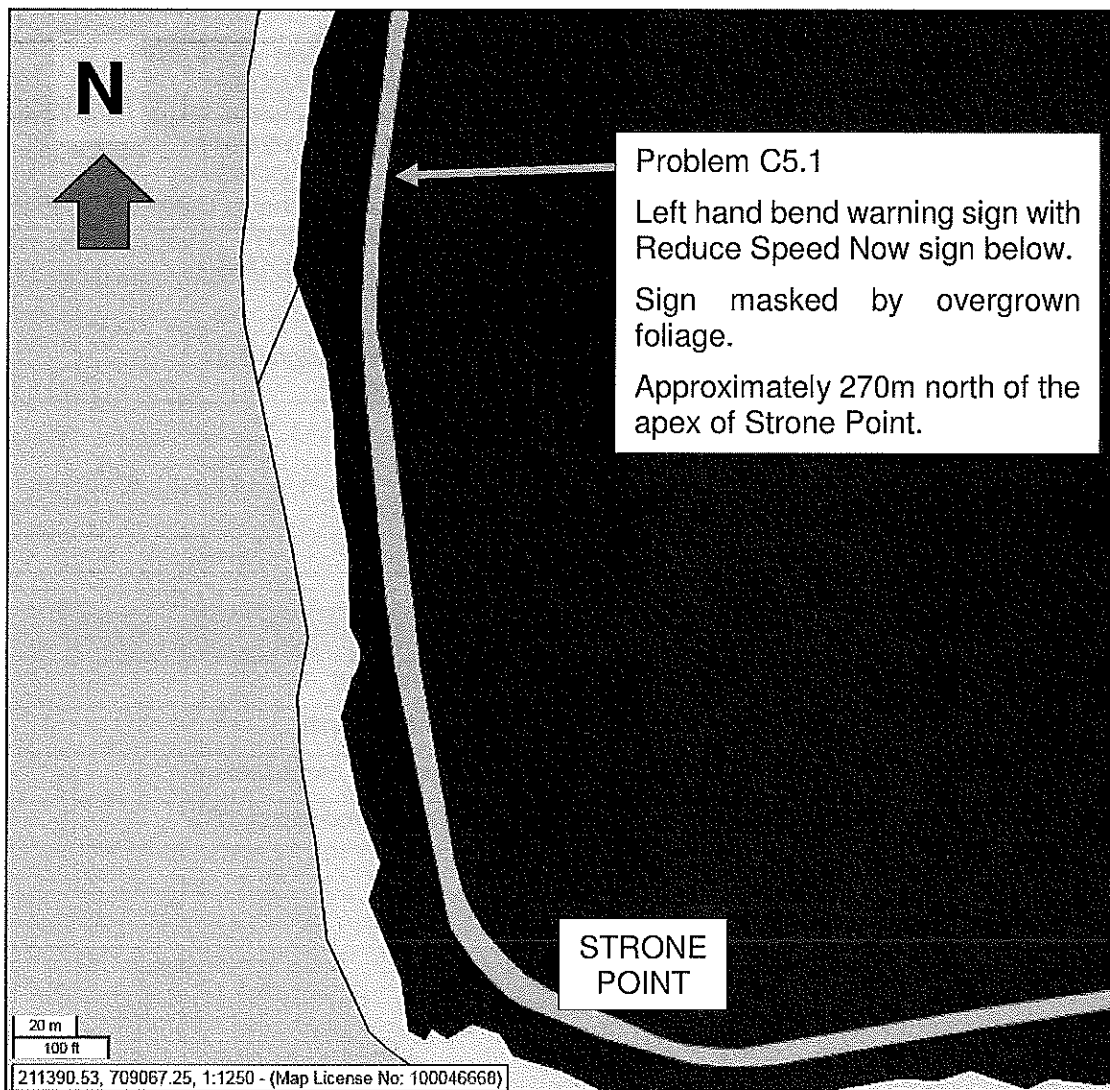
### APPENDIX B - Problem Location Plan and Photograph

LOCATION: Eastbound at Link Section Chainage 16520/58 – 3652 (approximately 270m north from the apex of the bend at Strone Point.)

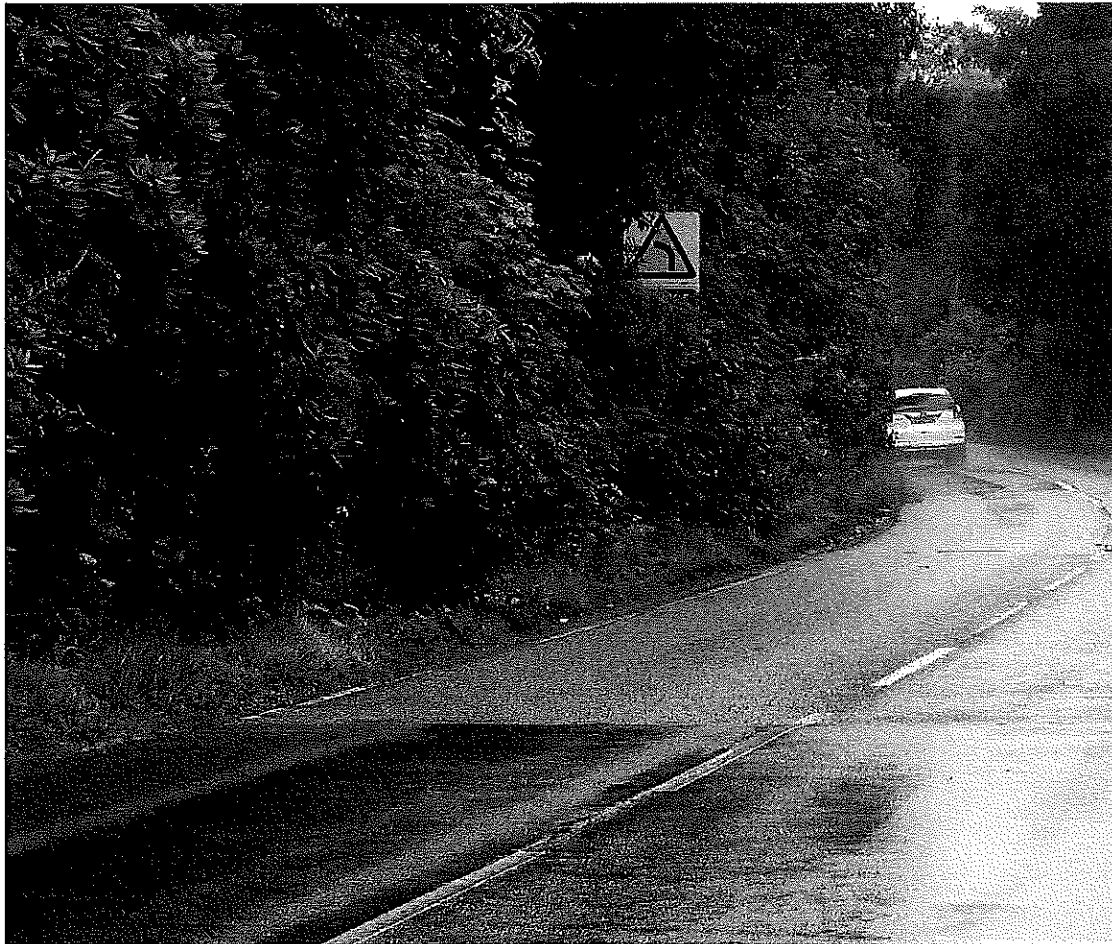
SUMMARY: The existing Left-hand bend warning sign with Reduce Speed Now sign fixed below, on the nearside of the carriageway is partially hidden by overgrown vegetation. This reduces the conspicuity of the sign making it easily missed on the approach to the bend which could result in late braking and loss of control type accidents.

Photograph of PROBLEM C5.1  
REDUCE SPEED NOW sign obscured by overgrown foliage.

Item	Problem	RSA Recommendation	Accept Problem / Recommendations	Accept Problem but Suggest Alternative Recommendation giving Reasoning	Disagree with Problem and Recommendation and Give Reasoning for Rejecting Problem / Recommendations
C5.1	<p>The existing Left-hand bend warning sign with Reduce Speed Now sign fixed below, on nearside of the carriageway is partially hidden by overgrown vegetation. This reduces the conspicuity of the sign making it easily missed on the approach to the bend which could result in later braking and loss of control type accidents.</p>	<p>Trim back the existing foliage and branches to provide a clear visibility of the signs for a minimum distance of 90m as detailed in the Traffic Signs Manual Chapter 4 Appendix A. The cutting back should be sufficient that future growth does not infringe on the sign visibility envelope.</p>	<p>Problem and recommendations accepted.</p> <p>The area of overgrown vegetation noted was outwith the Contract site boundary and therefore could not be addressed within the traffic management set up in place.</p> <p>Vegetation clearance will therefore be undertaken as part of BEAR Scotland's routine landscaping maintenance.</p> <p>It should be noted that an additional bend warning sign is located on the opposite verge as well as the presence of a Bend Ahead vehicle activated sign. The presence of these signs reduces the overall risk to road users and acts as mitigation until routine maintenance occurs through this section.</p>

RECOMMENDATION: Trim back the existing foliage and branches to provide a clear visibility of the signs for a minimum distance of 90m as detailed in The Traffic Signs Manual Chapter 4 Appendix A. The cutting back should be sufficient that future growth dose not infringe on the sign visibility envelope.
