Statement of Intent (SOI) Form:
Planned Maintenance Resurfacing

**A7 Hawick Police
Station
17/SE/0301/006**

Road Safety Audit Stage 2

A7 Guthrie Drive Pedestrian Improvements

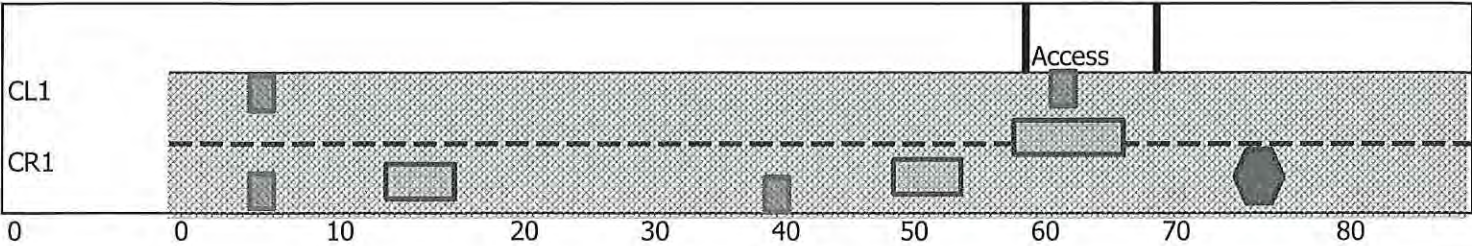
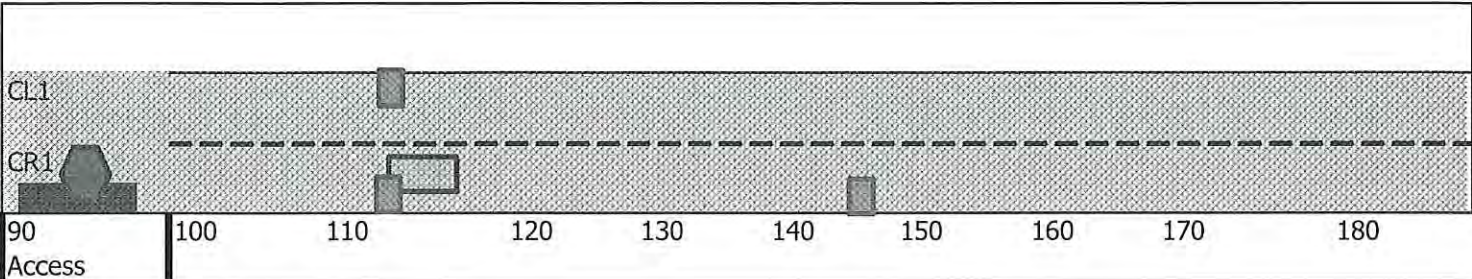
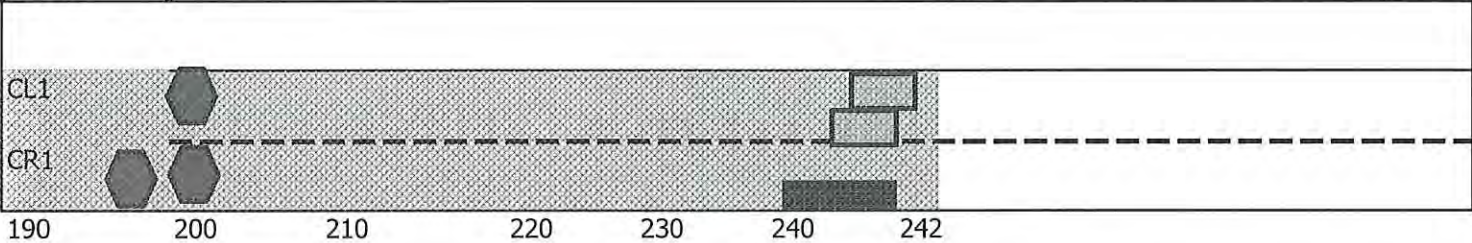
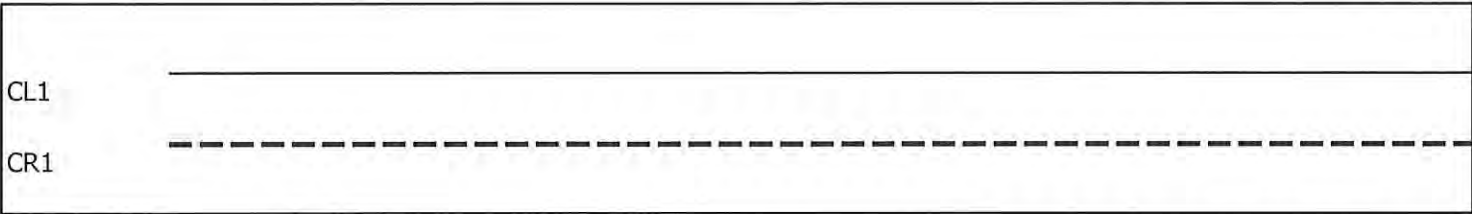
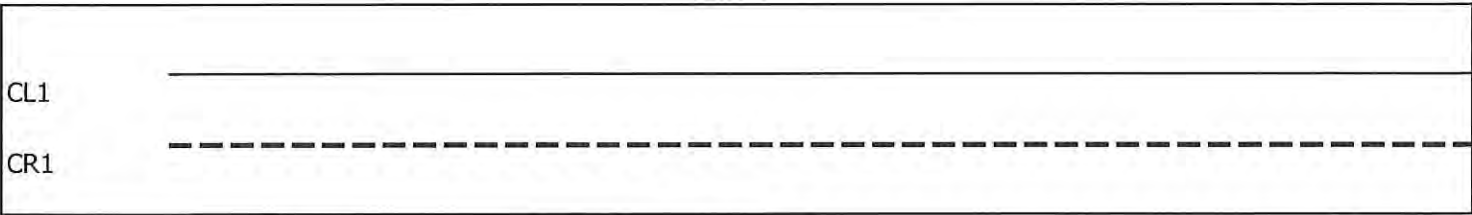
Visual Survey

SE62279042-235189458	Pothole (POTH CATEGORY 2	A7	11039/36	CAT2 POTHOLE, 8X0.5M	Chainage: 135m
SE59116146-341	Bituminous surf CATEGORY 2	A7	11039/36	A7 C/WAY N/B & S/B FRETING	Chainage: 226m

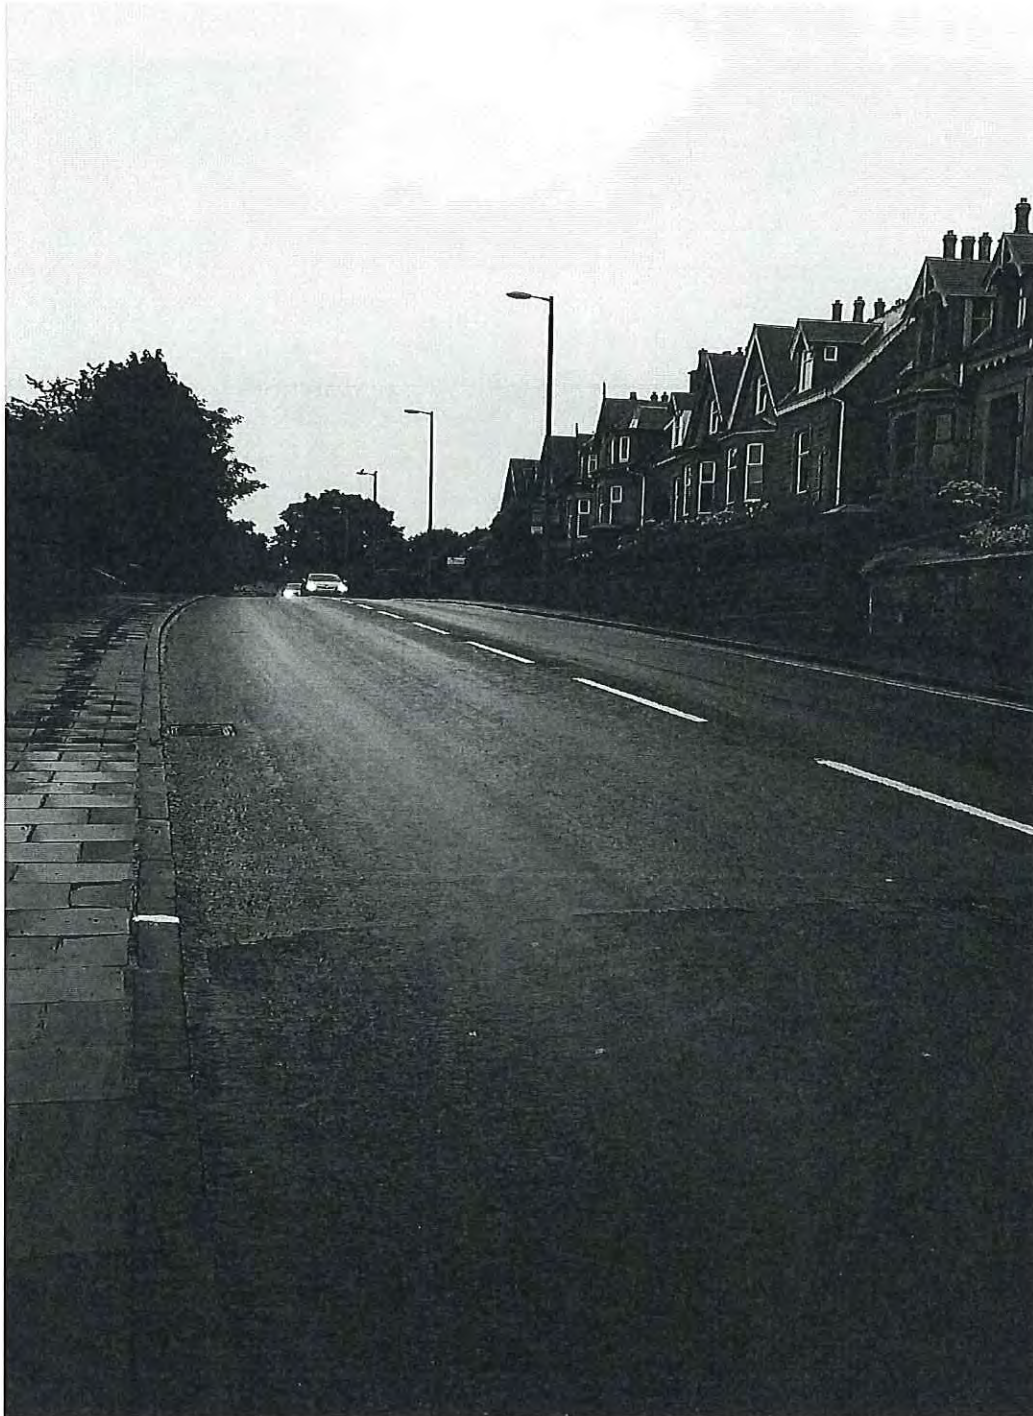
11039/36 ch56m start of scheme, fretting

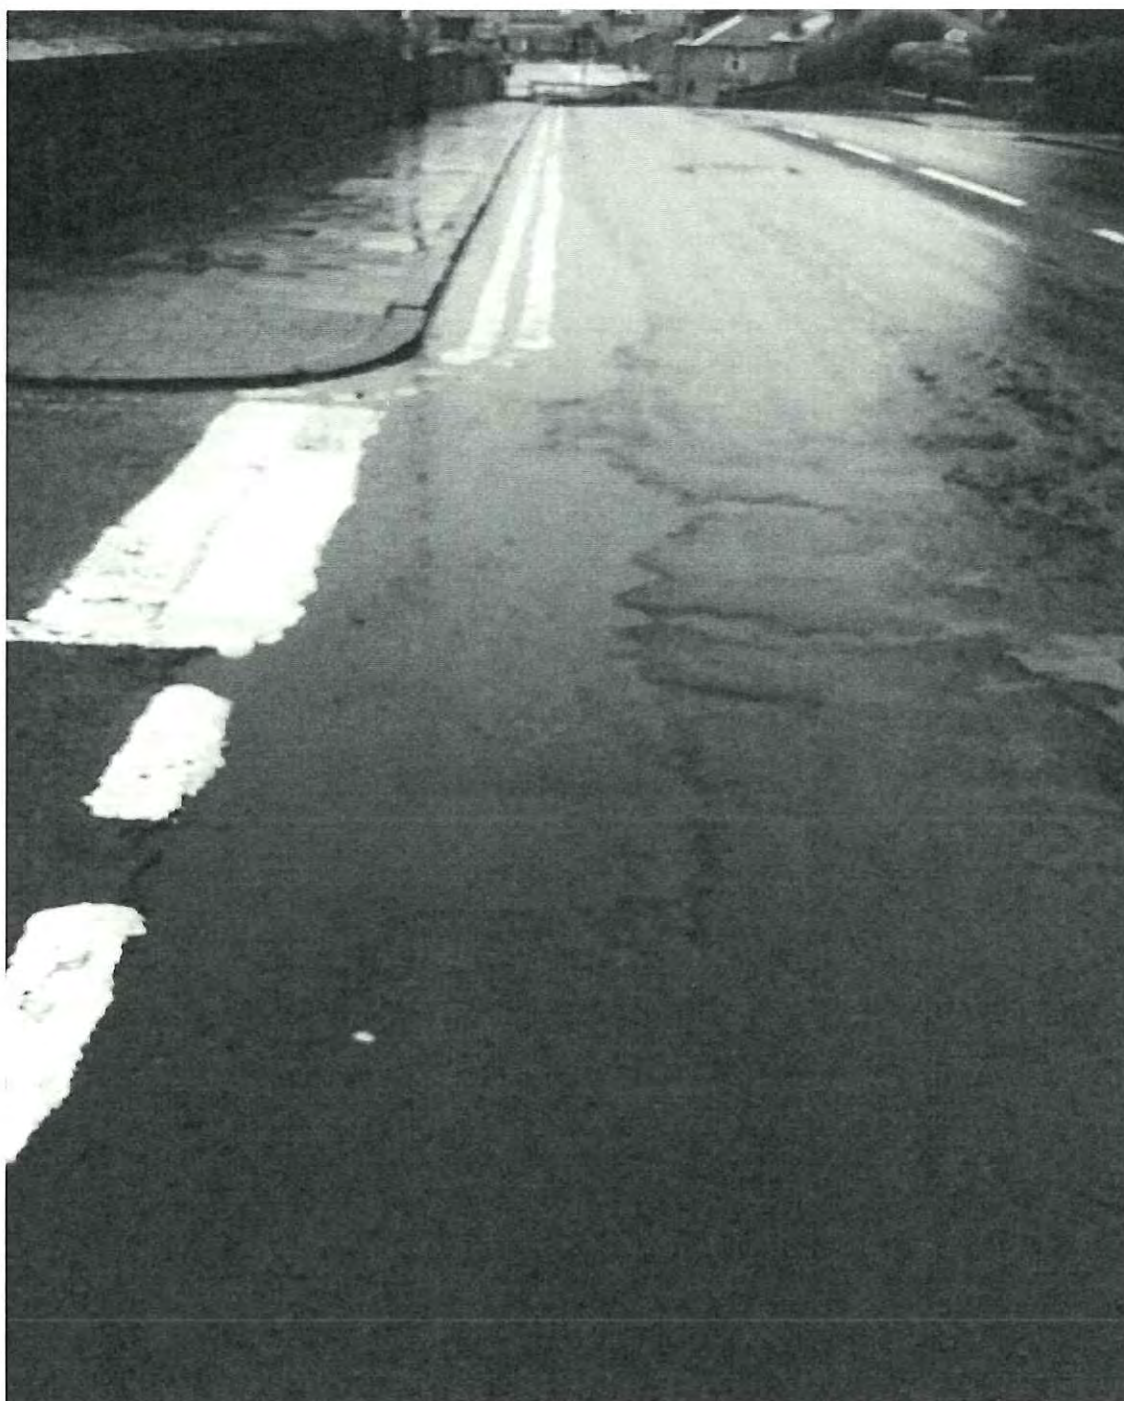
11039/36 ch95m SB starting to rut and fretting

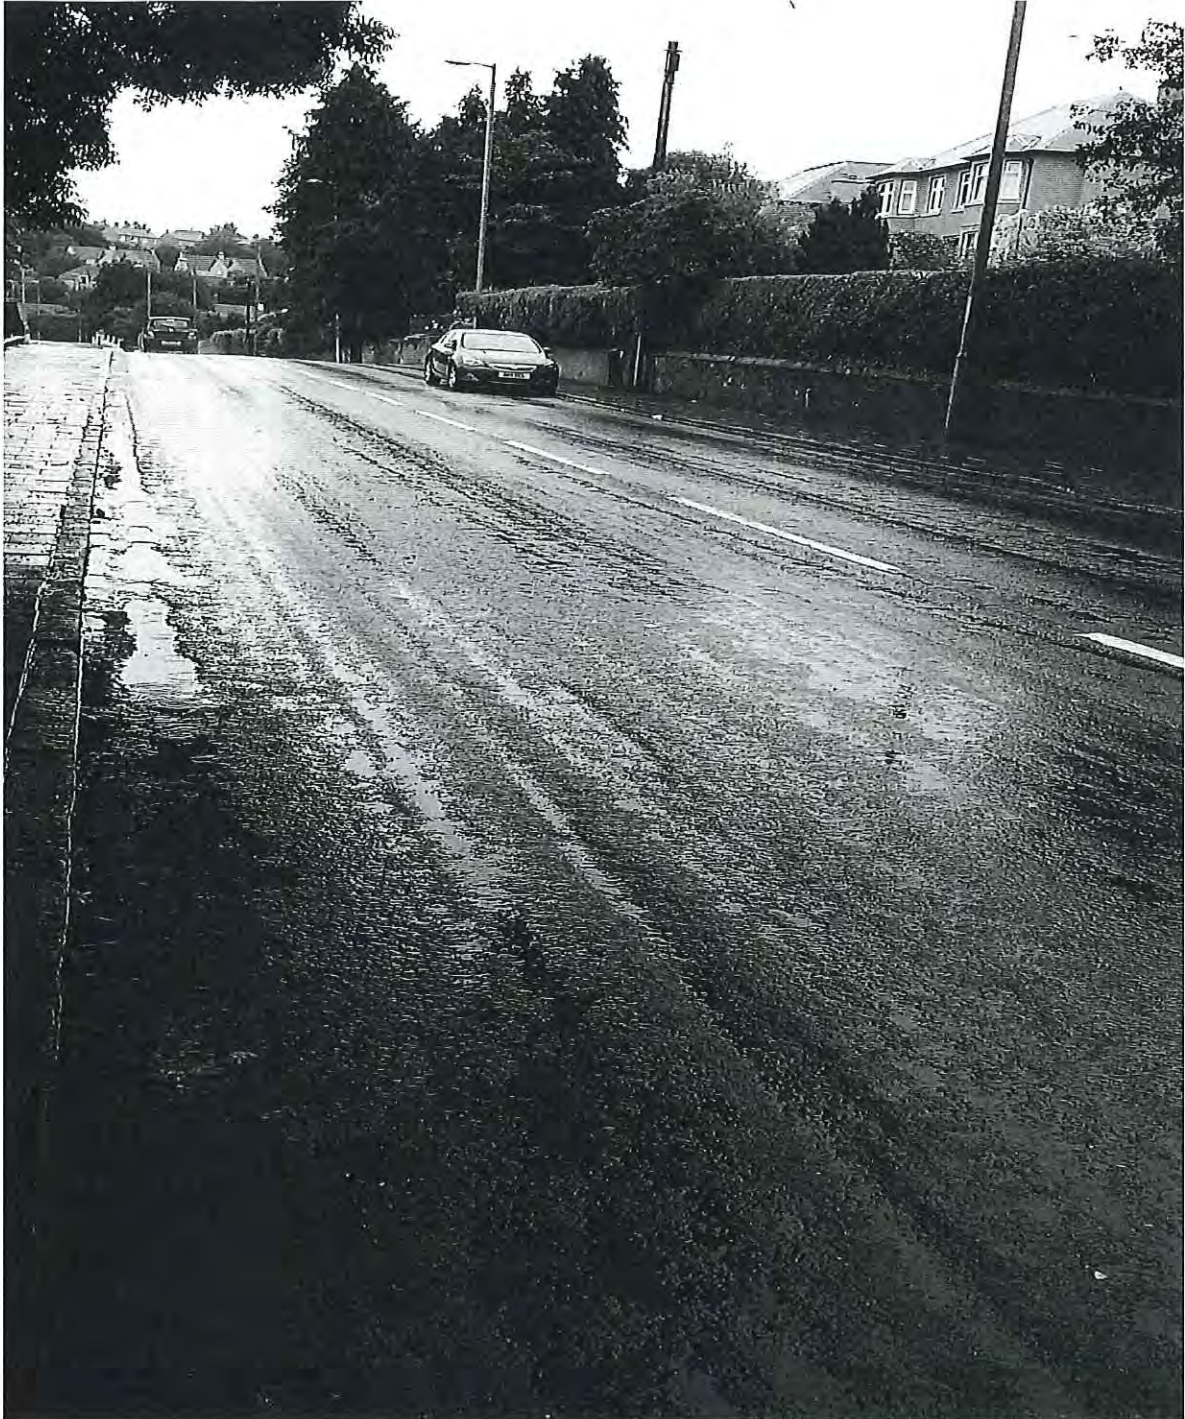
11039/36 CH113m fretting

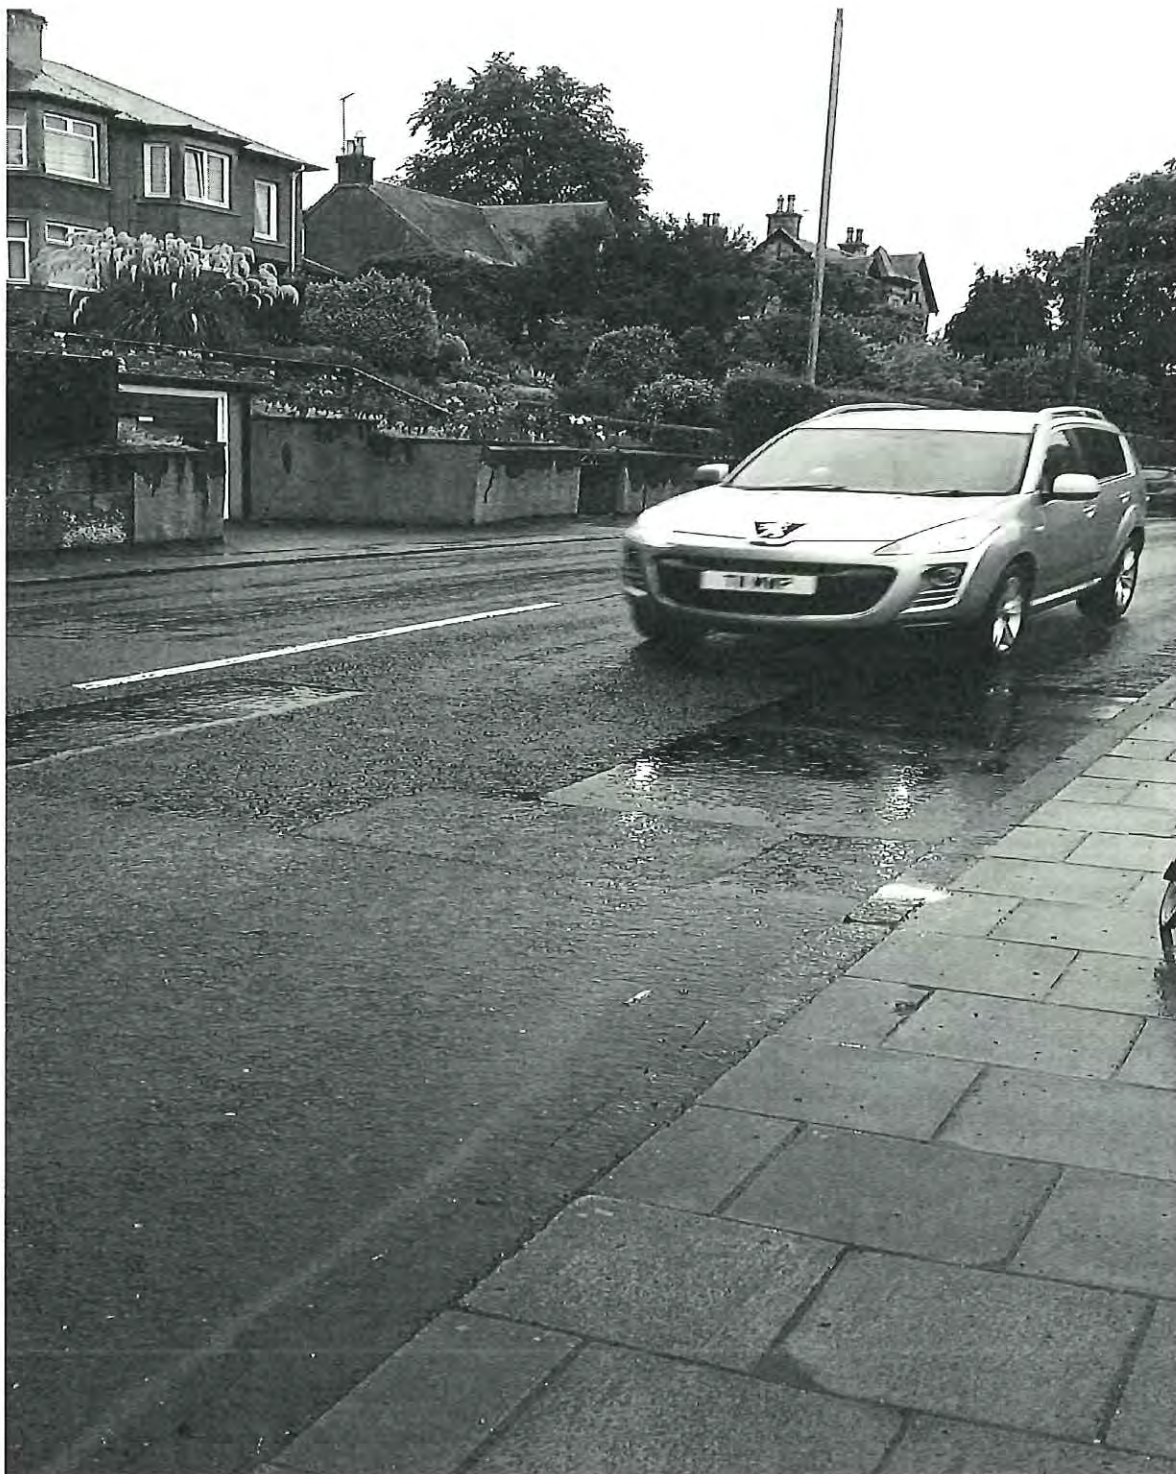
11039/36 ch298m end of scheme old patches and fretting

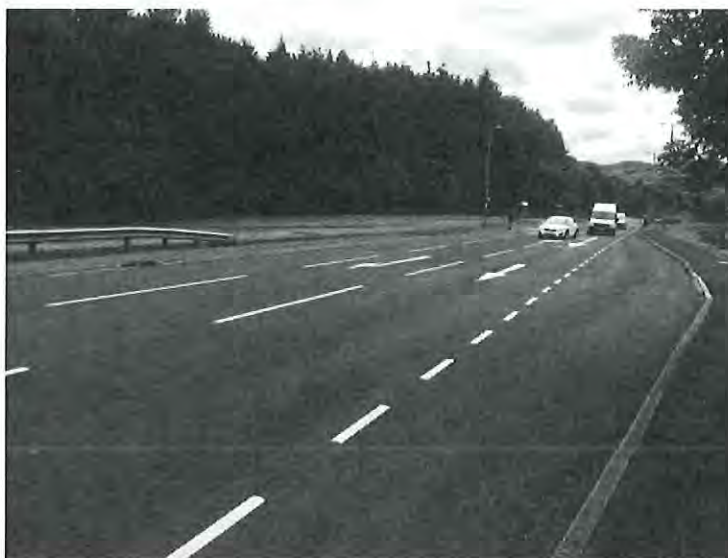
Location: Pedestrian crossing location 3

Summary: There is clear evidence of vehicles overrunning the existing central hatching when turning right into the B6359 road. The scheme will introduce a refuge island where the markings currently exist resulting in the potential of it being stuck by vehicles.

Ensure that the central hatched markings reflect vehicle swept paths and the stacking length required for the two side road junctions

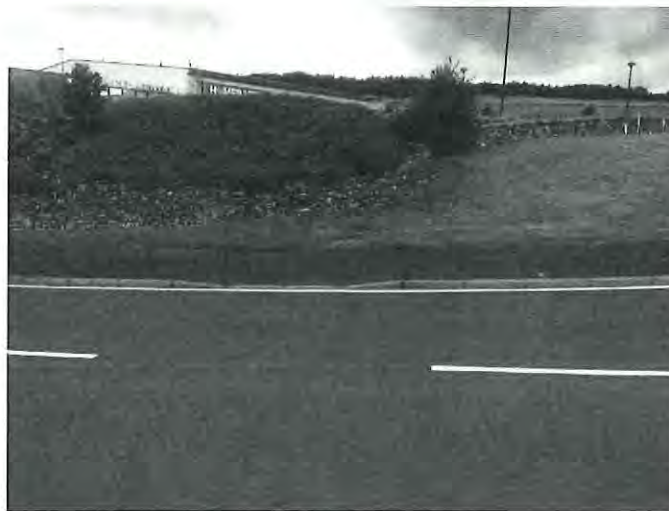
Location: Pedestrian crossing location 2

Summary: The surface of the western footway at crossing point 2 is uneven and presents a trip hazard for users. To effectively remove this hazard and ensure that the footway has a consistent gradient the existing manhole could be lowered to avoid issues for the mobility impaired.

Reduce the level of the existing manhole so that a consistent surface level is provided
