A9 Dualling: Kinraig to Dalraddy Stage 3 Cycle/Accessibility Audit

Client:	Wills Bros. John Paul JV Ltd.
Project Title:	A9 Dualling Kinraig to Dalraddy
Document Title:	Stage 3 Cycle/ Accessibility Audit
Document No:	MGT0275RP0022

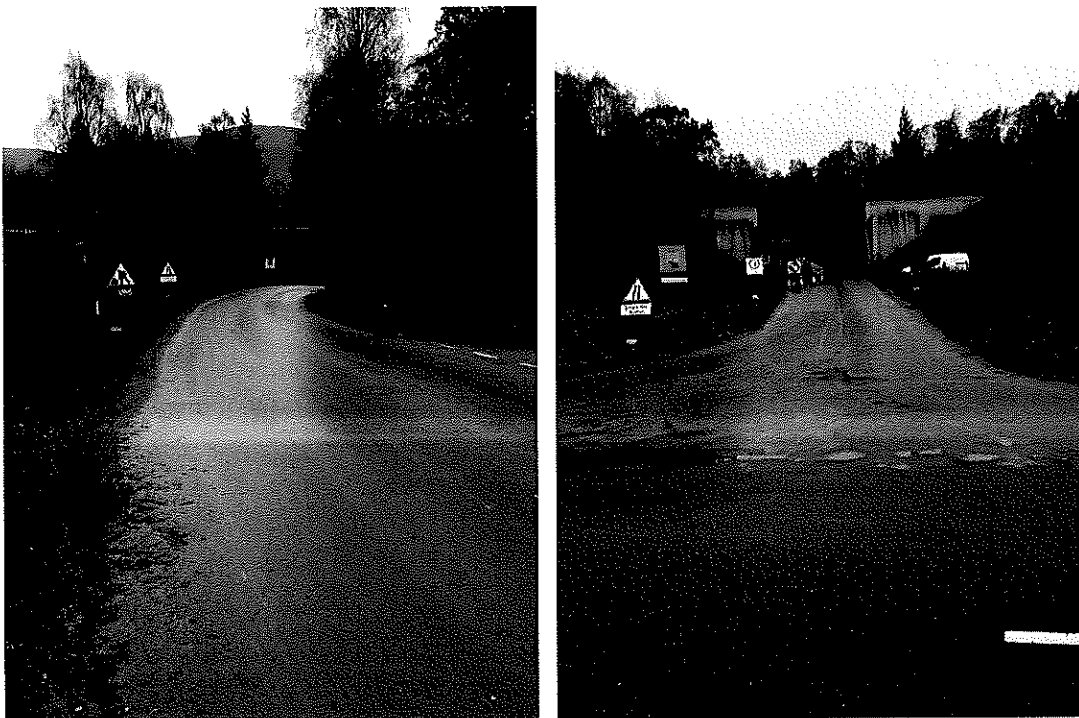
Location: Junction to RZSS Highland Wildlife Park, approx. Ch. 0

Summary: No signage on local road to identify NMU route.

There is no signage to identify the location of the NMU route to people travelling on the Local Road.

Problem 3.1 –No Signage Provided to Identify NMU Route

Appropriate signage should be provided to identify location of NMU route.

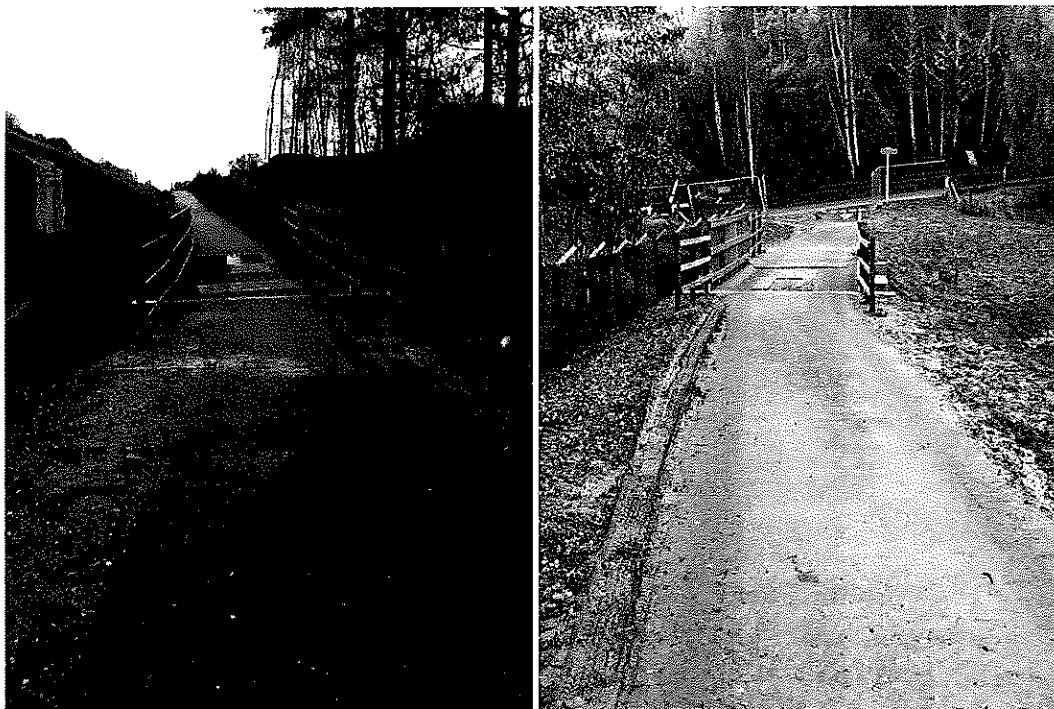
Location: ST01 NMU Bridge, approx. Ch. 30

Summary: Approaches to and from the NMU Bridge.

The fencing approaching and departing the parapets at ST01 are provided in line with the NMU track. This could lead to NMU's colliding head-on with the fencing causing injury.

Problem 3.3 – Fencing at ST01

Fencing at parapets should be tapered.

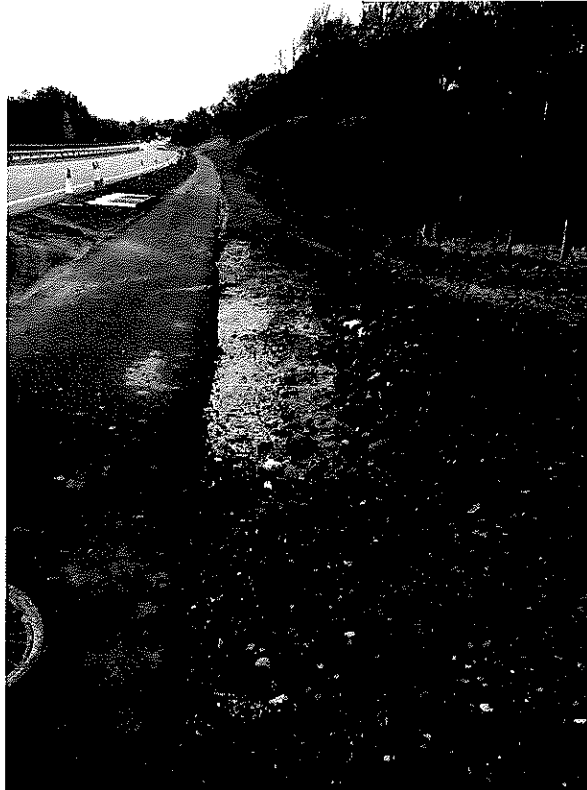
Summary: Verges unfinished or at lower level to the NMU Route.

There are several instances throughout the scheme where verge works are unfinished, or are at a lower level to the NMU Route. Cyclists who may be required to take evasive action to avoid other users inadvertently may travel into the verge and fall due to the level difference.

Problem 3.6 – Example of Verge Not Level with Cyclepath at Ch. 500

It should be ensured that the verges are flush with the level of the cyclepath.

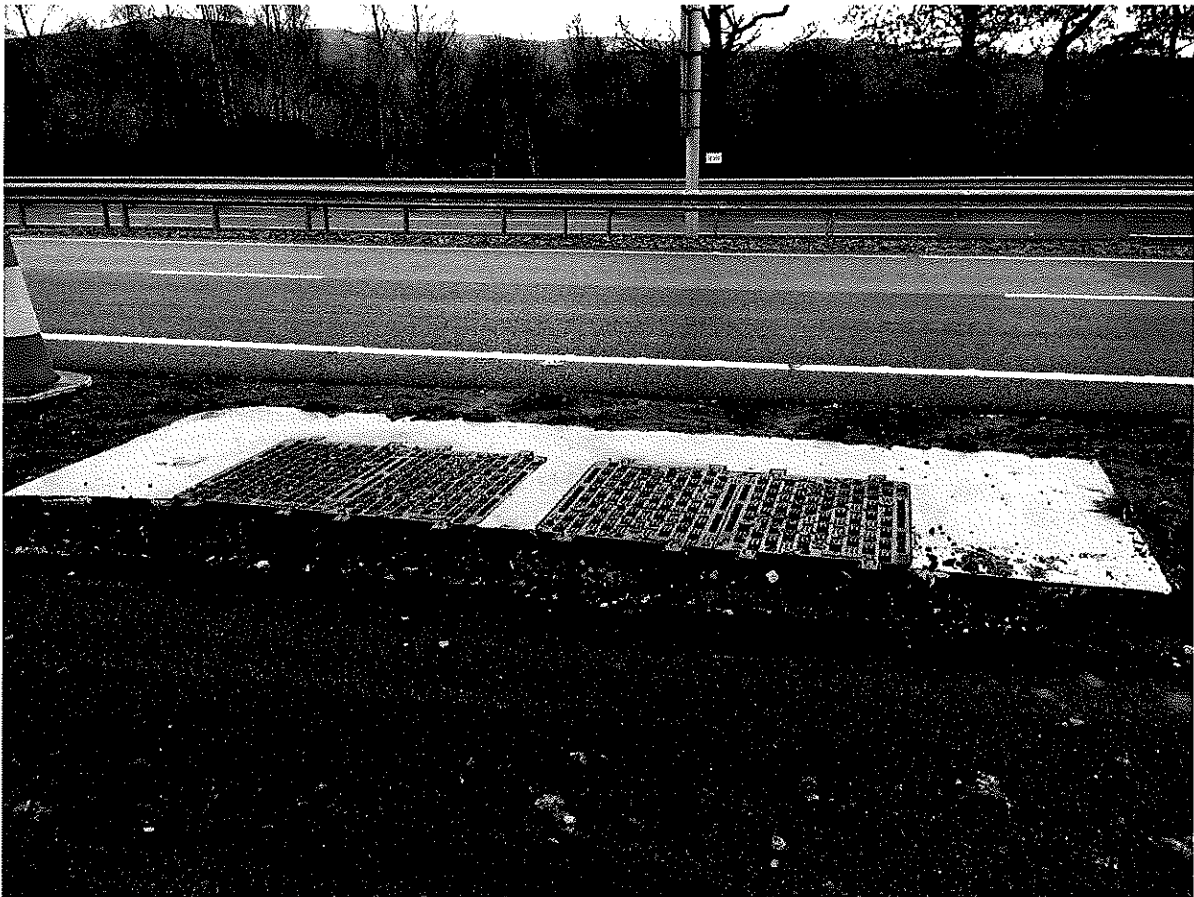
General; Raised/lowered Service Covers

There are several instances throughout the scheme where services covers are proud and lower than the adjacent NMU route. Cyclists who wander or are required to take evasive action to avoid other users may collide with these services resulting in falls due to the level difference.

Problem 3.7 – Example of Rasied Service Covers

Service covers should be flush with the adjacent ground level.

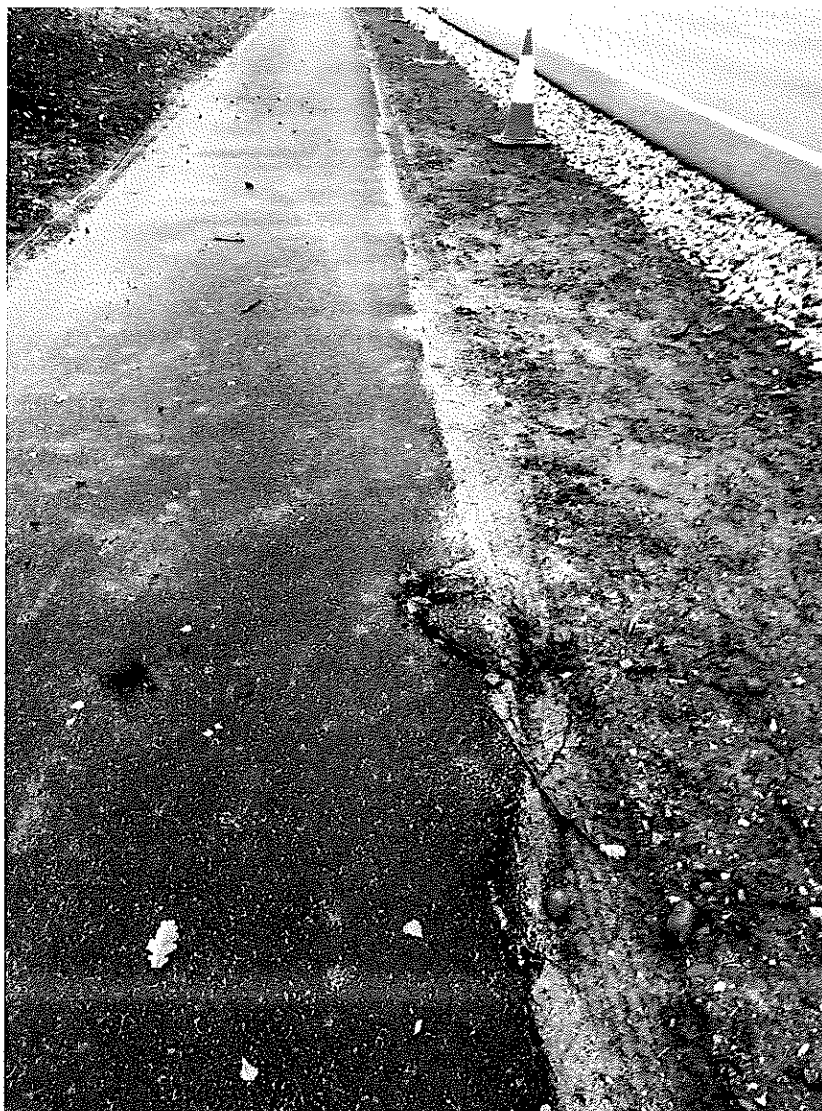
General; cracking of pavement at the edge of the NMU route.

There is a cracking in the NMU track surface at a few locations which appear to be result of vehicle tracking. This may result in falls and injuries due to uneven surfaces

Problem 3.8 – Cracked Surface at Ch. 1060

The pavement and verge surfaces should be repaired to ensure no cracking or uneven surfaces exist.

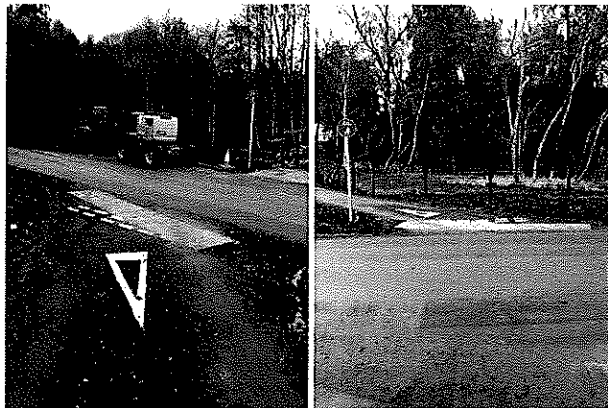
Location: Uncontrolled crossing point Ch. 1700 approx., south side of ST02.

Summary: Surfacing, marking and tactile paving unfinished

Surfacing, marking and tactile paving appear unfinished and may lead to confusion causing conflict between users leading to injury.

Problem 3.10 – Unfinished Work at Crossing

Works should be completed with tactile and markings provided in accordance with best practice.

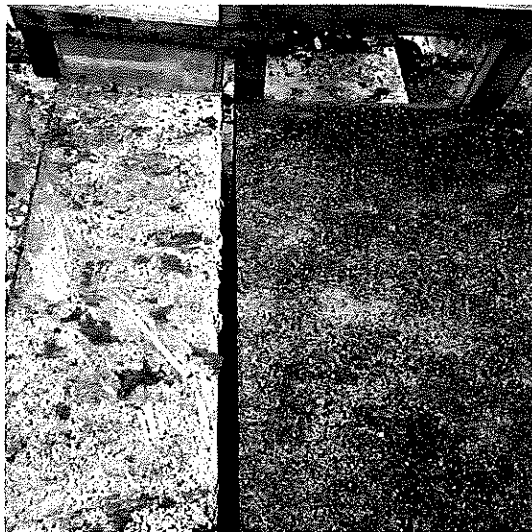
Location: NMU Watercourse Bridge crossing point Ch. 1720m approx.

Summary: Gap in NMU Bridge.

There is a 50mm gap in NMU Bridge surface. NMU's could trip and fall on this gap whilst riding across it.

Problem 3.11 – Gap in NMU Watercourse Crossing Bridge

The gap between the pavement and NMU bridge surface should be closed.

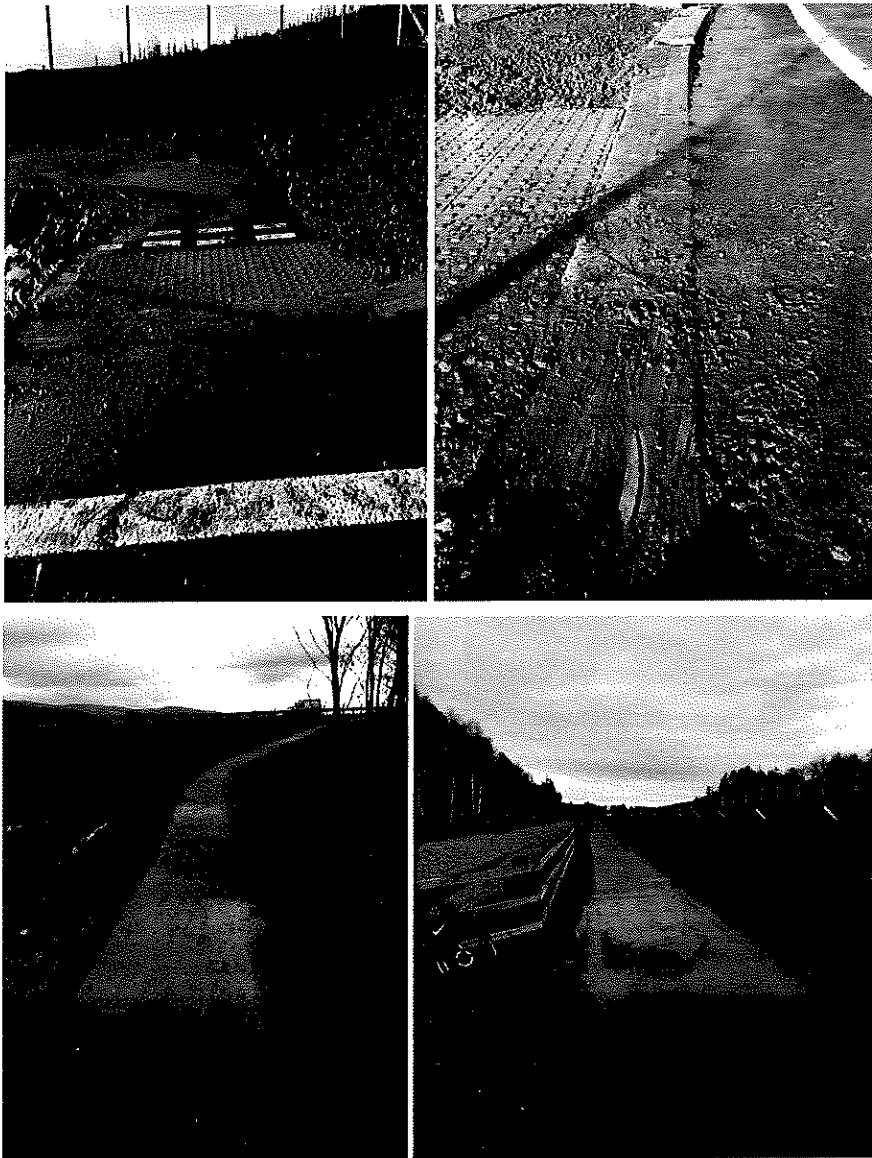
General; mud and debris on NMU surface.

There is mud and debris on the pavement surface at various locations along the NMU route. This can lead to cyclists falling causing injury.

Problem 3.13 – Examples of Mud and Debris on NMU Route

NMU route should be cleaned and all debris removed.

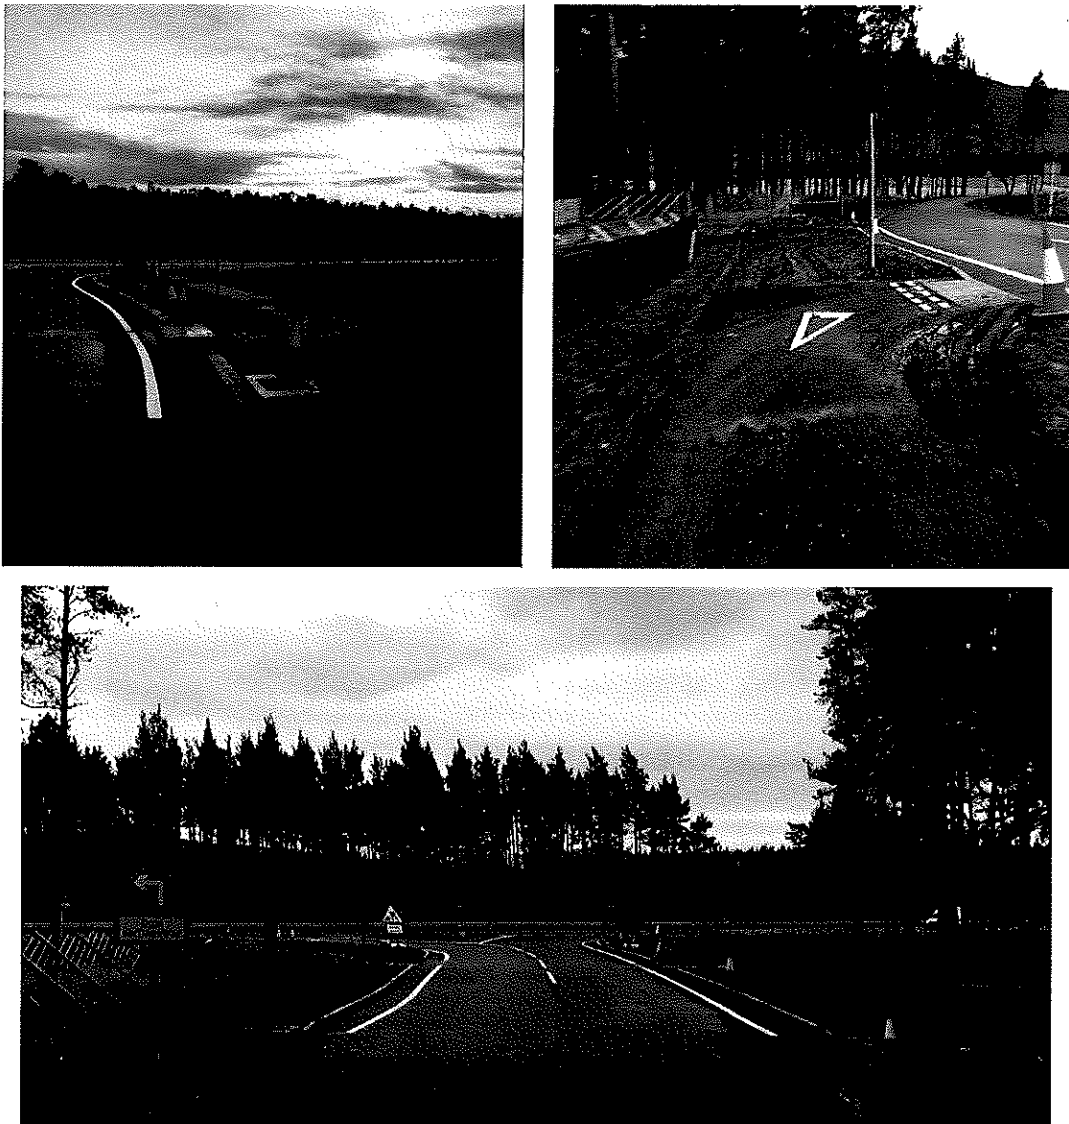
Location: Junction at Ch. 2350 approx. and CH. 6100 approx.

Summary: Geometric profile of cyclepath.

The cyclepath at junctions Ch. 2350 approx. and Ch. 6100 approx. are at 90 degrees to the road cycle lane. Cyclists seeking to make the 90 degree turn may stray into the road to make the turn leading to conflicts with vehicles and side swipe collisions.

Problem 3.14 – Examples of Cycle Path Diverting Through 90 degrees Ch. 2350 Approx. (Top Left) Ch. 6100 Approx. (Top Right) and Crossing Points at Junction at Ch. 6100 Approx. (Bottom)

The cyclists should be provided with appropriate geometry for turning without needing to enter the road carriageway and facilitate easier passing.

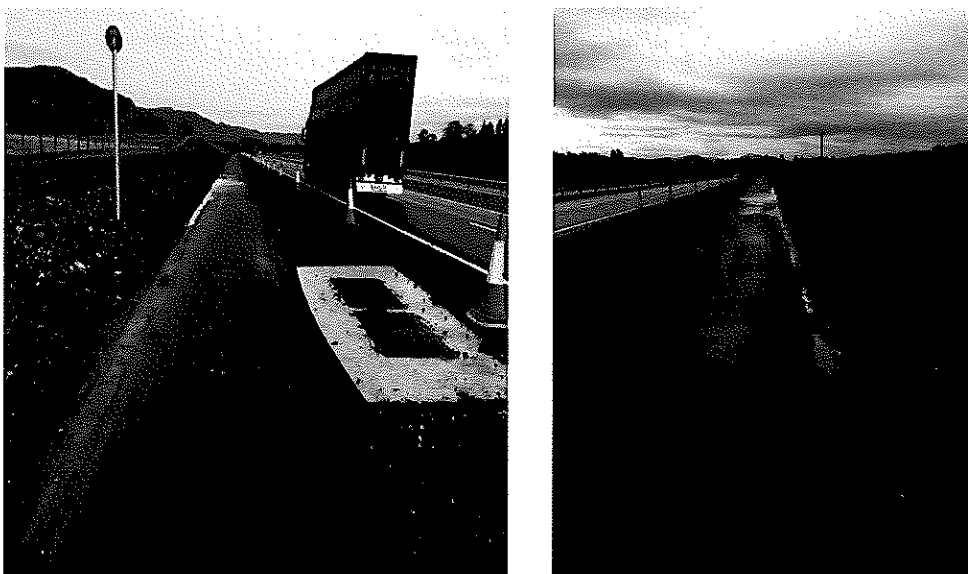
Location: Ch. 2450 to Ch. 2700 approx.

Summary: Drainage of NMU surface.

During the audit, ponding of water was noticed between Ch. 2450 to Ch. 2700 at the bottom of the embankment. This may lead to users making avoidance manoeuvres and/or black ice during freezing weather leading to falls/injuries.

Problem 3.15 – Examples of Ponding on the NMU Surface

Positive drainage should be provided to eliminate standing water occurrence.

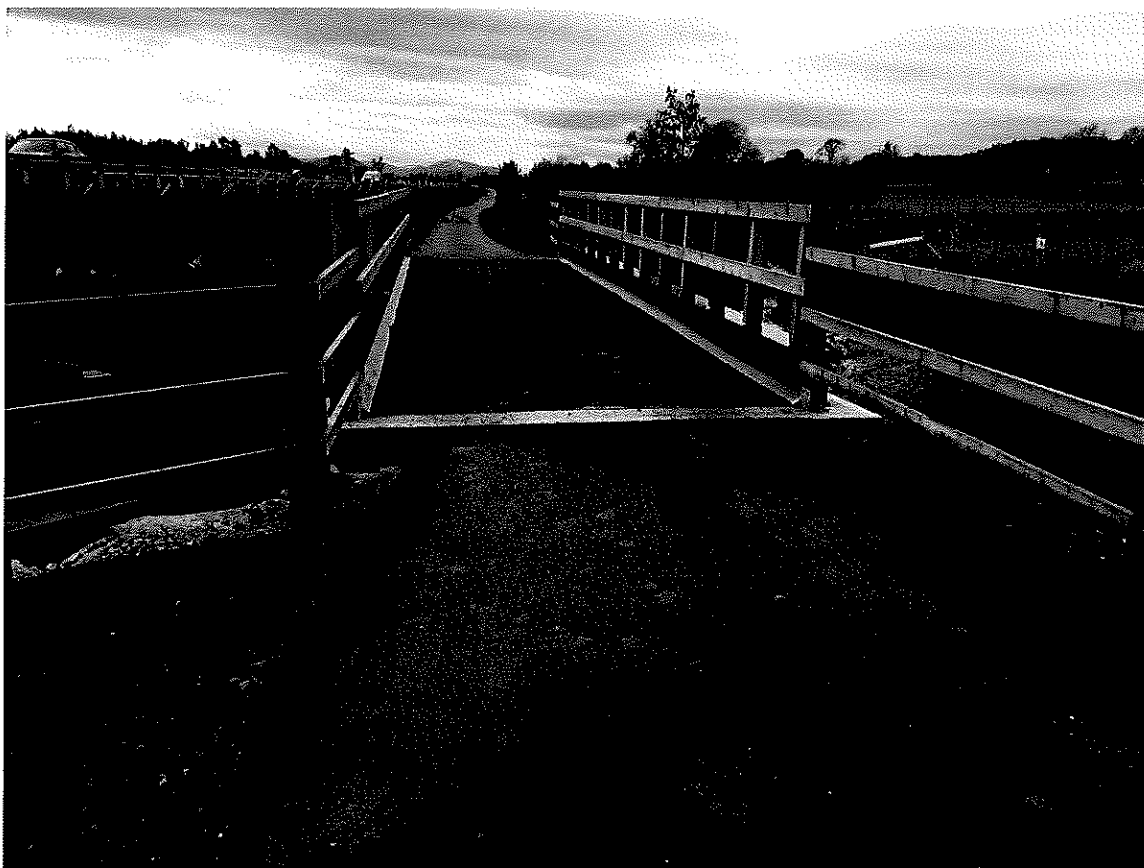
Location: NMU Watercourse Bridge crossing Ch. 3125 approx.

Summary: Hazard to cyclist and pedestrians.

There is a 200mm drop in level difference from the surface of the NMU bridge to the adjacent ground level as shown in the photo below. NMUs may trip and fall resulting in serious injuries.

Problem 3.16 – NMU Watercourse Bridge Ch.3125 Approx.

The ground level at the back of the structure needs to be raised to the level of the NMU surface.

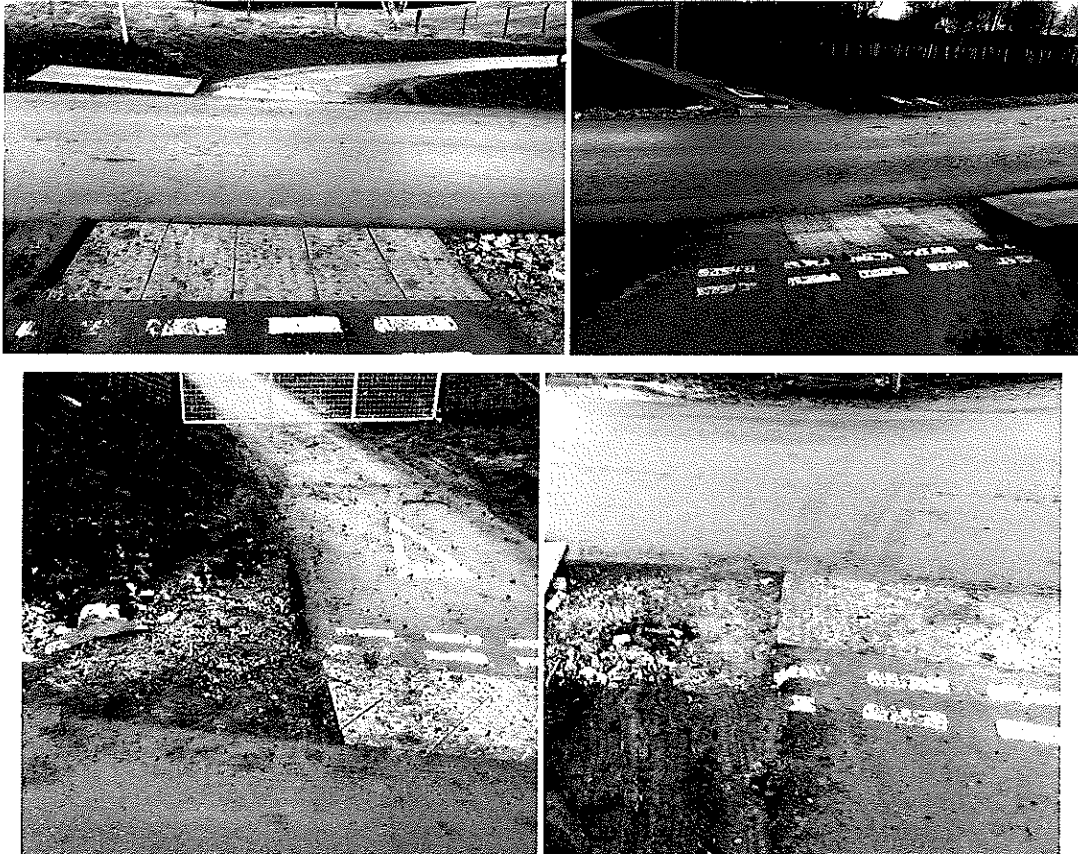
General; unfinished works around tactile paving.

Verge / surface works are incomplete around tactile or at a lower level than that of the NMU track. NMUs could trip and fall over this hazard resulting in serious injuries.

Problem 3.17 – Examples of Unfinished Works Around Tactile Paving

Verges should be flush with the level of the adjacent NMU track.

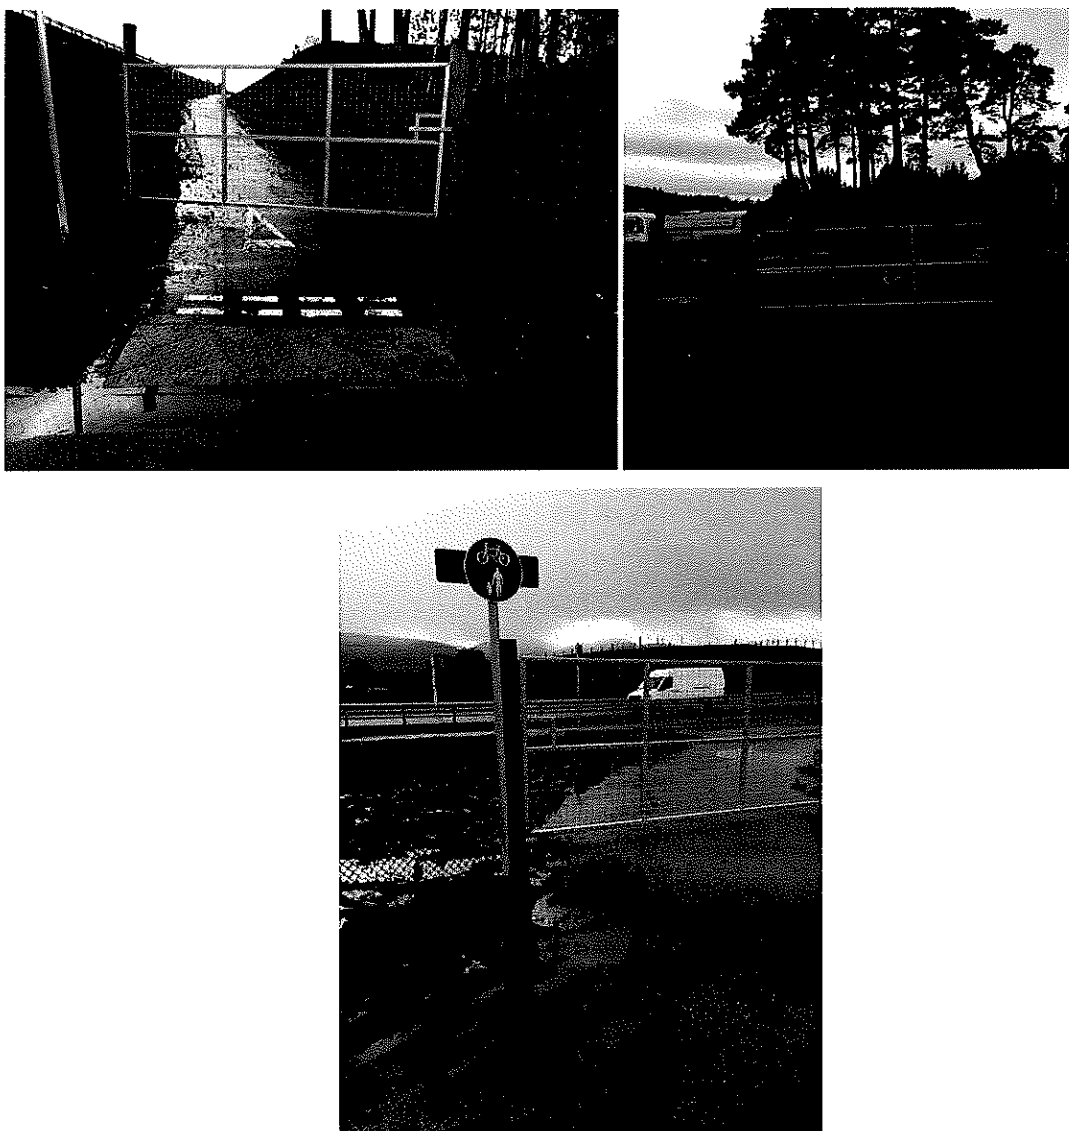
Summary: Gates at NMU crossings at Ch. 4450 and Ch. 6850

At the time of the audit some installed gates presented difficulty when opening and closing due to presence of unlevel ground, ponding, etc. This may lead to users not using or not closing gates causing safety problems.

**Problem 3.20 – Examples of Gate Openings at Ch. 4450 NMU Crossing (Top Left and Top Right)
Example of Gate Opening at Ch. 6850 (Bottom)**

A suitable level surface should be provided from both sides to enable all desired users to easily open and close gates.

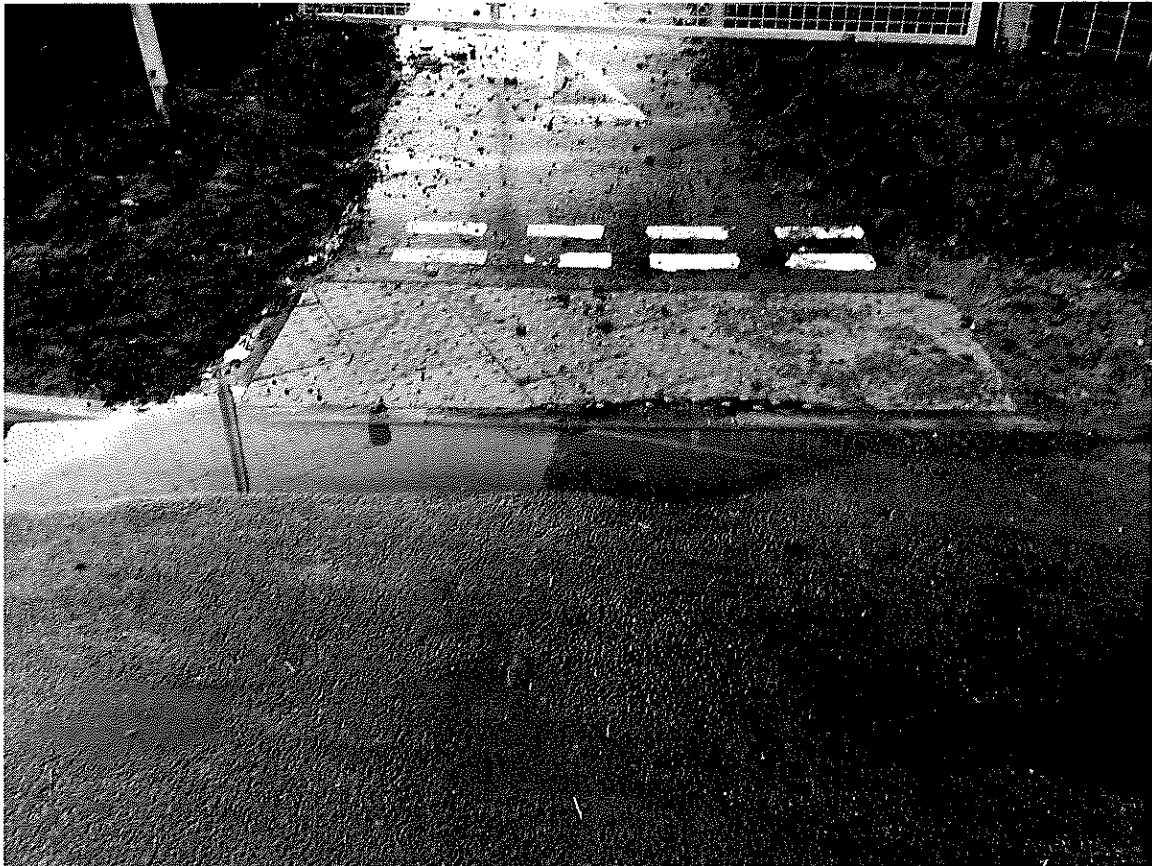
Summary: Standing water at NMU crossings.

There is standing water at a number of crossings. NMUs may deviate from the desire line or slip during icy conditions leading to injury.

Problem 3.22 – Standing Water at NMU Crossing Points

Positive drainage measures should be provided to ensure ponding does not occur.

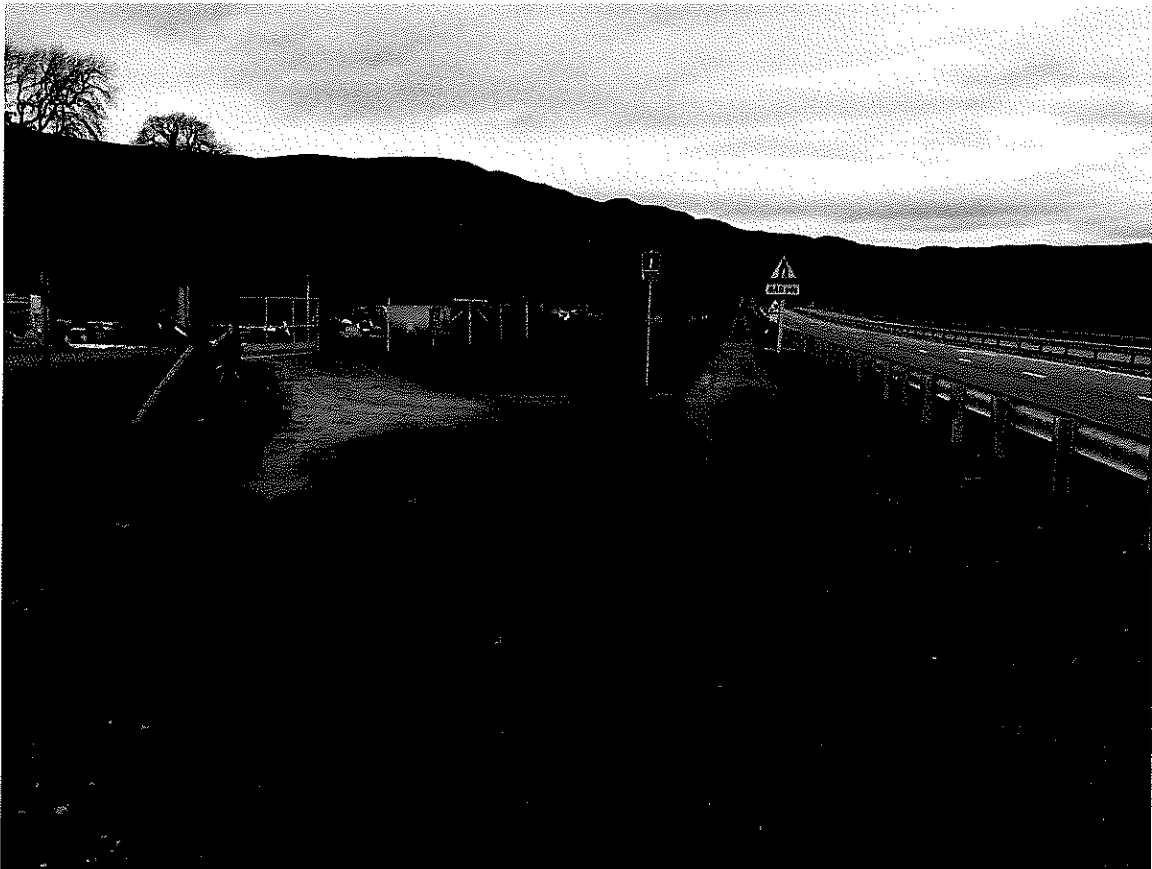
Location: End of shared NMU track, Ch. 6850 approx.

Summary: Hazard to NMUs.

End route signage has been provided for NMUs travelling northbound at Ch. 6900 approx. However, NMUs may continue northbound along the NMU route due to the unrestricted access. This may lead to unauthorised crossings further north.

Problem 3.23 – End of Shared NMU Track

A temporary restraint should be installed to further discourage NMU's continuing northbound.

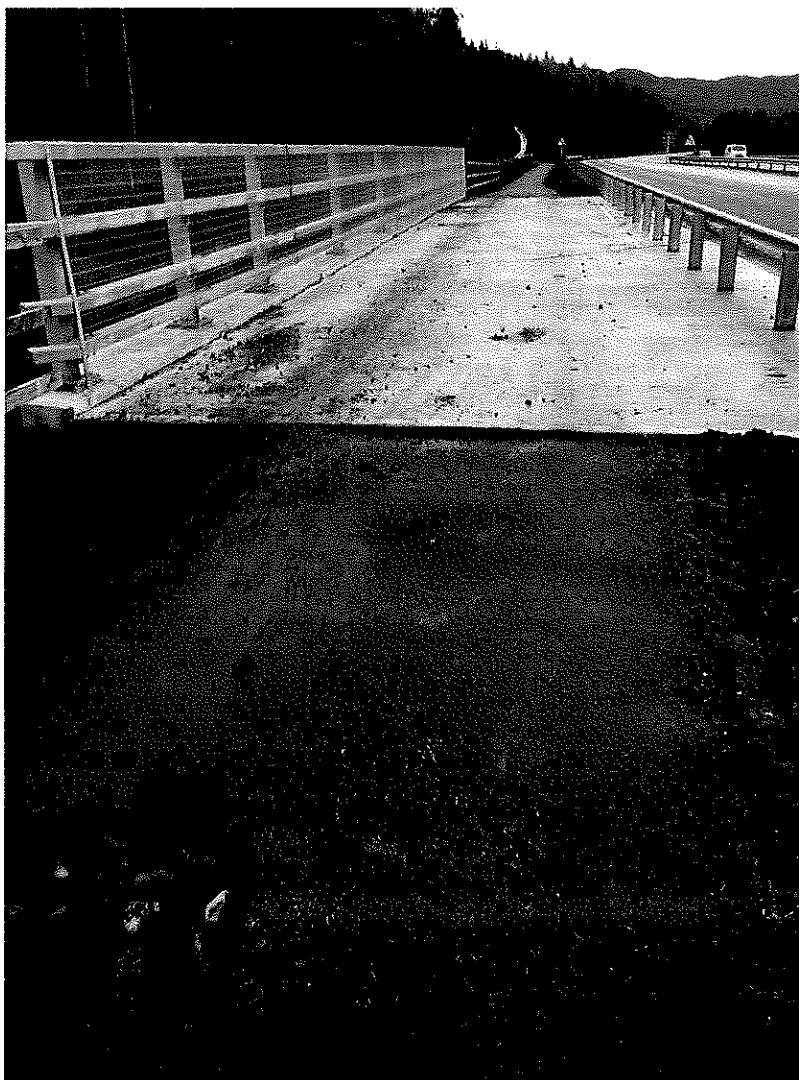
Location: Ch. 7180 approx., ST08

Summary: Geometric profile across ST08.

There is a sudden level difference from where the cyclepath joins the concrete surface of the Structure ST08. Cyclists traveling across may trip and fall across this abrupt level difference.

Problem 3.24 – NMU Track Approach to ST08

Ensure smooth transition onto structure deck.

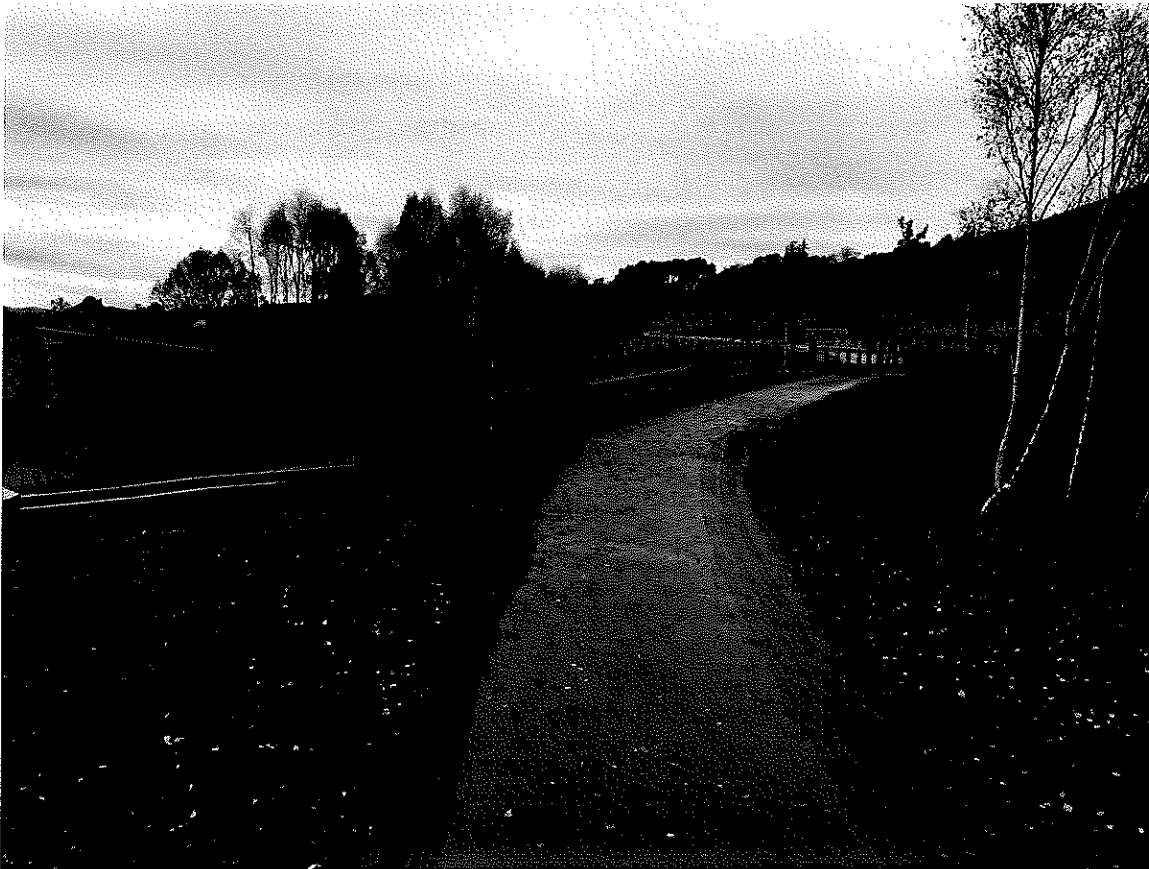
Location: General, NMU Bridge Crossings

Summary: Timber post and rail fencing

Cyclists can build up high speeds on long sustained gradients. Gates and fencing may suddenly appear in front in cyclists at night. This could lead to cyclists colliding with these hazards resulting in serious injury.

Problem 3.25 – Approach to NMU Bridge Crossing

Reflective tape should be installed on fences and gates on high speed approaches to ensure visibility at night.

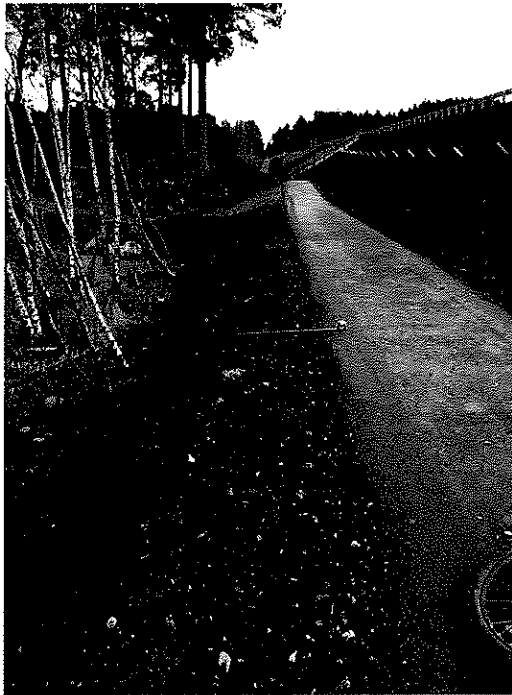
Location: Ch. 3850 approx.

Summary: Risk to NMU's.

Only a 1m verge is provided along the top of a high embankment at Ch.3850 approx. The recovery zone for NMU users along this section of the NMU track is narrow and could lead to serious injuries due to falling from embankments.

Problem 3.27 – NMU Track at Ch. 3850

Consideration should be given to the need for protective fencing along this section of the NMU track.
