Document: Form 162	Design of Reactive Operations

Scheme: Monthly Lump Sum (Category 1)	L.A Number: 02646521
Scheme Identifier: 19/NW/0701/001	RMMf ID: NW34514366-236805973,4,6,8, 81
Operations Instruction: OI/19NW02646

Route	A830	Location	EAST OF GLEN FINNAN
-------	------	----------	---------------------

Description of Defect(s):
Pothole (POTH); Dirty sign (DIRT) *patch number 4 to 85 done*

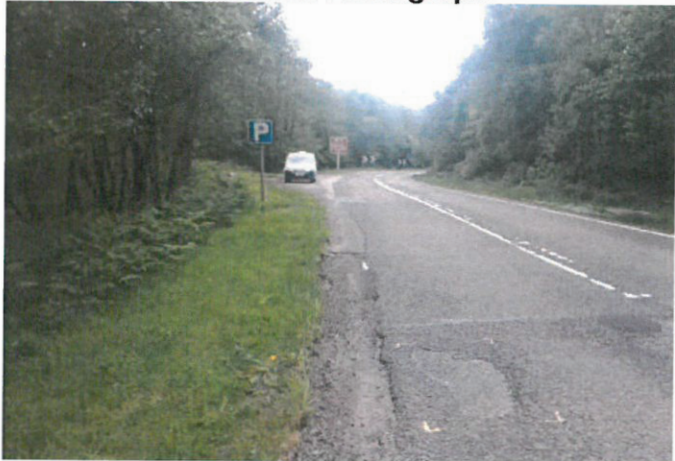
Location Photograph

Inspectors findings (include dimensions):
Patch x 4; clean sign
