Freedom of Information Request
Reference FOI/19/02250

From: redacted 11(2)
Sent: 01 May 2019 12:45
To: redacted 11(2)
Cc: redacted 11(2)
Subject: redacted - SW - Lesmahagow - redacted 11(2)
Follow Up Flag: Follow up
Flag Status: Flagged

Subject: M74 jct 10 Manhole

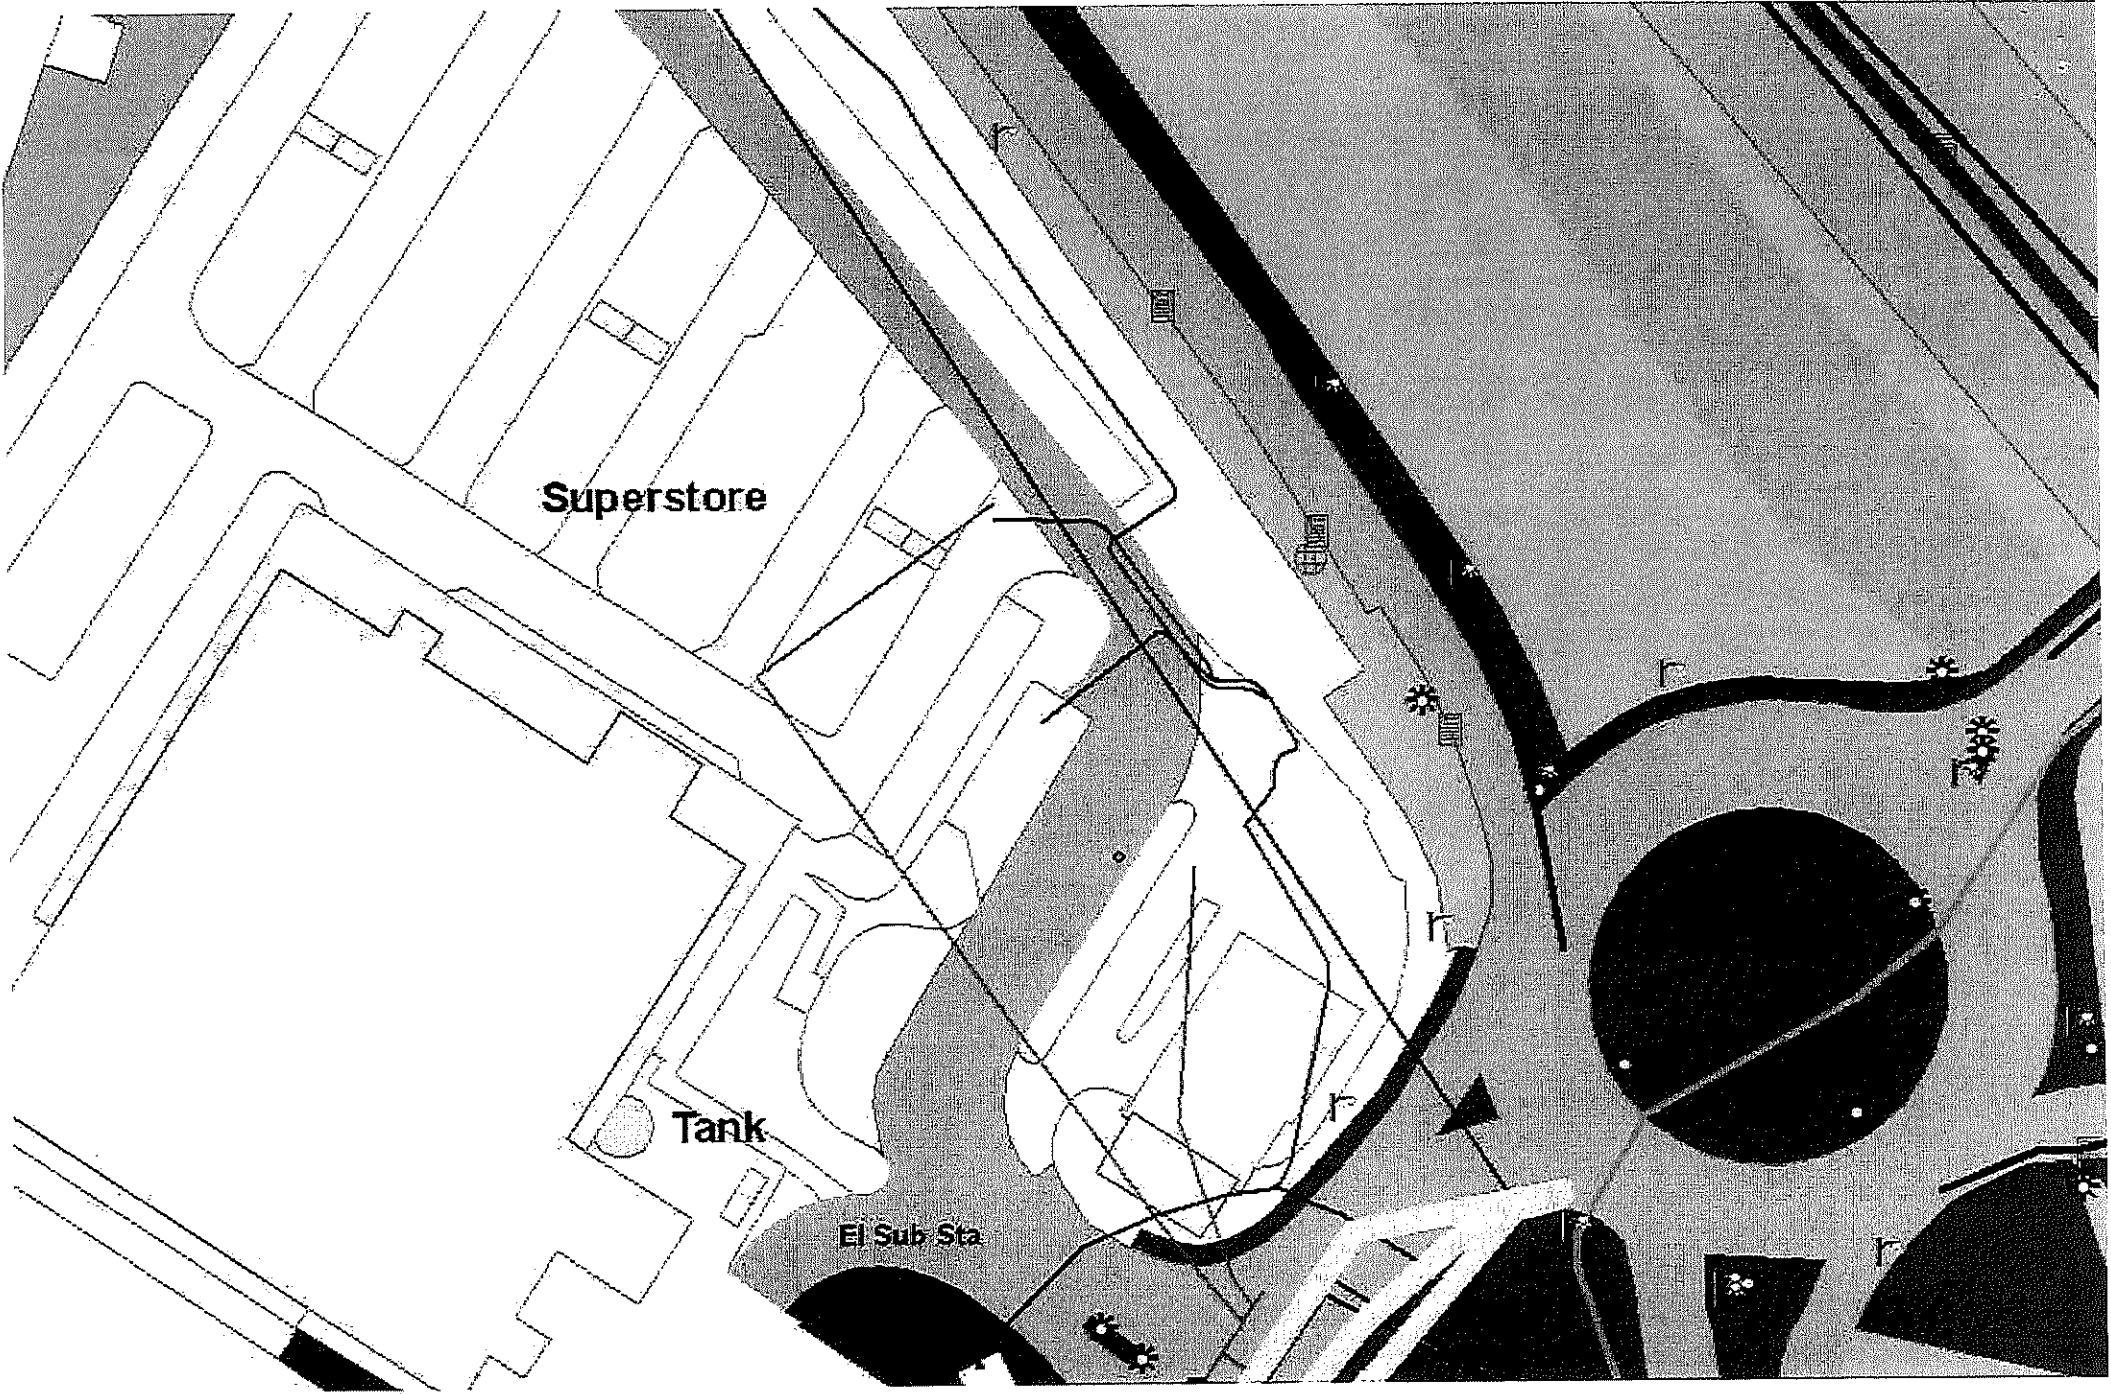
Red line - Scottish Power
Black line- Scottish Water Sewer.

Yes we checked the vault in SRWR and this only the manholes and gullies within the Trunk Road Boundary, which it did highlight a Scottish Water Sewer which is in black on the attachment, which could be this system which we have protected although it doesn't show the manholes.

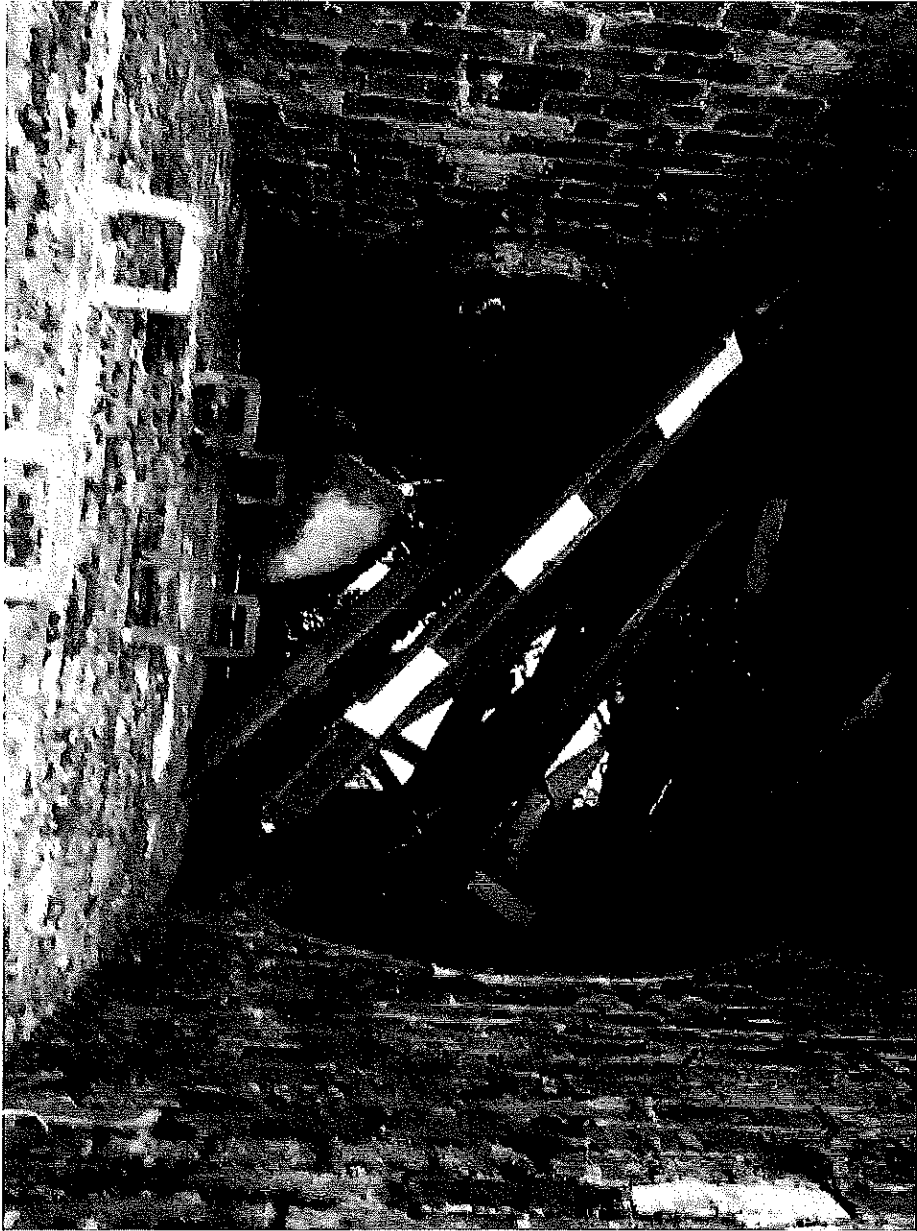
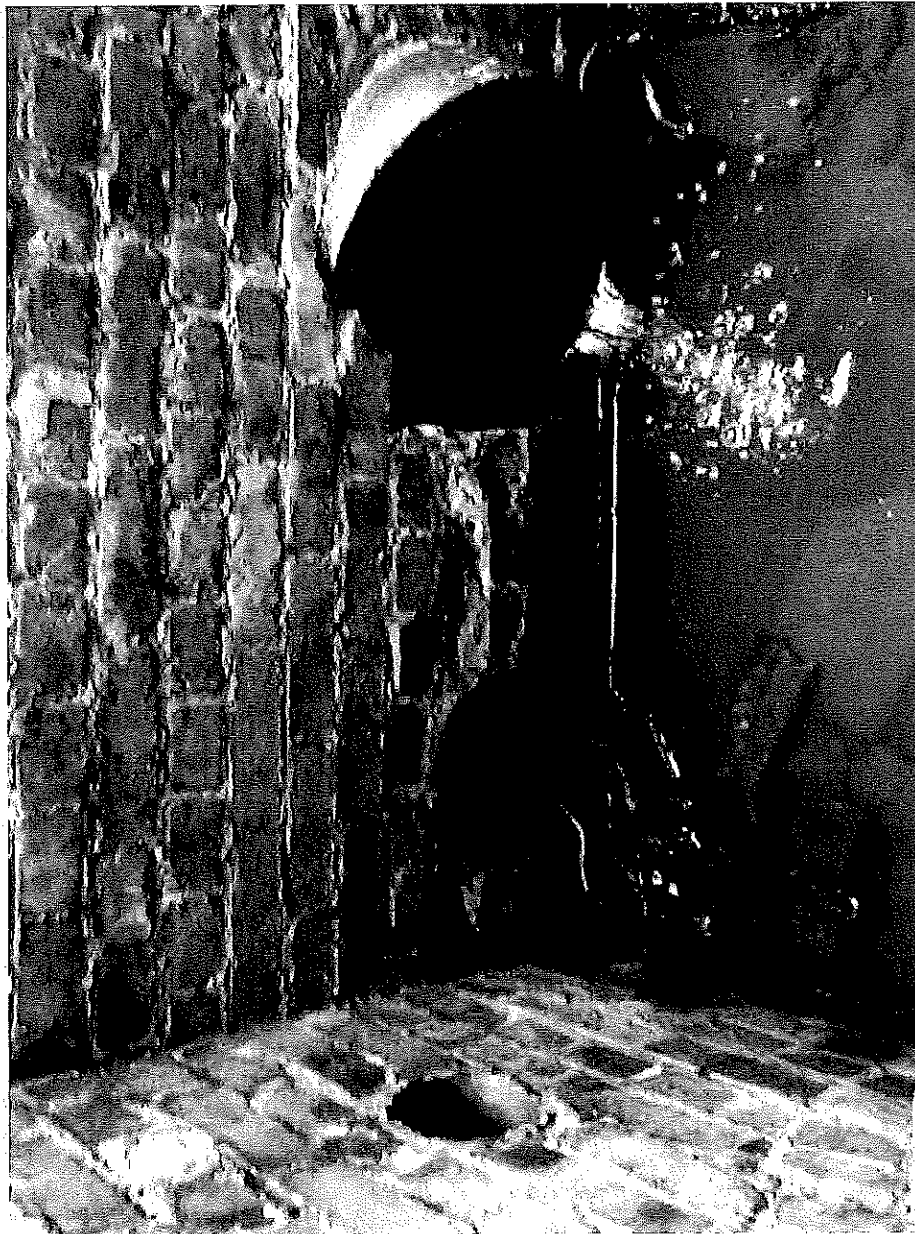
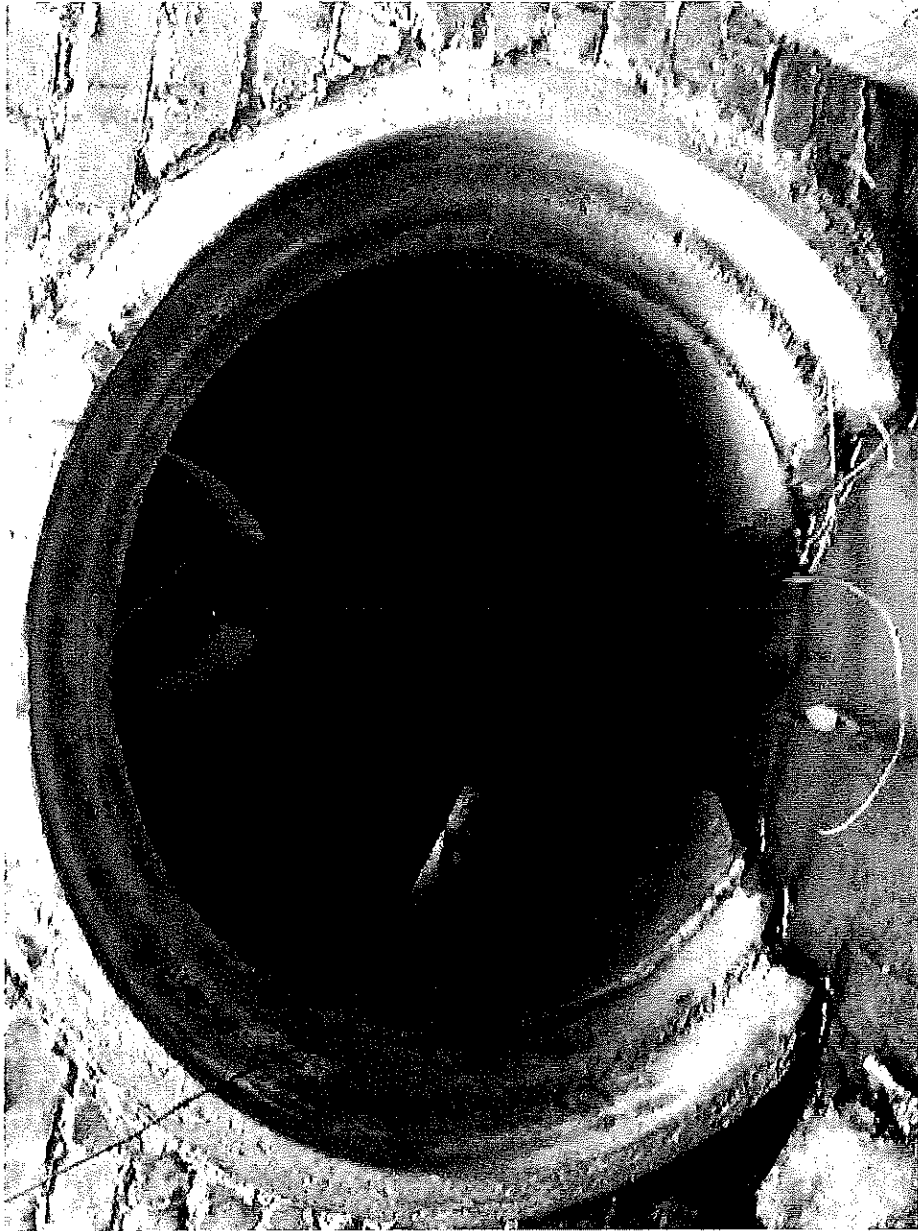
The flow of the Manhole is running parallel with the M74 in the N/B direction. There does not appear to be any outfalls from the M74 side indicating that the trunk road drainage system is connected to the system, however it may be connected to the main carrier pipe.

The overall depth of the manhole is approximately 3.4 metres deep, with 2 x 500mm inlets and a 1.2metre outlet. The area has been protected by pedestrian barrier.

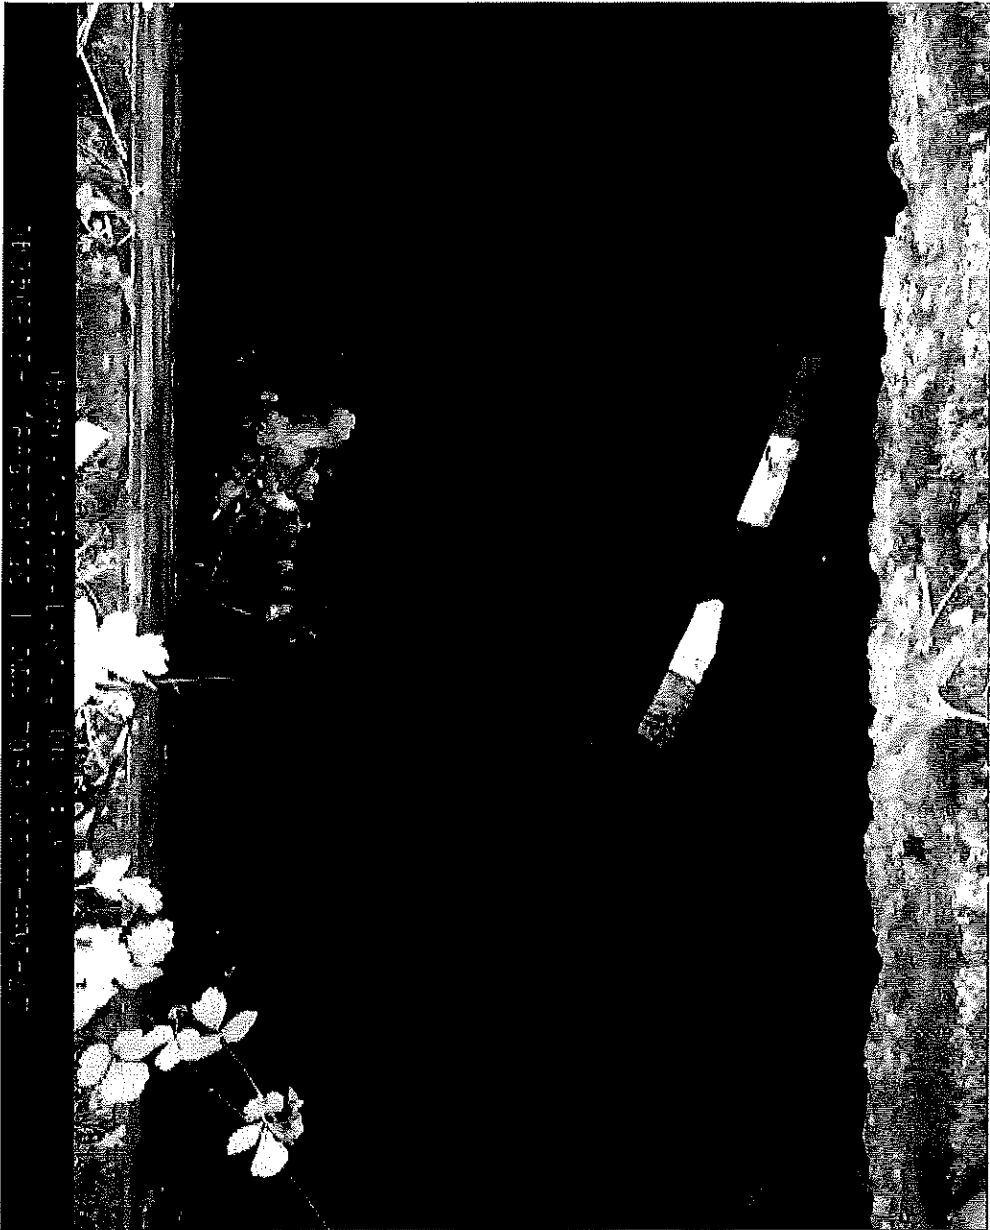
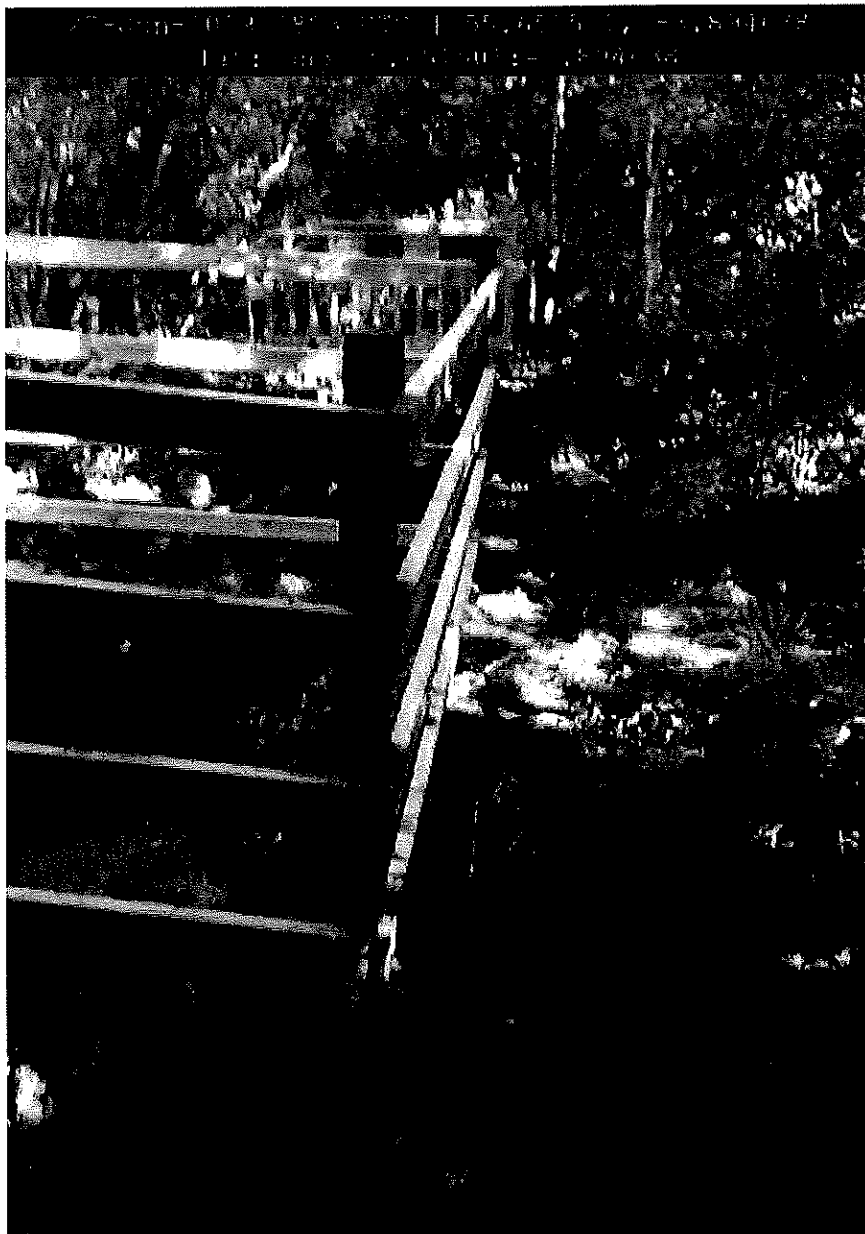
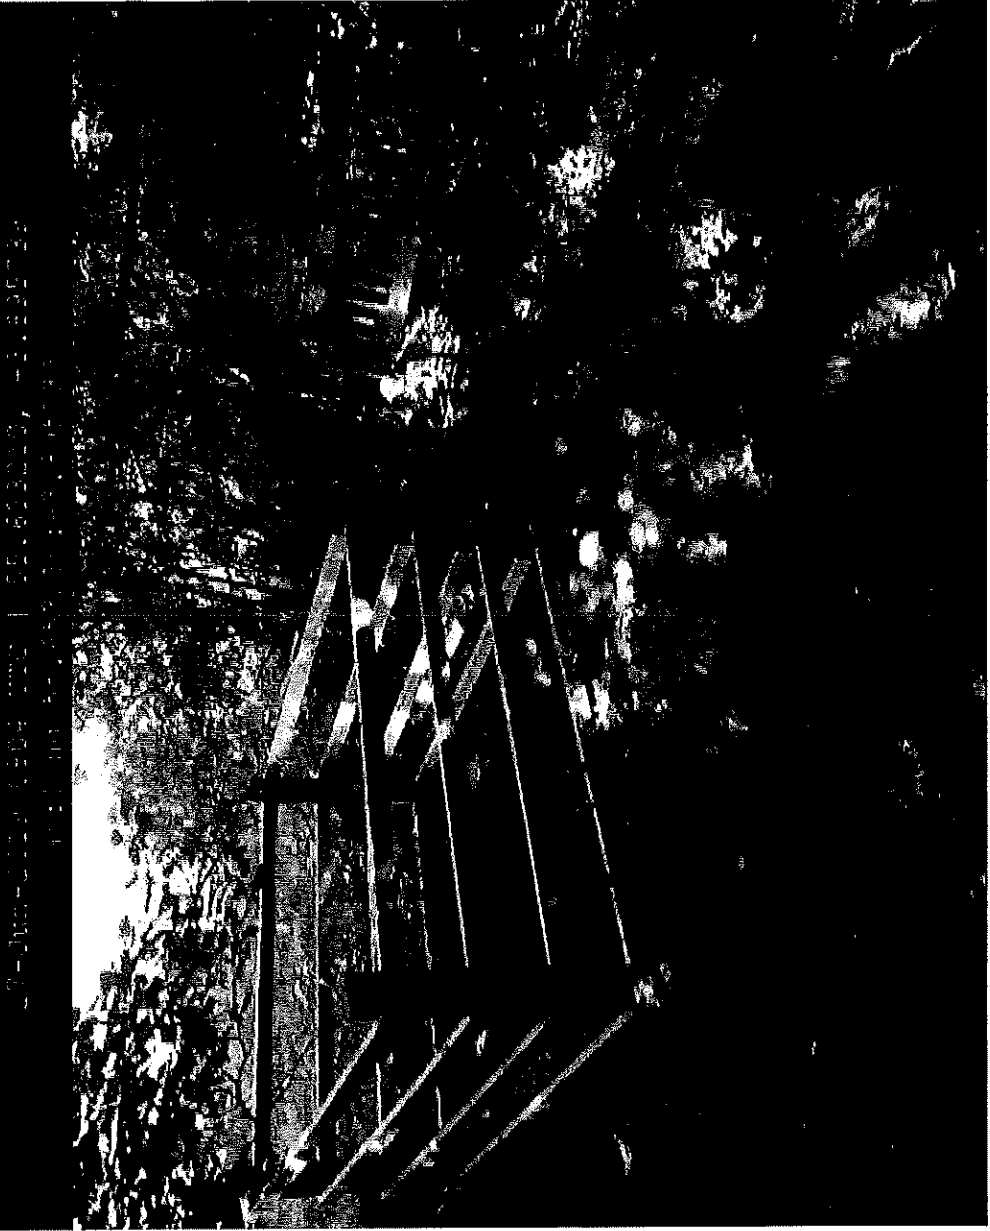
I have attached the photos of the newly installed fencing.

An update on where we are : To confirm that the fencing has been completed around the manhole 1 . A dye test was carried out yesterday at a number of the gullies on the slip road adjacent to the manholes, it doesn't appear to be connected at that point and no trace was detected within either of manholes.

The second manhole is protected currently by barrier and we will look to install the replacement finger if possible, failing that I would suggest that we protect this manhole in the same manner as the first one, by fencing it off.

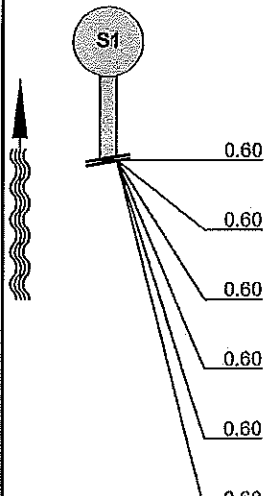
0.60	ST	Start of survey	(Misc) 0	0.6 m // 00:00:46
	0.60	MH	Manhole Remarks: S1	(Constr) 0	
	0.60	GO	General observation Remarks: INLET PIPE A	(Misc) 0	
	0.60	WL	Water level, 05% of sewer height	(Serv) 0	
	0.60	DES	Debris silt, 50% cross-sectional area loss	(Serv) 4	
	0.60	SA	Survey abandoned Remarks: HIGH SILT LEVEL	(Misc) 0

Structural Defects					Constructional Features				
Service Defects					Miscellaneous Features				
STR no def	STR peak	STR mean	STR total	STR grade	SER no def	SER peak	SER mean	SER total	SER grade
0	0	0	0	1	1	5	0.33	5	5

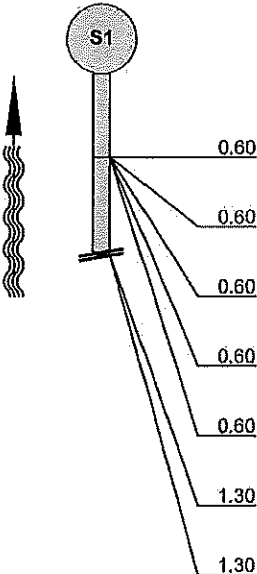
0.60	ST	Start of survey	(Misc) 0
	0.60	MH	Manhole Remarks: S1	(Constr) 0
	0.60	GO	General observation Remarks: INLET PIPE A	(Misc) 0
	0.60	WL	Water level, 05% of sewer height	(Serv) 0
	0.60	RM	Roots, mass, 30% cross-sectional area loss	(Serv) 5
	1.30	DES	Debris silt, 20% cross-sectional area loss	(Serv) 3
	1.30	SA	Survey abandoned Remarks: UNABLE TO PASS ROOTS/SILT	(Misc) 0

Structural Defects					Constructional Features				
Service Defects					Miscellaneous Features				
STR no def	STR peak	STR mean	STR total	STR grade	SER no def	SER peak	SER mean	SER total	SER grade
0	0	0	0	1	2	12	9.23	12	6
