**TREE CONDITION SURVEY
&
RECOMMENDATIONS
For
Piperdam, by Dundee**

For and on behalf of: Hiddleston and
Feist Architects

October 2019

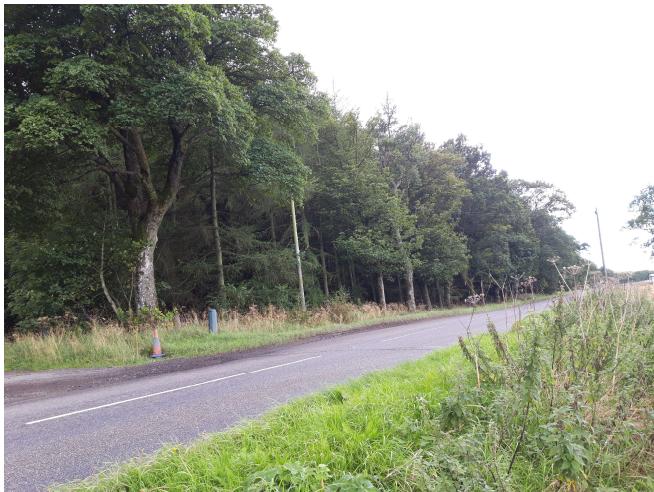
The tree cover is dominated by a row of mature Oak and Sycamore (see plate 1). A total of 55 individual trees have been recorded. The trees have been tagged and tree numbers run as follows: - T703 – T757

Plate 1 Row of Oak and Sycamore

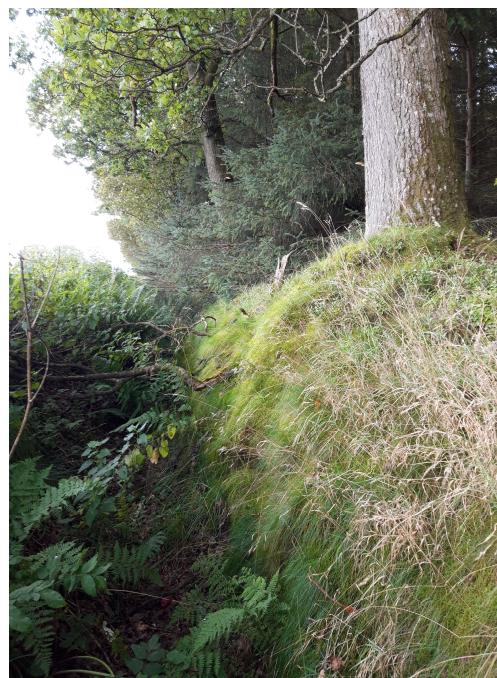
All the surveyed trees run parallel with the carriageway, and between the trees and the road there is a drainage ditch. The ditch, on the north side of the trees has a depth of nearly 2m which is likely to restrict the rooting zone of the trees. Root systems can extend in excess of the canopy spread and are usually found in the top 600mm of soil. This implies that the root structure of the trees is confined to a much smaller area than normally expected. Although there will be some rooting on the north side, it is likely that the roots are mostly present on the other sides of the tree. No significant evidence is observed to suggest that the trees are unstable; the ditch appears of considerable age and it is likely that roots have adapted to this environment. The main indicators of restricted rooting are likely to be diameter and crown growth and basal flare.

However, where the ditch is present on both sides, to north and south, it will be necessary to monitor these trees closely, especially if the plantation behind the Oaks is felled. Where ditches on both north and side occurs effects trees T739 – T742

Plate 2: drainage ditch to north of the trees
