## Port of Ardrossan Asset Condition Survey

20 April 2016  
Final Report  
PB3783

Document title Port of Ardrossan  
Asset Condition Survey  
Document short title Ardrossan Asset Condition Survey  
Status Final Report  
Date 20 April 2016  
Project name Ardrossan Asset Condition Survey  
Project number PB3783  
Client CMAL  
Reference PB3783/R106/301998/Edin

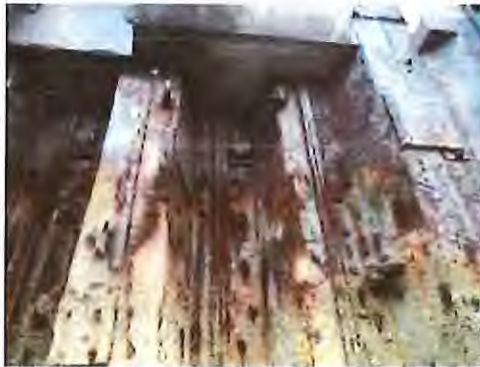
Photo 4

The steel sheet piles along the length of the berth to the roundhead are in a poor condition. Outwith the tidal zone near the soffit, the piles are corroding with delamination and loss of section evident (photo 4).

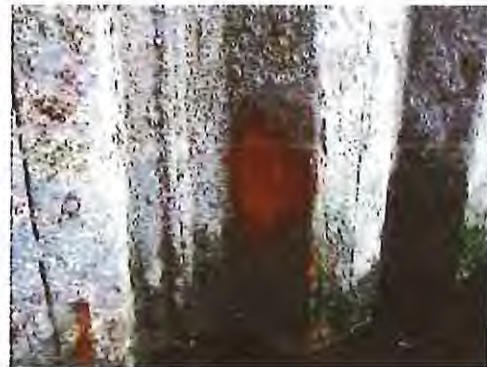
Photo 5

With reference to 'Management of Accelerated Low Water Corrosion in Steel Maritime Structures' (CIRIA publication C634, 2005), cathodic potentials within the region of  $-0.900\text{V}$  to  $-1.100\text{V}$  (vs Ag/AgCl) are recommended for maritime structures cathodic protection systems. Cathodic potential readings taken during the dive survey were typically in the region of  $-0.620\text{V}$ . Readings in this range are generally indicative of an increased potential for Accelerated Low Water Corrosion (ALWC).

In the intertidal zone and splash zone the orange deposit associated with ALWC is clearly evident along the length of the wall (photo 5). The piles were holed in a number of locations including adjacent to fender 2, at the ladder between fenders 5 and 6 (photo 6) and at the ladder between fenders 6 and 7 (photo 7). Each of these holes was typically of the order of  $100\text{mm} \times 100\text{mm}$  although one measured  $600\text{mm} \times 100\text{mm}$ .

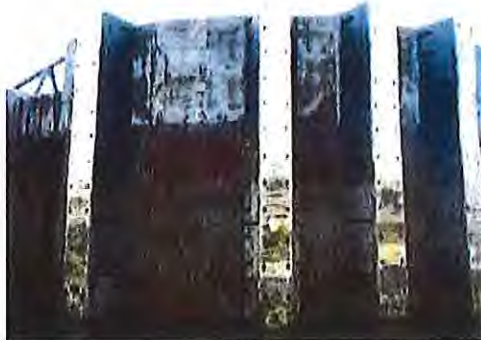
Photo 8

The fenders are generally in a fair condition however a number of defects were observed. These defects include loose and missing bolts at the connections between the MV elements and the quay (photo 12), face shields pulling from the MV elements (photo 9), abrasion damage to face shields and missing bolts at the connection between the MV elements and the face shield. In addition fenders 10 and 14 on the roundhead structure have been completely removed (photo 8).

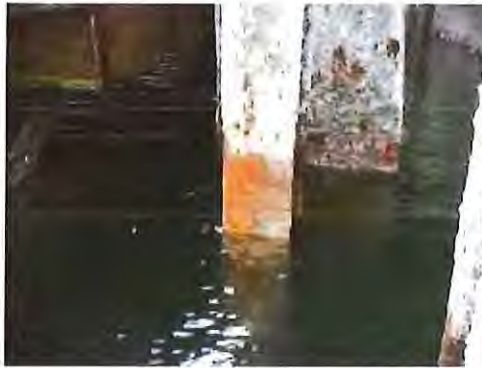
Photo 14

The steel piles are generally in a fair condition above the tidal zone and towards the deck soffit. There is rust staining but there does not appear to be significant loss of section (photo 16). Within the intertidal zone the piles are generally covered in hard and soft marine growth with orange deposit indicative of ALWC to the flanges over the full length of the piles (photos 14 & 15).

Cathodic potential readings taken during the dive survey were as high as -0.572V. This is generally indicative of Accelerated Low Water Corrosion (ALWC).

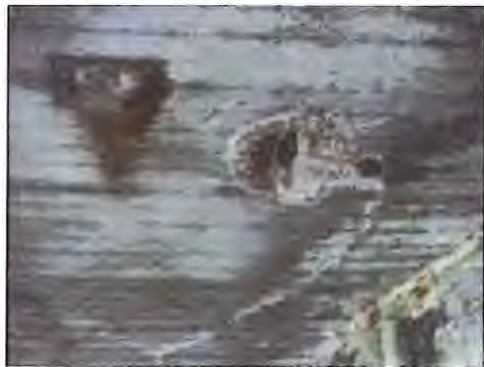
Photo 17

The reinforced concrete decks appear in a relatively good condition however a patch of concrete on the soffit on the West side of the ramp has spalled (photo 17). This section is approximately 1m x 1m in area and the reinforcement is visible and clearly corroding.

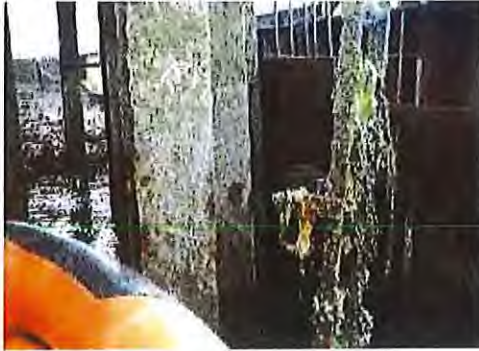
Photo 18

There are five emergency ladders located on the linkspan and along the length of the berth. The ladder suspended on the inner dolphin at the linkspan has a broken bracket and is misaligned following an impact (photo 18).

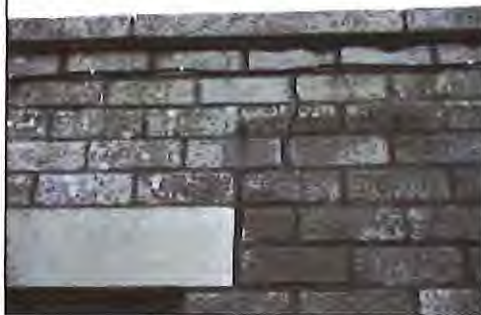
Photo 24

The linkspan operators building is generally in a fair condition. The paint to the door is dry and weathered and there are settlement cracks to some of the masonry walls (photo 24).

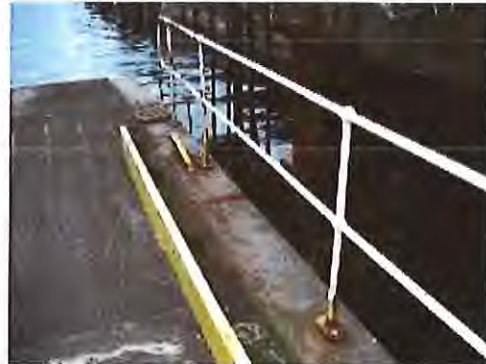
Photo 25

The gate at the entrance to the linkspan and the handrailing along the ramp are corroding (photo 25).

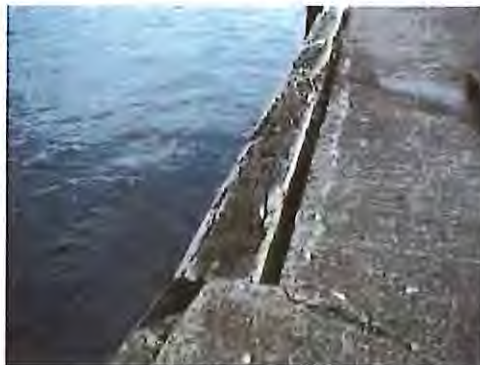
Photo 26

There is a timber cope along the edge of the masonry block section of the quay. This is generally rotting and the first section appears loose (photo 26).

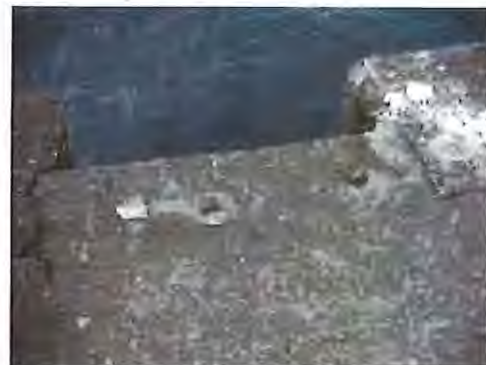
Photo 27

The grab rail from an old ladder has been removed from the deck but the bolts have not been cut flush. These present a trip hazard on the edge of the deck (photo 27).

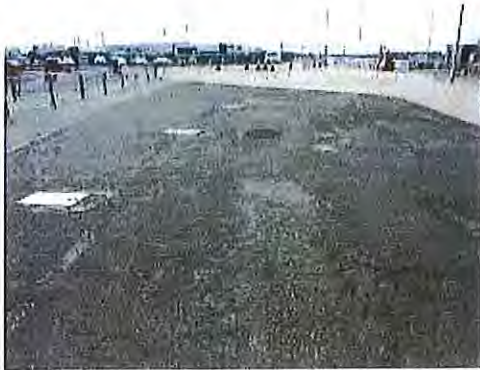
Photo 28

The surfacing to the deck area is a combination of block paving, tarmac and concrete. The surfacing is generally in a fair condition throughout the berth although the tarmac areas are beginning to break up and become uneven in places (photos 28 & 29).

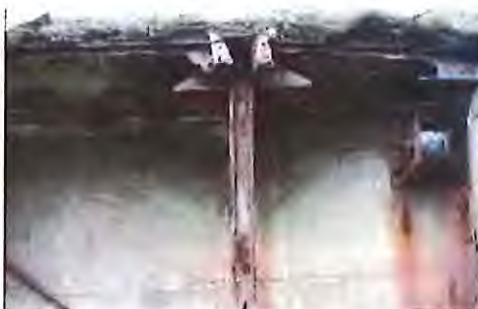
Photo 32

The section of suspended deck is in an extremely poor condition throughout its length. The longitudinal edge beams are extremely corroded with significant loss of section evident (photo 33). This is especially prominent at the North end of the berth above the old stairs. This first section of deck is supported by a single H-section steel pile and the longitudinal beam has completely corroded away on either side of the pile (photo 32).

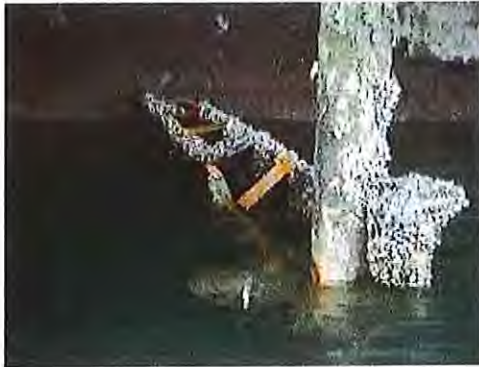
Photo 34

The transverse bracing members are also corroding with loss of section evident. This is particularly prominent to the lower braces (photo 35). These are in the intertidal zone and orange deposits are clearly visible. One of the members towards the linkspan end has failed completely and is no longer connected to the pile (photo 34) whilst another has become detached from the quay wall.

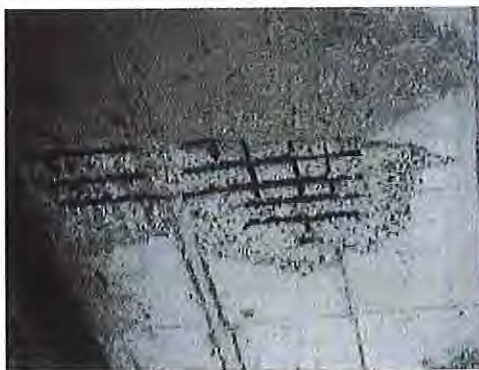
Photo 36

There are numerous patches on the suspended deck soffit where concrete has spalled (photos 36 & 37). At each of these locations the reinforcement is clearly corroding. It would appear that there is minimal cover to the reinforcement at these locations and this may be a significant contributing factor.

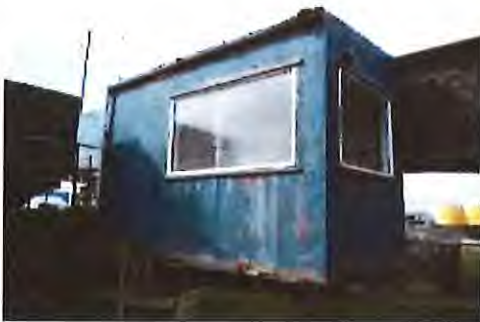
Photo 38

The linkspan operator and equipment buildings are generally in a fair-poor condition. Defects observed include corroded supports (photo 39), dry and weathered exterior paintwork (photo 38), blocked roof gutters. The gully in the area outside the buildings is blocked and a large amount of standing water was evident (photo 43).

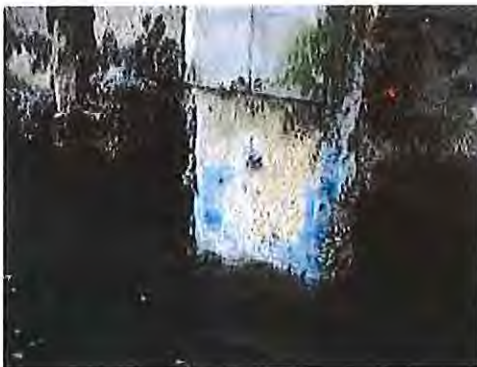
Photo 44

The fendering along the berth is generally in a fair condition. It is noted however that the bolts to each of the individual HDPE panels are not stainless steel. These bolts have completely corroded in the lower tidal zone (photo 45) and one panel is missing from fender 45, two panels missing from fender 49 (photo 44) and one panel loose on fender 40.

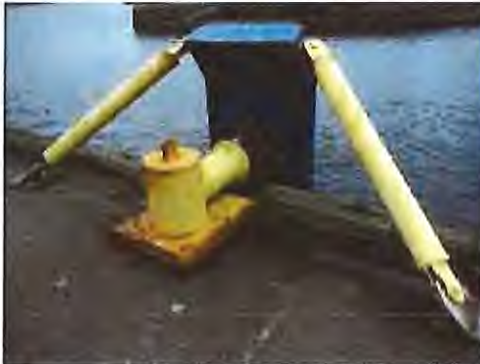
Photo 46

The steel frames to the fenders are suffering from minor surface corrosion at deck level (photo 46). It was further noted that the SCN400 fenders are all split or beginning to split (photo 47).

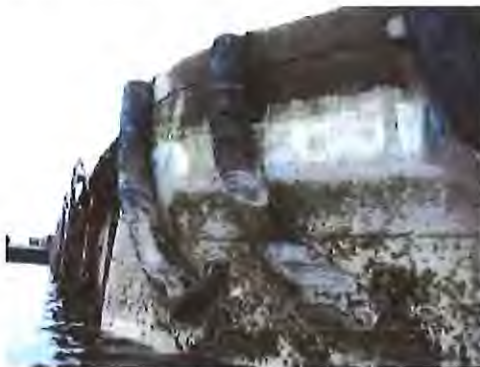
Photo 48

One of the cylindrical fenders has been removed completely from the structure (fender 36 – photo 48) whilst the lower bracket to fender 37 has two missing bolts and is loose (photo 49).

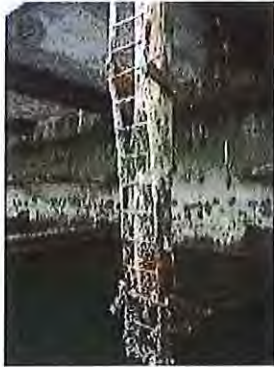
Photo 50

There are three emergency ladders situated along the length of the Irish Berth. The ladder nearest the linkspan has suffered minor impact damage yet remains secure and serviceable. The other two ladders have suffered more significant impact damage and the bottom brackets have sheared on both (photos 50 & 51).

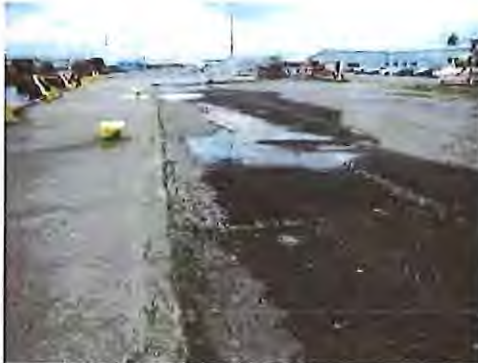
**Photo 55**

The surfacing to the deck area is a combination of tarmac and concrete. The surfacing is generally in a fair condition throughout the berth although the tarmac areas are beginning to break up and are uneven at a number of locations (photo 55). There is some cracking evident to the concrete slab.

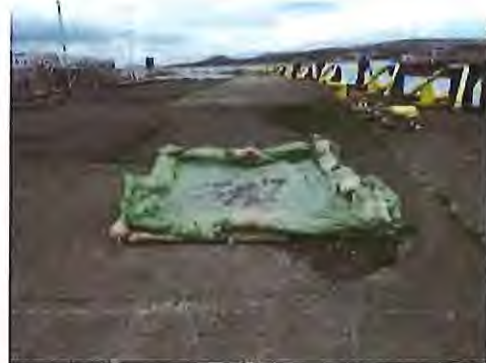
**Photo 56**

It was noted that there is an area of the deck between fenders 48 and 50 which is subsiding. This area is 3m to 10m from the cope (photo 56).

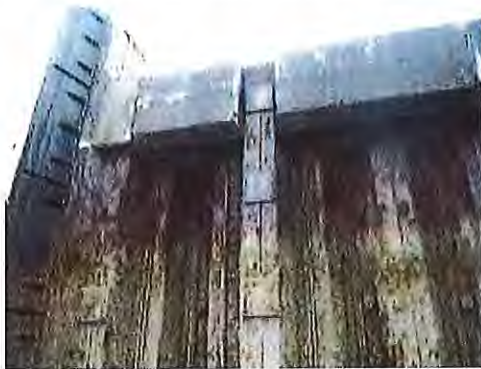
Photo 57

The steel sheet piles along the length of the berth to the roundhead are in a poor condition. Outwith the tidal zone near the soffit, the piles are corroding with delamination and loss of section evident (photos 57 & 58).

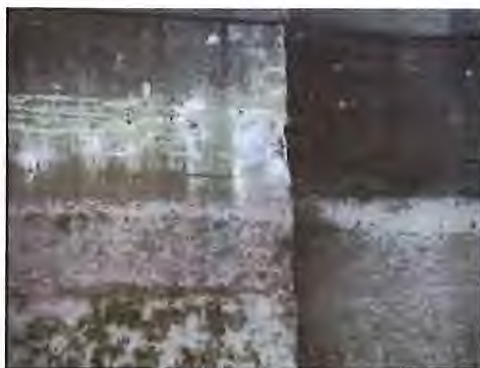
Photo 63

The concrete quay wall is generally in a good condition with only minor cracking identified during the inspection and minor impact damage to the roundhead structure (photo 63).

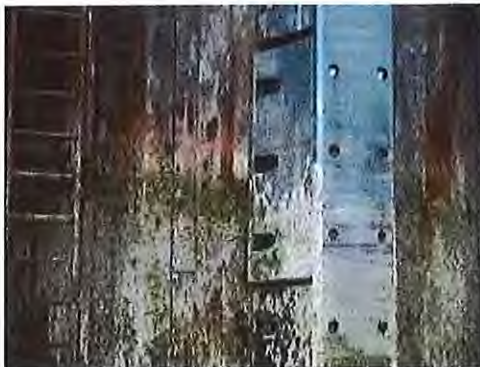
Photo 65

The fenders are generally in a fair condition however a number of defects were observed. These defects include loose and missing bolts at the connections between the MV elements and the quay (photo 65), face shields pulling from the MV elements (photo 66), abrasion damage to face shields and missing bolts at the connection between the MV elements and the face shields. In addition fenders 21 and 26 have been completely removed and all but three MV elements are missing at fender 24 where the bolts are still protruding from the quay wall.

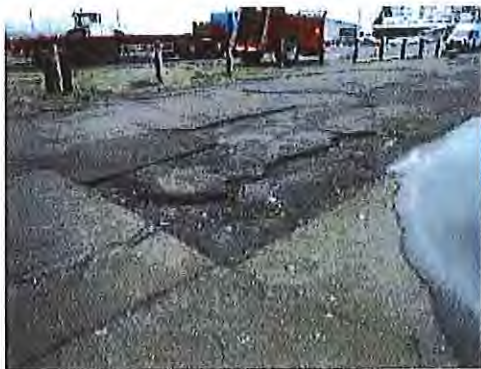
Photo 71

The surfacing along the berth is predominantly tarmac. This is generally in a poor condition and breaking up (photo 71). Furthermore the uneven surface and poor drainage results in large areas of standing water (photo 72).

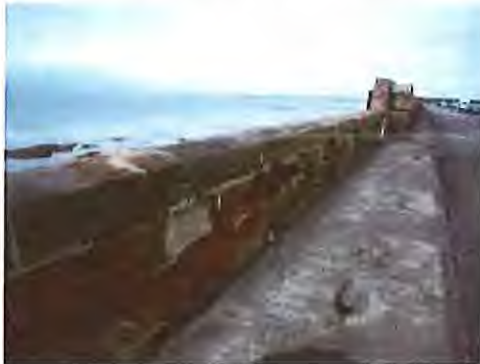
Photo 75

This section of wall is 1.15m high (on the landward face) and is constructed from stone block (photo 75). There is moderate erosion of the stone blocks on the seaward face of the wall and much of the pointing has failed and is missing. Several of the stone blocks have fallen from the wall leaving substantial voids (photos 76 & 77).

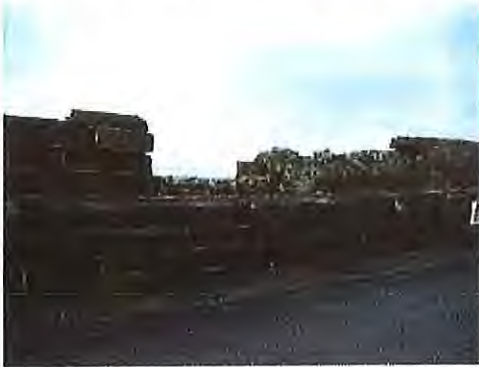
Photo 79

A section of the wall has come down between chainage 160m – 172m. The top stones on either side of this section also appear loose (photos 79 & 80).

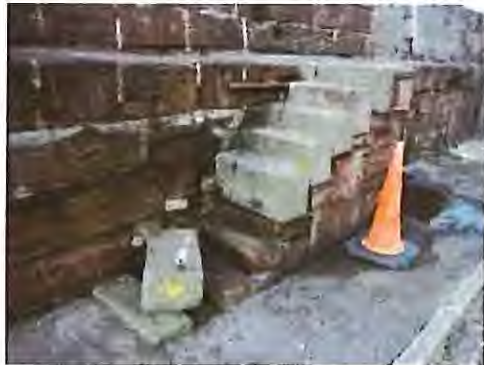
Photo 86

A stone stair provides access to the second tier of the wall on the landward face. The bottom steps are displaced and present a hazard to anyone ascending or descending the wall (photo 86).

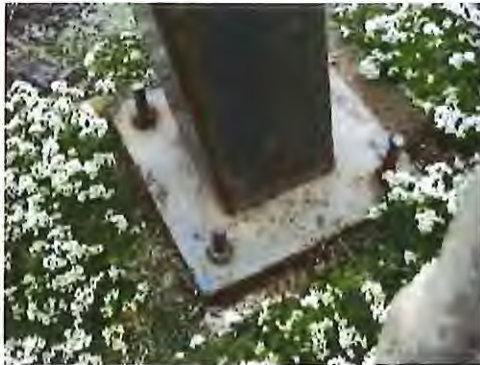
Photo 91

A large overhead gantry sign clearly shows the lane layout and where the commercial lanes are located. The steel frame to the gantry is in a fair condition with only minor surface corrosion to the frame and the holding down bolts (photo 91).

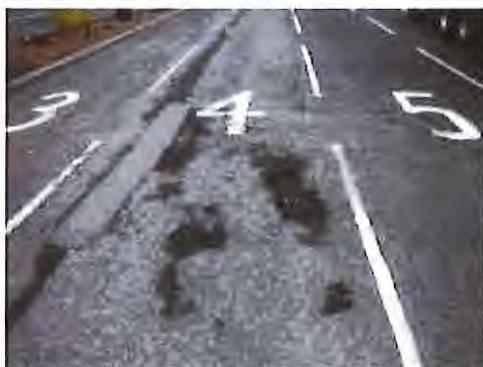
Photo 93

The tarmac surfacing to the marshalling area is generally in a good condition with only occasional damage or pot holing of the surface (photo 93). This is typically found in lanes 1 and 2, and at the entrance to lanes 3 and 4 where all cars queue to pass the check-in booth.

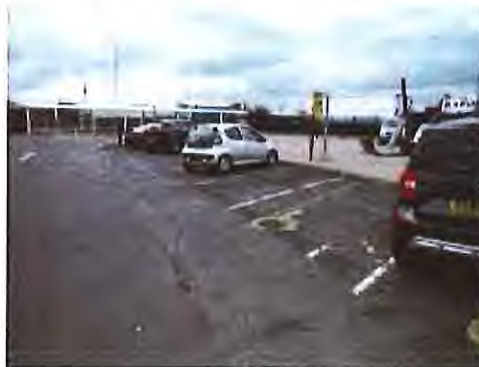
Photo 98

It is further noted that there is no pedestrian crossing from the short stay car parking outside the terminal building to the building itself (photos 98 & 99).

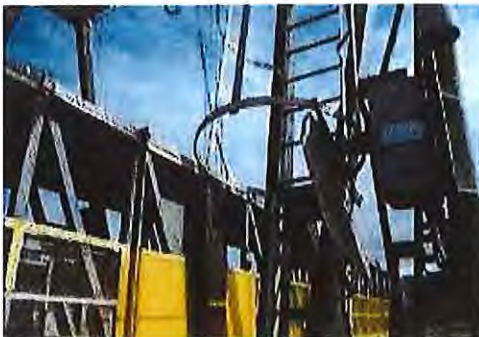
Photo 114

It was noted during the site survey that site personnel access the top of the Passenger Access System lifting towers via a hooped ladder. This ladder has an anti-climb gate installed but this was never locked during the entire survey (photo 114). Given the relatively low fencing it would be prudent to keep this locked to prevent unauthorised persons accessing the ladder.
