## A83 Tarbet – Campbeltown Trunk Road

### Cairndow to Lochgilphead Road Safety Study

**Scheme Ref: 15/NW/0801/002**

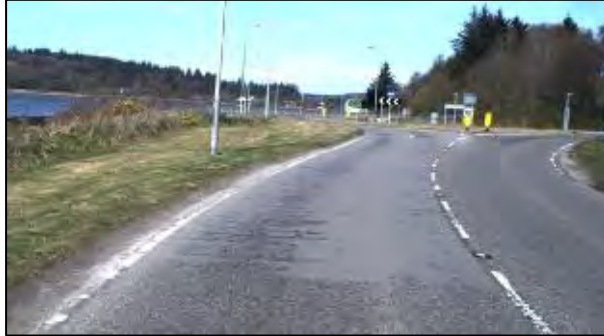
**Photo 1**

View looking north showing the extent of the dark grey high friction surfacing commencing approximately 60m inside the 30mph speed limit with the South bound approach being similar. This surfacing is showing signs of wear in the wheel tracks though the condition of the underlying surface remains satisfactory. There have been two accidents within the study period at this location with vehicles traveling too fast as causation factors. Although in a 30mph limit, the high speed approach from the south would warrant the retention of this surfacing.

(See later additional comments in section 2.10 Photo 21)

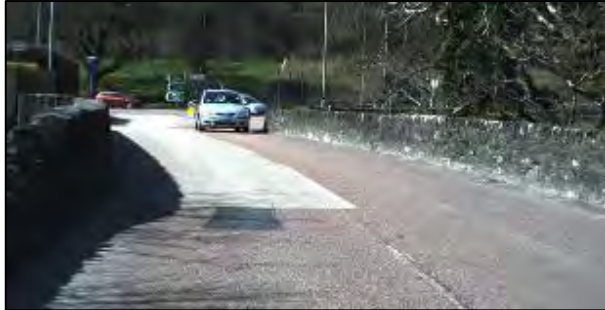
**Photo 2**

View looking towards the A816 roundabout showing buff high friction surfacing extending from the roundabout and crossing the river bridge on the immediate approach. One accident has occurred at this site with the narrowness of the road and masked signs being contributory factors. *HD36/06 "Surfacing Materials for New and Maintenance Construction"*<sup>(9)</sup> states that surfacing materials with the same PSV and AAV must be used across the carriageway.

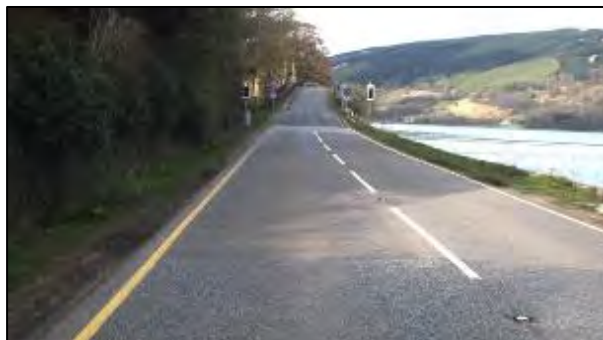
**Photo 3**

View looking North across the signals at the Inveraray bridge. High friction surfacing has been applied to the full width of the carriageway. This is showing wear immediately before the stop line in the braking area.

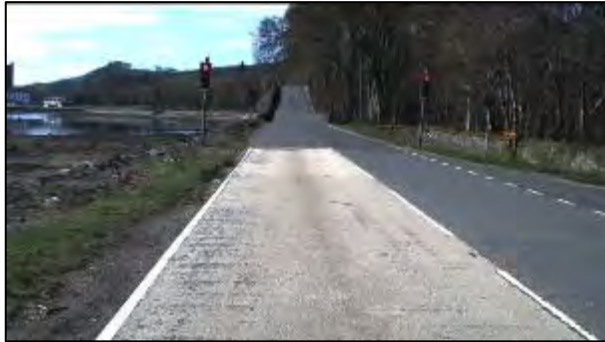
**Photo 4**

High friction surfacing has been used to the approach to the signals only for south bound approach rather than the full width of the carriageway. HD36/06 “Surfacing Materials for New and Maintenance Construction” states that surfacing materials with the same PSV and AAV must be used across the carriageway.

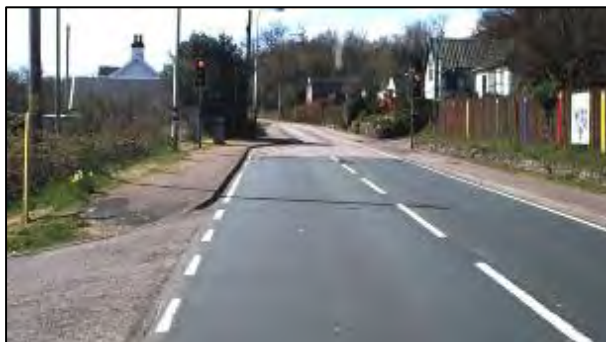
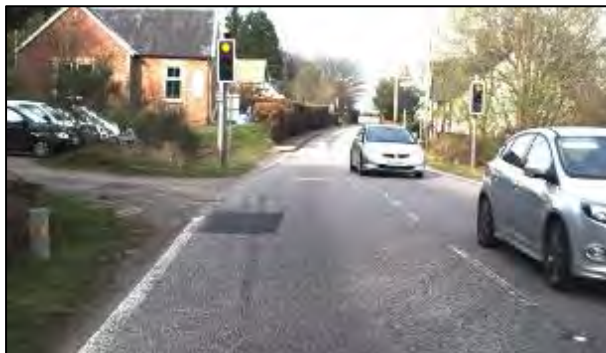
**Photo 5**

High friction surfacing is not present at the traffic signals installation at Minard. The road at this location is subject to a 40mph speed limit and the approach in photo 6 is close to the terminal point of a de-restricted section and on a downhill gradient. High friction surfacing is recommended as good design practice in *TD 50/04 The Layout of Signal Controlled Junctions and Signalised Roundabouts* <sup>(10)</sup> on the approach to traffic signals. There is however, no history of accidents at this location associated with the signals within the study period or back as far as 2005.

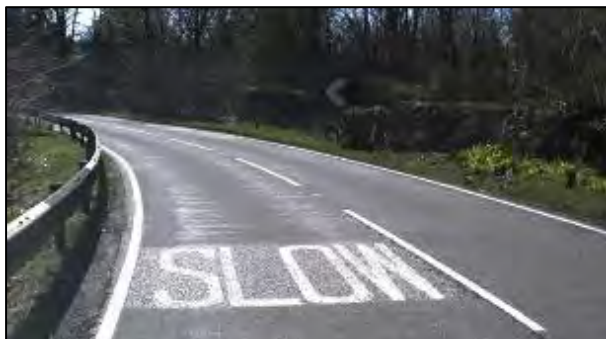
**Photo 7**

High friction surfacing ‘stop – start’ to avoid an existing road marking to the North of Furnace. This results in an inconsistency in grip at a location that has been identified as requiring a higher level than would normally be provided. The location of the SLOW marking in addition, is inappropriately placed on the bend and should be located at a suitable point in advance of the bend.

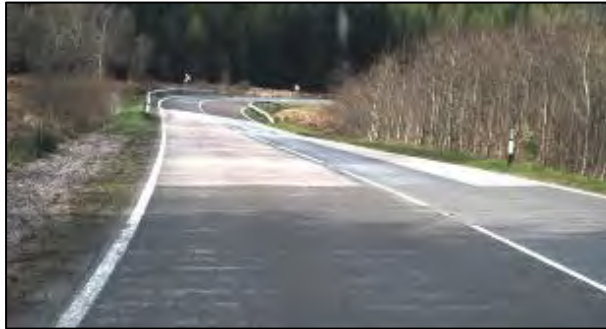
**Photo 8**

High friction surfacing at a set of multiple bends at Kilmichael Beg. A short section of approximately 45m has been left untreated between a left hand and right hand bends with the high friction material starting and stopping at the tangent points. Motorcycles may still be banked over between the bends and a change in grip and camber may destabilise the motorcycle.

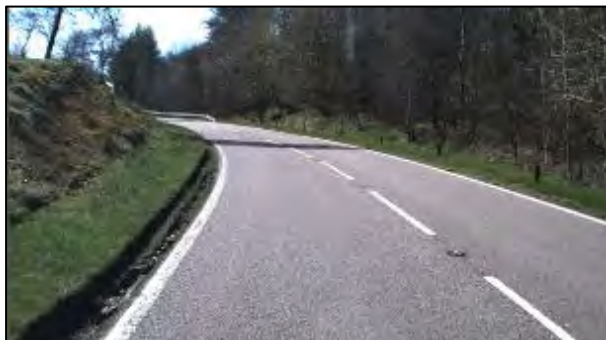
**Photo 9**

The edge of the carriageway between Armarlen and Douglas Water Bridge shows signs of being over-run. This has resulted in wash out of the edge of the carriageway. If left in this condition the integrity of the road construction will be compromised and the rutting will create a significant road safety hazard.

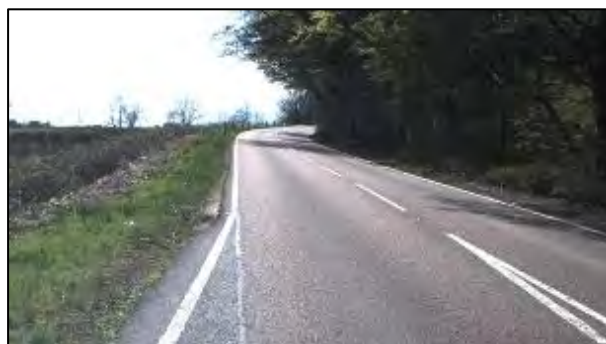
**Photo 10**

The edge of the carriageway to the south tie in of the development site at Port Ann is showing signs of being over-run. This is due to the poor alignment of the single side constructed right turn facility. The Port Ann site and junction has been the subject of a Stage 3 Road Safety Audit in which issues with alignment have been identified.

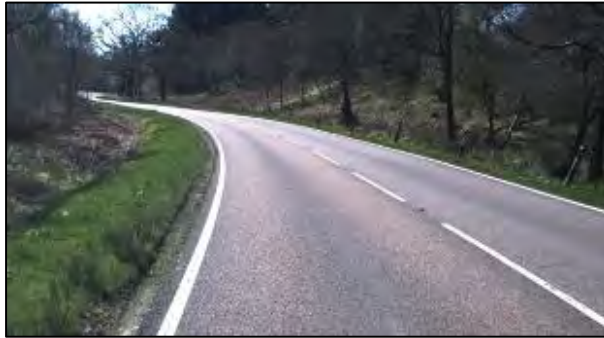
**Photo 11**

The edge of the carriageway to the north of Port Ann is showing signs of over running on the inside of the bend. The area also appears to be retaining water with the rush type grasses.

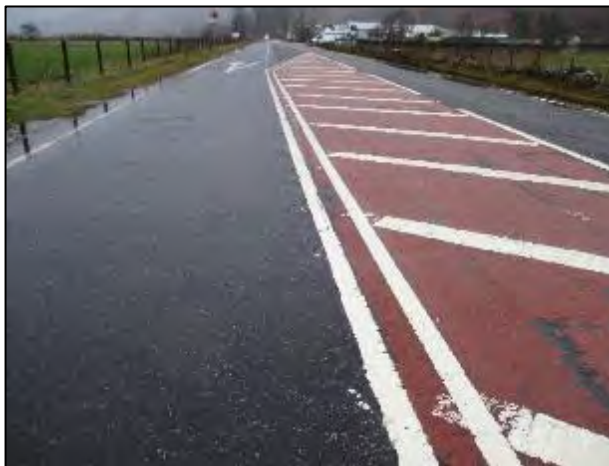
**Photo 12**

The road markings at the junction with Lock Fyne Oyster Bar consist of double white lines and a central hatched area to Diag.No.1013.3. These markings require reflecting road studs at 4.5m centres which are absent. Additionally, two 'tuck in' arrows to Diag.No. 1014 are required in advance from both directions. These are also absent.

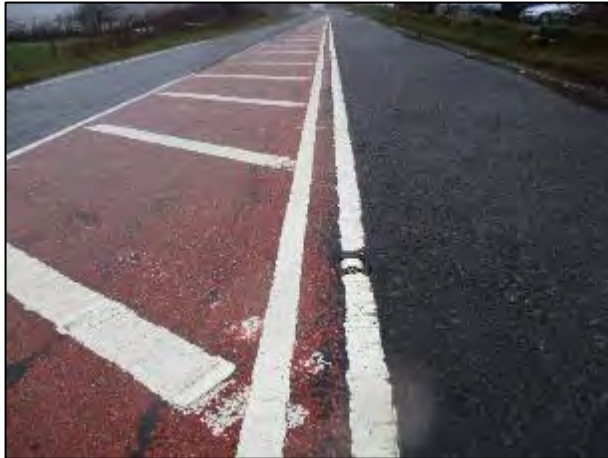
**Photo 13**

The road markings at the southern end of the junction with Lock Fyne Oyster Bar have few studs and are outside the double white lines.

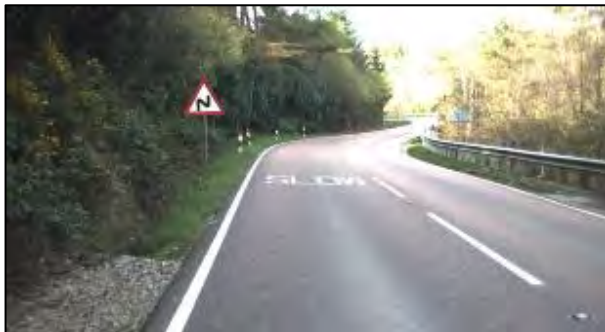
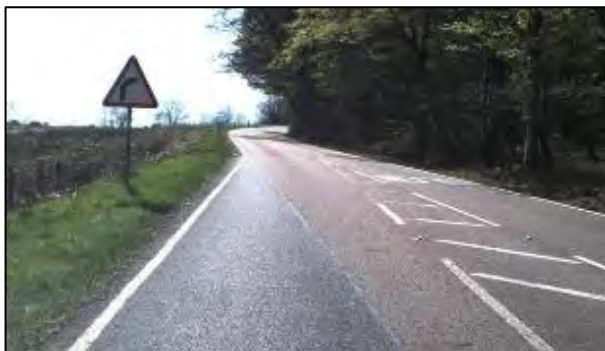
**Photo 14**

Inconsistency of signing the same set of multiple bends to the south of Port Ann. A double bend warning sign for North bound vehicles while there is single bend only sign for south bound traffic. The siting of the north bound sign is also too close to the actual bend. These signs should also be accompanied by distance plates and where necessary additionally accompanied by a “REDUCE SPEED NOW” signs to Diag.No.511.

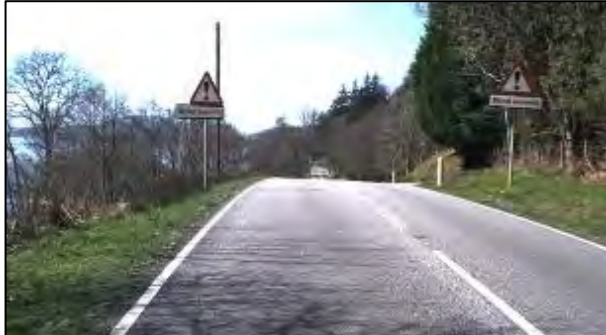
**Photo 16**

Blind summit signs and accompanying plate to Diag.No.563 and 563. These should be located between 180m to 245m in advance of the summit (the hazard) rather than at the actual location. Additionally, the supplementary plates should be arranged on two lines of text to reduce the overall width and lessen the chance of the overly wide signs from rotating. There are actually a sequence of three summits at the location at Achnatra 1.4km North of Strone Point, so the addition of a distance should therefore be included.

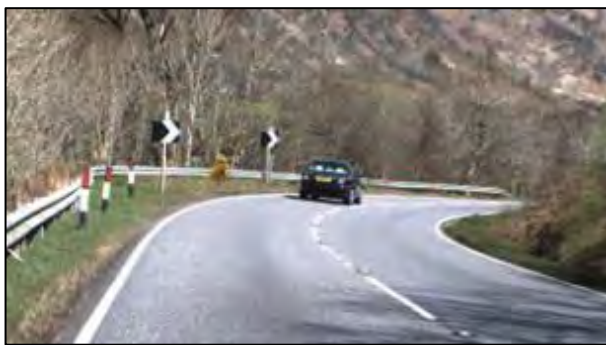
**Photo 17**

Chevron signs to Diag.No.515 exceeding the recommended mounting height of 1m in Chapter 5 of the TSM mounted on single posts, longer than required. These signs are located between the two junctions to Cairndow. Experience has shown that these signs spin around on the post over time due to various factors, and can then give misleading information. The signs should be re-mounted at the appropriate mounting height, with the opportunity taken to attach on twin posts and were possible, re-located to a position behind the barrier.

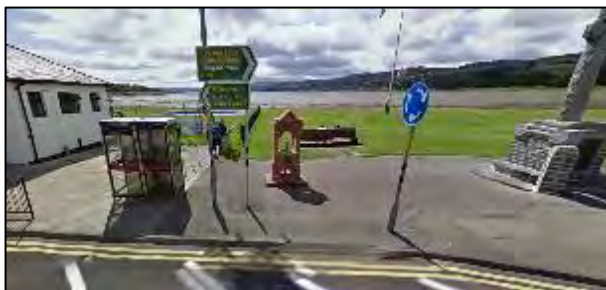
**Photo 18**

Destination inconsistency at Lochgilphead. The two roundabouts at the entrances to the town show the destination of Oban A816'. This is missing from the signs in the centre of the town. The present signing arrangements should be amended to provide consistency of destinations and avoid confusion, particularly for tourists who will be unfamiliar with the location.

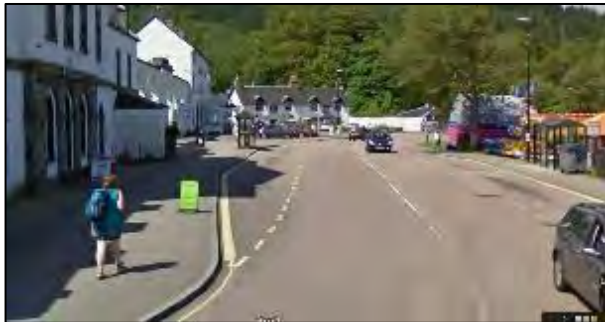
**Photo 19**

At the junction of the A819 in Inveraray there is no advance direction sign for North bound vehicles. This is particularly important due to the restricted headroom at the archway immediately after the junction. The A819 is used as an emergency diversion route should the A83 to Tarbet and the Rest and be thankful be closed. Advance signs should be provided from the South to indication of the restricted headroom.

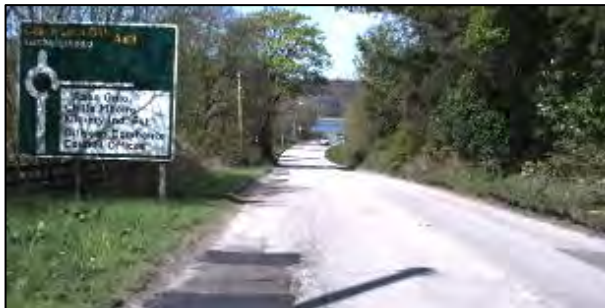
**Photo 20**

The photo shows the West bound approach to the 30mph speed limit at Kilberry, to the south of Lochgilphead. The Kilberry roundabout is not visible at this point due to the right hand bend on its immediate approach. In this instance, as the reduction in vehicle speeds is up to 30mph, combined with the masked roundabout, the 3, 2, 1 speed limit count down signs should be provided at this location.

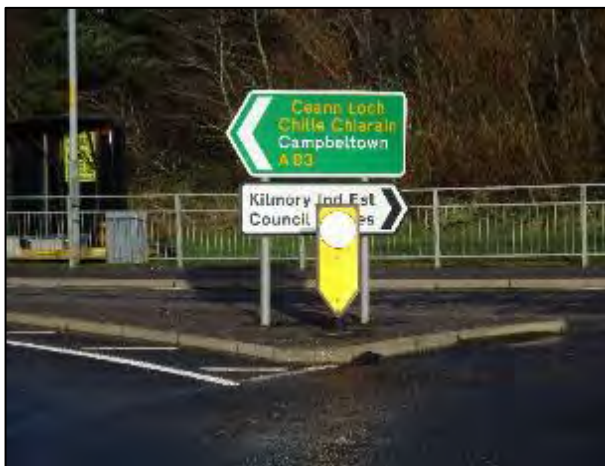
**Photo 21**

The photo shows signing at the Kilmory roundabout. The signing for Kilmory Ind Est has been in place since at least 2009 having been added to the existing posts and has poor visibility behind the bollard. Signing should only indicate the destinations at each exit rather than signing them around the roundabout. Additionally, the mounting height of the sign should be 2.0m minimum at the roundabout in accordance with TD16/7 Para.8.2.

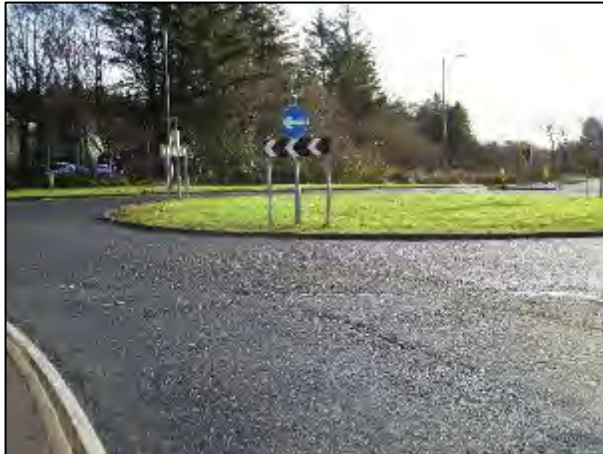
**Photo 22**

The recommendation for mounting height of chevrons at roundabouts in *Chapter 4 of the Traffic Signs Manual (13)* is 1m to the centre of the chevron from the road level. The signs at the Kilmory roundabout are mounted too high and therefore out of the headlight line for vehicles. It is recommended that the sign mounting heights are reduced for all legs of the junction.

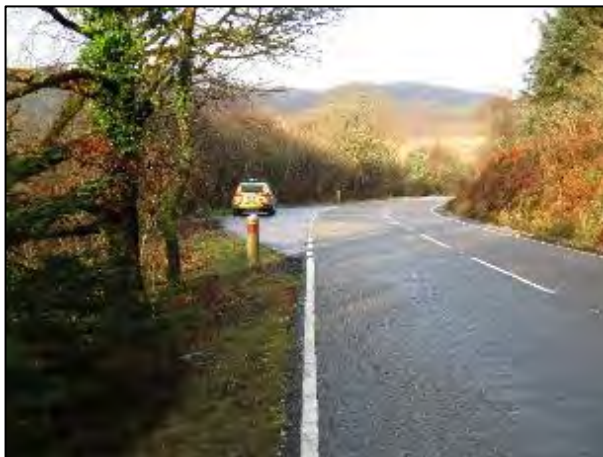
**Photo 23**

There are three laybys to the South of Inveraray that do not have signing to Diag. No. 801 'P' or advance signing to Diag. No. 2501 indicating the distance to the layby. A lack of signing can lead to late braking by vehicles wishing to use the layby and may lead to rear end shunt type accidents. It is recommended that the appropriate signing is installed at the three locations.

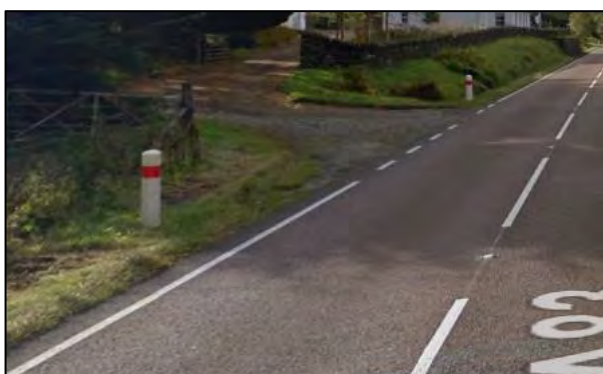
**Photo 24**

In September 2016 three sets of junction bollards were installed at Glaschonie following concerns raised by residents on this section of the A83. A further 65 sites have been identified within the Study area which require junction bollards.

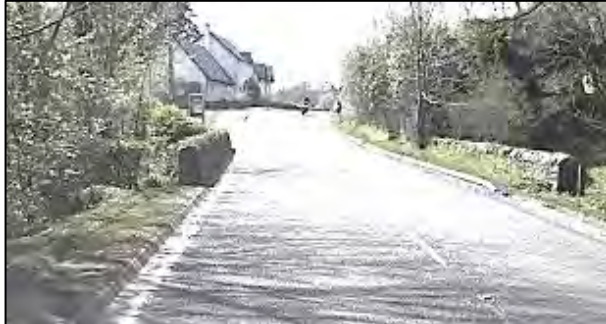
**Photo 25**

The photo shows the Bridge parapets in Lochgair adjacent to the edge of the carriageway. These do not have any warning to drivers of the obstruction immediately adjacent to the carriageway. It is recommended that appropriate signage is installed incorporate black/amber warning boards to Diag. No. 528.1 to increase their conspicuity.

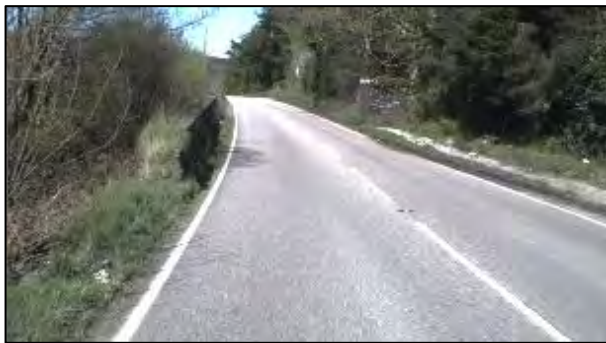
**Photo 26**

The photo shows the position of the Culvert parapet at Kilmory Pier adjacent to the edge of the carriageway for North bound traffic. It is recommended that a black/amber warning sign board to Diag. No. 528.1 is installed at this location to increase its conspicuity.

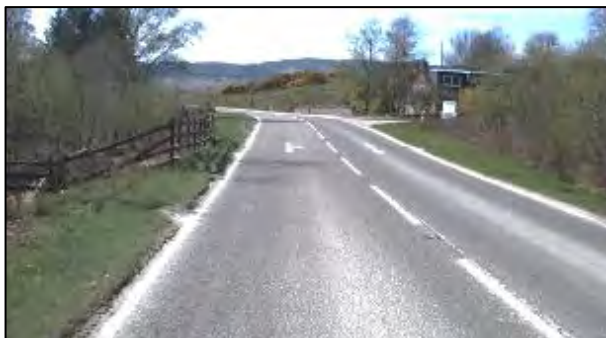
**Photo 27**

The photo shows the position of the post and rail fence over a culvert between Ballibeg and Barr Bhaltair adjacent to the edge of the carriageway for North bound traffic. The drop off above the actual culvert and the water course below would represent a hazard should a vehicle leave the road at this point. The fence should be re-assessed in line with *TD19/06 Requirement for Road Restraint Systems* <sup>(14)</sup> to determine its suitability. This junction also requires junction bollards.

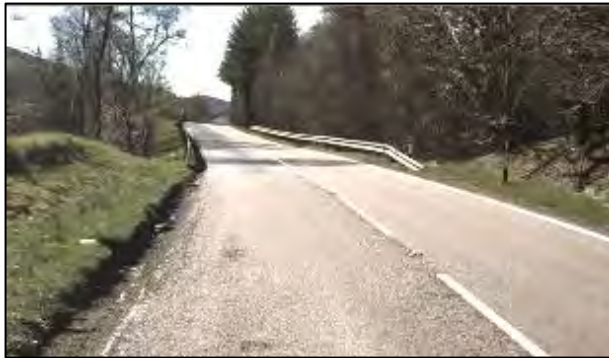
**Photo 28**

The barrier protection on the left of the photo is on a left hand bend and is close to the edge of the carriageway. There is evidence of over-running of the inside of the bend and some crash debris (wing mirror) in the photograph. It is recommended that the barrier end is reassessed in line with TD19/06 and extended approximately 125m to the north east to the straight alignment proceeding the bend.

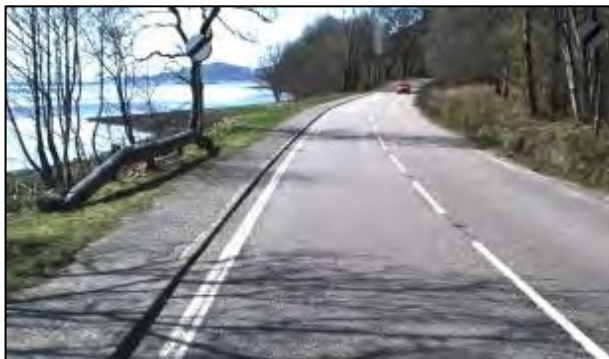
**Photo 29**

There are several short lengths of barrier protection that have been installed along the route to protect structures such as culverts. They all have P1 ramp end terminals and appear to be a substitute for pedestrian barrier. These should be re-assessed in line with TD19/06 Requirement for Road Restraint Systems to determine their suitability.

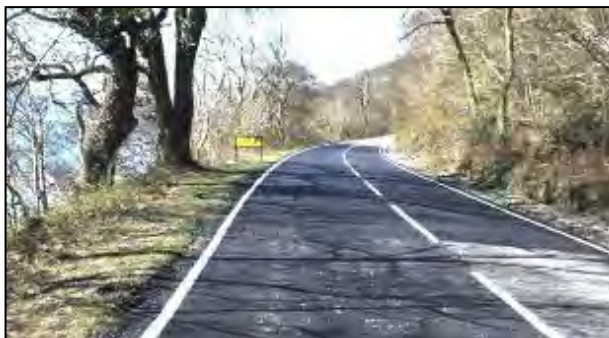
**Photo 30**

The recommendations in TD19/06 are that a RRRAP assessment should be carried out on trees that have a girth greater than 250mm at 300mm above ground level. There are similar instances to the situation shown in this photo along the whole route. In some instances, trees are in the narrow section of land between the road and the edge of the loch with the roots effectively retaining the bank.

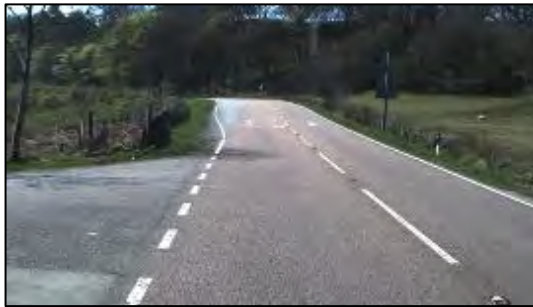
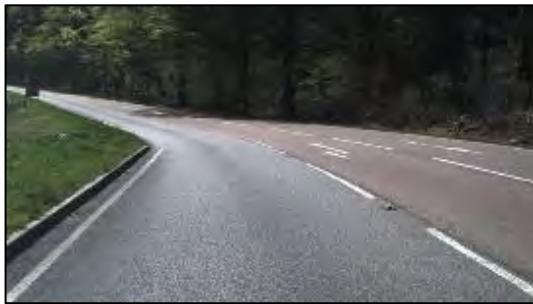
**Photo 33**

The construction of the new junction in Port Ann for a proposed development presents an awkward alignment to motorists. The edge line and kerbing have produced a series of angular tie-ins that have the effect of causing vehicles to clip the apex points. The kerb line end point to the south of the junction (Photo 33) represents a particular issue as it may de-stabilise a vehicle, particularly a motorcycle if clipped. This junction has been the subject of a Stage 3 RSA which has made various recommendations to improve its safety.

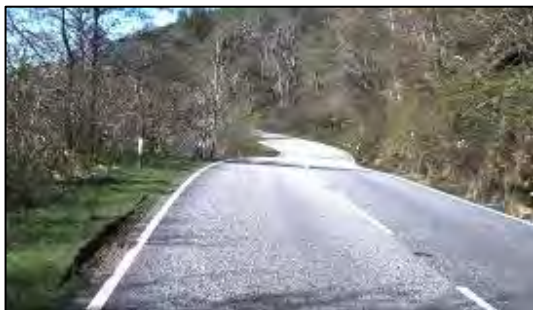
**Photo 34**

The double bends between Strone Point and Dunderave Castle are signed with warning signs and hazard marker posts, the latter being less than recommended in current standards.

A review of the current alignment in line with APG E115 would justify an increase in the number of hazard marker posts at bend sites at this and other locations along the route. The upgrading of the current arrangements will give drivers a more consistent message as to the severity and alignment of the road.

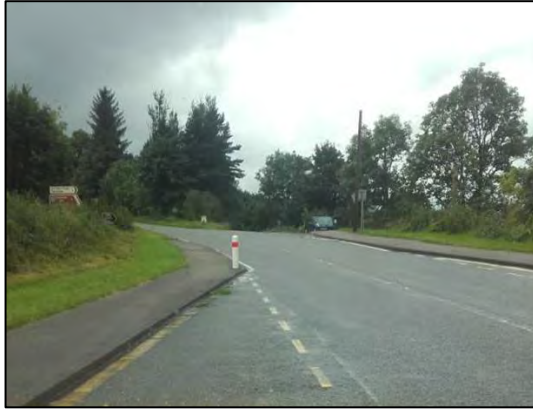
**Photo 35**

The road markings at the junction for Cairndow (East junction) have bus stops East and West bound. The edge line for the bus stops ties into the tangent point at the end of the layby and the edge line is spaced off by approximately 200mm from the kerb line. For East bound traffic, this point ties into a left hand bend. The effect is that the corner appears to 'jut out' into the carriageway at the start of the bend. It is recommended that yellow bus stop edge line is altered so that it ties into the white edge line at the end of the layby to produce a smooth alignment. There is a planned local access path (remote to the trunk road) planned to the rear of Glaschoine with access across the A83 at this location. It is recommended that warning sign Diag. 562 and 'Pedestrians Crossing' signs are installed.

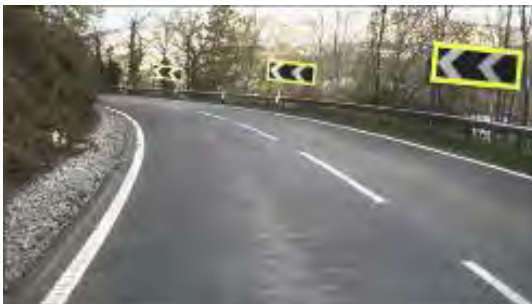
**Photo 36**

The alignment of the road at Strone Point shown in photo 36 has had 10 accidents in the five year study period. A recent scheme has cleared trees and bushes around the bend to provide improved visibility. As part of the scheme, Vehicle Activated signs have been installed for the bend as shown in photo 37, these being to Diag. 512 'Bend ahead' and a message SLOW DOWN in LED's. The trigger speed of the two signs is set at 45mph for West bound and 40mph for East bound, reflecting the approach speeds. A further scheme is planned to carry out a realignment of the carriageway at the bend in 2017. No further actions are therefore recommended for this site.
