Inspection Defect Summary Report

(Road is 'A96',)
 (Section Code is 17675/00) Or
 (Section Code is 17675/13)

17675/13 : JUNCTION B9017 NEWMILL TO JUNCTION B9016 BUCKIE

Visual Condition Survey

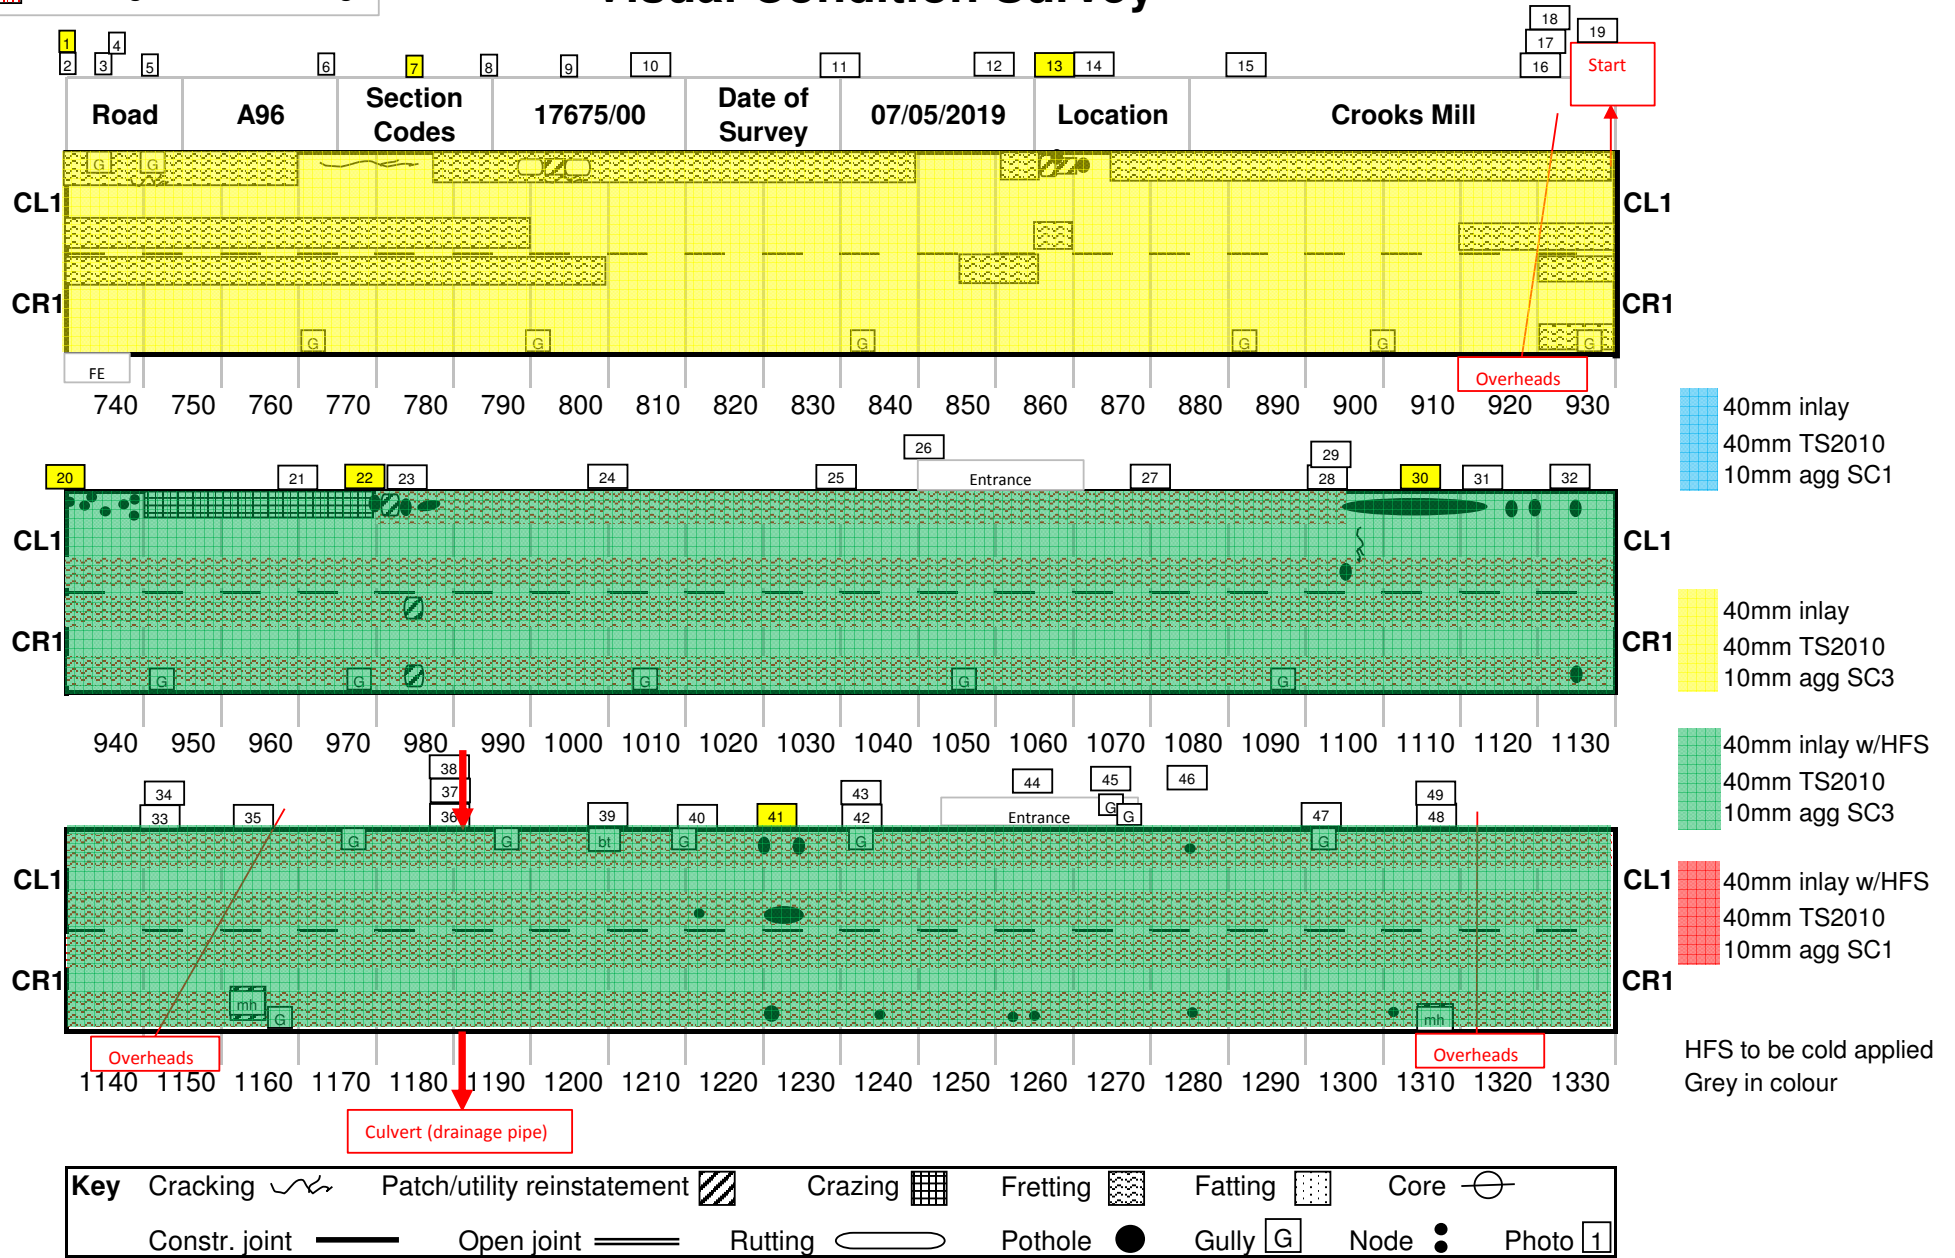
- worn High Friction Surfacing

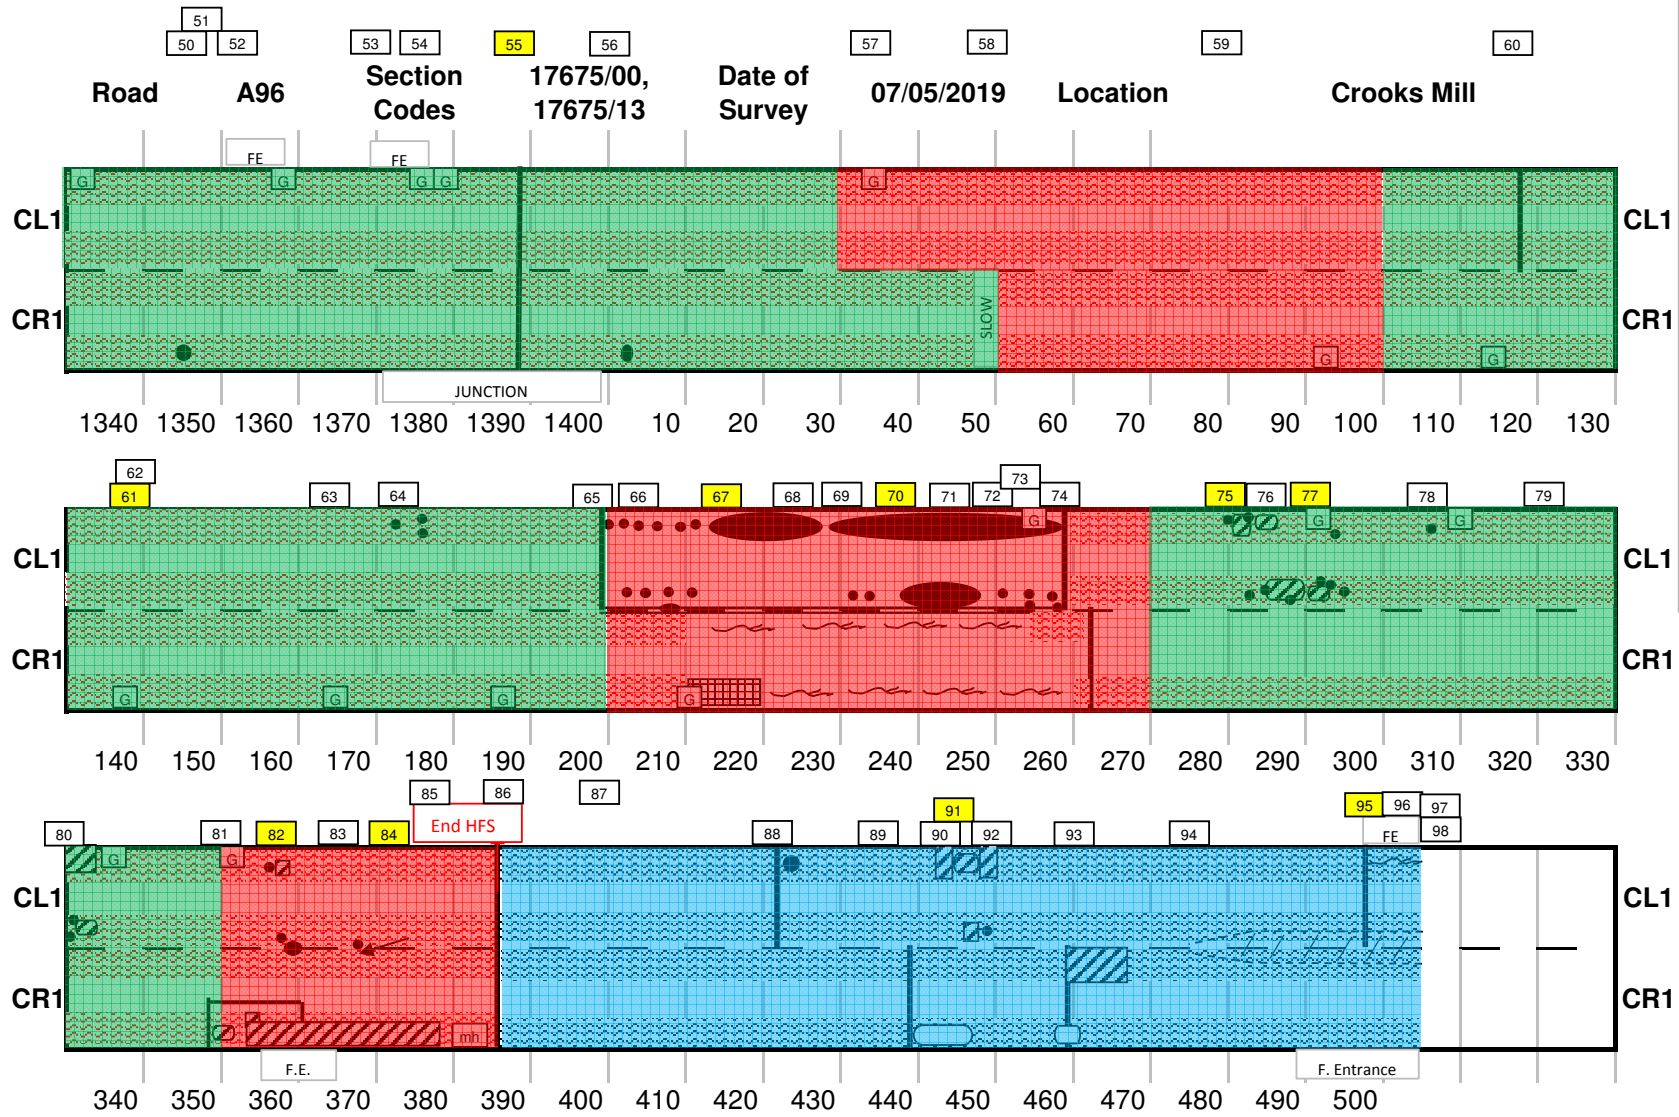
- Ch 622m - AV marker post
- Ch 623m - GAS marker post
- Ch 624-629m - entrance CL1
- Ch 643-669m - Junction CR1
- Ch 929m - Start of 1x5's and solid white
- Ch991m - Start of 6x3's
- Ch 1026-1073m - Little Forge Farm Entrance CR1
- Ch 1038-1044m - Arrow
- Ch 1055m- End of HFS
- Ch 1146m - End of 6x3's, start of centre hatching
- Ch 1158-1175m - entrance CR1
- Ch 1166-1175m - entrance CL1
