Broad Bay Transocean Load Site ROV footage: Review of Anchor Leg Impact on Seabed and at Load-out location (OHT Hawk)

Marine Scotland

24<sup>th</sup> October 2016

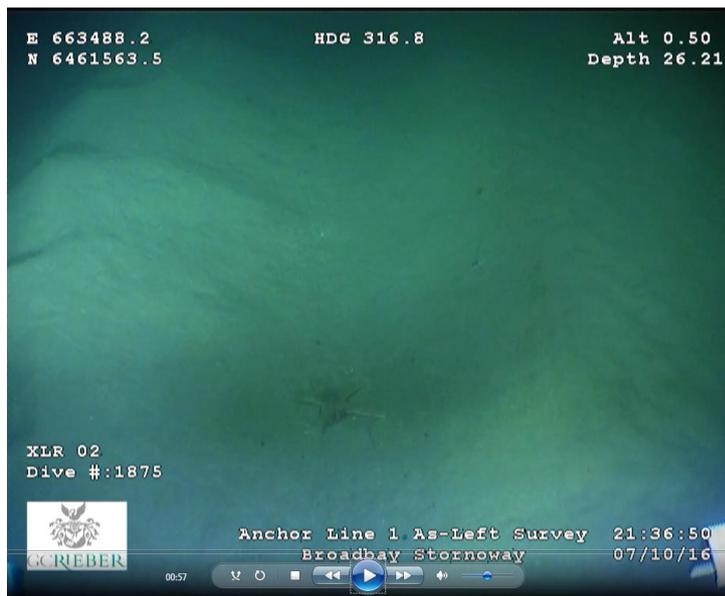
The individual anchor legs were observed to cause significant disturbance to the seabed. The removal process has left a deep trough along the seabed with steep berms. The impact is concentrated at the actual pull out area immediately associated with each anchor.

It is very difficult to give exact dimensions for these individual anchor pull out areas. However by observing the altitude indicator on the ROV heads up display and sounder, some of the troughs are at least 1.5 m to 2 m deep and have berms of approximately 0.5 to 1 m in the immediate area of the pull out. The individual anchor pull out areas vary in length and breadth but scarring diminishes gradually towards the ship end and centre of the anchor spread.

Anchor line 1, ROV part 2. Anchor scar on sand

If this area were regularly fished with mobile gear, then deployment of a chain mat campaign should be specifically targeted at the anchor pull out areas only.

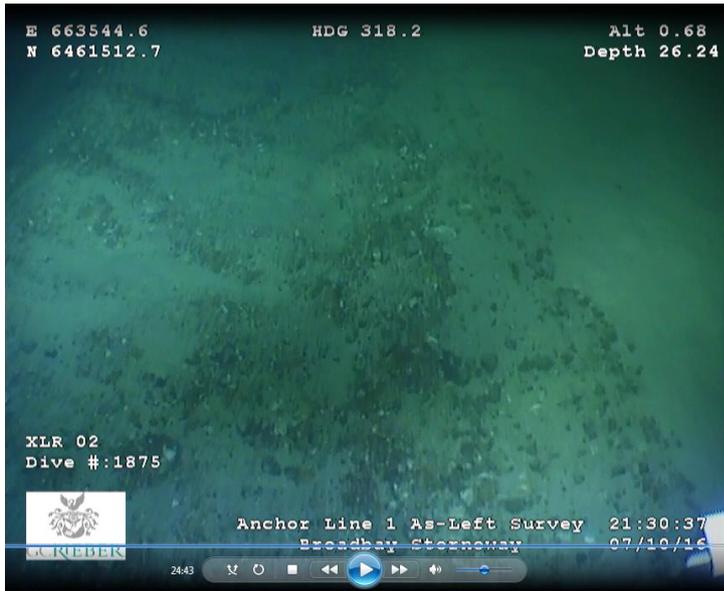
Anchor line 1 part 1. Trough related to anchor scarring

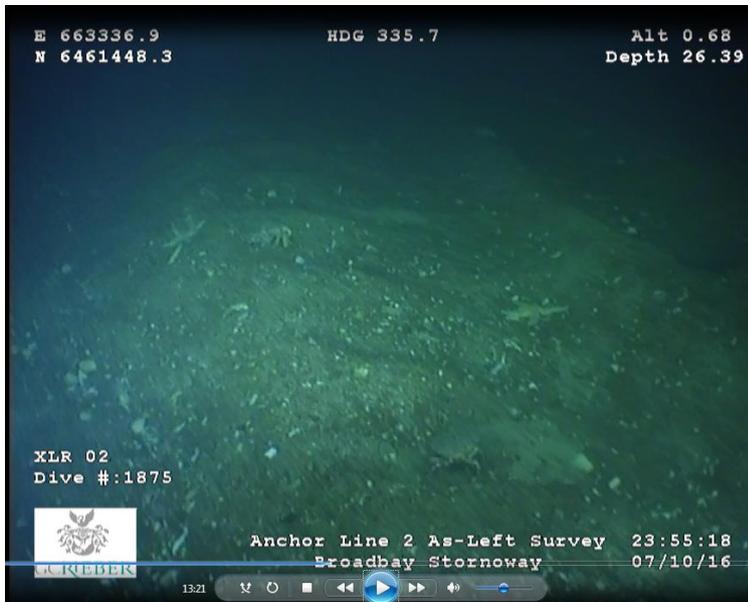
The anchor scars were rich in echinoderms and crustaceans. They appear to concentrate in large numbers along the scar, presumably due to the disturbance caused.

Anchor line 2 part 2. Trough and horizontal striations perpendicular to trough on gravelly sand. *Asturias rubens* and *Cancer pagurus* attracted to the disturbance.

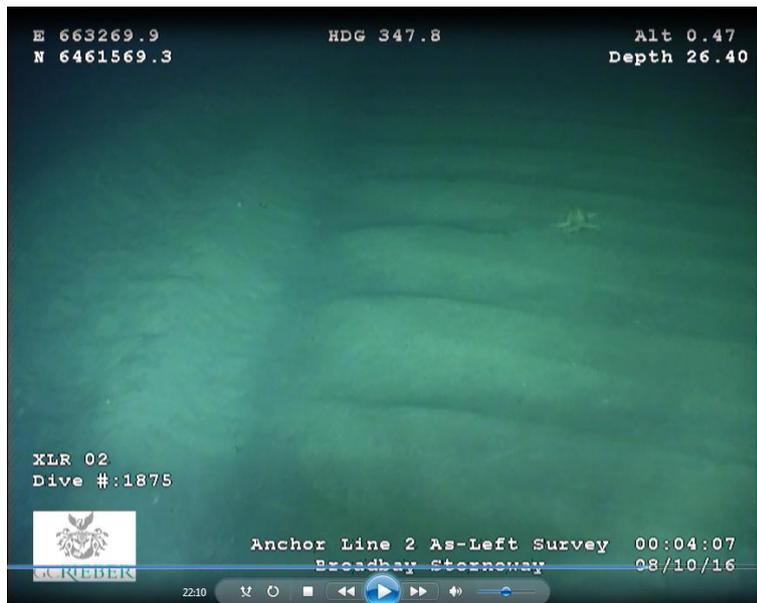
Anchor line 2 part 2. Trough caused by anchor on a rippled sandy seabed.
