Link 14040 and 14049 were identified in the Moving Cursor Programme 2016. A five year 10 month accident investigation study was undertaken from 1 January 2012 to 31 October 2017 (utilising latest data available on Iris at the time of writing).

Stage One and the subject of this report (B7047 to Montfode Roundabout) includes Link/Sections 14040/07 (2.9kms) and 14040/90 (160m) at the roundabout.

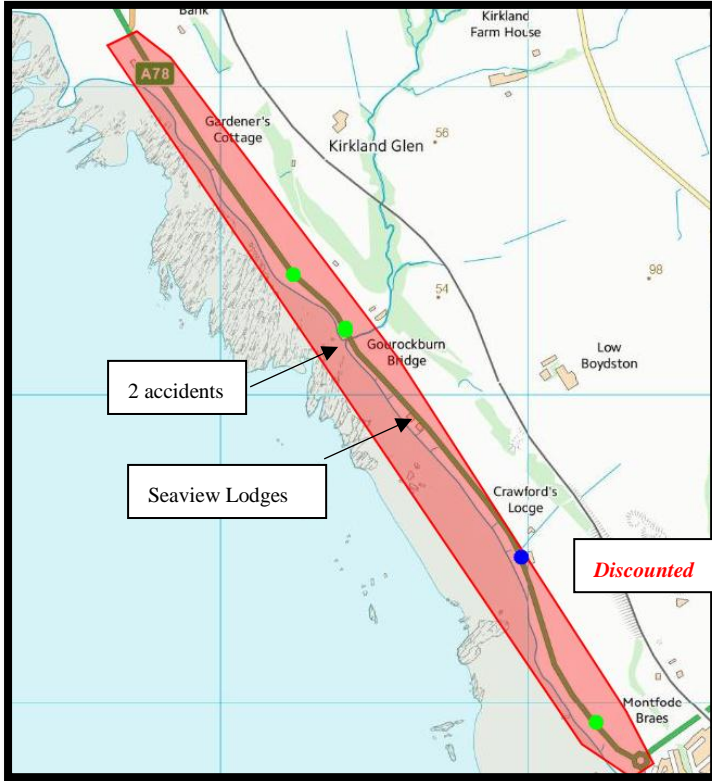
- Centre line road studs were in place throughout the section
- The section does not have a 1m hard strip adjacent included within its cross section. The Edge line is hard to the kerb)
- Edge line studs in place from B7047 junction to Seaview lodges. However these are predominantly placed behind the edge line and not in the running lane as advised in Traffic Signs Manual chapter 5.
- From Seaview Lodges to Montfode Roundabout there are no edge studs.
- The spacing of the studs is not consistent with that advised in Traffic Signs Manual chapter 5 (TSM5). In particular in sections with warning lines to Diag Non 1004.1. TSM5 recommends 9m spacing. On site it is 18m for the majority of the section.
- There is street lighting associated with the B7047 junction and the Montfode Roundabout.

The locations of the wet accidents are shown overleaf.

1. Introduce a 1m hard strip along the length of the section as per the Cross Section for this road type in TD 27/05 (on the sections where there is no central hatching)

2. Upgrade the road markings and road studs to meet the current standards.
 - a. New edge line road studs where none exist
 - b. Remove edge line studs from the channel and set in the running lane of the carriageway
 - c. Provide centre line studs where required at appropriate centres.

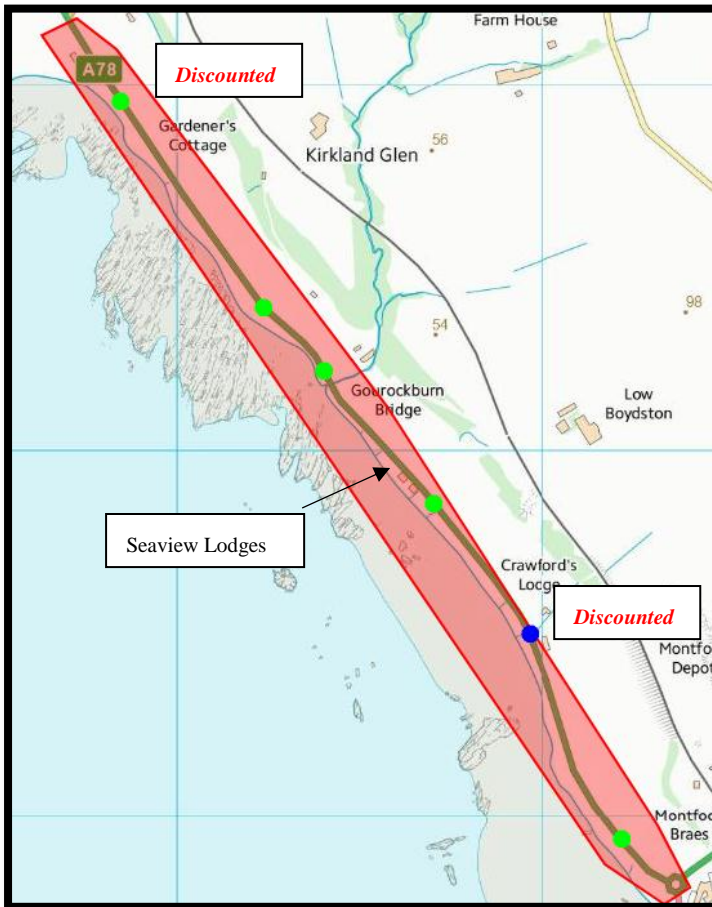
The location of after dark accidents are below

It can be seen that they are spread between the sections with full stud provision and incomplete provision.

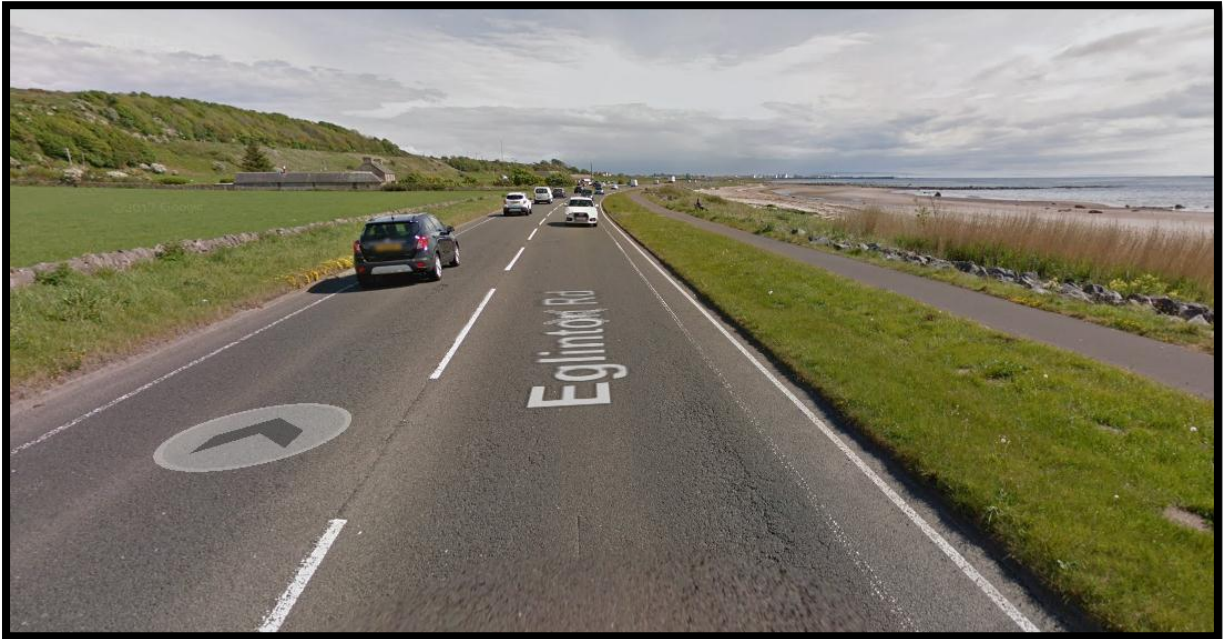
The approach to the junction for Northbound traffic (Those needing to turn right into the restaurant has SSD in accordance with TD 9/93 >215m). This is the same for southbound traffic.

Southbound Approach at 215m

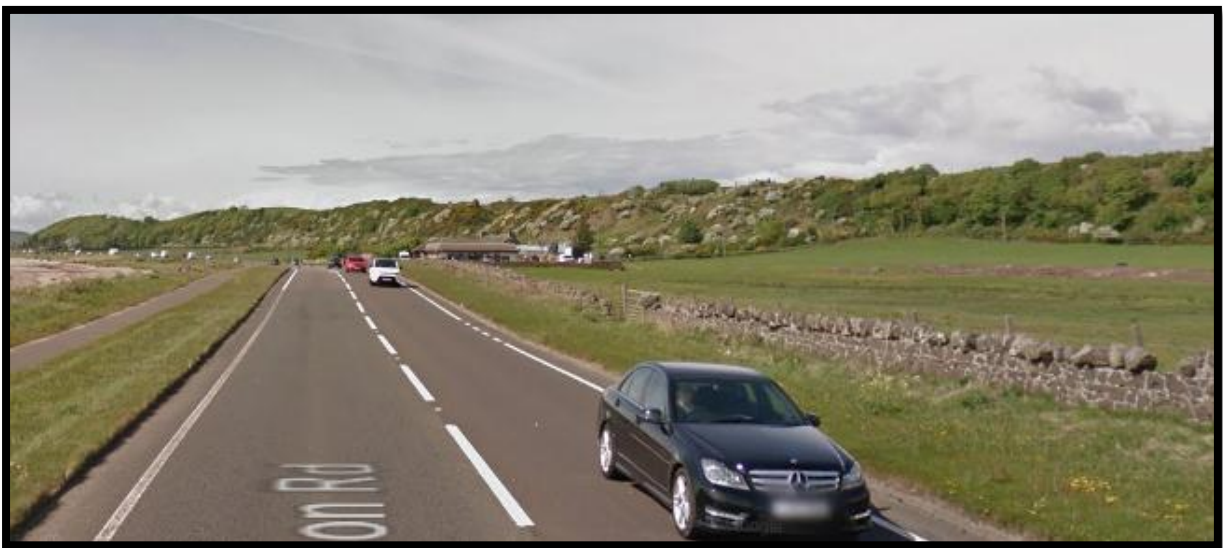
Northbound Approach at 215m
