A9 redacted 11(2)

Noise Monitoring Report – Non-Technical Summary

May 2023

## BEAR NW Bridges

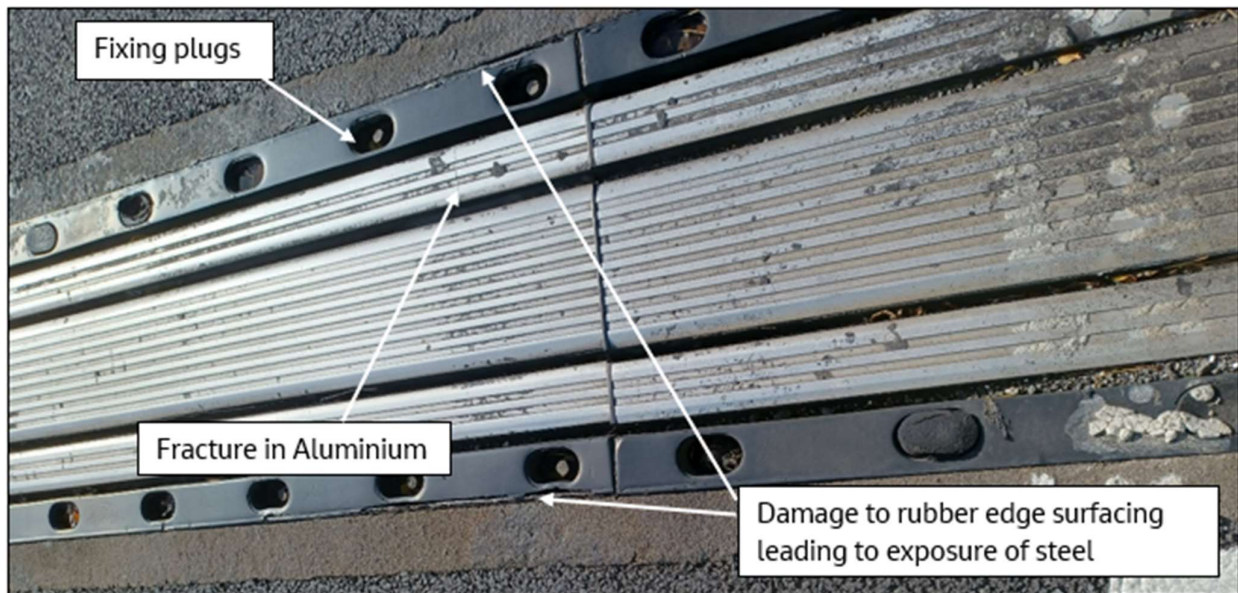
The bridge joints were inspected at the time of the noise survey by the acoustic specialist. The surfacing around the joints appeared to be in good condition, smooth and in-line with the surface of the joint. It was observed that the passage of traffic has led to wear and degradation of the running surface of the joint. This could lead to the increase in noise levels generated by the passage of traffic. When the bridge joints are installed, a rubber surface covering is installed to the edges of the joint, protecting the steel reinforcement of the joint (see Figure 2). During the inspection, it was observed that the joints at both ends are worn in the areas where vehicle tyres run over the joints. Figure 3, on the next page, shows an image of the worn rubber surface, taken during the October 2022 visit.

This increase in noise could be caused by the wear pattern. The steel edge reinforcing is now exposed, so vertical impacts through the reinforcing during the passage of vehicles over the softened rubber surface are likely to

generate impact noise and potentially transfer vibration into the structure. This can lead to vibration in the bridge beams and to re-radiated noise from the bridge structure itself. Re-radiated noise is caused by vibrations that pass into other parts of the bridge, such as the beams, which can then cause noise themselves. During the surveys, it was clear that vibration was being transferred into the bridge beams. It was also noted during the surveys, that the plugs used to infill the mounting bolt holes are becoming loose and falling out (see Figure 3), leading to a greater potential for the rubber surrounding to be worn through abrasion from traffic and greater exposure to atmospheric conditions, accelerating the wear.

Figure 3: Image taken during October 2022 site visit of joint degradation

It should also be noted that the supporting bridge bearings at the abutments are also worn and there is the possibility that this may also have contributed to the increase of noise levels in the vicinity of the bridge joints.

During the surveys, it was observed that the bridge joints are worn, although serviceable. The wear and tear on them could be leading to the increase in noise generation results captured during the surveys. As a result of the observations and the measurements taken during the surveys, degradation of the joints is likely to be the principal contributing factor to noise generation therefore it is recommended that the existing bridge joints are replaced. However, prior to any replacement, the functionality of the existing bridge bearings should be assessed to ensure any new joints can operate effectively, and as designed.
