A737 St James to  
Kilbarchan Collision Study  
SCOTTISH TRUNK ROAD  
NETWORK - SOUTH WEST UNIT  
22/SW/0801/012/RP/001

December 2022

Project Name:	SCOTTISH TRUNK ROAD NETWORK - SOUTH WEST UNIT
Project Number:	22-SW-0801-22
Report Title:	A737 St James to Kilbarchan Collision Study
Report Number:	22/SW/0801/012/RP/001

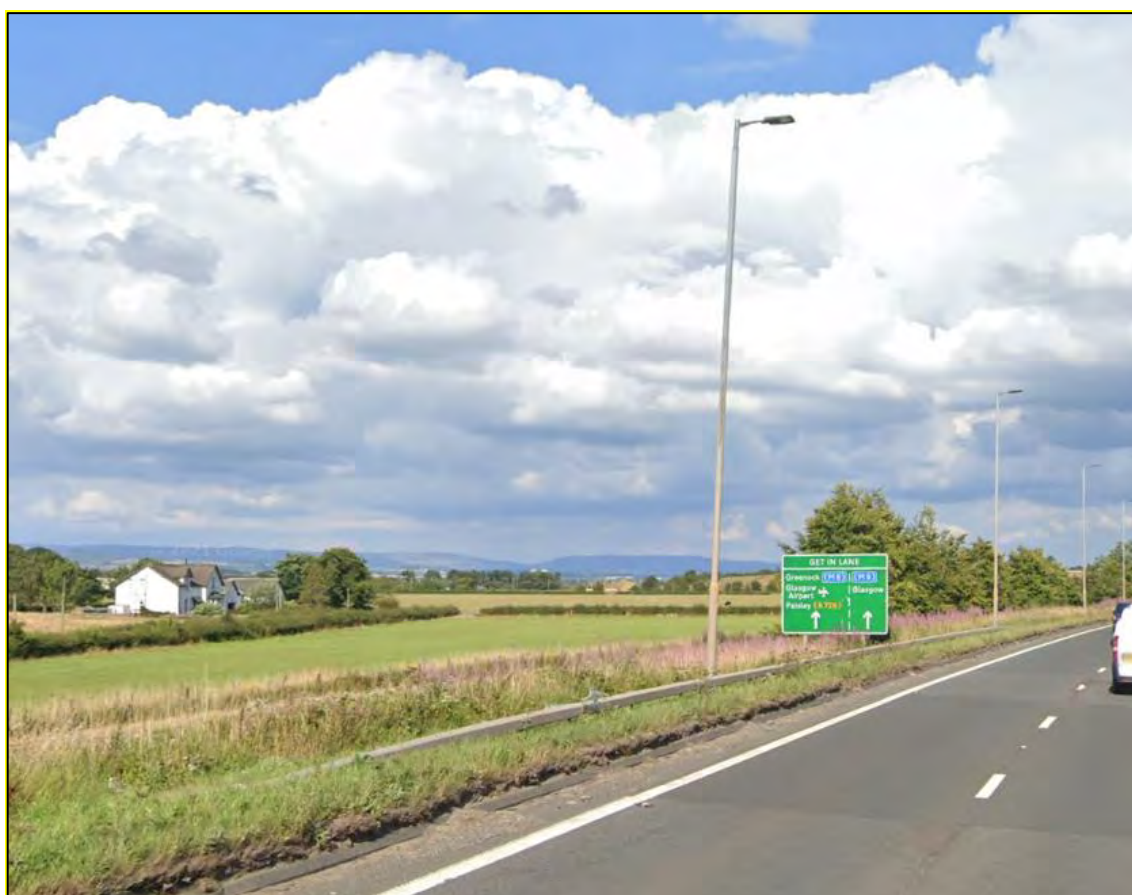
Figure 3-2 – A737 Mainline Northbound Verge Safe System Defects

- 3.1.4 As part of the Safe System Approach to Road Safety, this section of the A737 has been reviewed to identify any possible measures to improve the safety of the road and roadsides where possible. It should be noted that although these improvements may not directly link to collisions within this report, they will ultimately reduce the risk of collisions and reduce the severity of injury should a collision occur. Several measures have been identified on this section of the A737 including passive safety upgrades to the street lighting columns and road signs and the replacement of sub-standard P1 vehicle restraint system (VRS) terminal ends. Figure 3-2 below shows an example of non-passively safe street lighting columns and road signs alongside a sub-standard P1 VRS terminal.
- 3.1.5 The Safe System Approach to Road Safety measures are further discussed in Chapter 9.

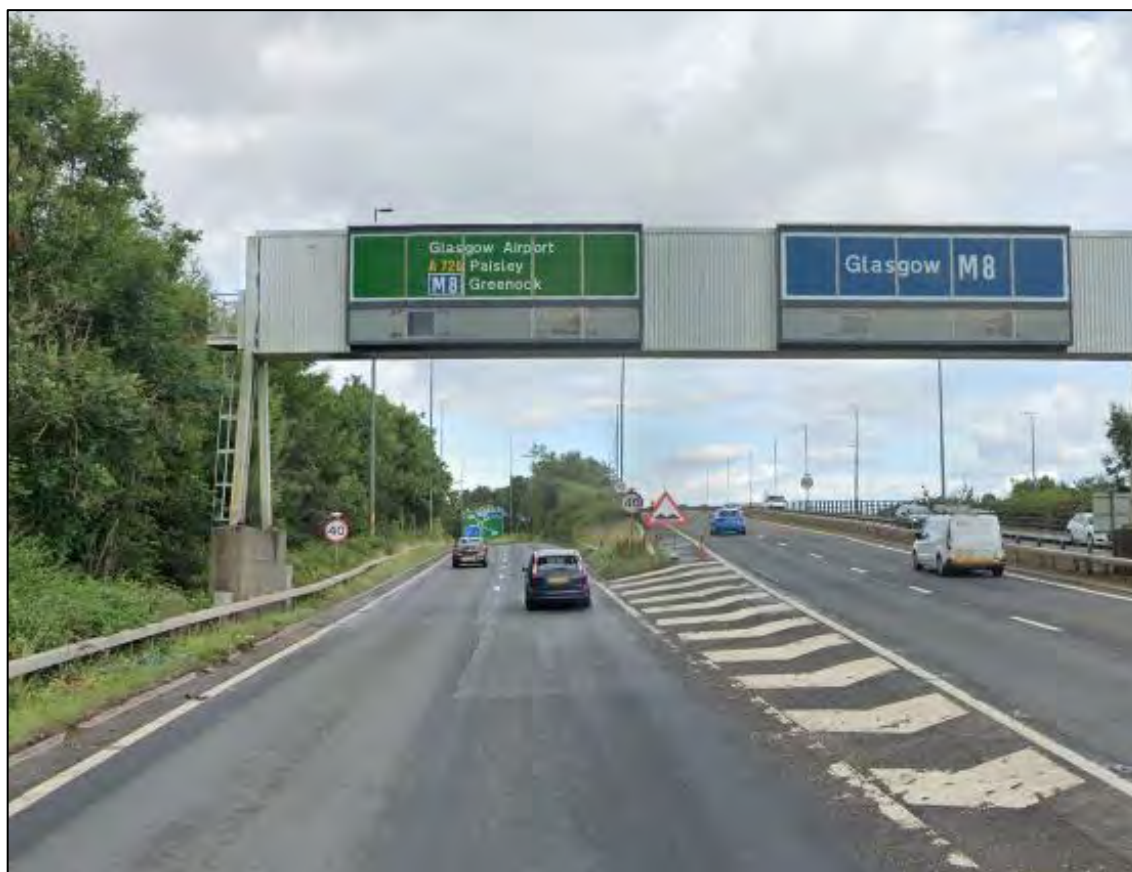
Figure 4-2 – A737 Northbound Off-Slip Diverge View

4.2.3 Figure 4-2 below, depicts the road space on the A737 off-slip road at the diverge. There is an uphill climb to a crest prior to a left-hand bend where visibility appears to be restricted. The alignment of the slip road is considered to be one of the contributing factors of the 40mph speed limit which is in place immediately from the beginning of the slip road.

- 4.2.4 The 40mph speed limit signs on the slip road are not particularly conspicuous. A 50mph roundel sign immediately beyond in the offside, serving the northbound A737 mainline carriageway on the viaduct, potentially provides conflicting information to drivers. This may encourage higher speeds than desirable on the slip road. It is feasible to enhance conspicuity of the 40mph gateway by relocating the signs, however this will require amendment of existing traffic regulation orders. The verges at this location are also extremely saturated with vehicle restraint systems, vegetation, drainage, and lighting columns. A potential solution to reduce speeds on the slip road is to provide 40mph repeater signs spaced between 250m-350m over the full length of the off-slip as per **Chapter 3 of the 'Traffic Signs Manual' (TSM)**.

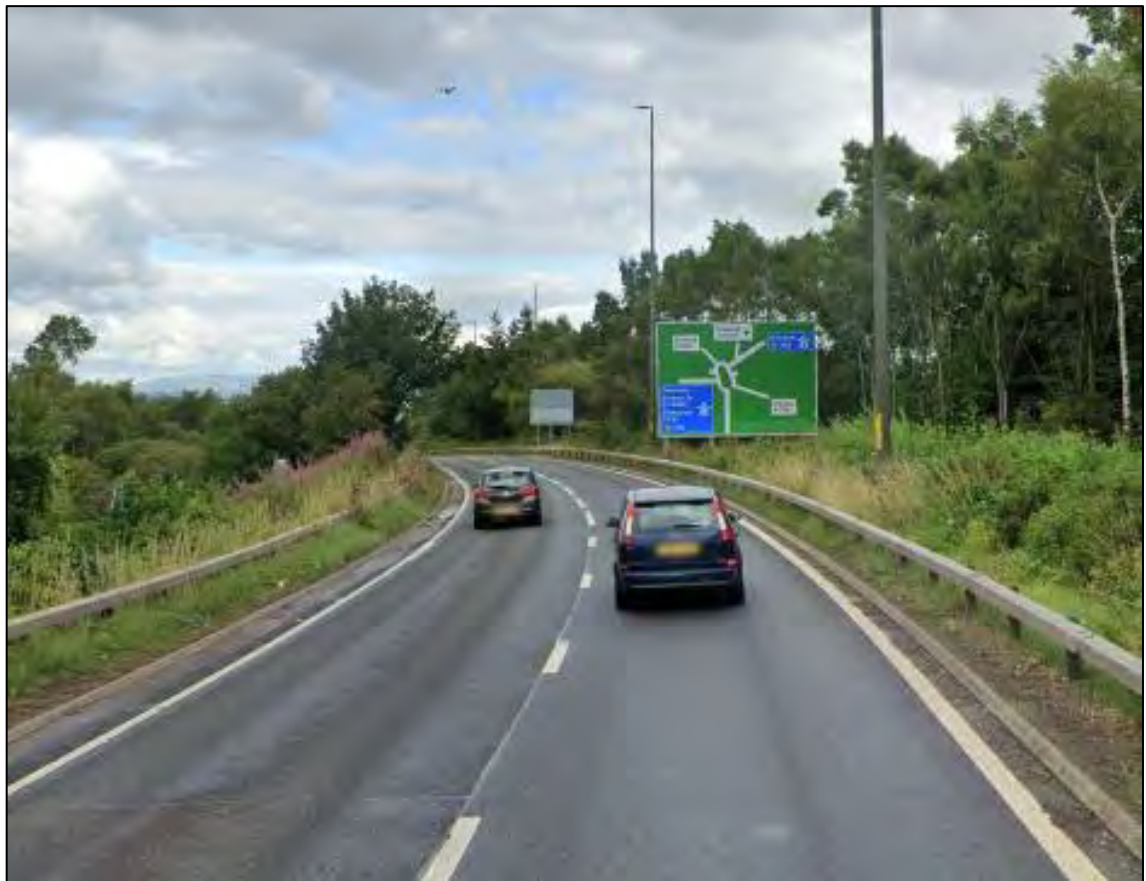
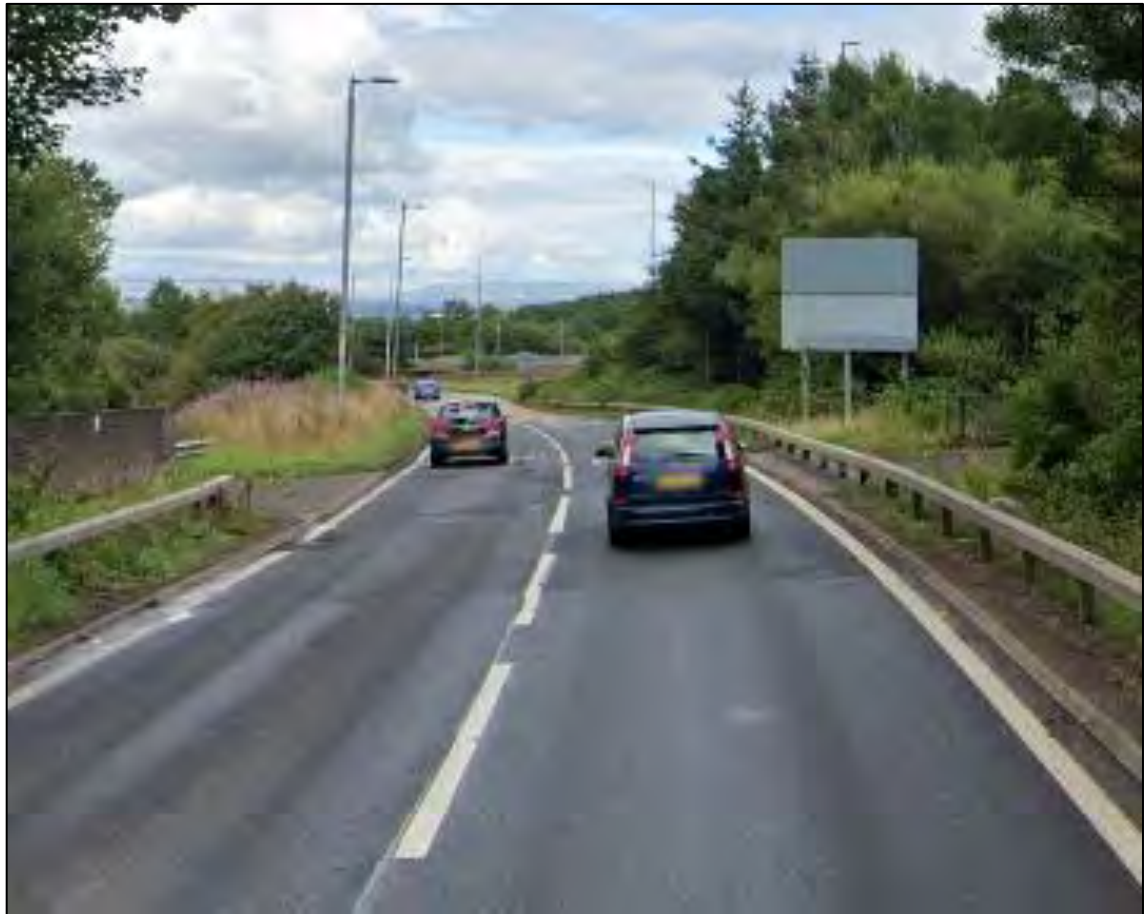
- 4.2.5 Collision KA01110 occurred on the sweeping left-hand bend approaching St James Interchange roundabout on the off-slip. The collision was slight in severity and occurred during the hours of darkness at 07:30 in wet conditions. The collision data describes a vehicle failing to judge another vehicles path or speed resulting in a shunt with a vehicle who was waiting to go ahead, indicating there may have been slow moving traffic or a queue on the approach to the roundabout past the left-hand bend.

- 4.2.6 The left-hand bend is illustrated in Figures 4-3 and 4-4 below. Considering the slip road through the sweeping left-hand bend, the lane line extends through the first half of the bend before it changes to hazard warning line. As per Chapter 5 of the TSM the hazard warning line should have a minimum of seven marks on approach to the hazard. Therefore, the hazard warning lines should be extended through the full extents of the left-hand bend to a point where the forward visibility is no longer reduced to accord with the TSM.
- 4.2.7 There also appears to be an area of vegetation to the back of the VRS which further restricts the forward visibility around the bend, and it is recommended that this vegetation is cleared as much as practicable to increase visibility.

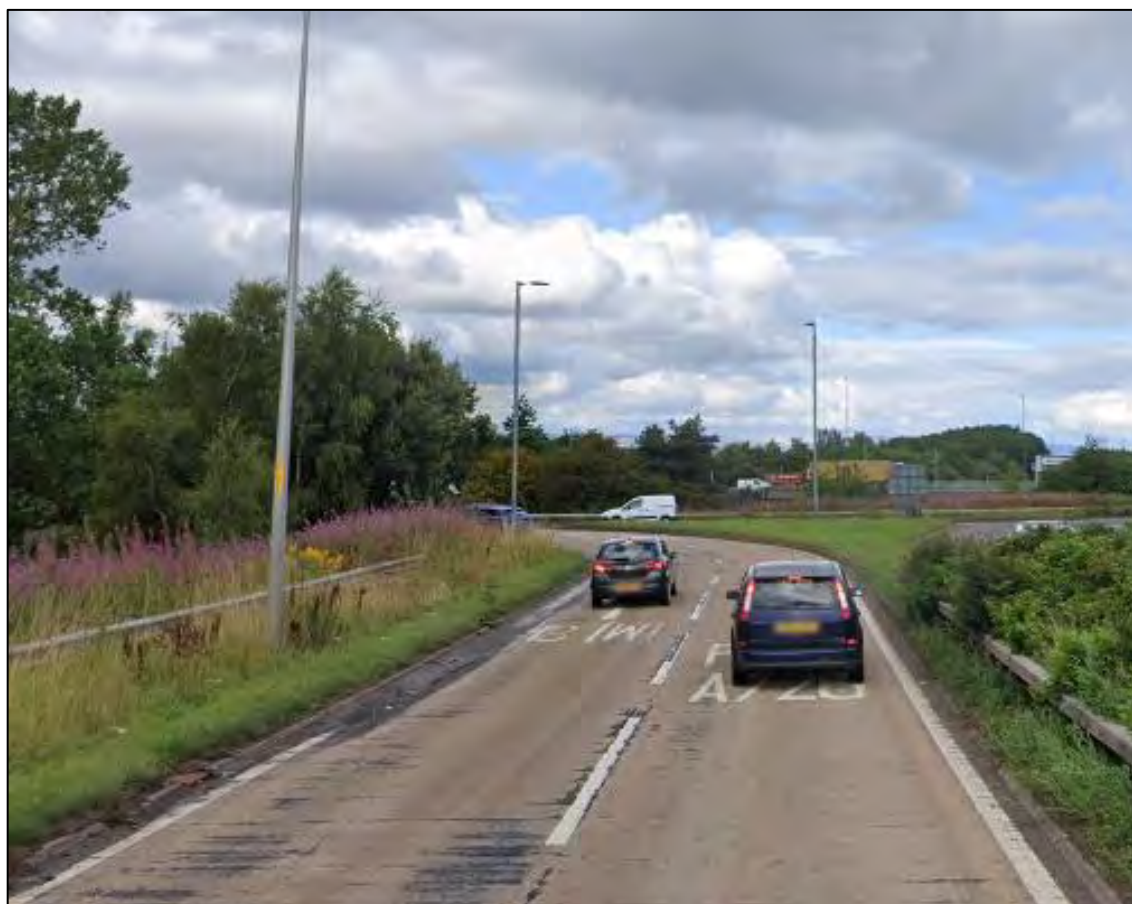
Figure 4-5 – A737 Northbound Off-Slip Approaching St James Interchange Roundabout View

- 4.2.10 The roundabout entry appears to be set at an acute angle. This means that drivers **approaching the 'Give way' would need to turn their head over their right shoulder to** fully check for oncoming circulatory traffic. If the driver approaches at a higher than appropriate speed, which is possible given the contributory factor analysis, then they may make an early decision to enter the roundabout with only a cursory look and may fail to see a vehicle.

- 4.2.11 It is noted that this A737 entry to St James Interchange Roundabout is the only trunk road arm which is not signalised with both of the M8 off-slips and also the A726 local authority arm from Paisley being signalised. It is recommended that the A737 entry is considered for signalisation in consultation with Renfrewshire Council.
- 4.2.12 As an interim measure, a sight screen is recommended to be installed on approach to the roundabout in order to help reduce approaching speeds and encourage drivers to take more care when approaching the roundabout. Additional chevron signs to diagram 515 could be incorporated within the sight screen.

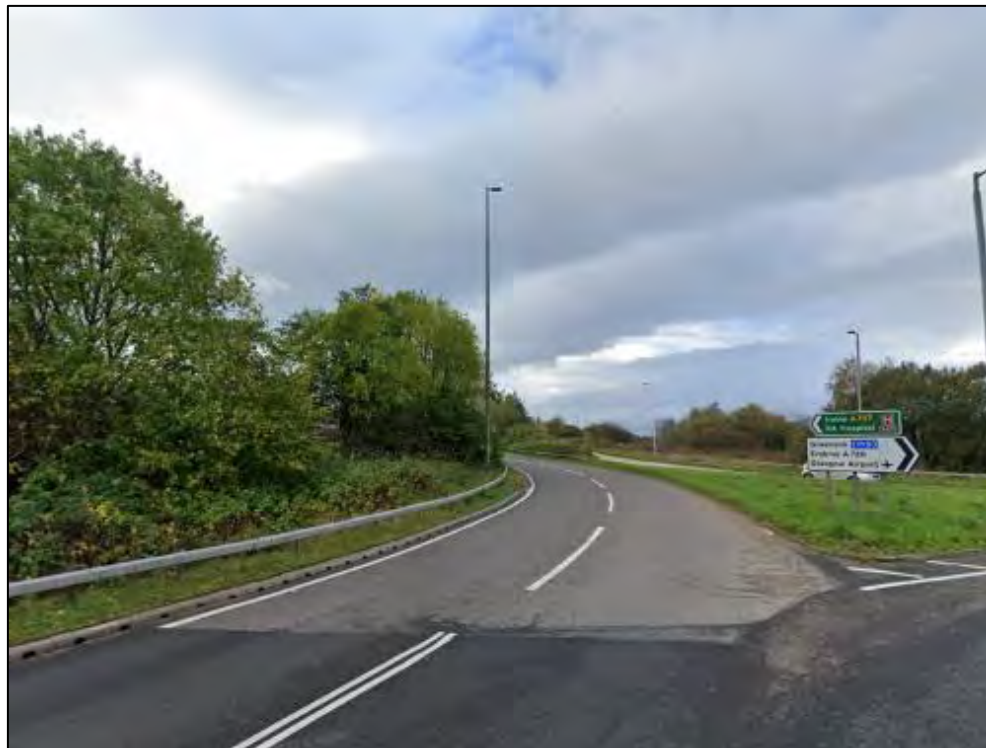
Figure 4-6 – St James Interchange Roundabout Exit to A737 On-Slip

4.3.3 Figure 4-6 below, illustrates the view from the St James Interchange roundabout circulatory toward the exit to the A737 southbound on-slip. The image shows a two-lane exit from the roundabout with a short dedicated left lane delineated by double white lines. Whilst it is appreciated that this use of a double white line system is not wholly in line with Traffic Signs Manual Chapter 5, it is on the Local Authority carriageway and we are not sure of their purpose so do not want to amend. There appears to be a restriction to forward visibility at the exit caused by tree branches and foliage immediately behind the VRS on the nearside, however, it is unlikely this contributed to the recorded collision at this location. It should also be noted that the prior two arms of the roundabout before the A737 on-slip exit are signalised helping to manage traffic behaviour.

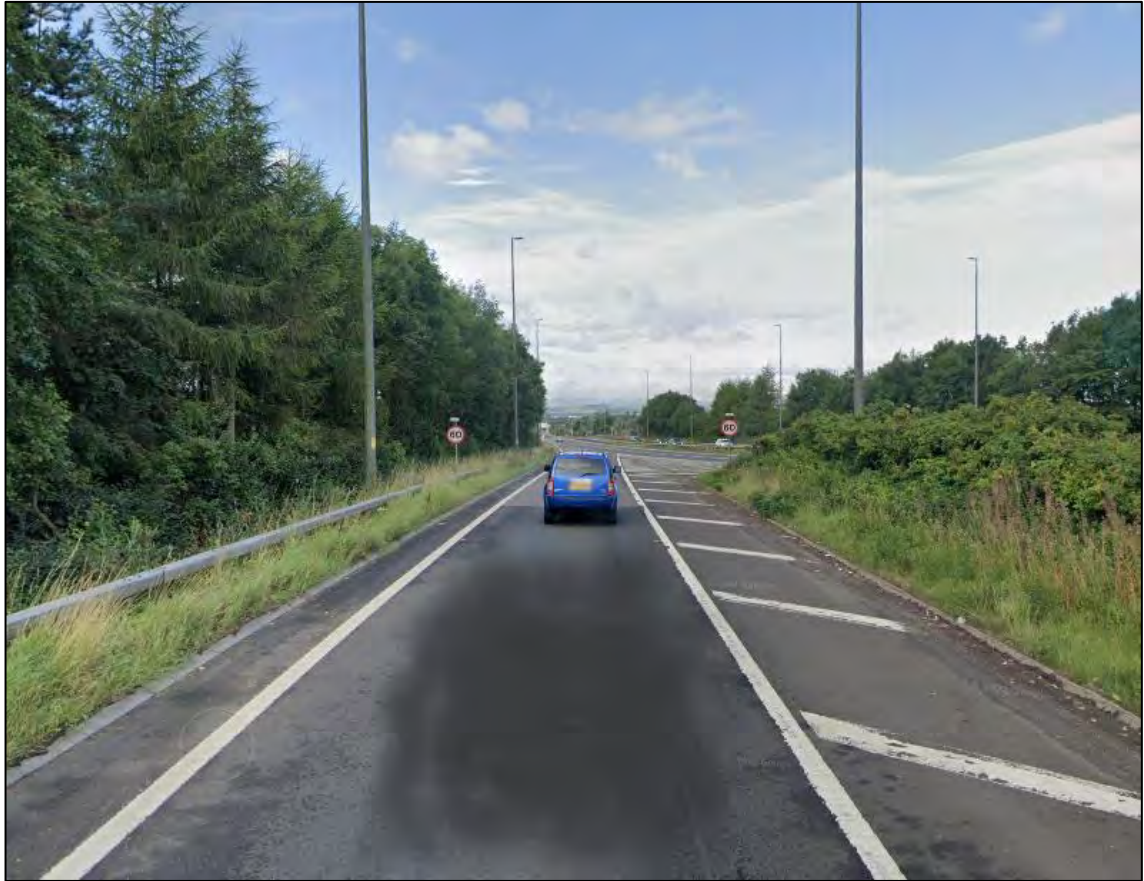
Figure 4-7 – St James Interchange On-Slip Approach to A737 Mainline Merge

- 4.3.6 Figure 4-7 above illustrates the view from the southbound on-slip looking towards the merge onto the A737 mainline. The image highlights the presence of heavy shrub growth that separates the slip road from the southbound mainline carriageway. This growth appears to restrict inter-visibility between mainline and on-slip road traffic. Comparing the available visibility at the merge to the requirements within DMRB CD122, it can be advised that there are no obstructions to visibility between the connector road and mainline along the full length of the merge nosing and the desirable minimum mainline stopping sight distance (215m) is available from the back of nose.

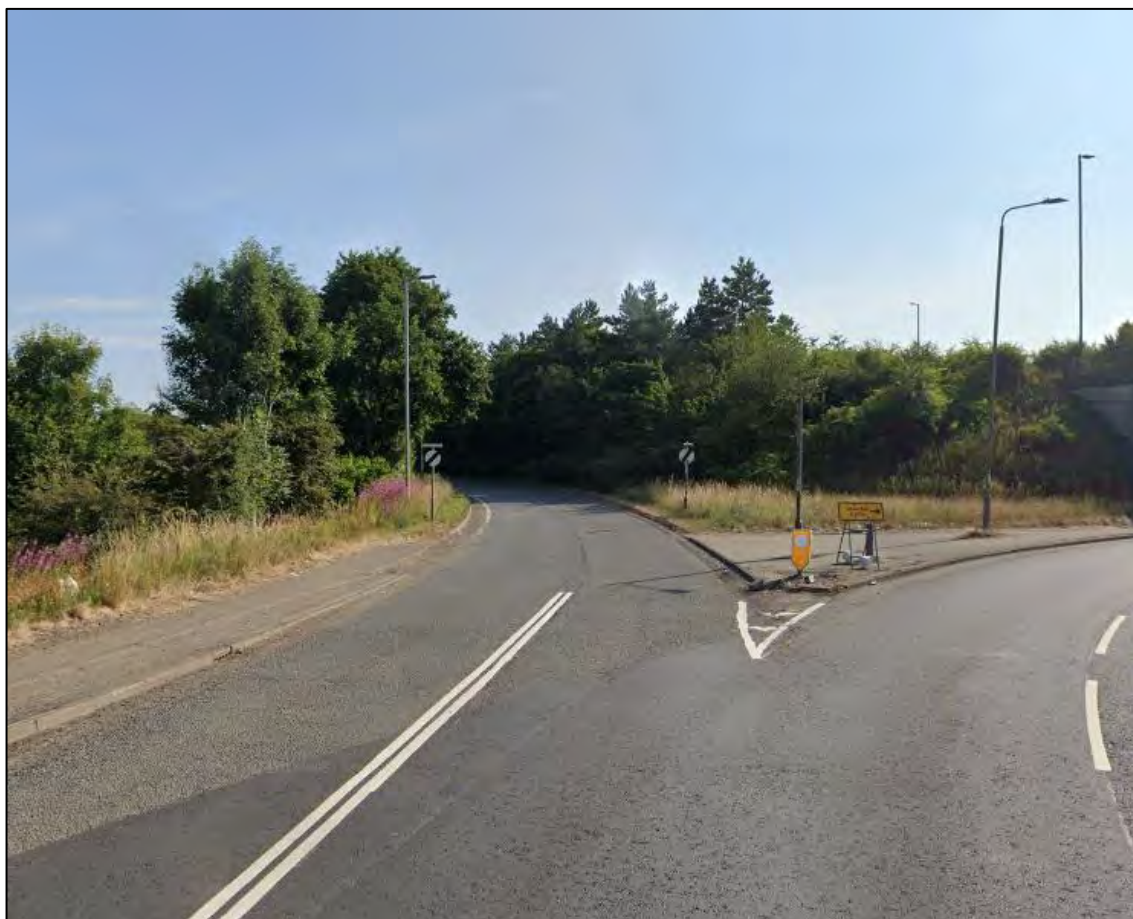
Figure 5-2 – Linclive Junction Northbound On-Slip Entry

- 5.2.2 Collision KA01402 was slight in severity and involved two vehicles entering the A737 northbound on-slip from Linclive Roundabout. One vehicle already on the roundabout circulatory attempted to overtake a second vehicle who joined from the A761 north-western arm. It should be noted that since the collision in 2018, the road markings on the approach to the slip road entry have been improved to include a double white line segregated left turn lane from the A761 western arm to better manage lane discipline at this location. Whilst it is appreciated that this use of a double white line system is not wholly in line with Traffic Signs Manual Chapter 5, it is on the Local Authority carriageway, and we are not sure of their purpose so do not want to amend. The current road layout is shown within Figure 5-2 below.

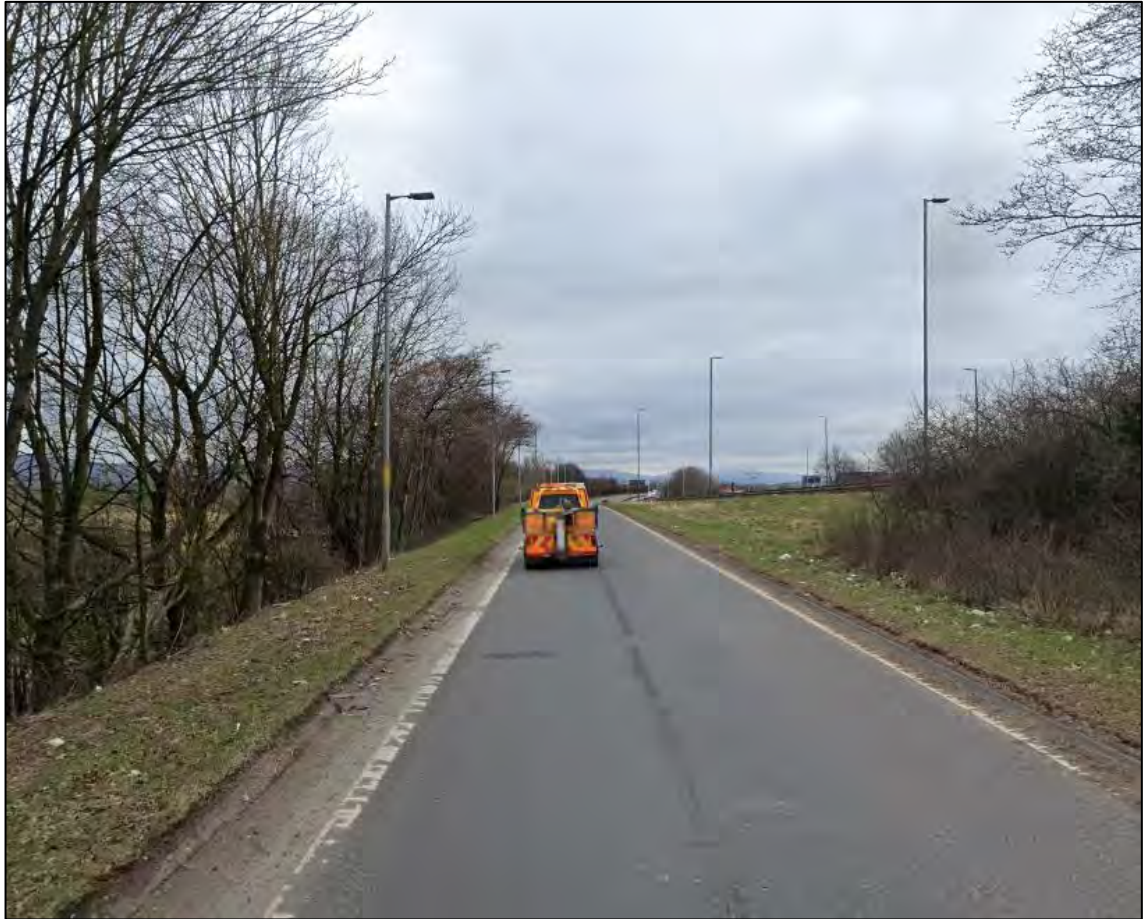
Figure 5-3 – Lincrive Junction Northbound On-Slip

- 5.2.4 Collision 1056637 involved two vehicles and was slight in severity. The collision occurred during the day and when the road surface was dry. It can be advised that a vehicle was parked on the A737 northbound on-slip and was struck by another vehicle attempting to overtake. The main contributory factor was failure to look properly which indicates the driver misjudging the parked **car's** location was the causation of this collision. The road layout of the northbound on-slip at the approximate location of Collisions 880101 and 1056637 is shown within Figure 5-3 below.

- 5.2.5 It can be advised that the width of the on-slip shown within Figure 5-3 is 7m from kerb to kerb. According to DMRB CD127 for an MG1B single lane slip road there should be a 3.3m hard shoulder, 3.7m lane and 0.3m offside hard strip. Two lanes exit Lincrive Roundabout onto the northbound on-slip however there are no formal road markings or signs to reducing the lanes to a single lane prior to the merge onto the A737 mainline. It is recommended therefore that road markings and signs are introduced to formally reduce the lanes to a single lane prior to the A737 merge as shown in Figure 3.14b of CD122.
- 5.2.6 Similarly to the A737 mainline, the lighting columns on the slip road are not passively safe and it is recommended that these are upgraded in line with the Safe System Approach to Road Safety.

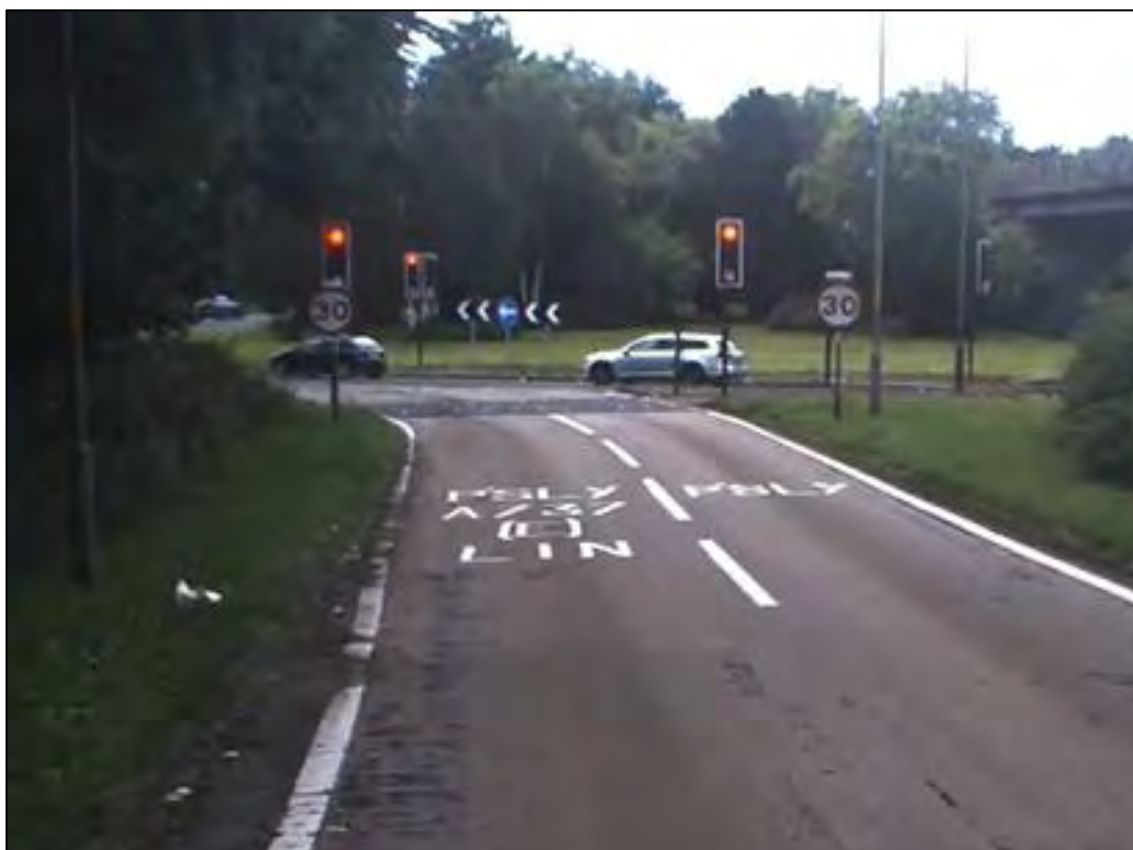
Figure 5-4 – Lincrive Junction Northbound Off-Slip

- 5.3.2 Figure 5-4 illustrates the view from the A737 northbound off-slip approach looking towards the traffic signals at this arm of Lincrive Roundabout. A pedestrian crossing phase can be called upon demand and therefore high friction surfacing is present 100m in advance of the crossing location. The slip road has a '**New Traffic Signals Ahead**' warning sign, a roundabout advanced direction sign and a lane destination sign. SLOW road markings are located 120m and 170m from the roundabout entry, however these would suggest that the slip road is a single 6m wide lane on the slip road which may increase approaching speeds. It is recommended that the width of the slip road is further investigated to determine if any improvements can be implemented such as lane line road markings further back on the slip road, removing the 6m wide single lane and helping to reduce vehicle speeds.

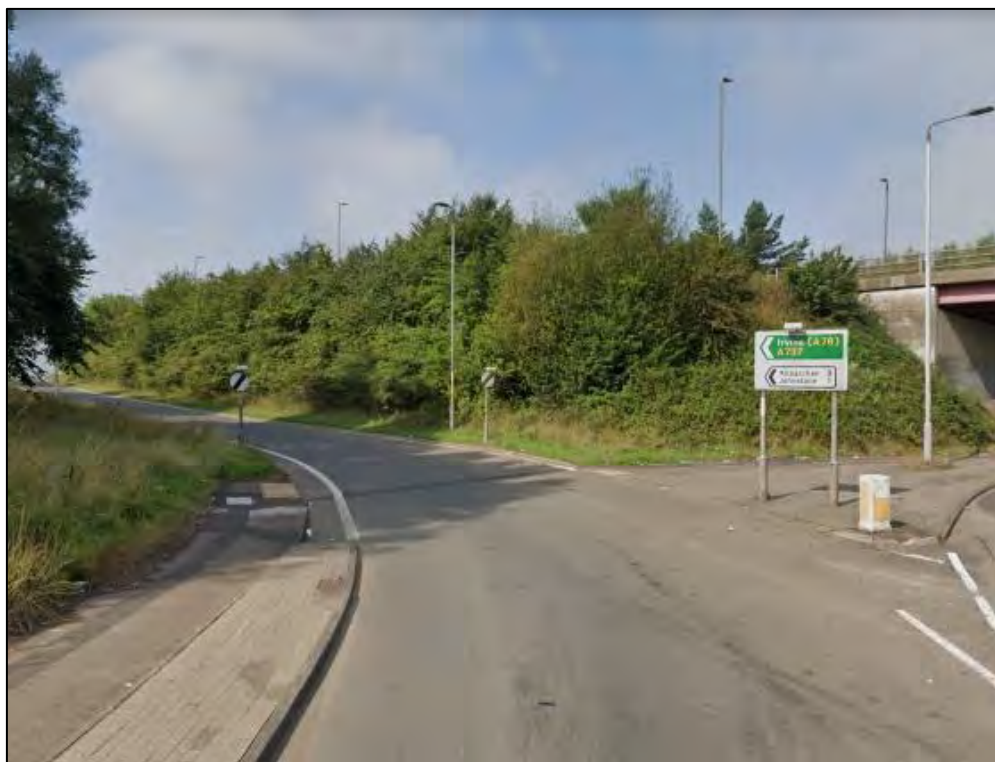
Figure 5-5 – Lincrive Junction Southbound On-Slip

- 5.4.4 Figure 5-5 shows the view looking from Linclive Roundabout towards the southbound on-slip. There is currently an uncontrolled pedestrian crossing with dropped kerbs and tactile paving in place. The crossing distance is 7.2m and the visibility to crossing is to standard according to DMRB CD116 Table 3.43. As mentioned previously, the other pedestrian crossing on this side of the roundabout is signal-controlled at the northbound off-slip however this uncontrolled arrangement provides a less suitable crossing arrangement for pedestrians, particularly those who are mobility impaired, given the likely volume of vehicles exiting the roundabout on to the slip road.
