# TERM CONTRACT FOR THE MANAGEMENT AND MAINTENANCE OF THE SCOTTISH TRUNK ROAD NETWORK

### A9 B9161 MUNLOCHY JUNCTION PROHIBITION OF RIGHT TURNS (TEMPORARY WORKS)

#### ROAD SAFETY AUDIT

#### SCHEME ID: 22-NW-0801-008

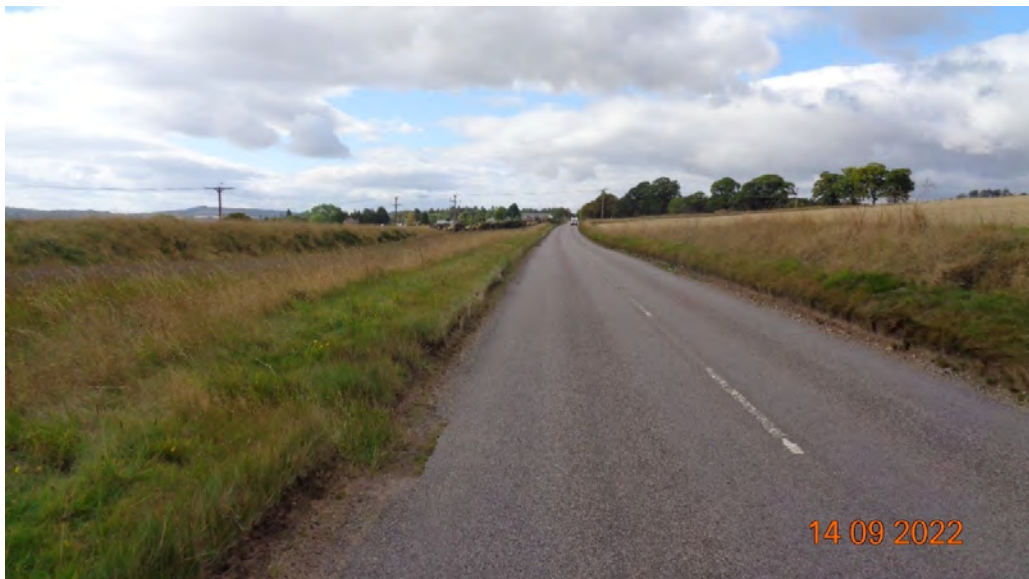
Summary: Proposed sign to be located on high and uneven verge.

The proposed information sign mounted on a high-level A-frame is to be located on a 400mm raised uneven verge. Although to be sandbagged there is a risk that it could fall into the live traffic lane increasing the likelihood of injury to the occupants of a passing vehicle, considering the temporary arrangement could last up to six months.

**PHOTO 1:** Looking west along verge towards proposed sign location.

It is recommended the sign is mounted on a passively safe post arrangement.

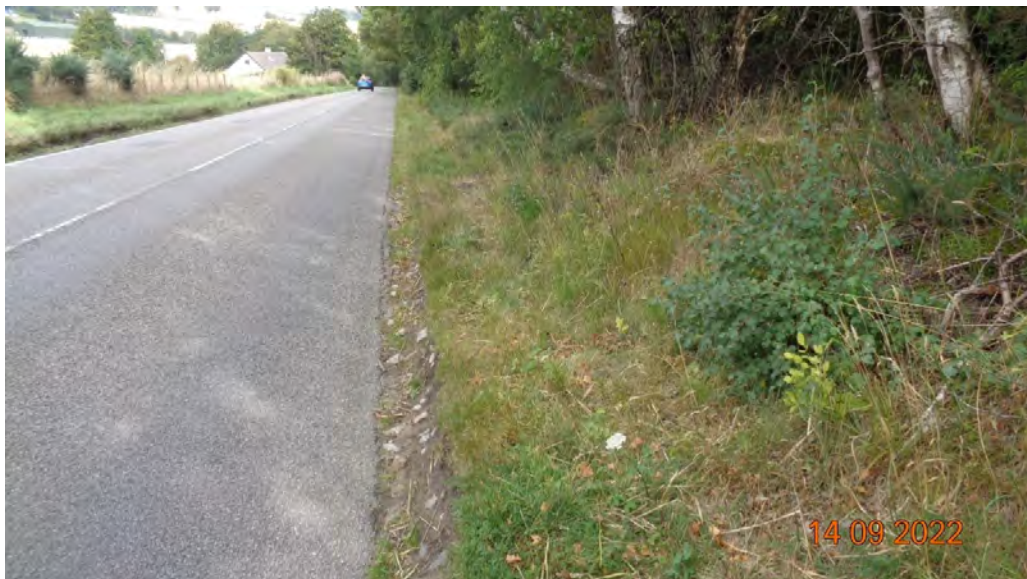
Summary: Proposed sign to be located on narrow and uneven verge.

The proposed information sign mounted on a high-level A-frame is to be located on a raised uneven verge. Although to be sandbagged there is a risk that it could fall into the live traffic lane increasing the likelihood of injury to the occupants of a passing vehicle, considering the temporary arrange could last up to six months.

**PHOTO 2** : Looking north on the B9161 from proposed sign location.

It is recommended the sign is mounted on a passively safe post arrangement and any tree branches that obscure clear sight to the sign are removed.

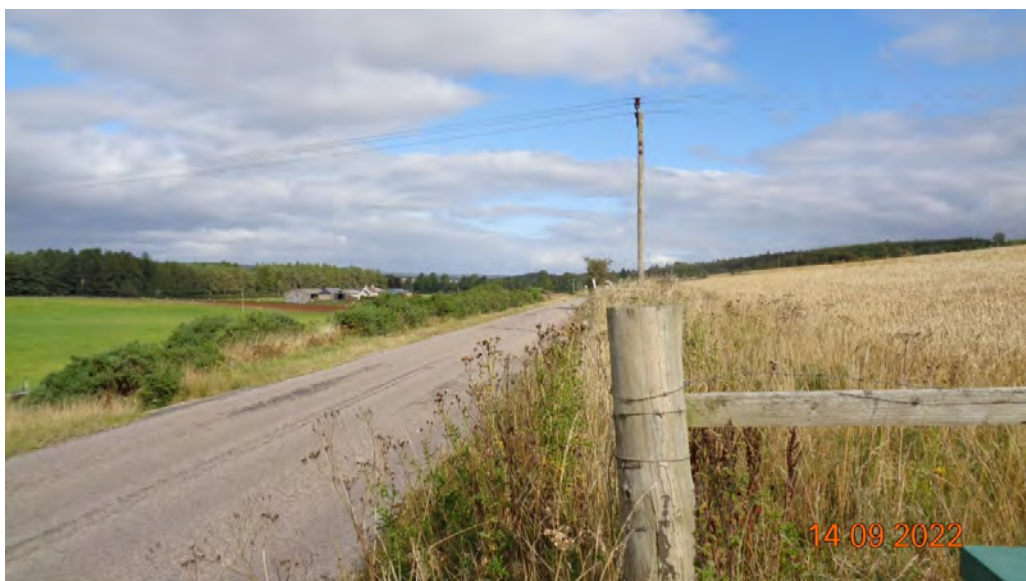
Summary: Proposed sign to be located on narrow and high verge.

The proposed information sign mounted on a high-level A-frame is to be located on a raised uneven verge. Although to be sandbagged there is a risk that it could fall into the live traffic lane increasing the likelihood of injury to the occupants of a passing vehicle, considering the temporary arrange could last up to six months. Clear sight distance to the proposed sign will also be severely restricted due to the profile of the verge and fence line.

**PHOTO 3:** Looking north on the B9161 from proposed sign location.

It is recommended the sign is located on the offside of the carriageway where there is a wide and even verge.
