A78 Montfode to Monktonhead
Road Safety Investigation
Pennyburn Roundabout to Eglinton
Interchange
18/SW/0801/035
August 2020

Project Title: A78 Montfode to Monktonhead
Report Title: Road Safety Investigation
Revision: 0
Status: DRAFT

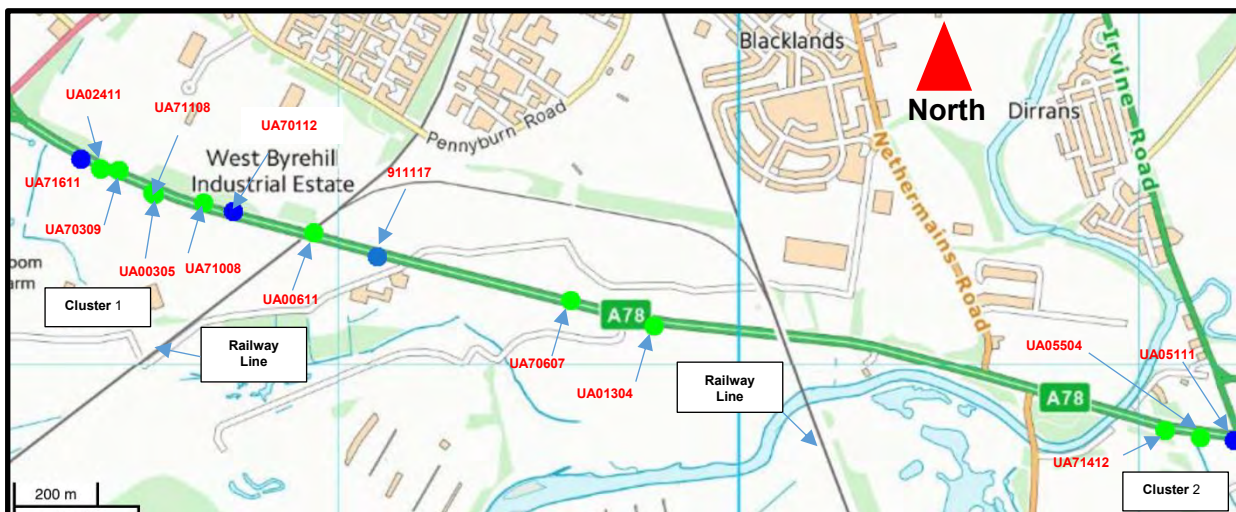
Figure 4.2. Accident Locations

Of the 14 accidents there were three Serious and nine Slight injury.

Reviewing the accidents it can be seen that there are-

- Four accidents that involve external contributory factors that cannot be addressed by engineering measures– Redacted
- One pedestrian accident. Contributory factor given as Redacted so difficult to understand any cause.
- Seven single vehicle accidents.
- 65% of the collisions involved wet or icy roads.
- Almost half (6/14) were in the dark.

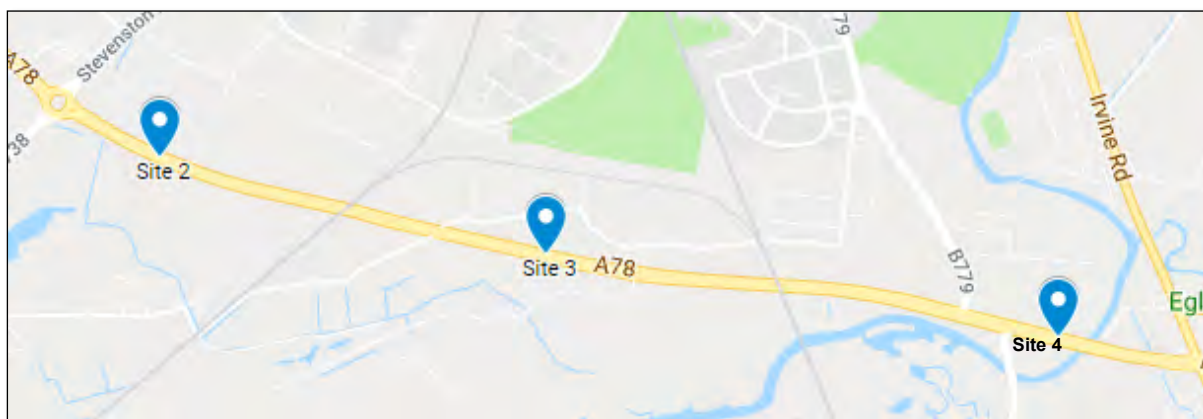
Figure 4.4.3 Speed Survey Locations

It can be seen from the results in Table 4.4.3 above that the speeds at Site 3, the long straight middle section between the two railway lines, are a cause for concern with the 85%ile speed being above the National Speed Limit (NSL), and over 34% of all vehicles above the NSL. Further investigation was undertaken of the survey results to understand the speeds by vehicle class.

It can be seen from the above results the confirmation of the higher speeds in and around Site 3, which is as expected given there are junctions in the vicinity of the other sites.

What is apparent is the high level of speeds and speeding is most prevalent amongst the vehicles that are restricted to a 50mph speed limit (HGV's – 90% and 94% at Site 3 and 75% and 87% at Site 4).

Given the above, it is recommended that measures are introduced to mitigate the accidents involving inappropriate vehicle speeds. In particular a measure that can target vehicles by their class.

It is proposed to introduce speed/class Vehicle Activated Signs (VAS) on this section of the A78 route, as detailed below.

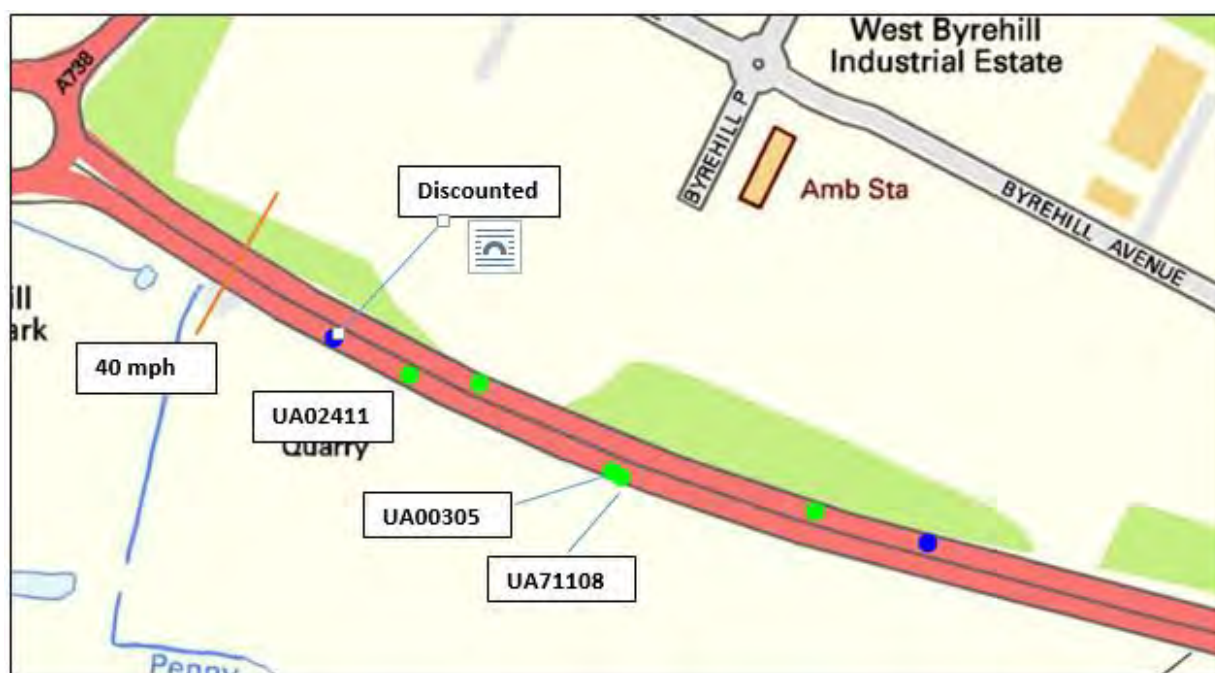
Figure 5.2.3 Sub-Section 7a - Northbound/Westbound accident locations.

It can be seen from the above that there is a common pattern associated with shunt type accidents. These accidents are plotted below, with the 3 shunt accidents shown (by accident reference), and the fourth which is discounted also highlighted.

It can be seen from the accident locations that all of the shunt accidents are on approach to the 40mph speed limit. Looking at this the road environment and the upcoming 40mph limit followed by the roundabout can result in vehicles slowing down and different rates.

- Given the northbound accidents are occurring between approximately 300 – 450m of the roundabout, it is proposed to introduce Transverse Yellow Bar markings on the approach. This will give additional warning of the roundabout and further assist in reducing approach speeds.
 - This however does not fully meet the requirements of Traffic Signs Manual Chapter 5 so a non-prescribed sign application for this use is required.
- It is noted that several of the road markings are not to standard and require upgrading to meet standards. This could be done as a risk reduction measure.

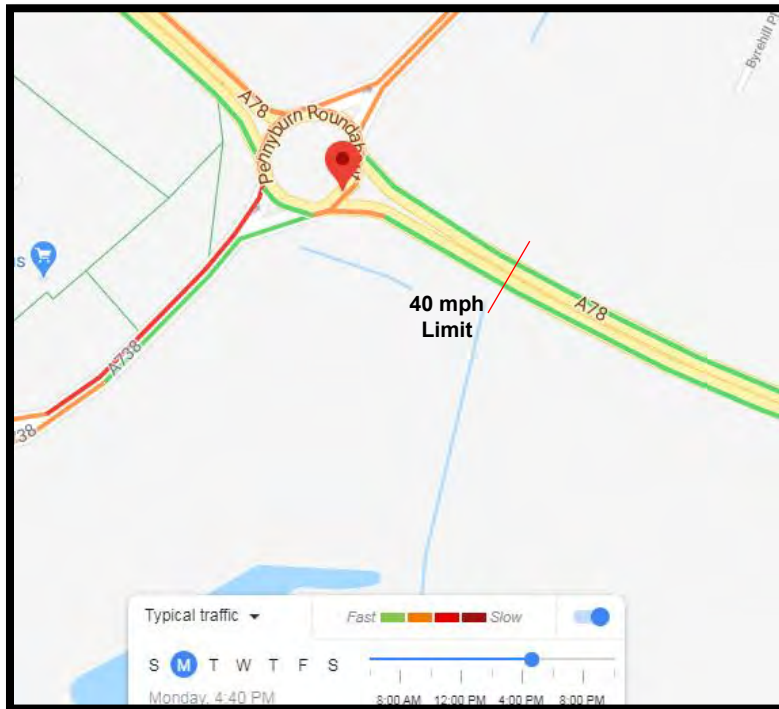
Figure 5.2.3.1 Queue on approach to roundabout.

It can be seen from the above that the typical queue is not beyond the 40mph limit, and this concurs with the accidents happening beyond this is not resulting from queueing vehicles.

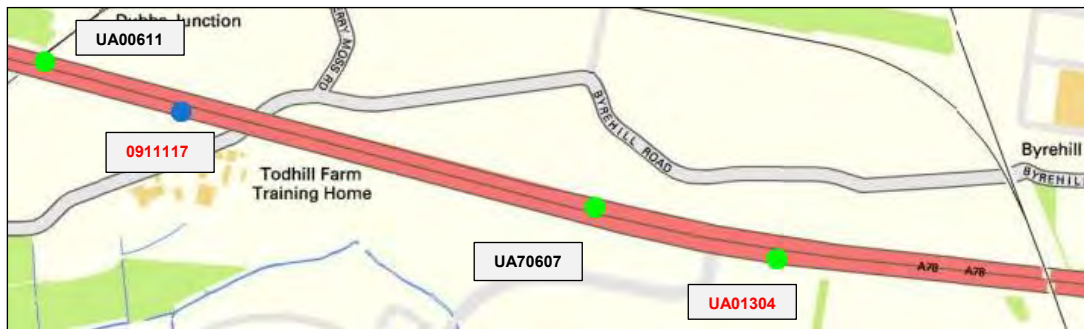
Figure 5.3 Sub-Section 7b accident locations

Sub-Section 7b above, recorded four reported road accidents during the five year period investigated. As previously detailed the accidents were as follows:

Given the low number of treatable accidents it is considered that these will be mitigated by the introduction of the Vehicle Activated Signs recommended in Sections 4.4.6 and 4.4.7

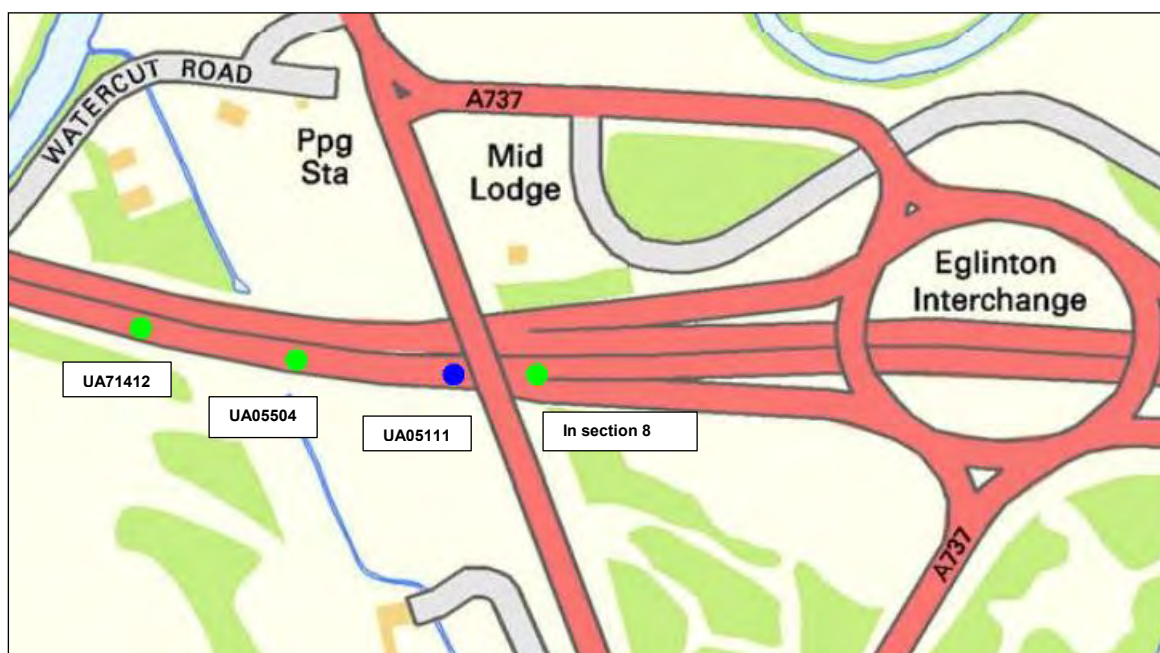
Figure 5.4. Sub-Section 7c Accident Locations

Sub-Section 7c above, recorded three reported road accidents during the five year period investigated. As previously detailed the accidents were as follows:

Given the low number of treatable accidents and the lack of a common pattern there are no further recommended measures. It is considered that these accidents will likely receive some mitigation by the introduction of the Vehicle Activated Signs recommended in Sections 4.4.6 and 4.4.7
