Inspector: Redacted	Date: 14-September-2021	Next inspection type/date: Principal due 05/07/2023	
Bridge Name: KIRKWOOD STREET F/B	Bridge Ref No: M8 22-22 F40	Road Ref No: M8	Primary Deck Form (G4) 12
BICS Inspector Level: INSPECTOR (21/01/2019)	Map Ref: OSE 256,167	OSN 664,183	Primary Deck Material (G6) A
Span 1 of 4 Span Width (m) 3.50	Span Length (m) 13.60	Deck Overall Length (m) : 89.80	Secondary Deck Form (G5) 20
All above ground elements inspected: Yes	Photographs? Yes		Secondary Deck Material (G6) P
Number of construction forms in bridge span	<input checked="" type="checkbox"/> 1 <input type="checkbox"/> 2 <input type="checkbox"/> 3 <input type="checkbox"/> More

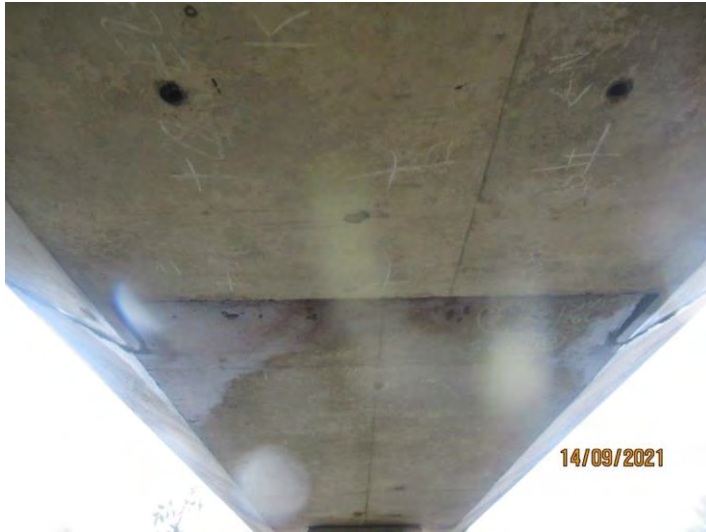
Set	Element No/Description	S	Ex	Def	Work Required	Priority (ranking 3 or 4 only)	Estimated Cost	Comments/Remarks
Deck Elements	1 Primary Deck Element (Table G4)	3	B	2.2	N No Action Monitor Only	Not Applicable	£0	Photo 1 - (Typical) Longitudinal and transverse cracking of reinforced concrete deck soffit >0.3mm in places. Also rust staining which may suggest early signs of delamination.
Deck Elements	4 Half Joints	2	B	2.4	N No Action Monitor Only	Not Applicable	£0	Localised area of delamination at RHS of the half joint soffit. also staining at half joint as a result of seepage through de bonding sealant at parapet upstand joint above.
Deck Elements	6 Parapet Beam Or Cantilever	2	B	2.2	N No Action Monitor Only	Not Applicable	£0	Longitudinal cracks on parapet edge beam.
Load Bearing Sub Structure	8 Foundations	6	F	0.0	?	Not Applicable	£0	Foundations buried unable to inspect.
Load Bearing Sub Structure	9 Abutments (Incl. Arch Springing)	2	B	2.2	N No Action Monitor Only	Not Applicable	£0	Leaching and dampness on exposed area of bank seat curtain wall. Access to inspect area difficult due to low headroom beneath soffit.

Photo 1 – Cracking on soffit

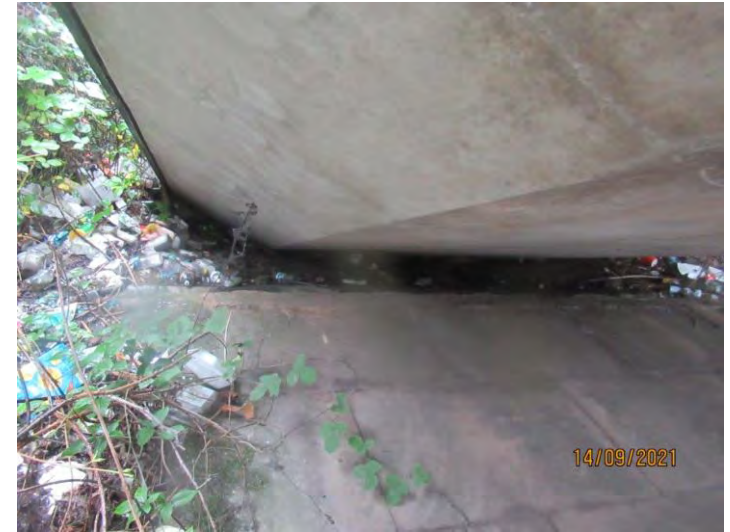
Load Bearing Sub Structure	14 Bearing Plinth/Shelf	1	A	2.4	N No Action Monitor Only	Not Applicable	£0	Bearing plinths appear to be in a good condition with no evidence of delamination.
Load Bearing Sub Structure	14 Bearing Plinth/Shelf	3	D	99.3	Cyclic Maint - Bearings & bearing shelves	3	£1	Photo 2 - Bearing shelf at ESP 1 has a build up debris and rubbish. This should be addressed at the next cyclic maintenance visit.
Durability Elements	17 Waterproofing	1	A	14.1	Waterproofing - Replacement	Not Applicable	£130,000	The soffit of the structure shows no signs of seepage. The FTI states that the waterproofing is 49 years old and past its lifespan, should be considered for replacement in any future improvement scheme.
Durability Elements	18 Movement/Expansion Joints	2	C	10.12	N No Action Monitor Only	Not Applicable	£0	Minor leakage through expansion joint rubber insert at end support No1 RHS and through polysulphide joint in the parapet upstands at the half joint.

Photo 2 - Rubbish and debris on ES1 bearing shelf

WORK REQUIRED				
Element No	Suggested Remedial Work	Priority (ranking 3 & 4 only)	Estimated Cost	Action/Work Ordered?
14	Cyclic Maint - Bearings & bearing shelves - Photo 2 - Bearing shelf at ESP 1 has a build up debris and rubbish. This should be addressed at the next cyclic maintenance visit.	3	£1	No
21	P Paint - Photo 4 - (Typical) Parapet paint protective system is broken down to substrate. The galvanise system is mostly intact apart from site welded joints and bottom of posts.	3	£7,000	No
30	Cyclic Maintenance - Vegetation - Photo 5 - Debris and build of litter on revetment in span 1.	3	£1	No

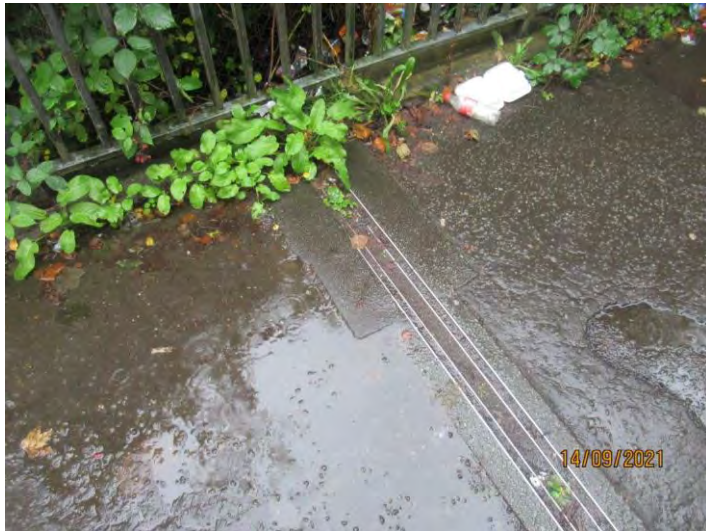
Durability Elements	18 Movement/Expansion Joints	3	E	99.3	Cyclic Maint - Expansion joints	Not Applicable	£1	Photo 3 - ES1 and half joint expansion joints full of debris and should be cleared during next Cyclic Maintenance visit.
Durability Elements	21 Painting: Parapets/Safety Fences	5	C	4.1	P Paint	3	£7,000	Photo 4 - (Typical) Parapet paint protective system is broken down to substrate. The galvanise system is mostly in tact apart from site welded joints and bottom of posts.
Safety Elements	23 Handrail/Parapets/Safety Fences	2	C	5.2	Cyclic Maintenance - Vegetation	Not Applicable	£1	Minor vegetation growth encroaching on both parapet rails behind ESP 1.
Safety Elements	23 Handrail/Parapets/Safety Fences	2	B	1.1	N No Action Monitor Only	Not Applicable	£0	Minor surface rusting to parapet.
Safety Elements	25 Footway/Verge/Footbridge Surfacing	2	B	5.2	Cyclic Maintenance - Vegetation	Not Applicable	£1	Minor vegetation growth at LHS of footway in span 1.

Photo 3 – Joints full of debris

Durability Elements	18 Movement/Expansion Joints	3	E	99.3	Cyclic Maint - Expansion joints	3	£1	See Photo 3 - Expansion joint rubber inserts at Half joints in span No 3 blocked with debris.
Durability Elements	21 Painting: Parapets/Safety Fences	5	C	4.1	P Paint	3	£7,000	See photo 4 - (Typical) Parapet paint protective system is broken down to substrate. The galvanise system is mostly intact apart from site welded joints and bottom of posts.
Safety Elements	23 Handrail/Parapets/Safety Fences	2	B	3.5	N No Action Monitor Only	Not Applicable	£0	Localised areas of missing mortar at post bases both sides of span 3.
Safety Elements	23 Handrail/Parapets/Safety Fences	2	B	1.1	N No Action Monitor Only	Not Applicable	£0	Localised areas of minor surface rusting on both parapet rails and post bases in all spans. Also minor surface rust on barrier fixings.
Safety Elements	25 Footway/Verge/Footbridge Surfacing	2	C	9.4	N No Action Monitor Only	Not Applicable	£0	Cracks are evident in top layer of the surfacing in all spans.

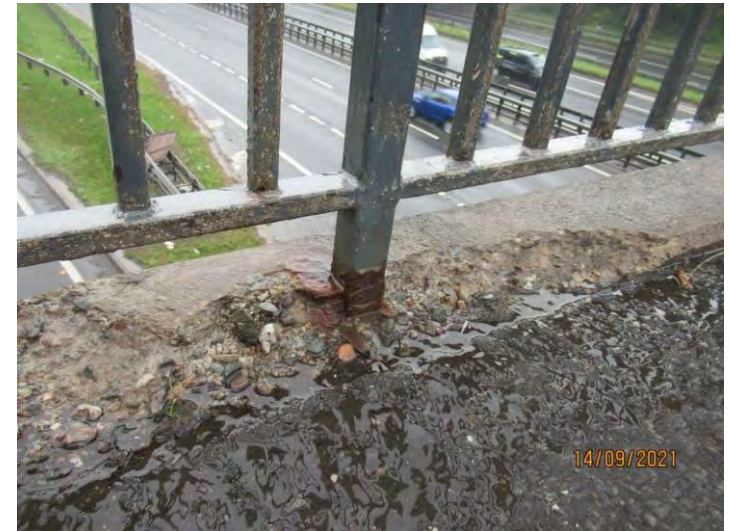
Photo 4 – Failed protective paintwork on parapets.

21	P Paint - See photo 4 - (Typical) Parapet paint protective system is broken down to substrate. The galvanise system is mostly intact apart from site welded joints and bottom of posts.	3	£7,000	No
11	Concrete - Repairs – Photo 8 - Expansive corrosion of embedded reinforcement is resulting in rust staining at top of intermediate support No3 on uplink face.	3	£1,500	No

21	P Paint - See photo 4 - (Typical) Parapet paint protective system is broken down to substrate. The galvanise system is mostly intact apart from site welded joints and bottom of posts.	3	£7,000	No
25	Other - Surfacing - Photo 12 - Footpath surfacing is breaking up exposing localised areas of concrete and which appear to have no waterproofing.	3	£2,000	No

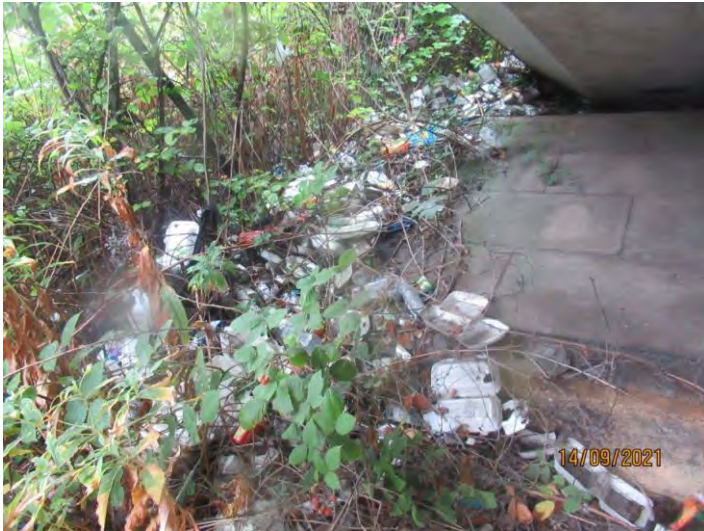
Safety Elements	25 Footway/Verge/Footbridge Surfacing	2	C	9.2	N No Action Monitor Only	Not Applicable	£0	Cracks are evident in top layer of the surfacing in all spans.
Other Bridge Elements	30 Revetment/Batter Paving	3	D	99.3	Cyclic Maintenance - Vegetation	3	£1	Photo 5 - Debris and build of litter on revetment in span 1.
Other Bridge Elements	33 Embankments	3	D	5.2	Cyclic Maintenance - Vegetation	Not Applicable	£1	Photo 6 - Moderate vegetation growth on embankment in span 1.
Ancillary Elements	35 Approach Rails/Barriers/Walls	1	A	1.1	N No Action Monitor Only	Not Applicable	£0	Metal railings all structurally sound and connected

Photo 5 – Rubbish and debris on revetments

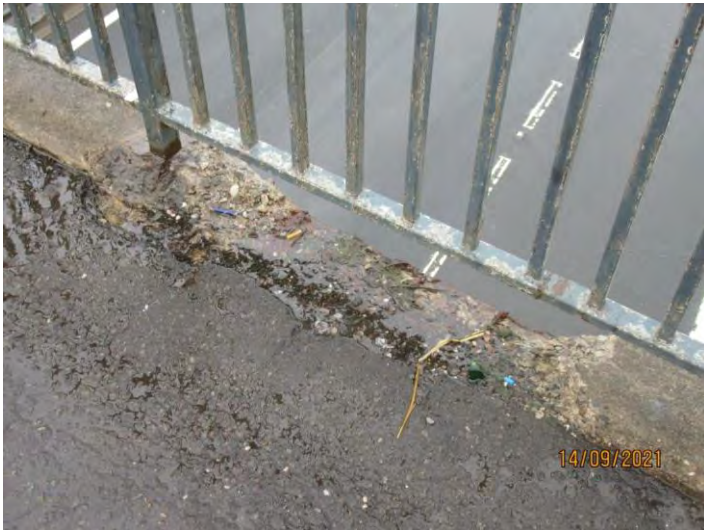
Photo 7 – Spalling on parapet edge beam

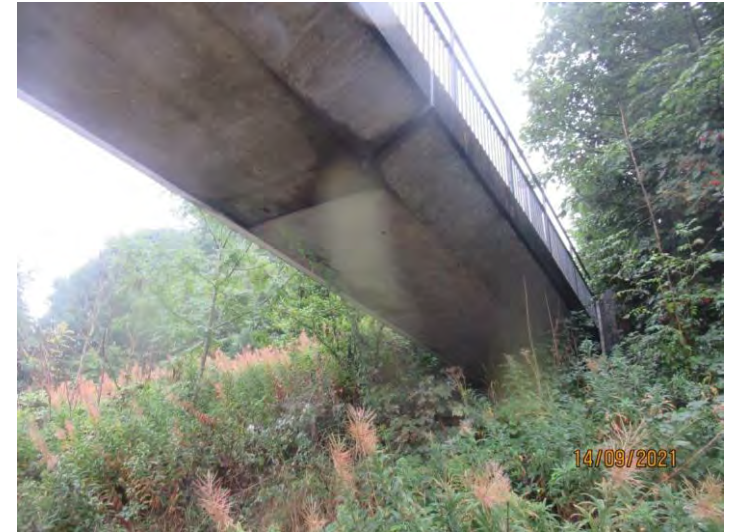
Photo 6 – Vegetation growth on embankments

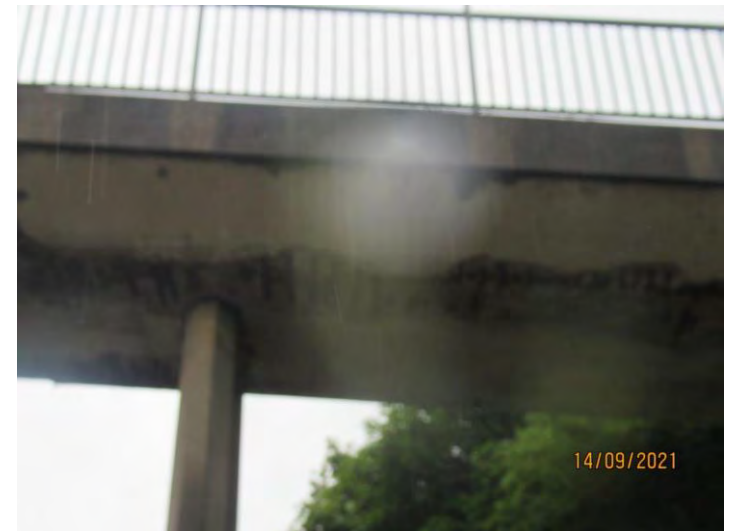
Photo 8 – Expansive corrosion at top of piers

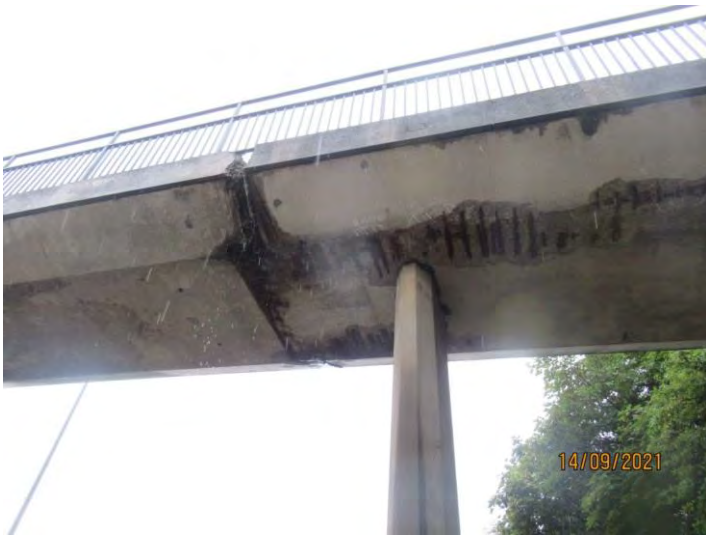
Set	Element No/Description	S	Ex	Def	Work Required	Priority (ranking 3 or 4 only)	Estimated Cost	Comments/Remarks
Deck Elements	1 Primary Deck Element (Table G4)	3	C	2.1	Concrete - Repairs	3	£1,000	Photo No.11 - Localised areas of spalled concrete on soffit exposing reinforcement in span No3.
Deck Elements	1 Primary Deck Element (Table G4)	3	B	2.2	N No Action Monitor Only	Not Applicable	£0	See Photo 1 - Longitudinal and horizontal cracking of reinforced concrete deck slab and soffit >0.3mm in places. As the deck is post tensioned a risk review to BD54/15 standard was undertaken and had a risk rating of 48%.
Deck Elements	1 Primary Deck Element (Table G4)	2	B	99.2	N No Action Monitor Only	Not Applicable	£1	Localised area of water staining at uplink half joint.
Deck Elements	4 Half Joints	4	D	2.1	Concrete - Repairs	3	£3,000	Photo 9 - Cracked / delaminated and spalled concrete on soffit and parapet upstand of half joint at uplink side of span 3.

Photo 11 – Spalling on soffit

WORK REQUIRED				
Element No	Suggested Remedial Work	Priority (ranking 3 & 4 only)	Estimated Cost	Action/Work Ordered?
1	Concrete - Repairs - Photo No.11 - Localised areas of spalled concrete on soffit exposing reinforcement in span No3.	3	£1,000	No
4	Concrete - Repairs – Photo 10 - Cracked / delaminated and spalled concrete on soffit and parapet upstand of half joint at uplink side of span 3.	3	£3,000	No
6	Concrete - Repairs – See Photo 10 - Parapet upstand showing evidence of scaling from frost damage and salt attack exposing aggregate of concrete in places. Also localised spalls on concrete of parapet fascia, upstand and in way of uplink expansion joints at half joints which is providing path for water.	3	£2,500	No
15	Cyclic Maint - Drainage – See Photo 9 - Gully grating cover completely blocked preventing water from entering drainage system.	3	£1	No
18	Cyclic Maint - Expansion joints - See Photo 3 - Expansion joint rubber inserts at Half joints in span No3 blocked with debris.	3	£1	No

WORK REQUIRED				
Element No	Suggested Remedial Work	Priority (ranking 3 & 4 only)	Estimated Cost	Action/Work Ordered?
1	Concrete - Repairs - Photo 11 - Expansive corrosion of embedded reinforcement resulting in multi directional cracking, delamination and spalling exposing reinforcement on the soffit of the RC slab.	3	£4,000	No
18	Joints - Replace - Missing polysulphide sealant at both sides of ESP 5.	3	£500	No
21	P Paint - See Photo 3 - (Typical) Parapet paint protective system is broken down to substrate. The galvanise system is mostly intact apart from site welded joints and bottom of posts.	3	£7,000	No
25	Other - Surfacing - See Photo 12 - Cracks are evident in top layer of the surfacing with localised areas of top layer missing.	3	£1,500	No

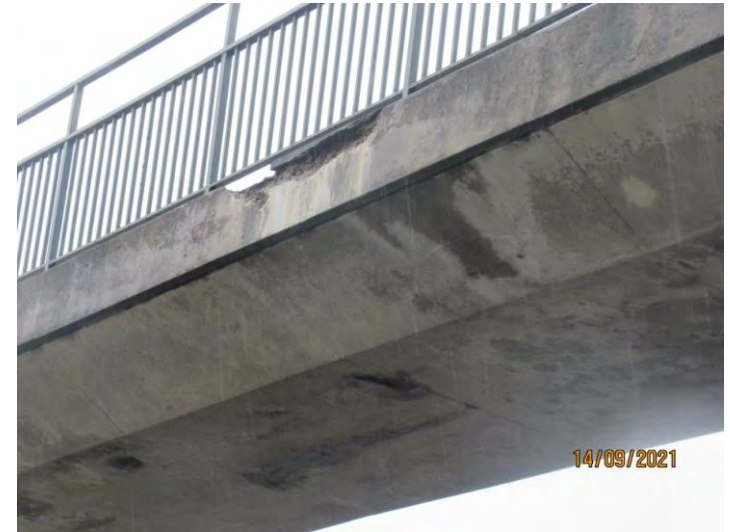
Deck Elements	4 Half Joints	3	D	99.3	N No Action Monitor Only	Not Applicable	£1	Water seepage from half joint at both sides of the deck.
Deck Elements	6 Parapet Beam Or Cantilever	3	C	2.1	Concrete - Repairs	3	£2,500	Photo 10 - Parapet upstand showing evidence of spalling from frost damage and salt attack exposing aggregate of concrete in places. Also localised spalls on concrete of parapet fascia, upstand and in way of uplink expansion joints at half joints which is providing path for water.
Deck Elements	6 Parapet Beam Or Cantilever	2	B	2.2	N No Action Monitor Only	Not Applicable	£0	Localised areas of transverse cracking on parapet beam upstand.

Photo 10 – Spalling to parapet edge beam

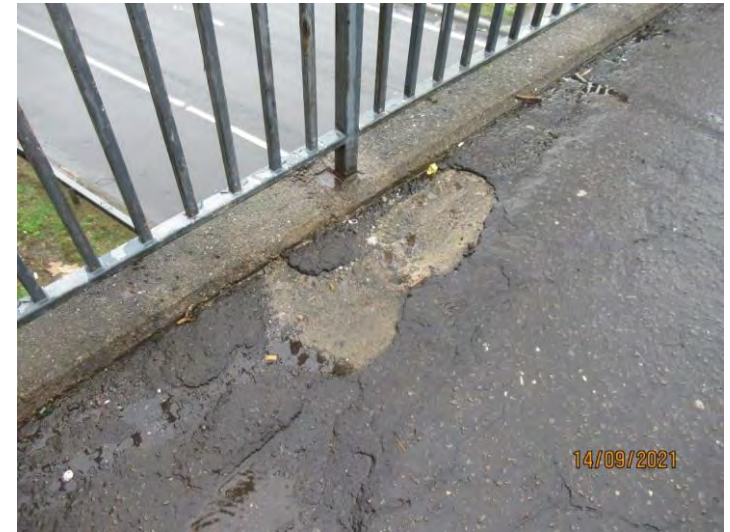
Safety Elements	25 Footway/Verge/Footbridge Surfacing	3	C	99.3	Other - Surfacing	3	£2,000	Photo 12 - Footpath surfacing is breaking up exposing localised areas of concrete and which appear to have no waterproofing.
Ancillary Elements	35 Approach Rails/Barriers/Walls	1	A	99.1	N No Action Monitor Only	Not Applicable	£0	Safety barrier appears in good condition.

Photo 12 – Break up of footway
