SCOTLAND TRANSERV SOUTH WEST

PRINCIPAL INSPECTION REPORT

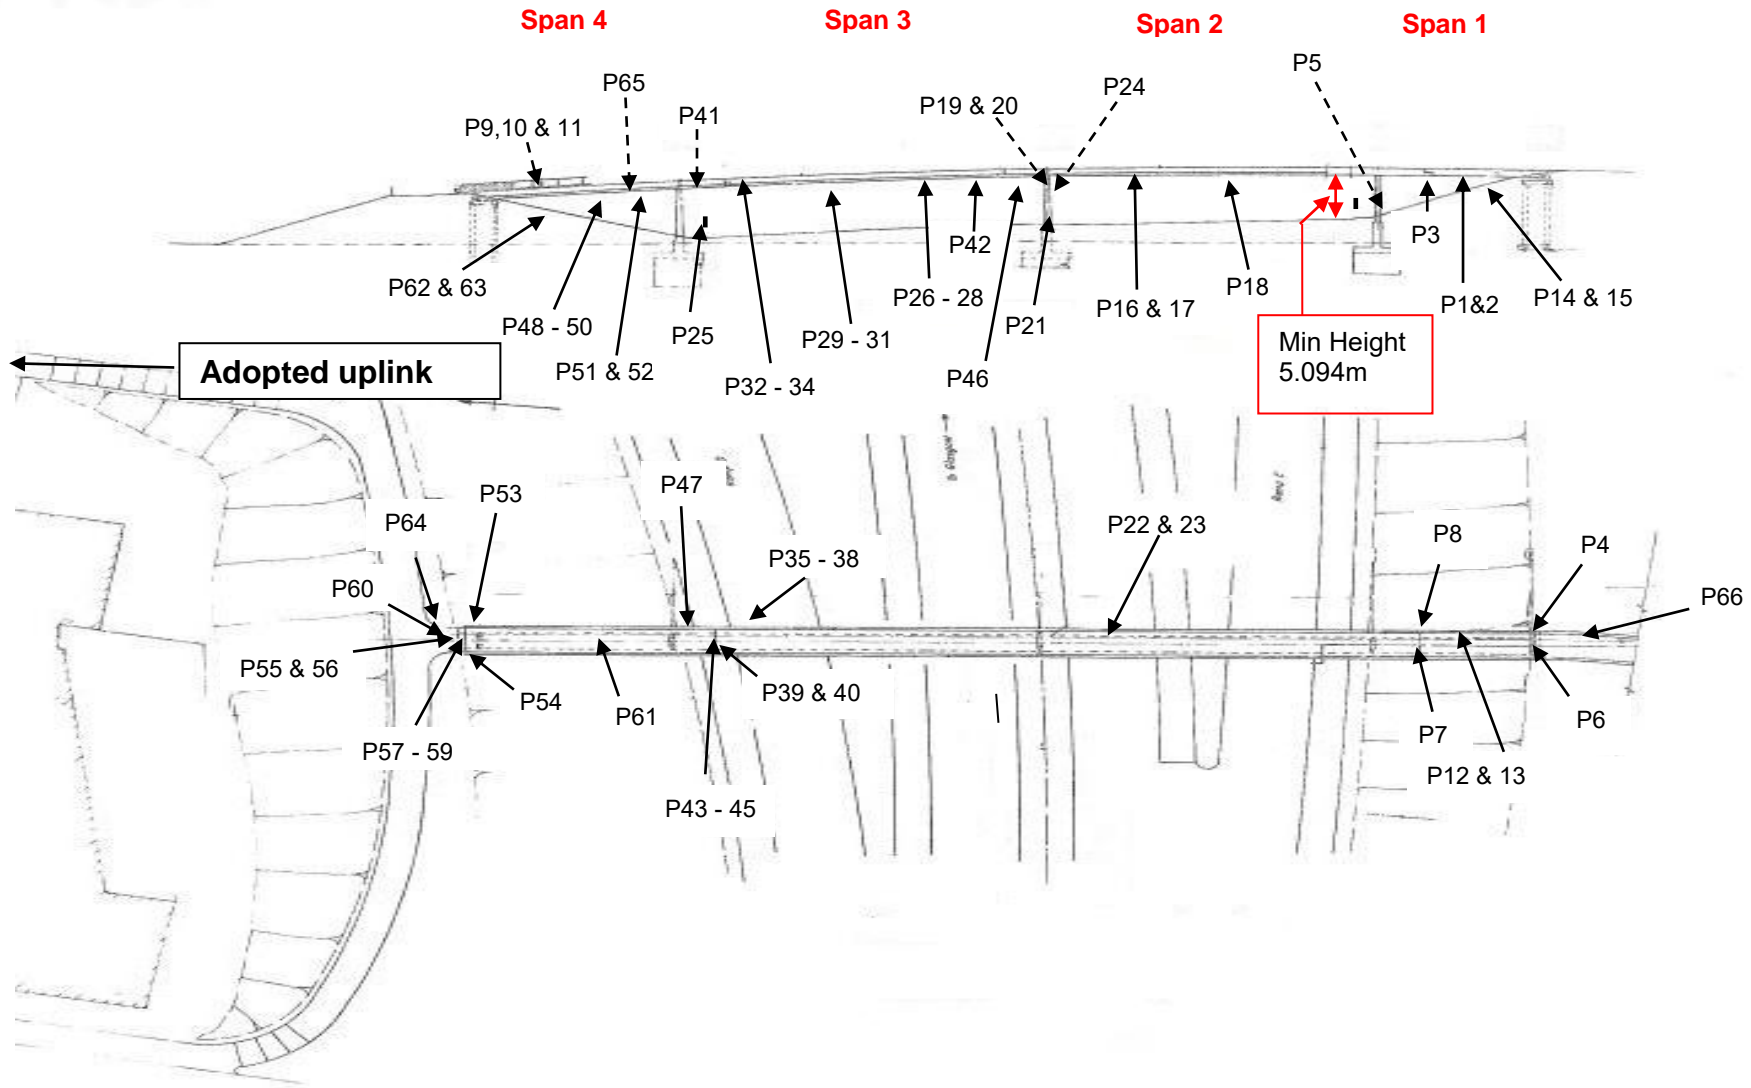
**M8 22-22 F40 Kirkwood Street F/B
 Principal Inspection Report 2017
 General Arrangement Drawing
 Defect Photograph Location Plan Sketch**

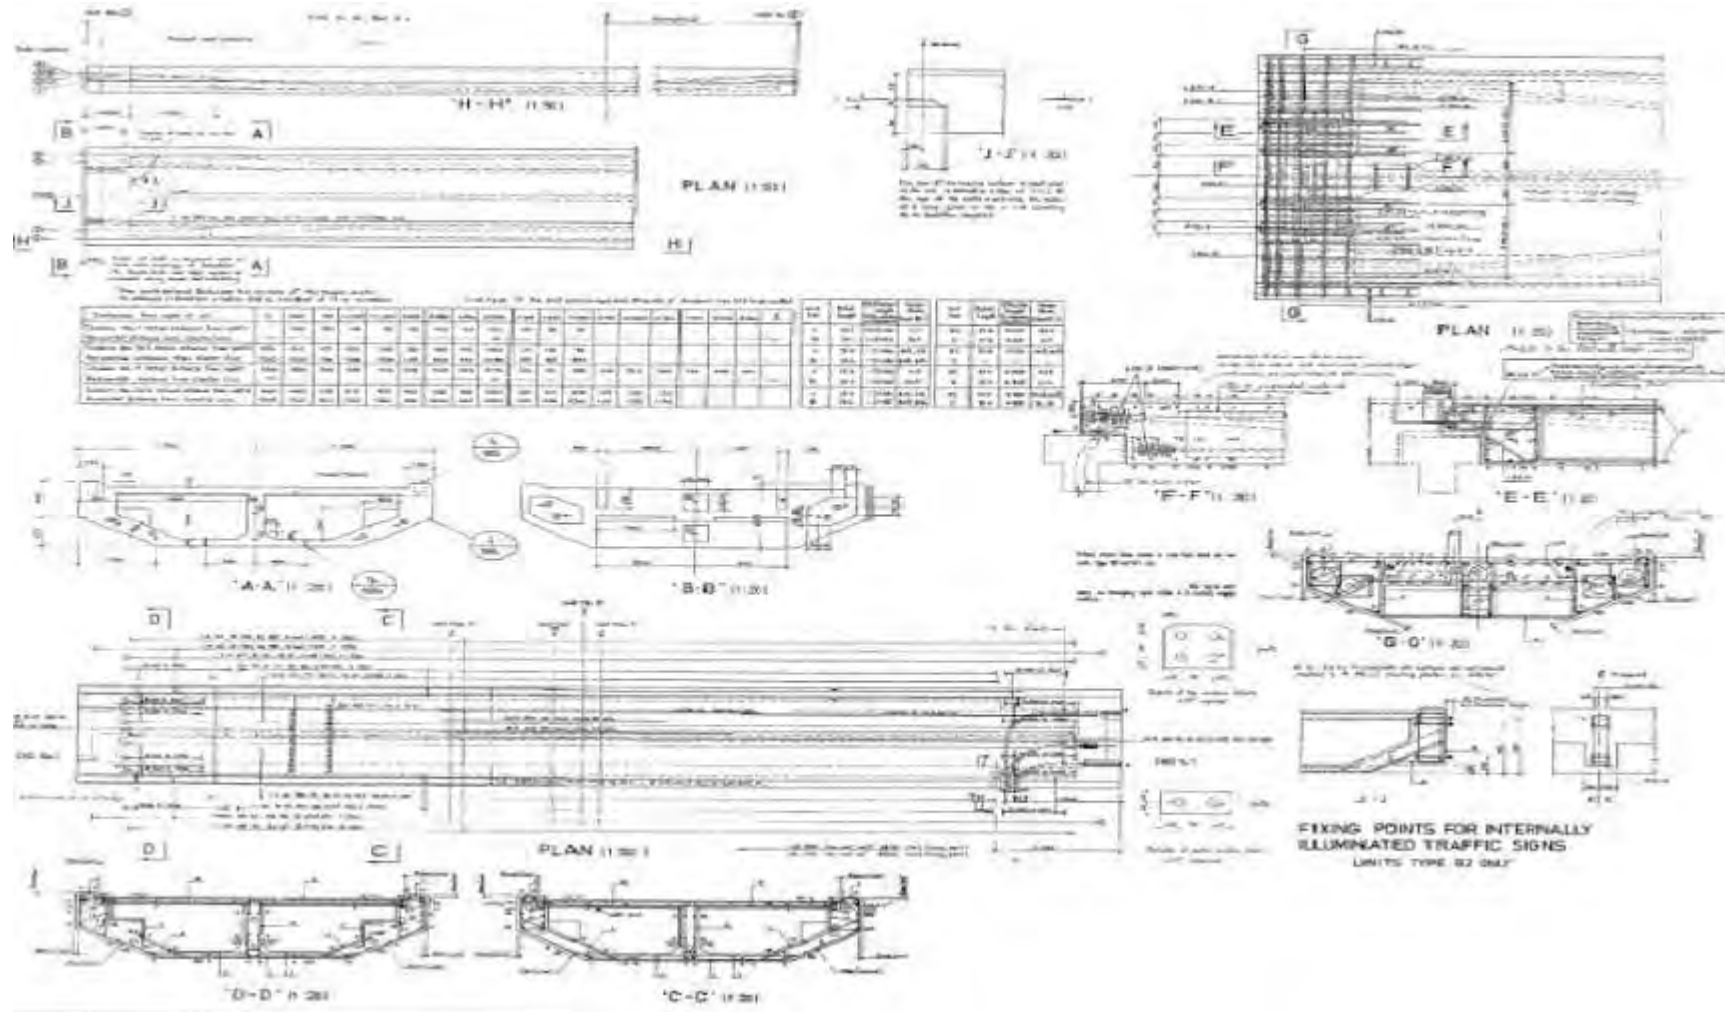
**M8 22-22 F40 Kirkwood Street F/B
Principal Inspection Report 2017
General Arrangement Drawing**

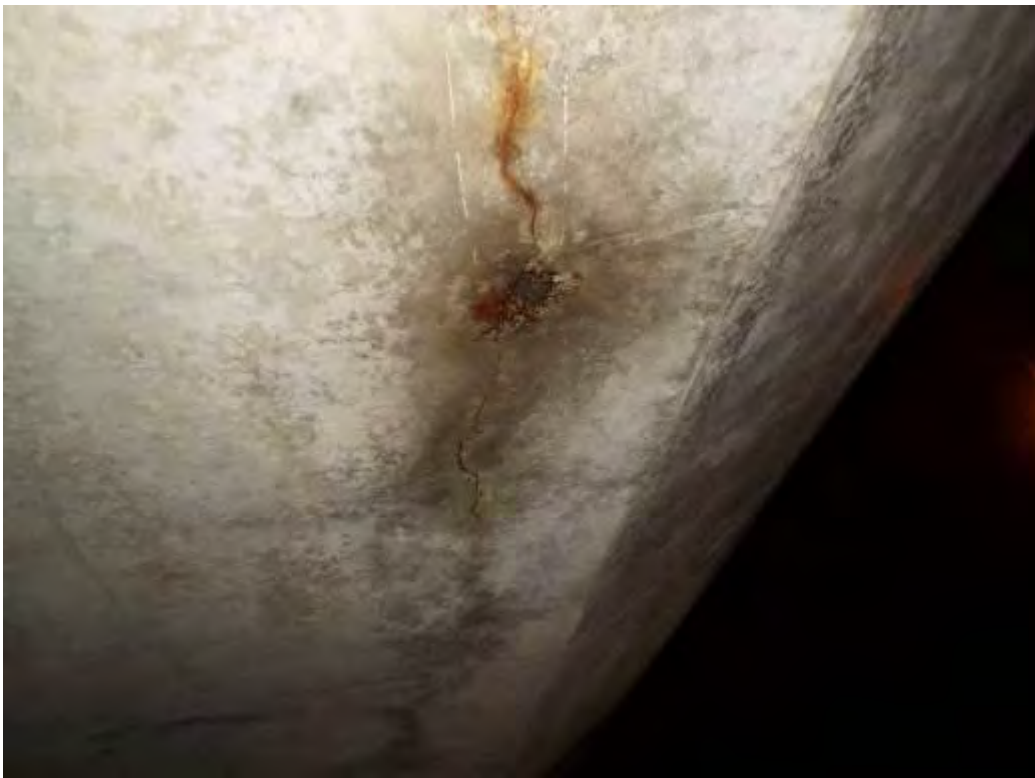
Photograph No.1 - (Typical) Longitudinal and horizontal cracking of reinforced concrete deck slab and soffit >0.3mm in places. Also rust staining which may suggest early signs of delamination.

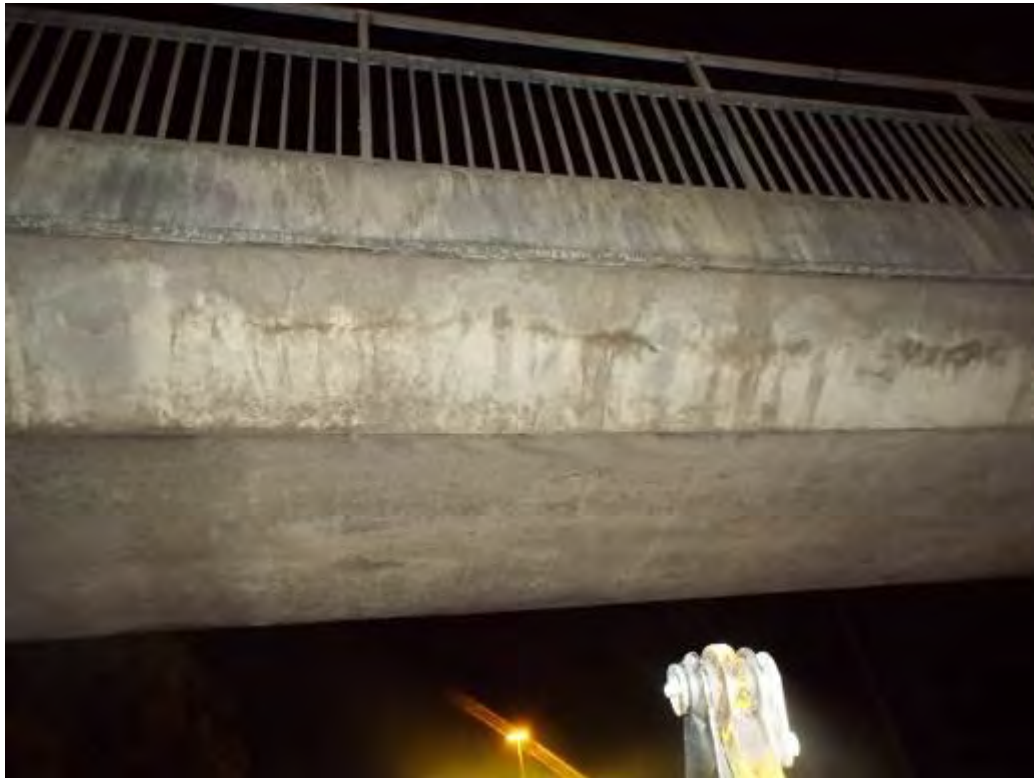
Photograph No.2 - (Typical) Longitudinal and horizontal cracking of reinforced concrete deck slab and soffit >0.3mm in places. Also rust staining which may suggest early signs of delamination.

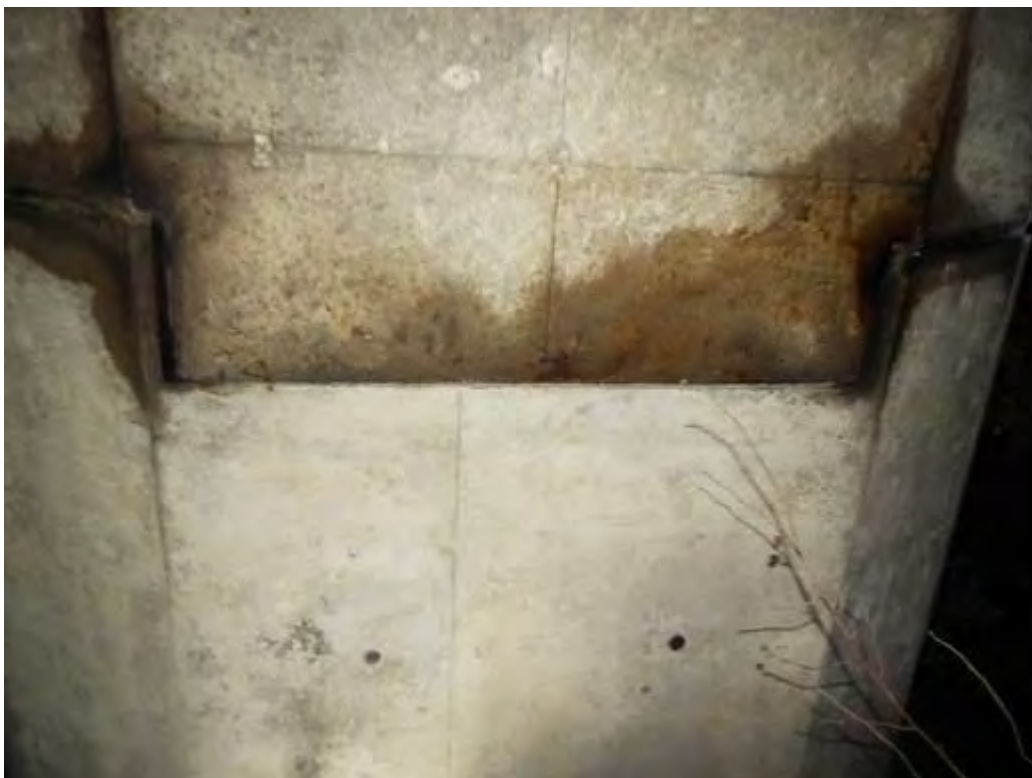
Photograph No.3 - Staining at half joint as a result of seepage through de-bonding sealant at parapet upstand joint above in span 1.

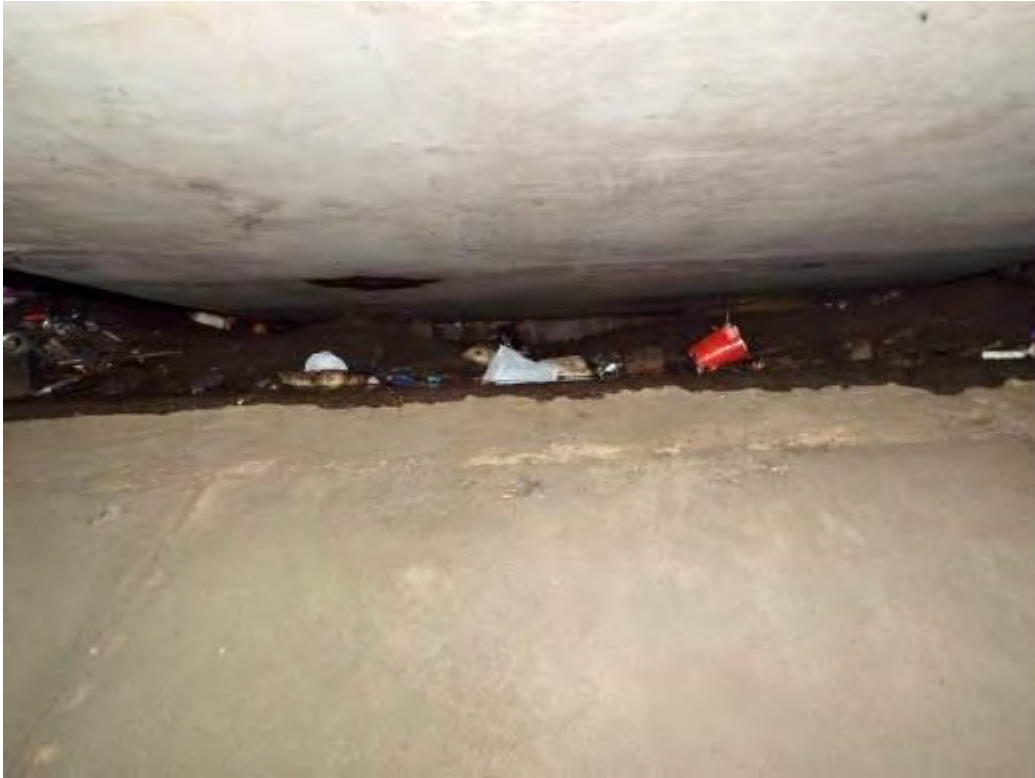
Photograph No.4 - Leaching and dampness on exposed area of bank seat curtain wall at ESP 1.
Access to inspect area difficult due to access beneath soffit.

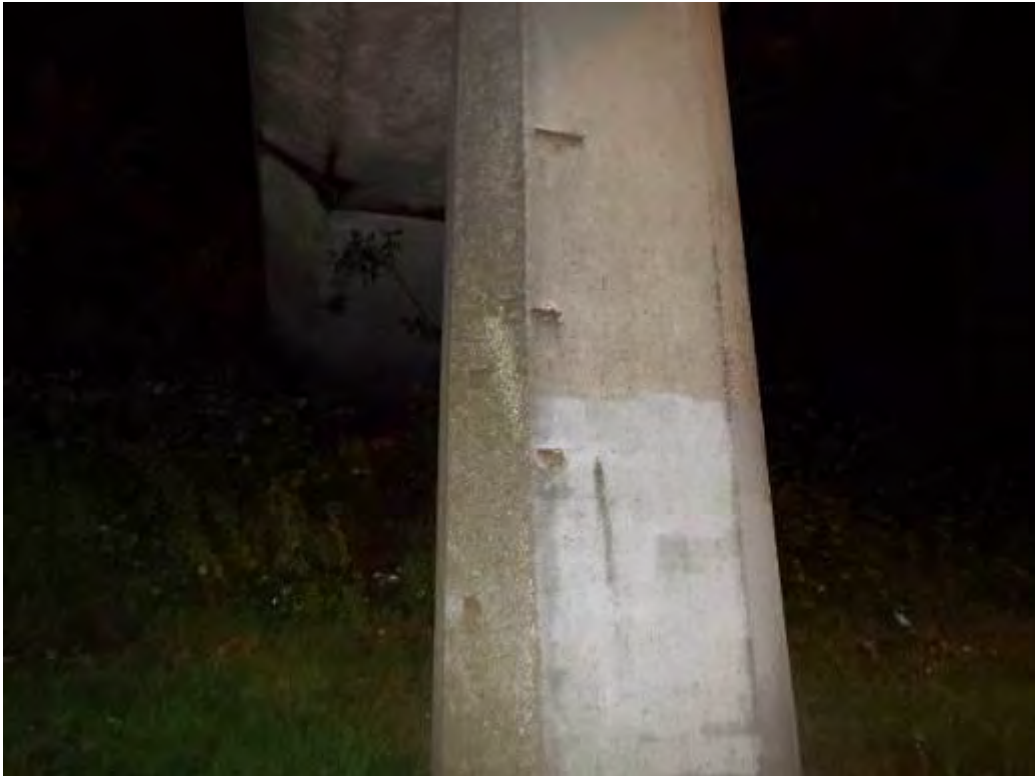
Photograph No.5 - Minor localised spalling exposing localised areas of reinforcement on ISP 2.

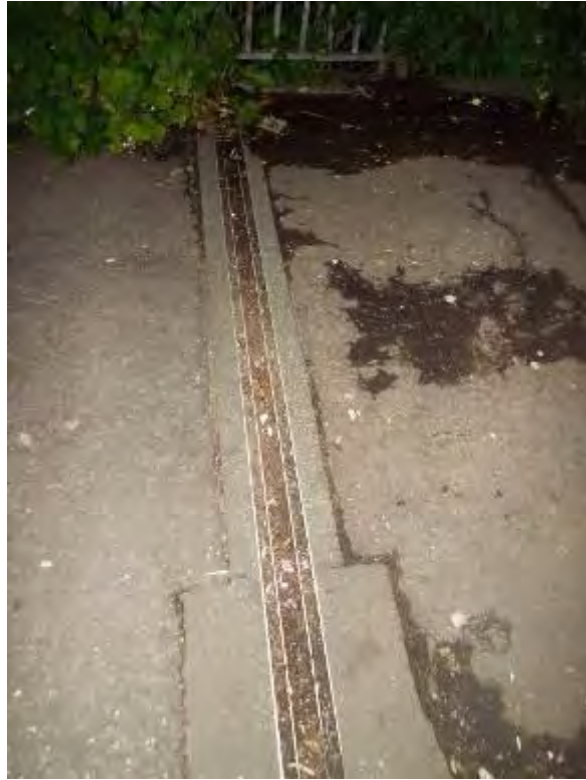
Photograph No.6 - Expansion joint rubber inserts at end support No1 in span No1 blocked with debris.

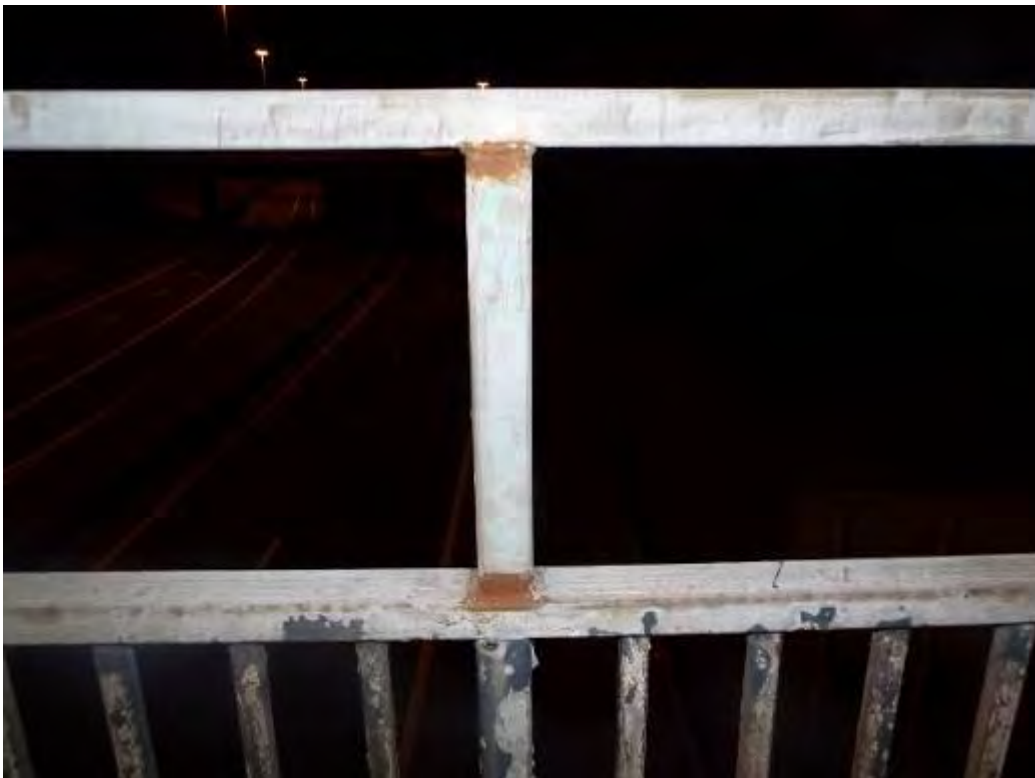
Photograph No.9 - (Typical) Existing paint system is beyond its useful life span. All paint coats failed.

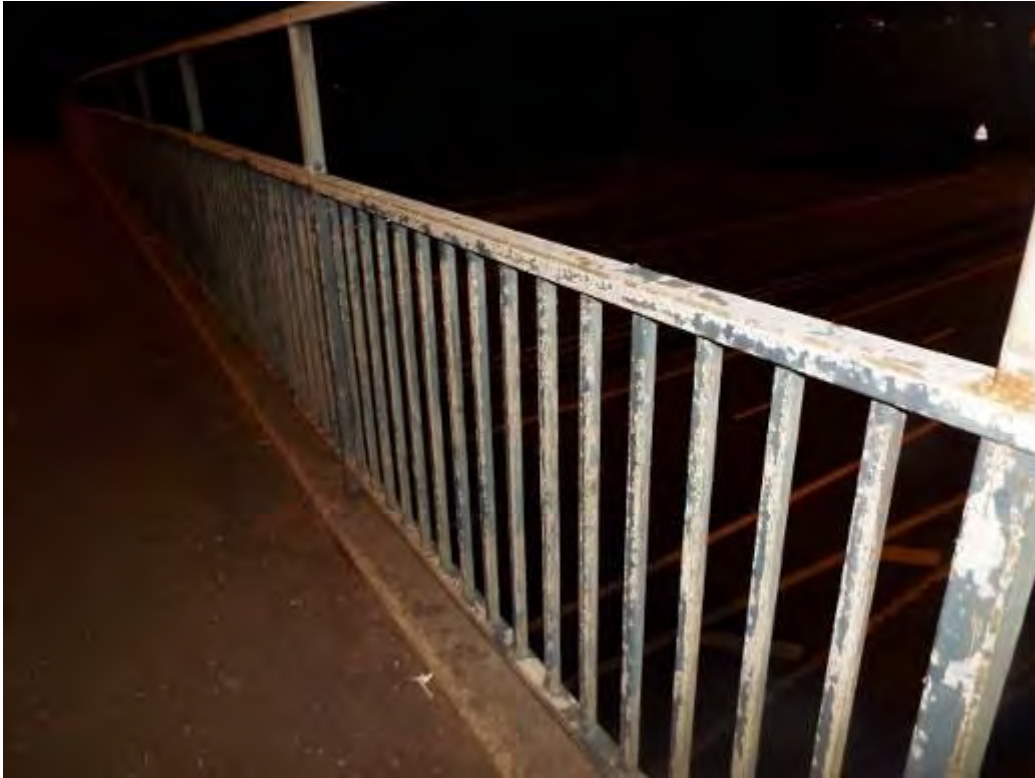
Photograph No.10 - (Typical) Existing paint system is beyond its useful life span. All paint coats failed.

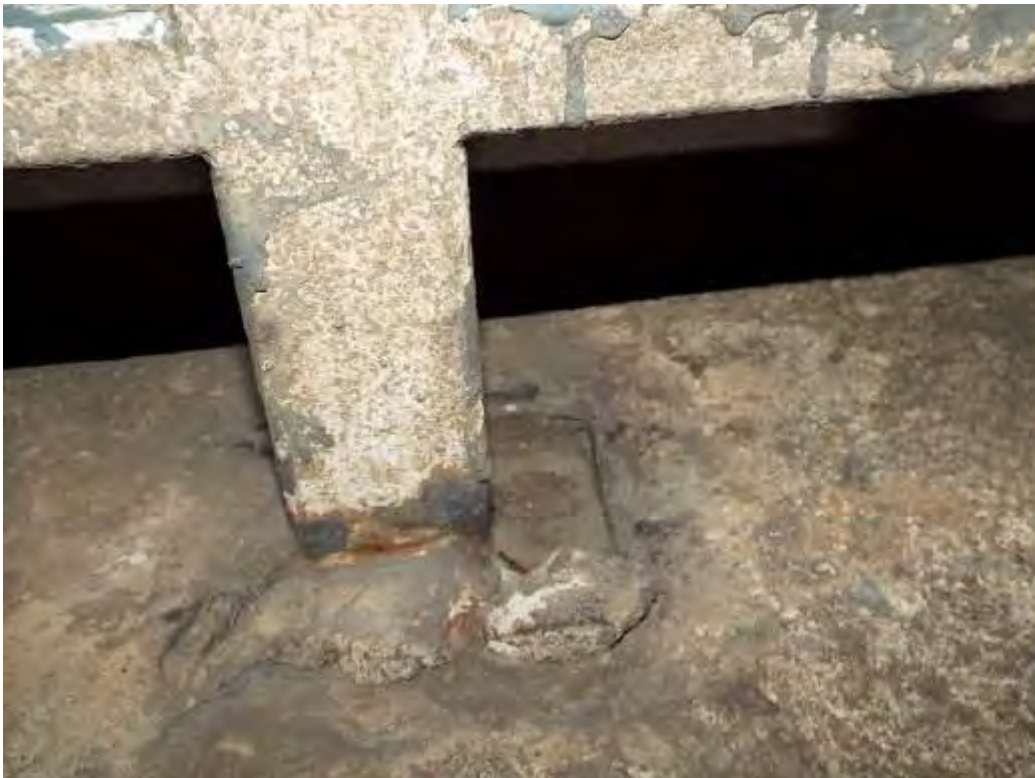
Photograph No.11 - (Typical) Localised areas of minor surface rusting on both parapet rails and post bases in all spans.

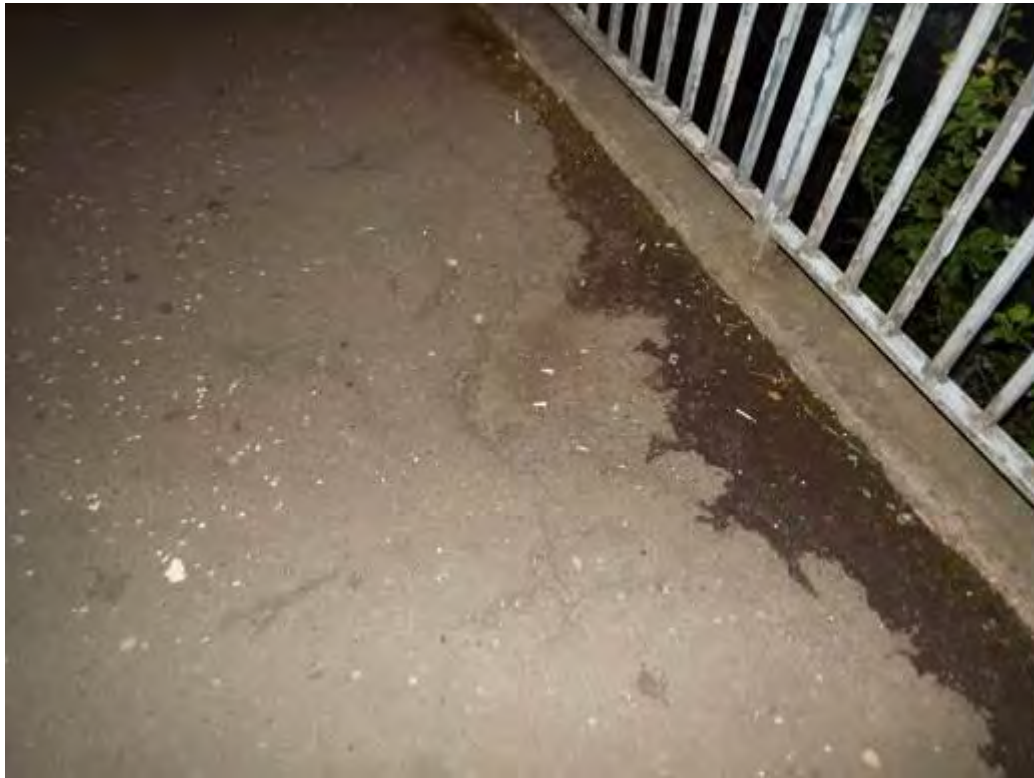
Photograph No.12 - (Typical) Footpath surfacing appears to have been treated with road salts / grit which may affect the condition of the concrete. Surfacing is ponding due to existing levels and lack of drainage outlets.

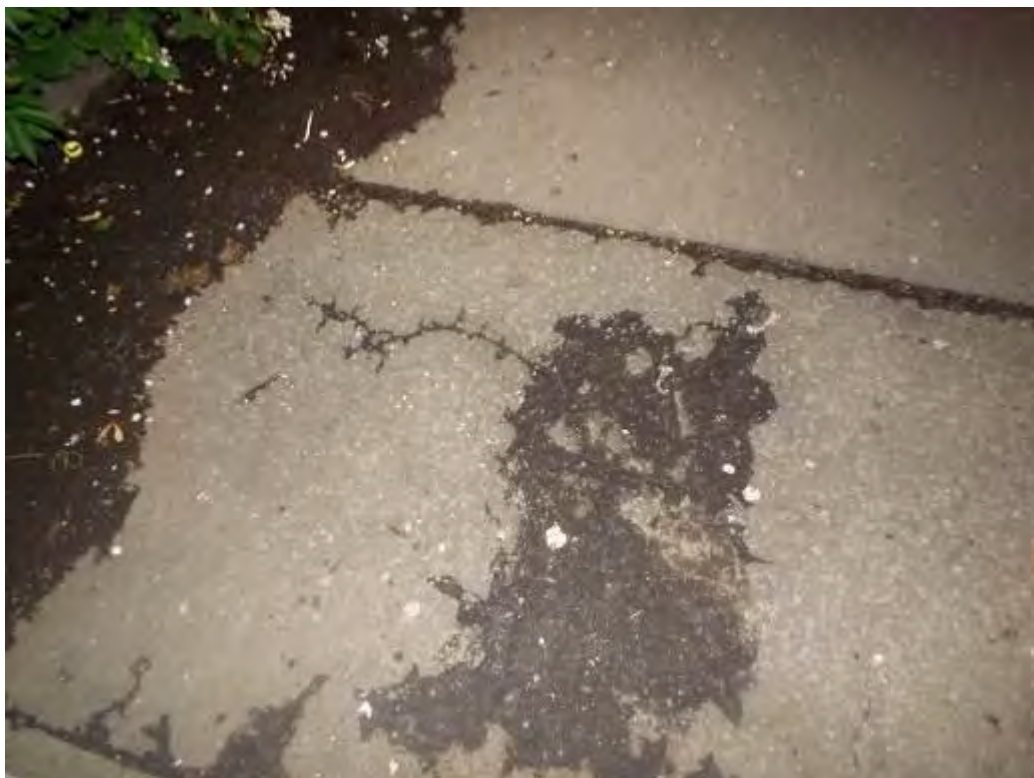
Photograph No.13 - (Typical) Cracks are evident in top layer of the surfacing.

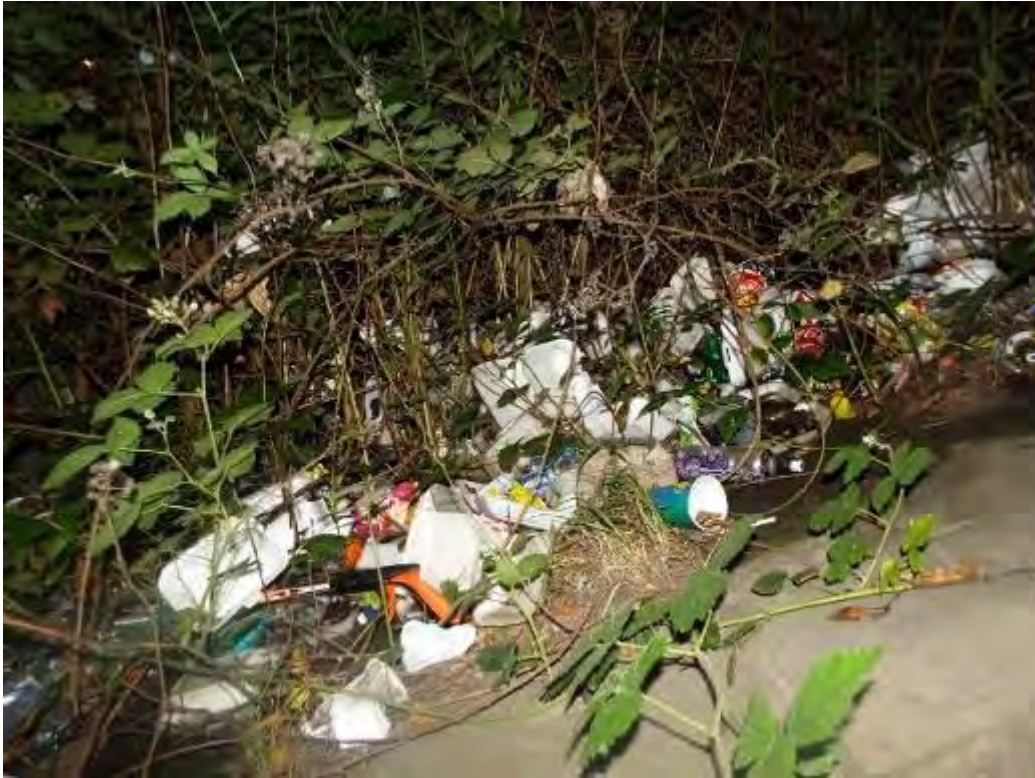
Photograph No.14 - Debris and build of litter making area unsightly on revetment in span 1.

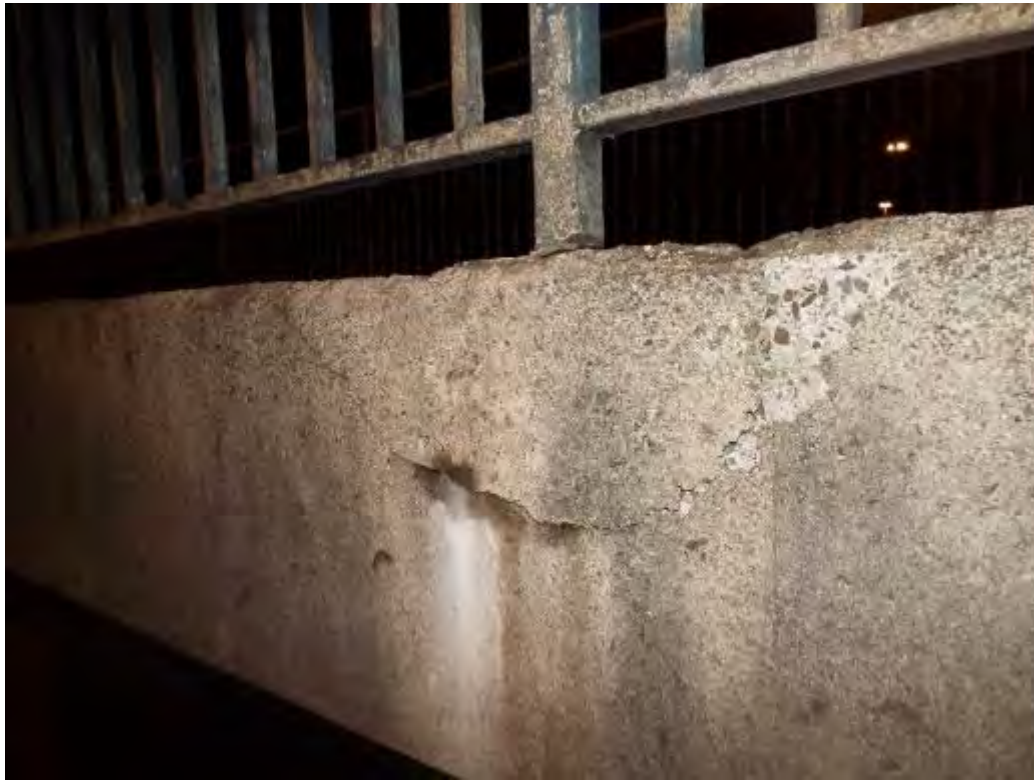
Photograph No.16 - Moderate localised spall where handrail parapet is recessed into concrete of parapet upstand. At LHS above lane 2 of M8 westbound.

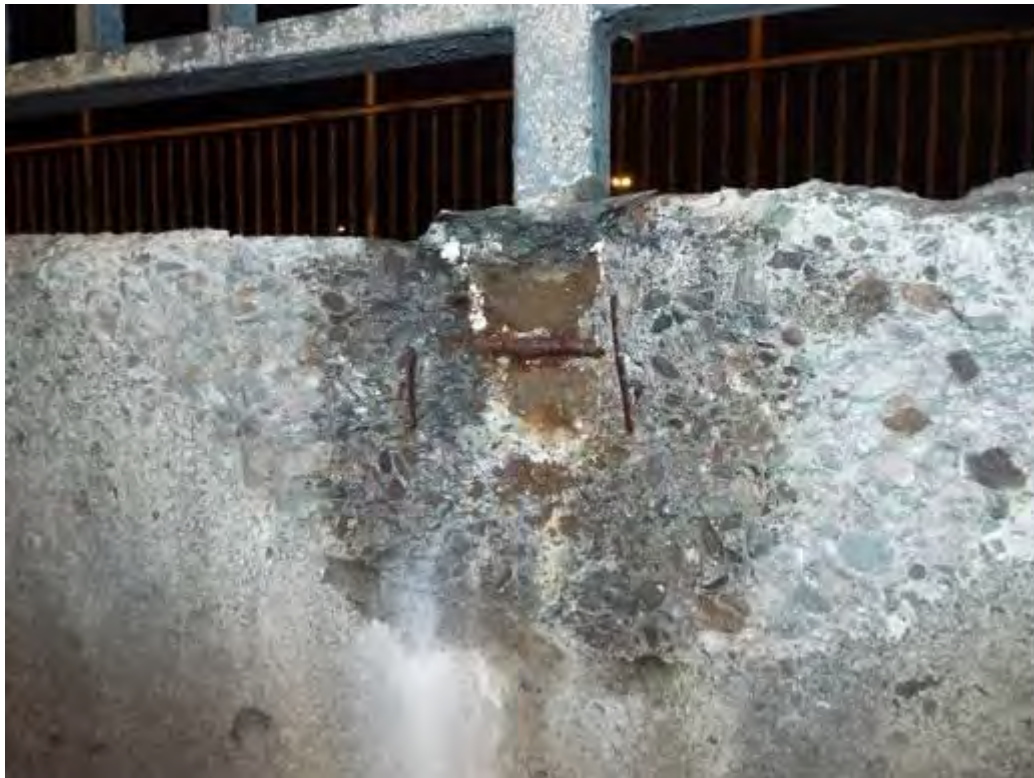
Photograph No.17 - Moderate localised spall where handrail parapet is recessed into concrete of parapet upstand. At LHS above lane 2 of M8 westbound.

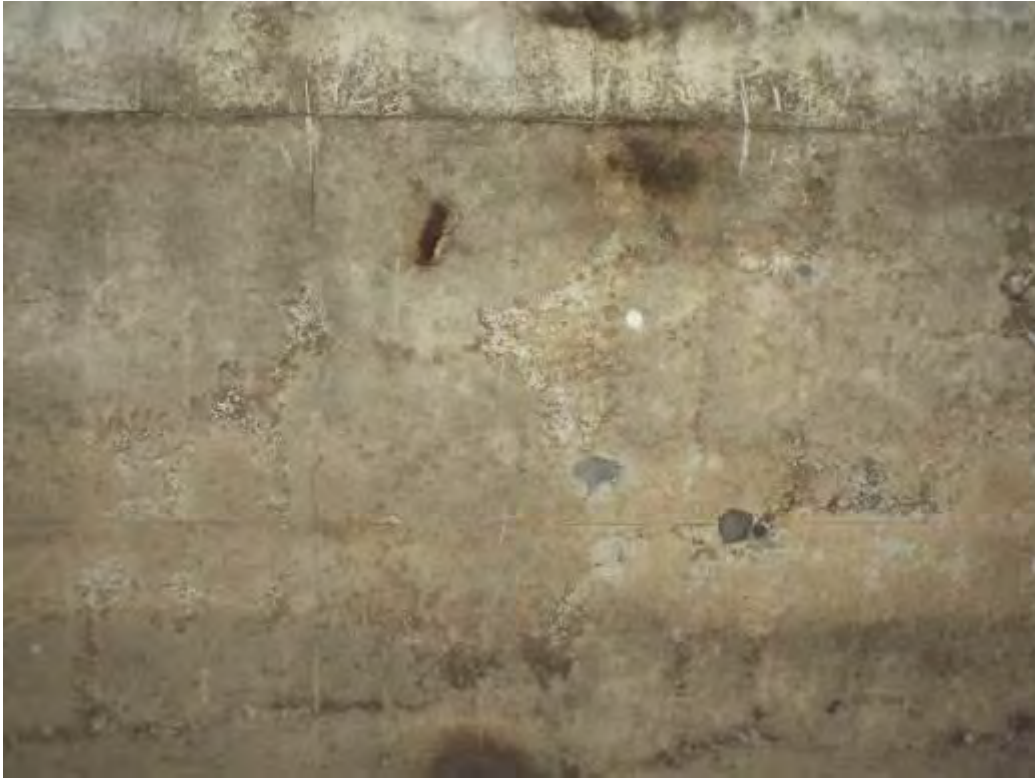
Photograph No.18 - Minor spall exposing reinforcement on soffit of deck slab at LHS.

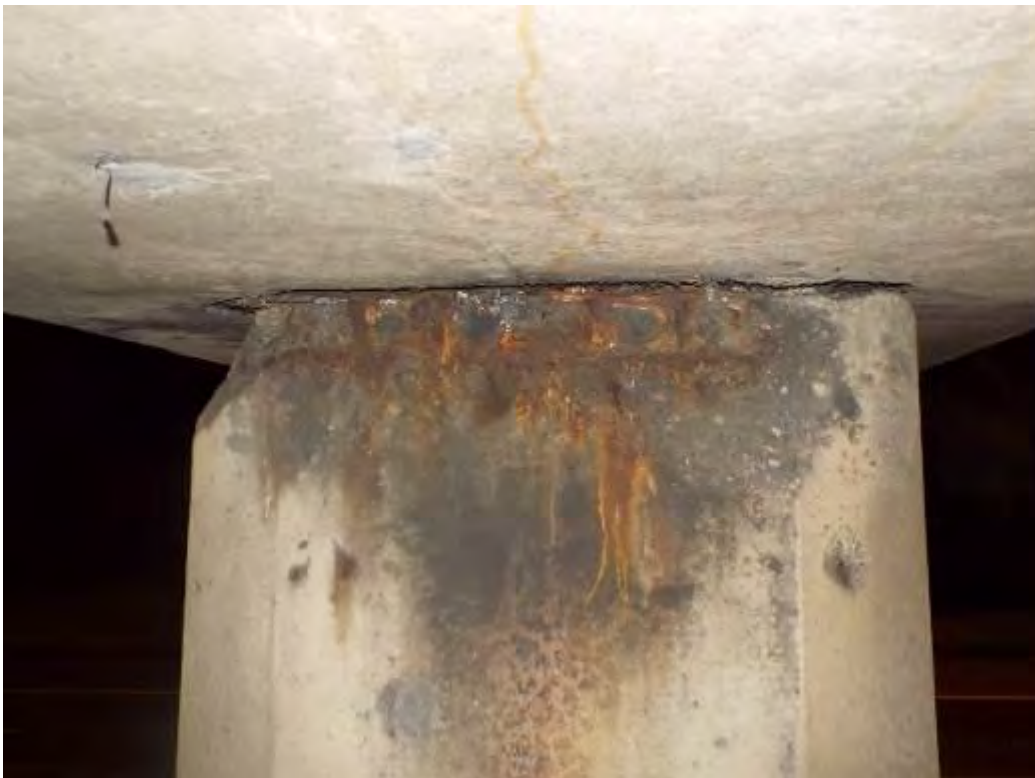
Photograph No.19 - Expansive corrosion of embedded reinforcement is resulting in rust staining at top of intermediate support No3 on uplink face.

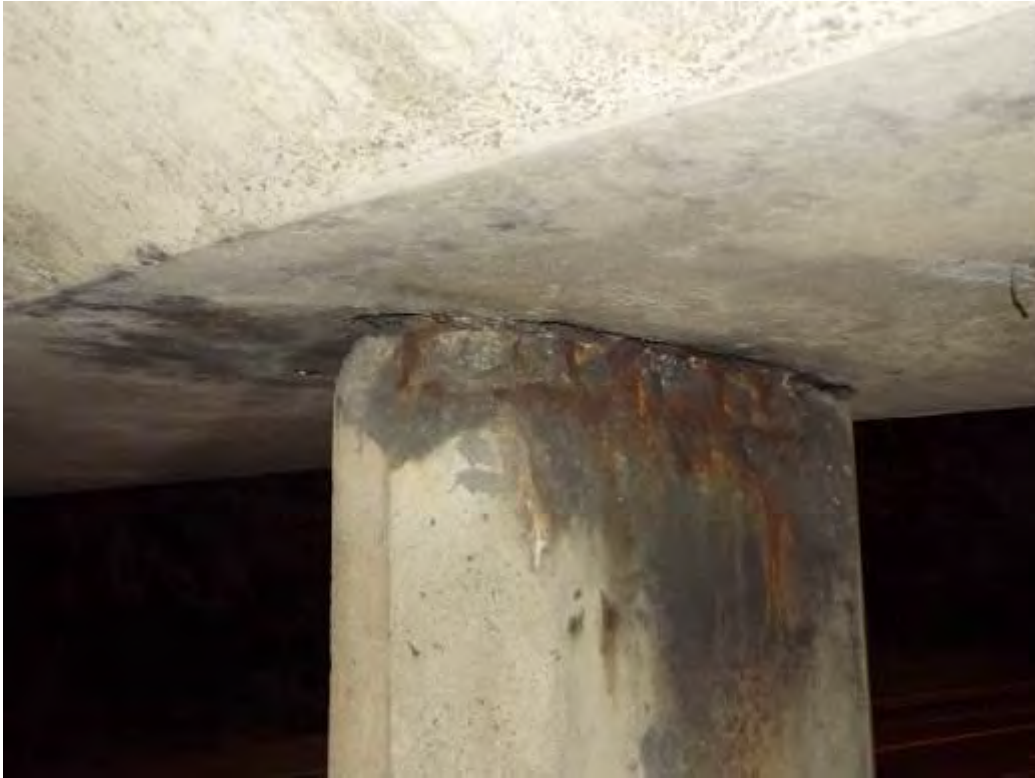
Photograph No.20 - Expansive corrosion of embedded reinforcement is resulting in rust staining at top of intermediate support No3 on uplink face.

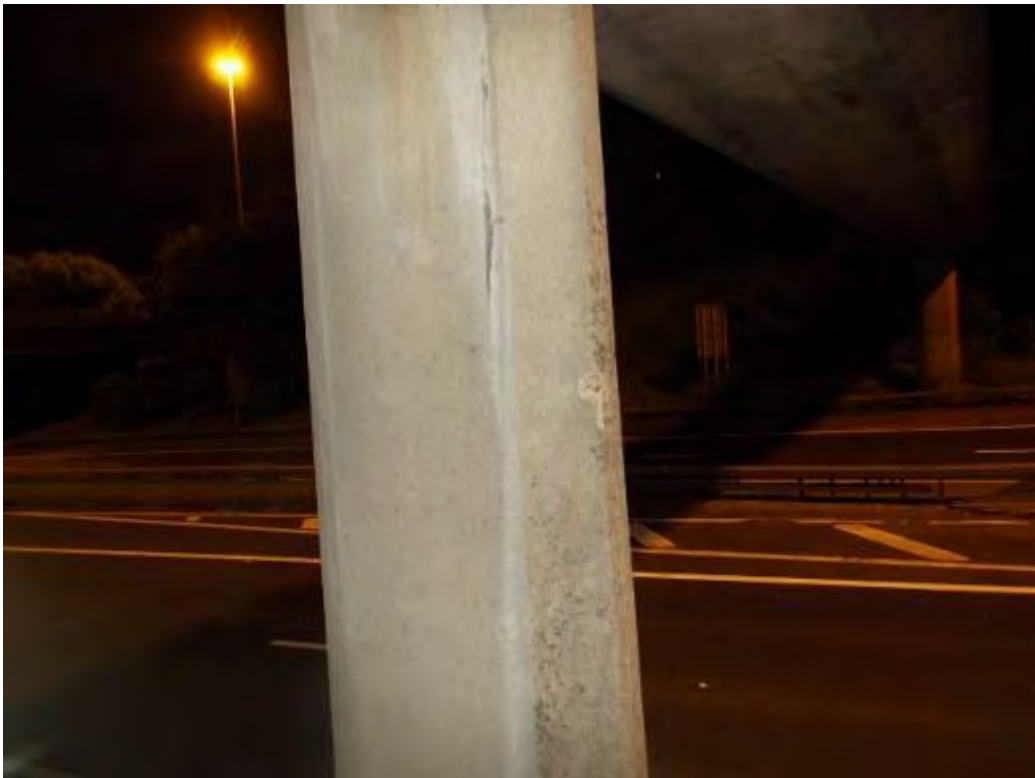
Photograph No.21 - Minor impact damage on ISP 3 at LHS.

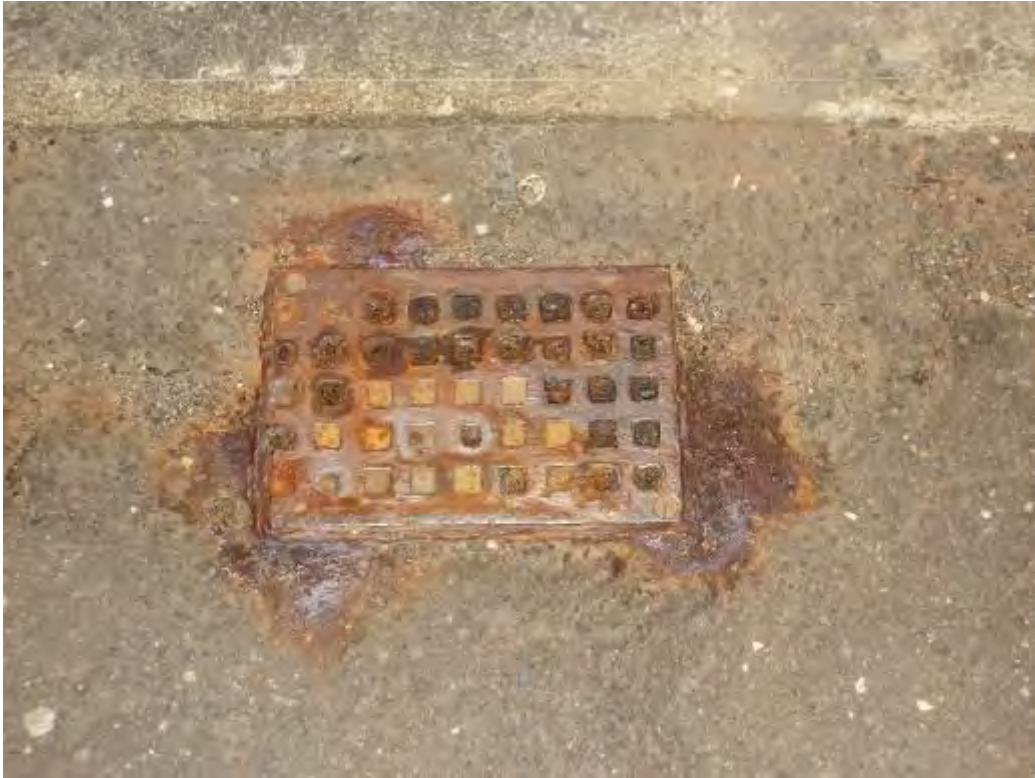
Photograph No.22 - Gully grating cover completely blocked preventing water from entering drainage system.

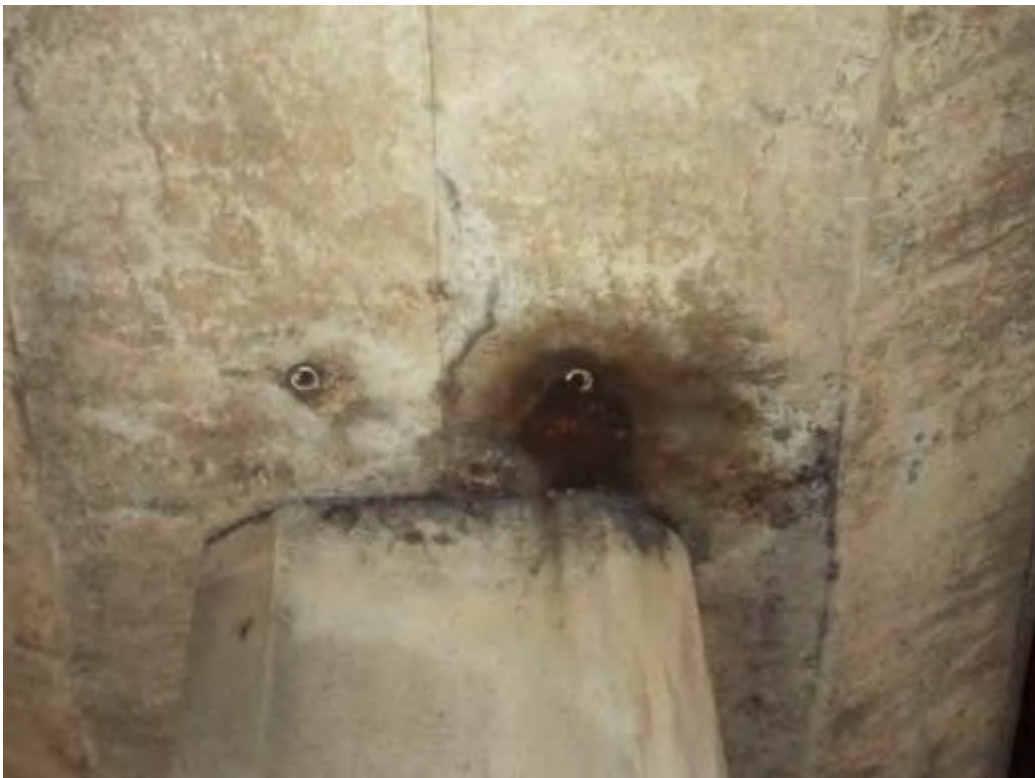
Photograph No.23 - Deck dripper blocked causing staining on Span 2 soffit adjacent ISP 3 downlink face.

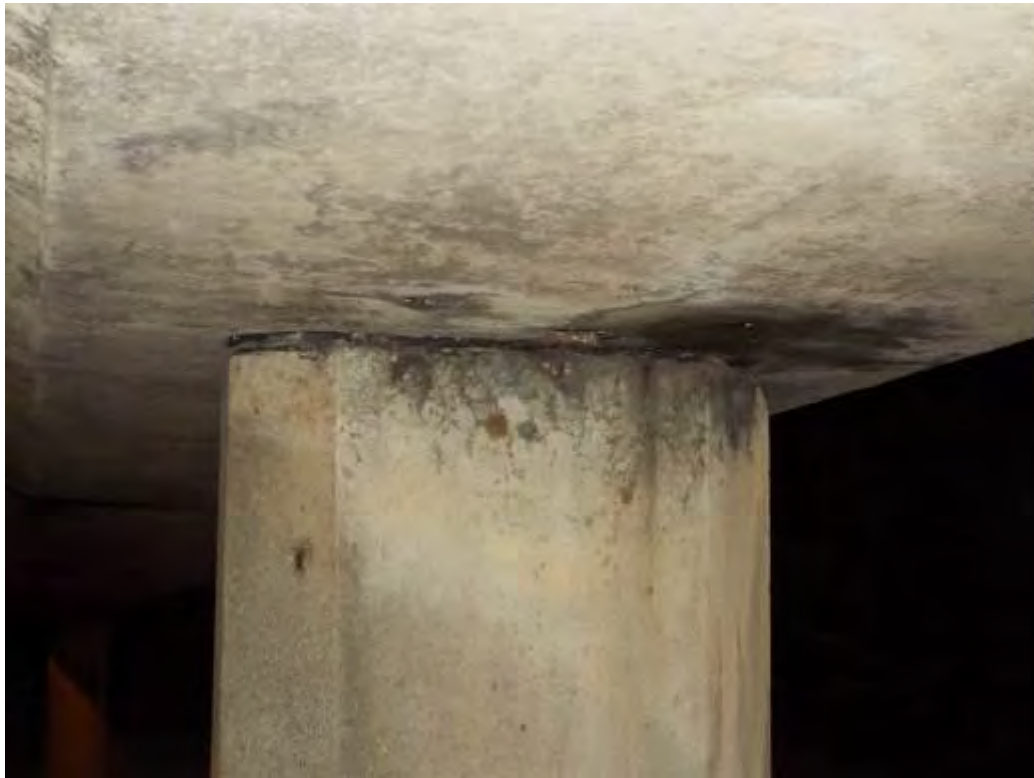
Photograph No.24 - Random cracking at top of ISP 3 on downlink face.

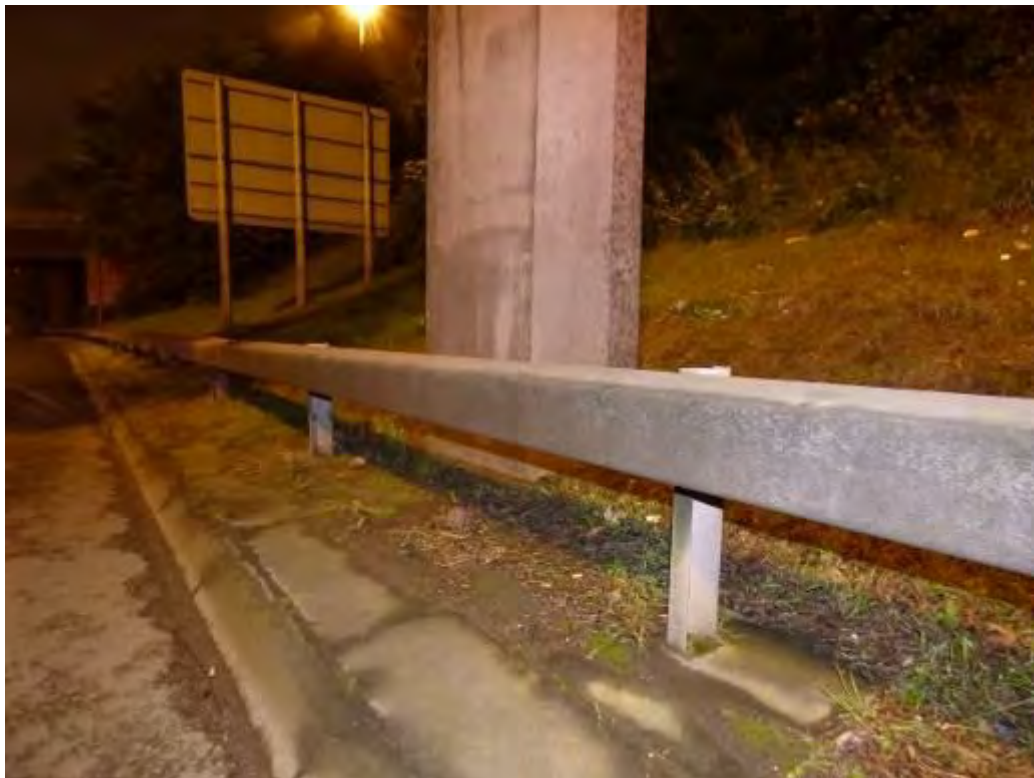
Photograph No.25 - Safety barrier currently single height OBB protecting slender pier at intermediate support No2. Due to increase traffic from new M74 on secondary carriageway barrier height / containment should be reviewed.

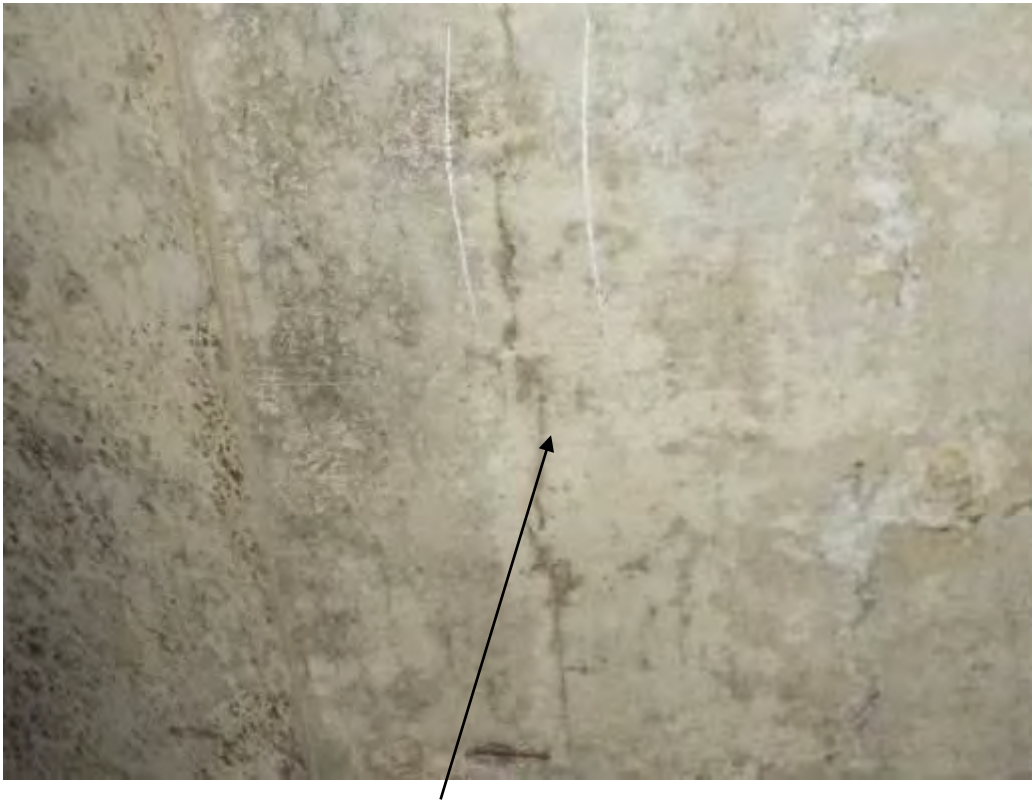
Photograph No.26 - Longitudinal cracking of reinforced concrete deck soffit >0.3mm in places.
