SCOTLAND TRANSERV SOUTH WEST

PRINCIPAL INSPECTION REPORT

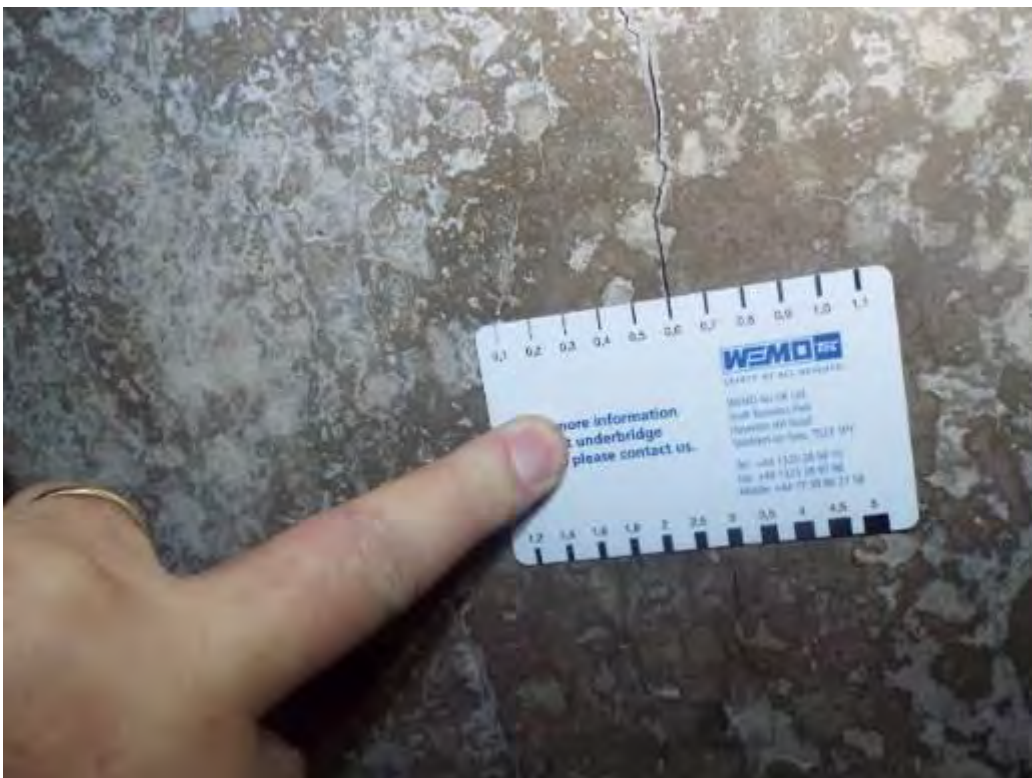
Photograph No.27 - Transverse cracking of reinforced concrete deck slab >0.6mm in places.

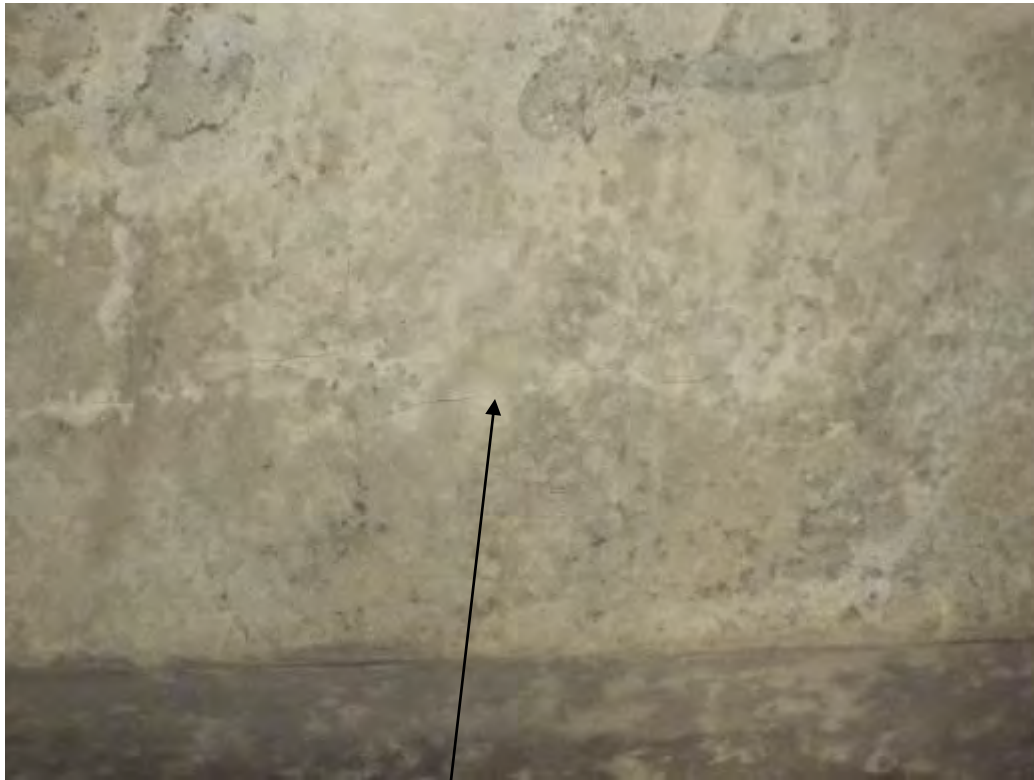
Photograph No.28 - Longitudinal cracking of reinforced concrete deck slab >0.3mm in places.

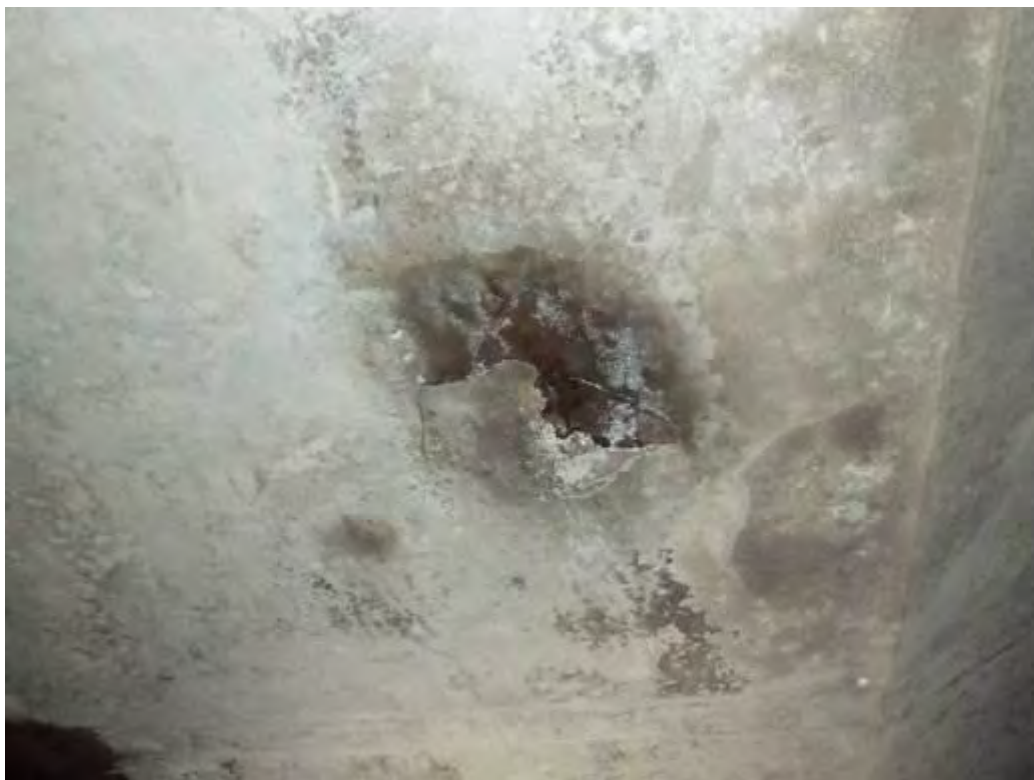
Photograph No.29 - Localised areas of spalled concrete on soffit and exposing reinforcement in span No3.

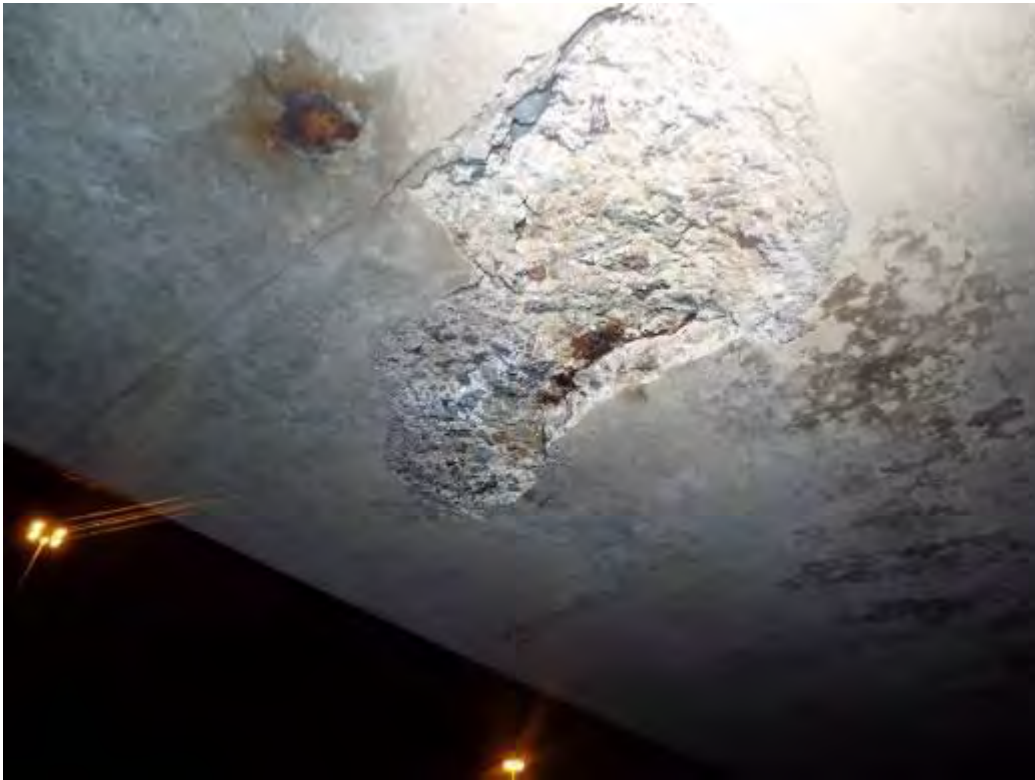
Photograph No.30 - Localised areas of spalled concrete on soffit exposing reinforcement in span No3.

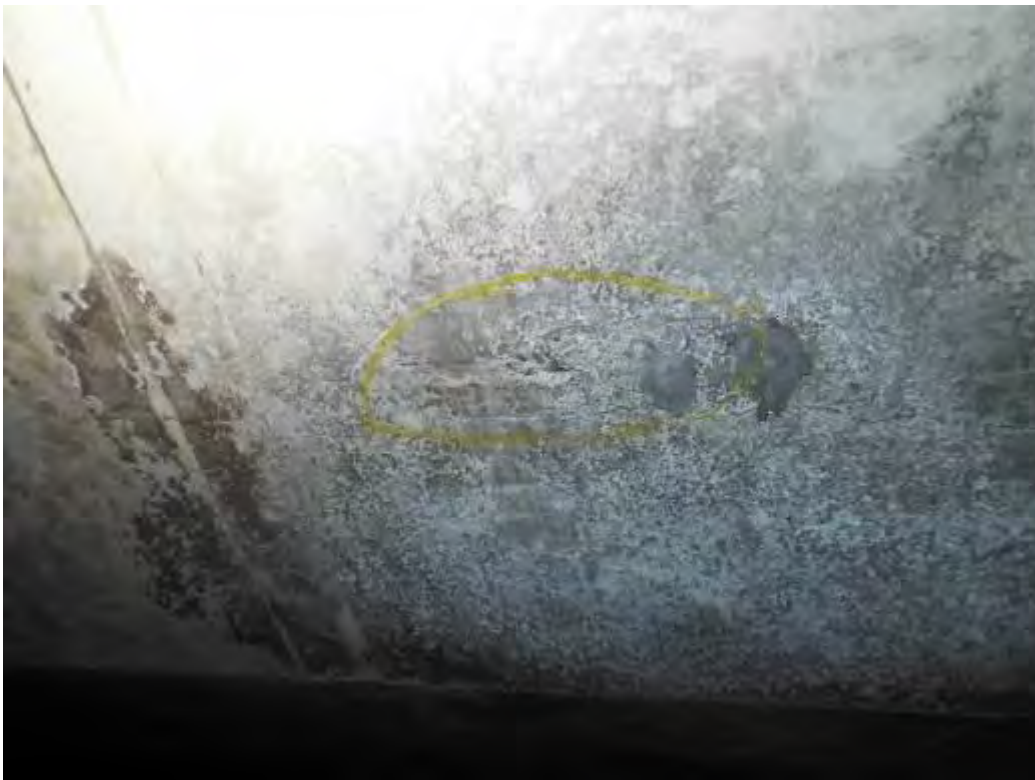
Photograph No.31 - Localised areas of spalled concrete on deck slab exposing reinforcement in span No3.

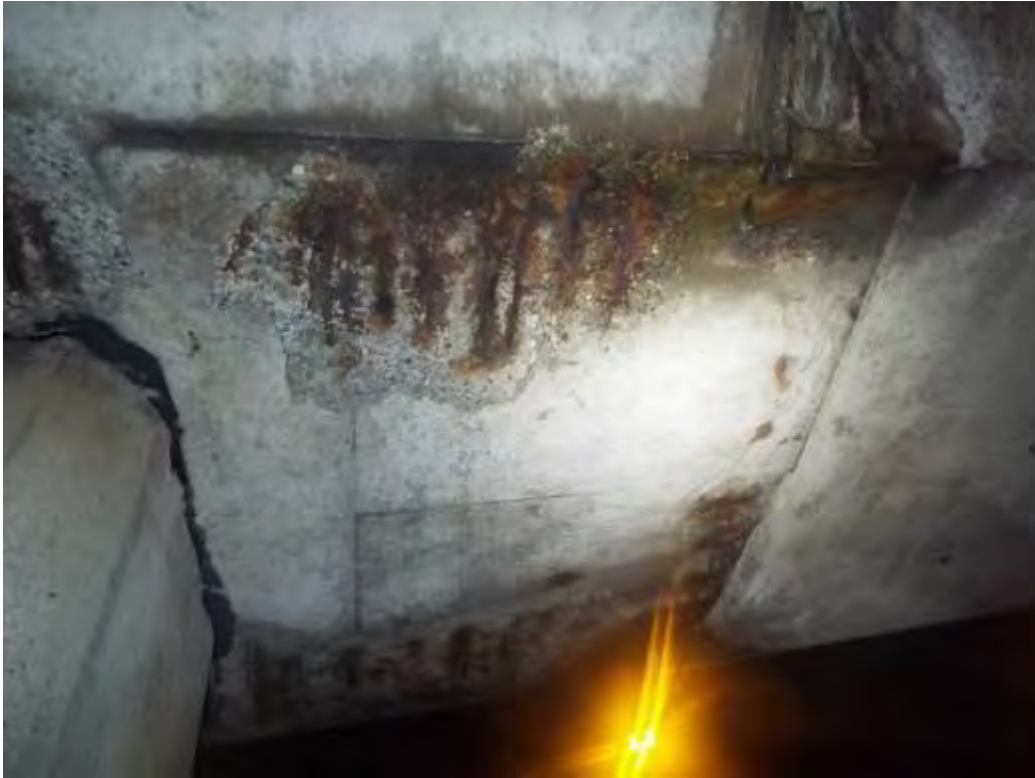
Photograph No.32 - Cracked / delaminated and spalled concrete on soffit at half joint uplink side of span No3 on downlink side of intermediate support No4.

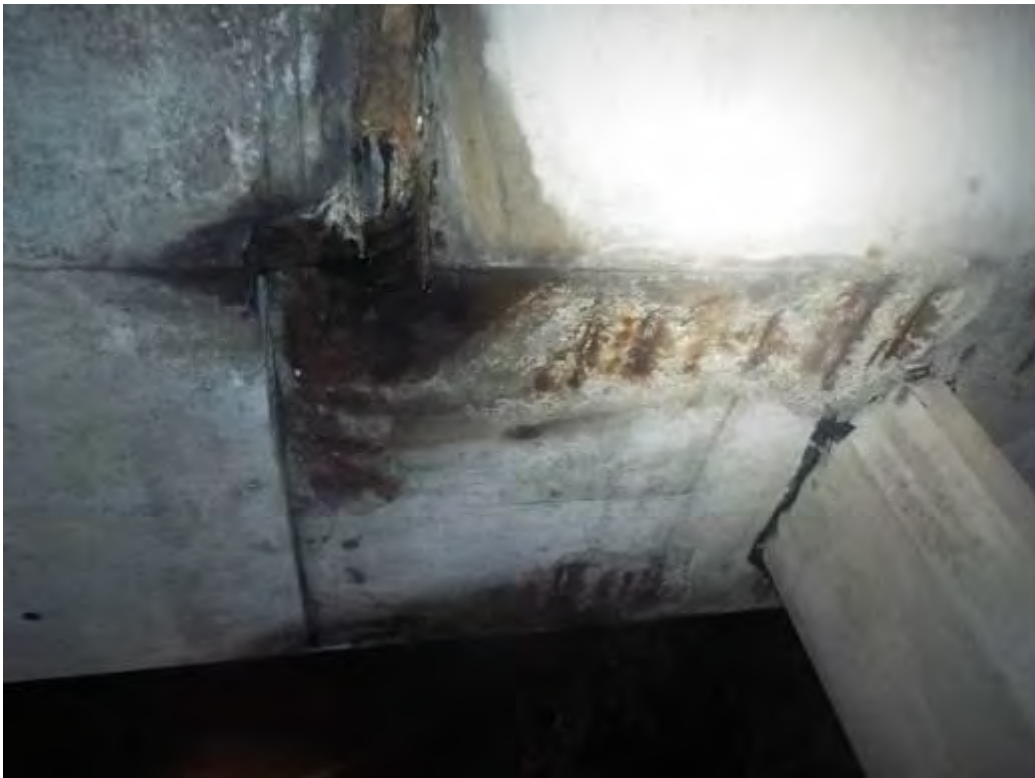
Photograph No.33 - Cracked / delaminated and spalled concrete on soffit and half joint at uplink side of span No3 on downlink side of intermediate support No4.

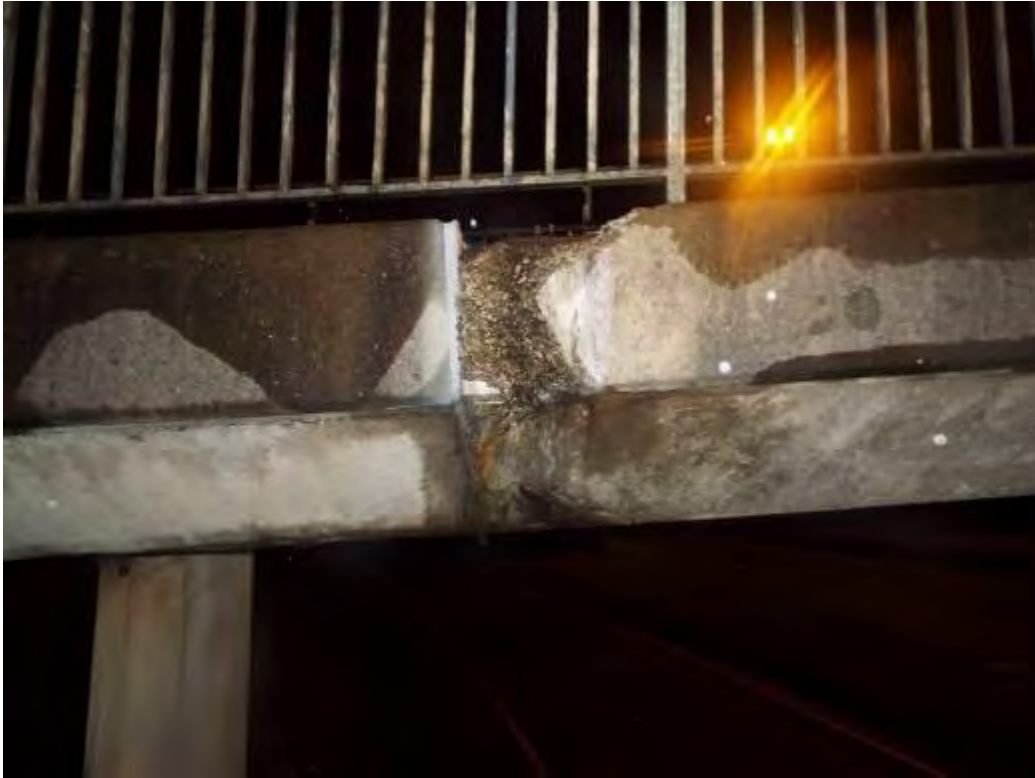
Photograph No.34 - Cracked / delaminated and spalled concrete on parapet upstand of half joint at uplink side of span No3 on LHS.

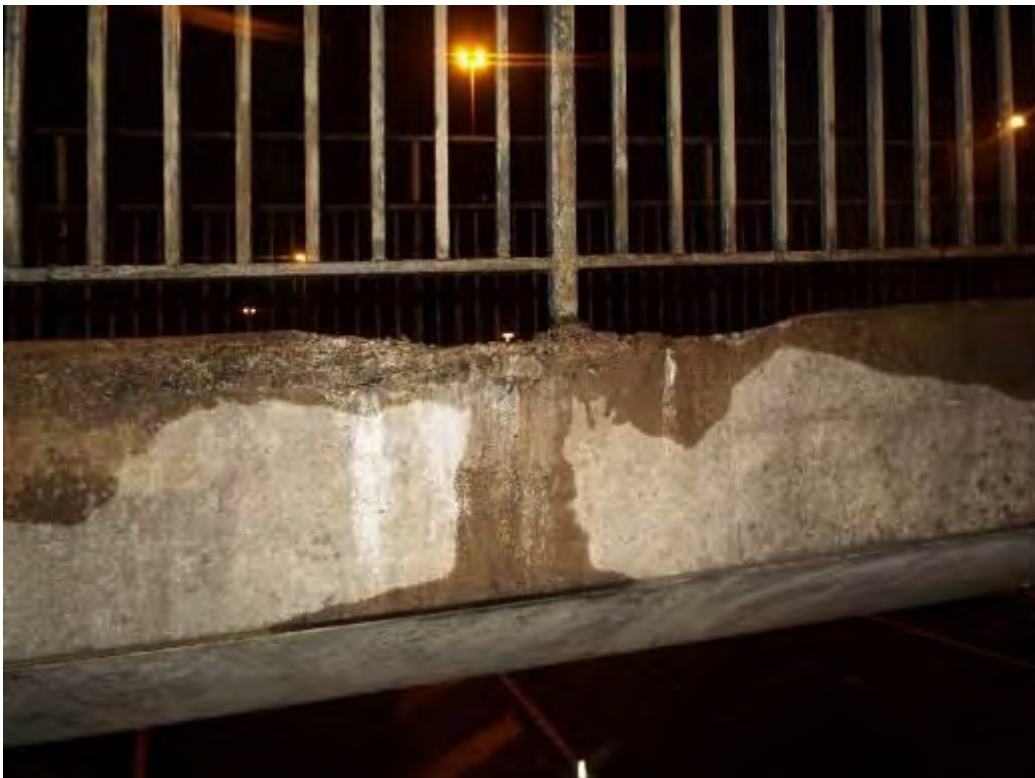
Photograph No.35 - Parapet upstand and showing evidence of scaling from frost damage and salt attack exposing aggregate of concrete in places.

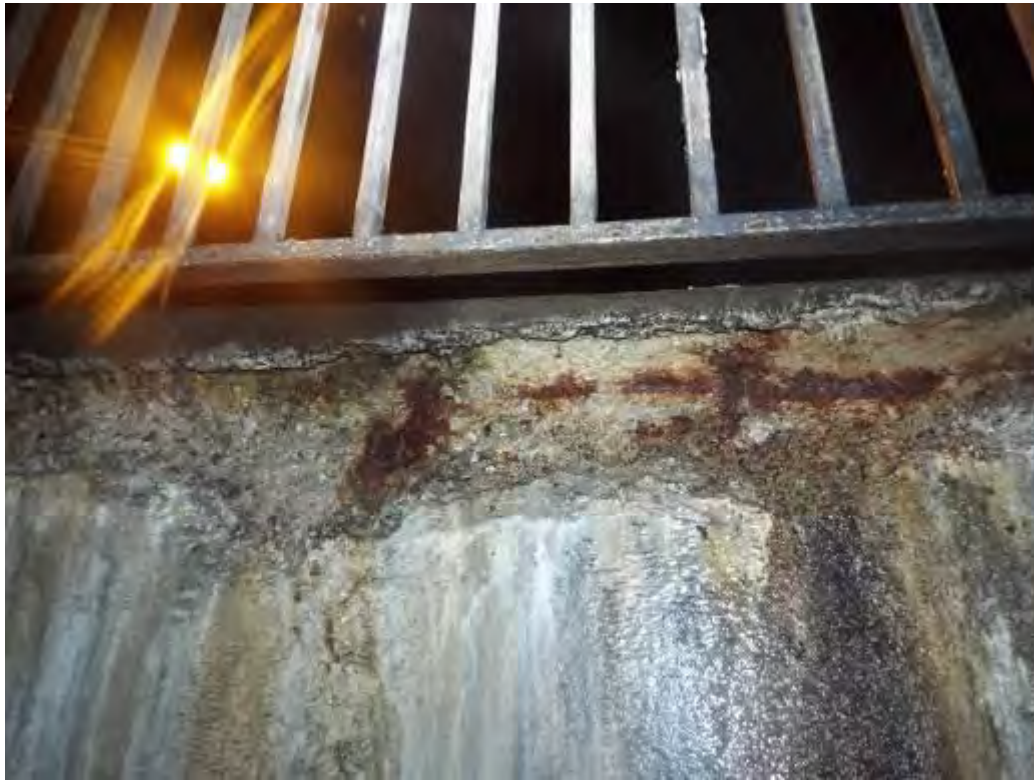
Photograph No.36 - Parapet upstand and showing evidence of scaling from frost damage and salt attack exposing aggregate of concrete in places. Also localised spalls on concrete of parapet fascia.

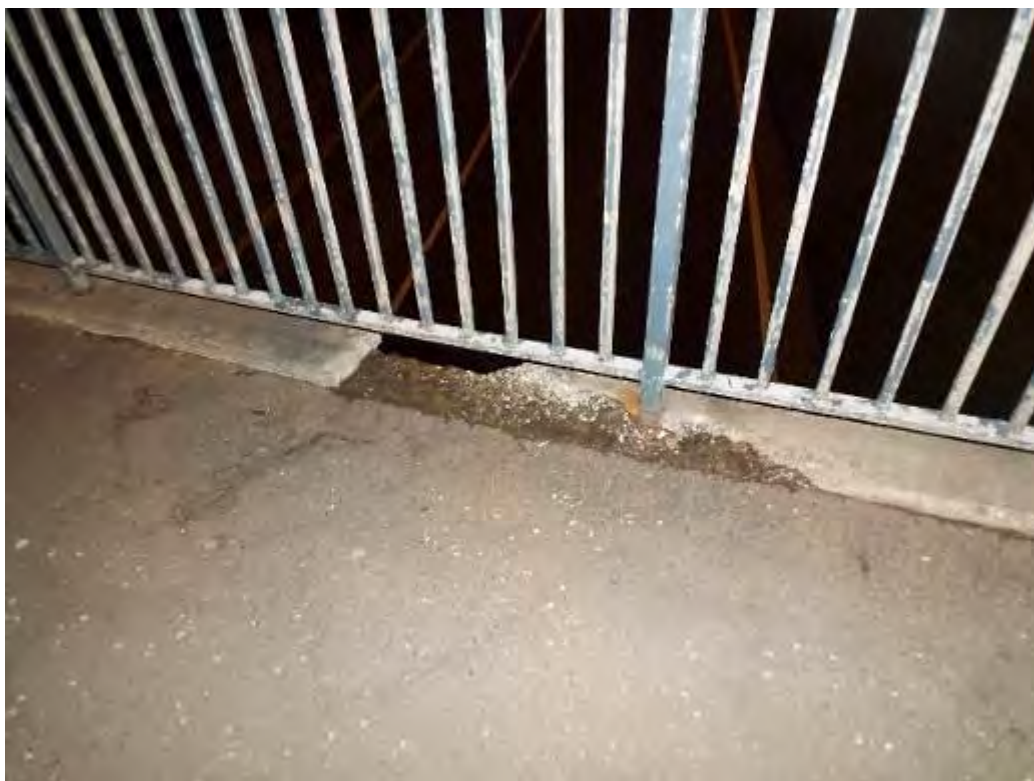
Photograph No.37 - Parapet upstand and showing evidence of scaling from frost damage and salt attack exposing aggregate of concrete in places.

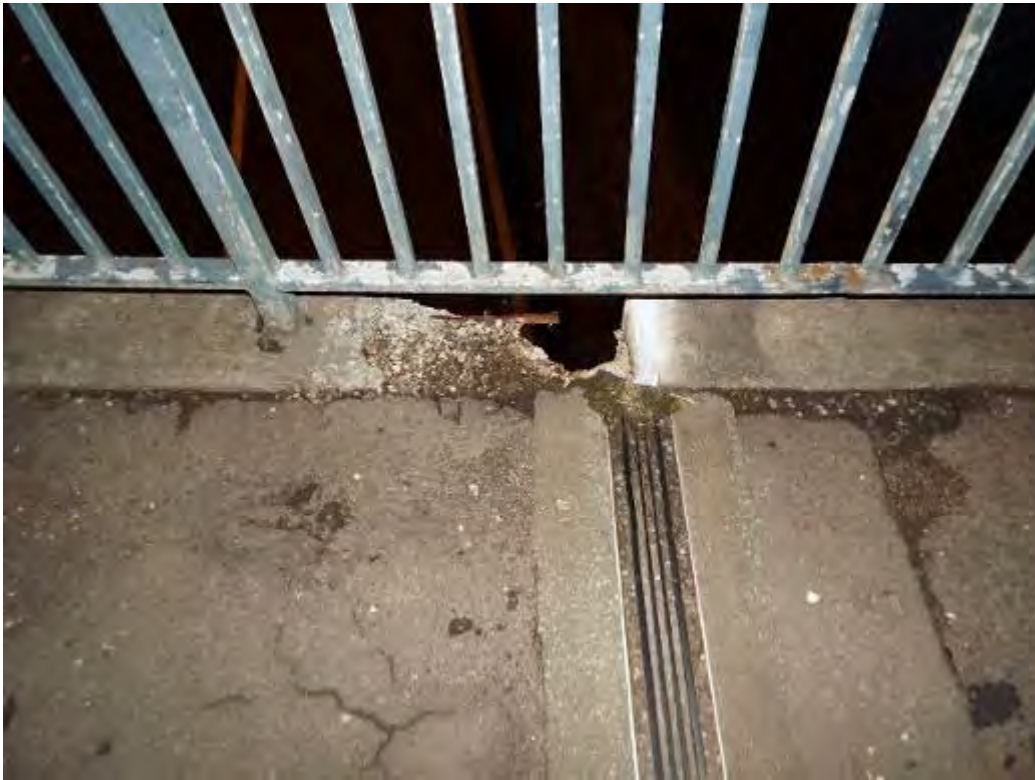
Photograph No.38 - Parapet upstand and showing evidence of scaling from frost damage and salt attack exposing aggregate of concrete in places at half joints which is providing path for water to saturate joint interface below.

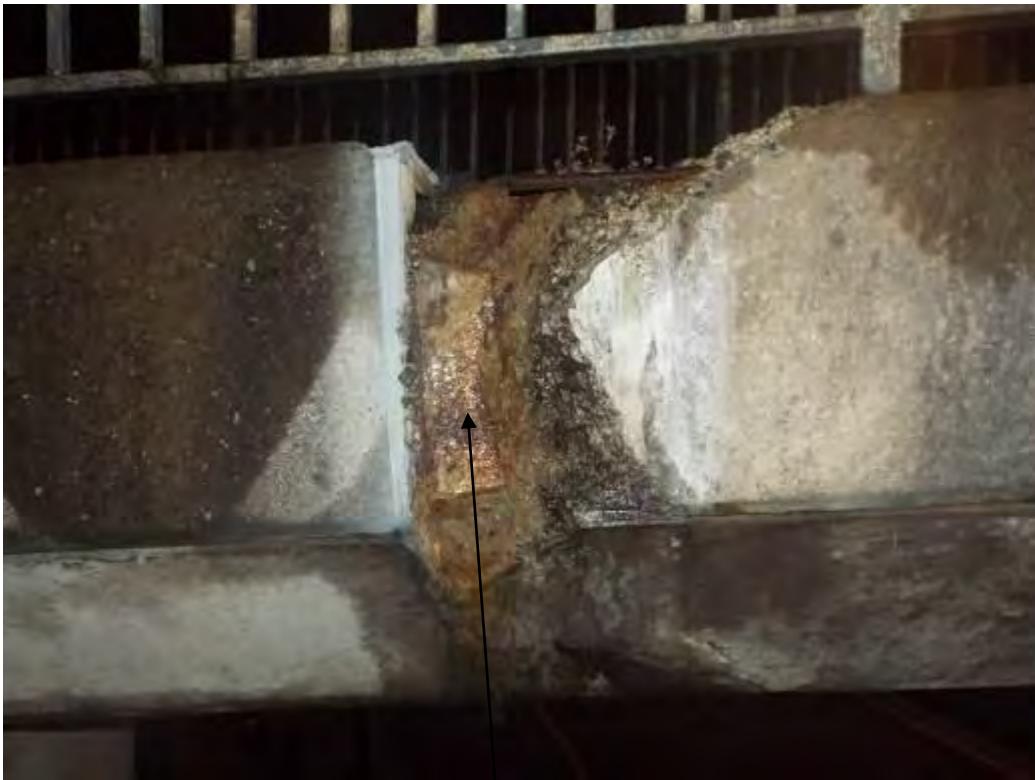
Photograph No.39 - Moderate spalling exposing mortar cap to post tensioned anchor block at uplink half joint LHS.

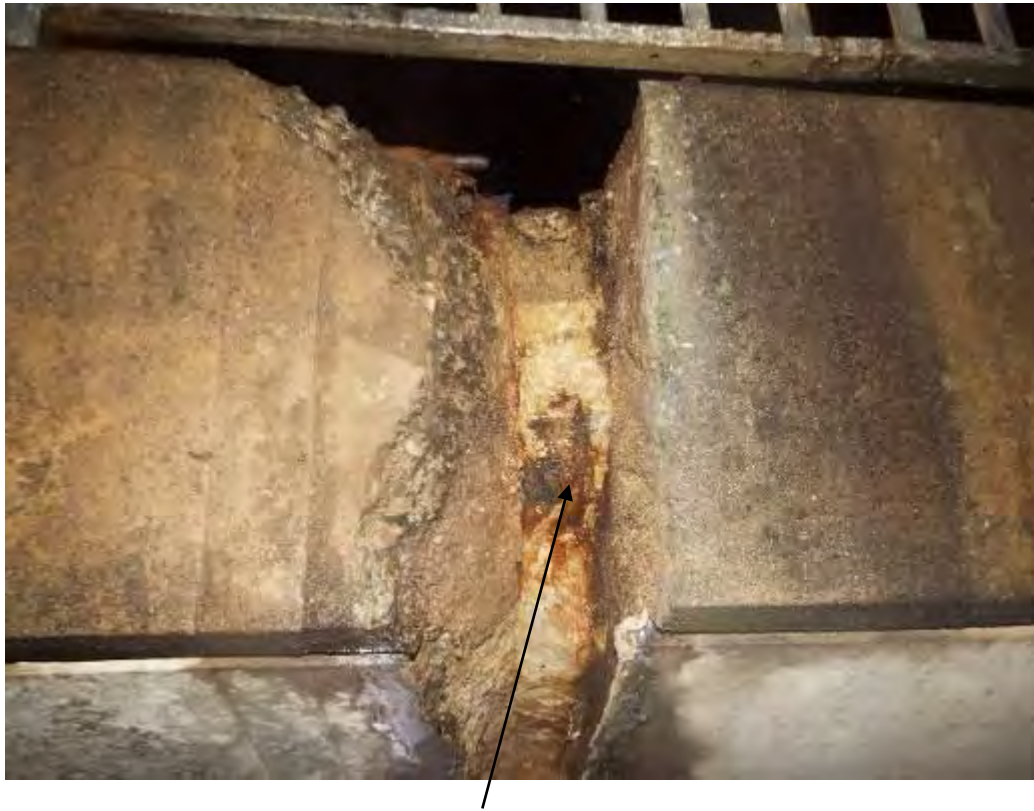
Photograph No.40 - Moderate spalling exposing mortar cap to post tensioned anchor block at uplink half joint RHS.

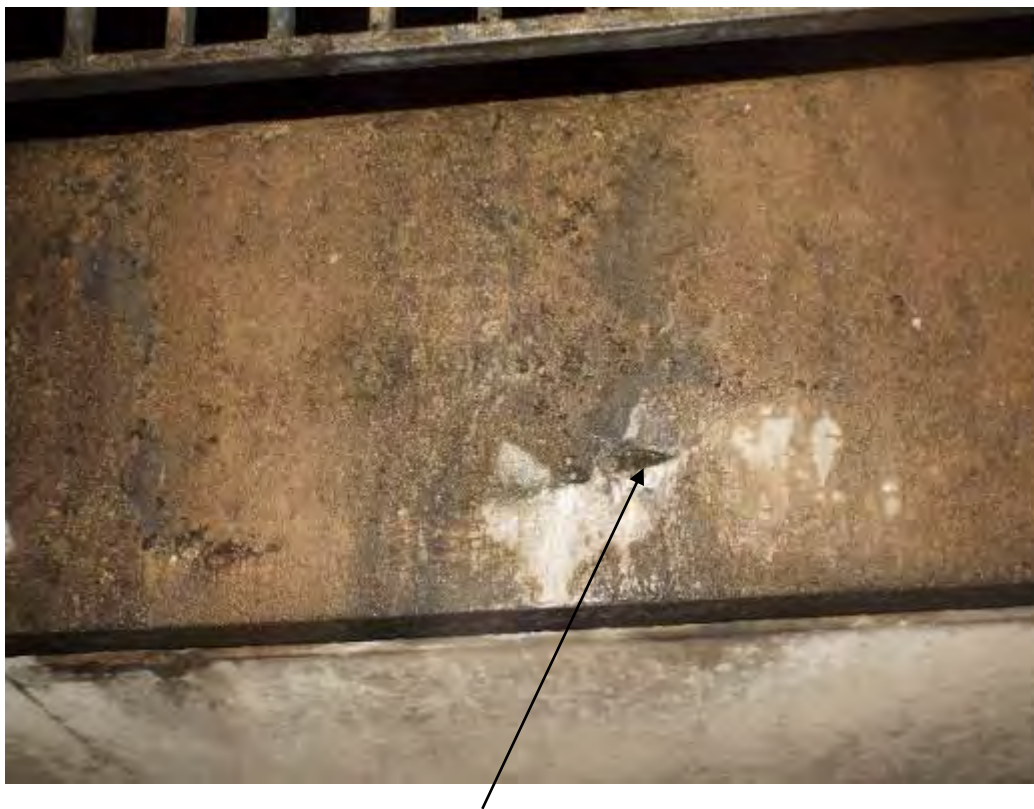
Photograph No.41 - Minor random cracking with 40mm void and leaching at LHS on parapet fascia.

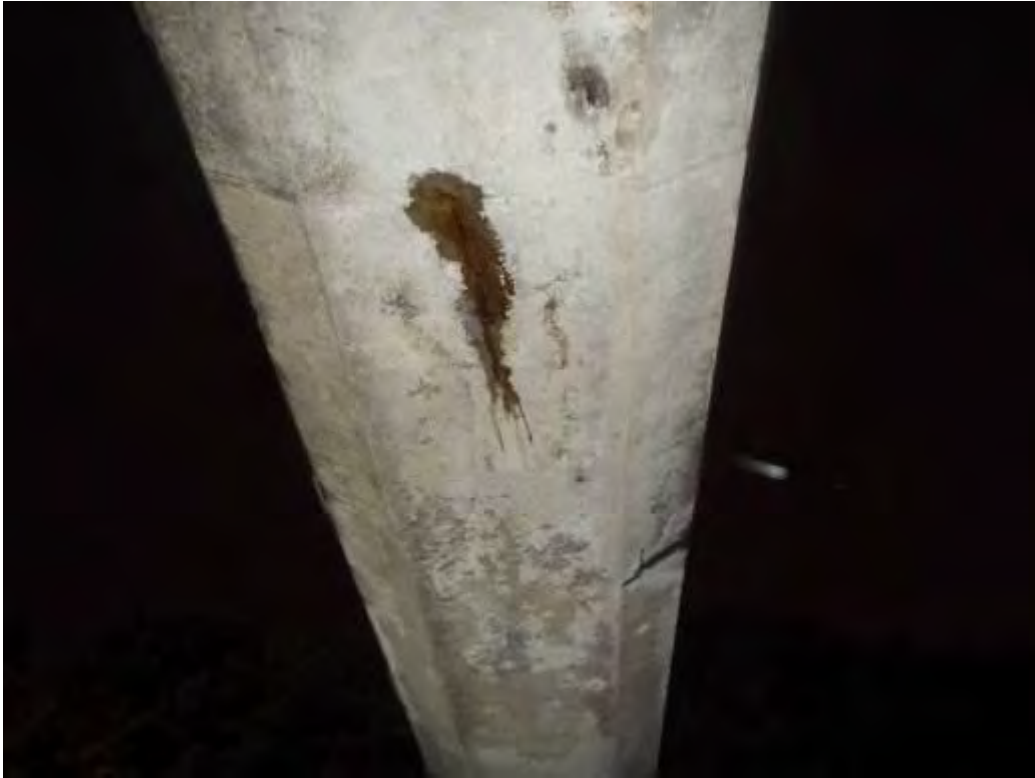
Photograph No.42 -The soffit of the structure shows signs of seepage in span 3.

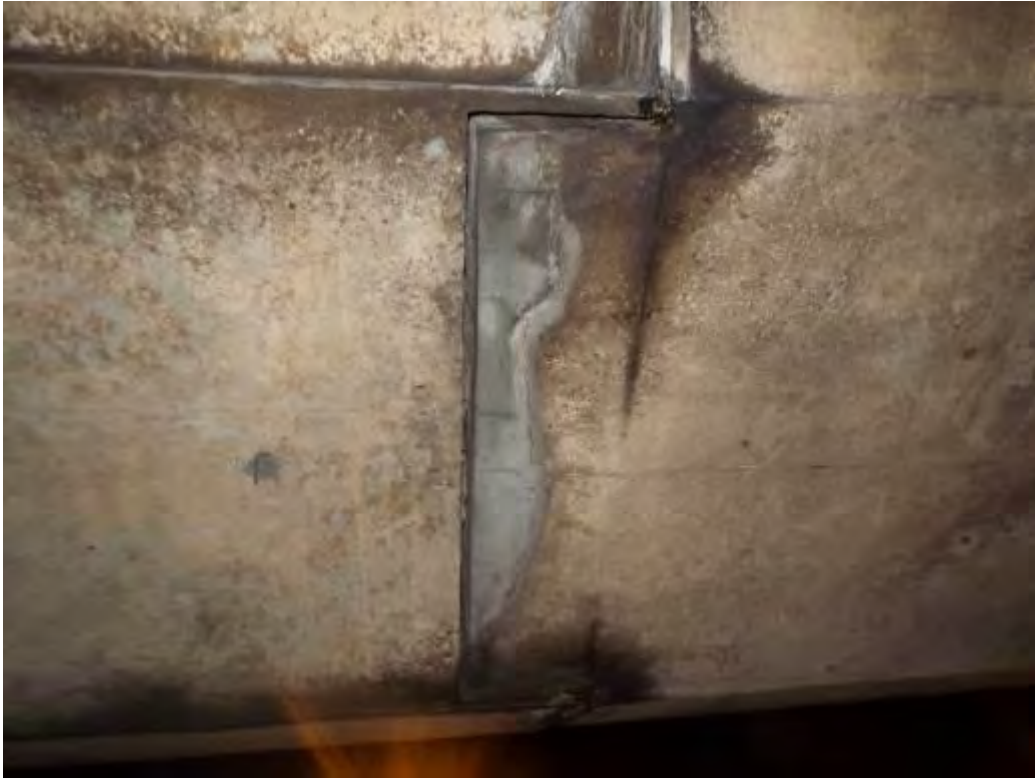
Photograph No.44 - Minor leakage through expansion joint rubber insert at both half joints in span 3 and through polysulphide joint in the parapet upstands at the half joints.

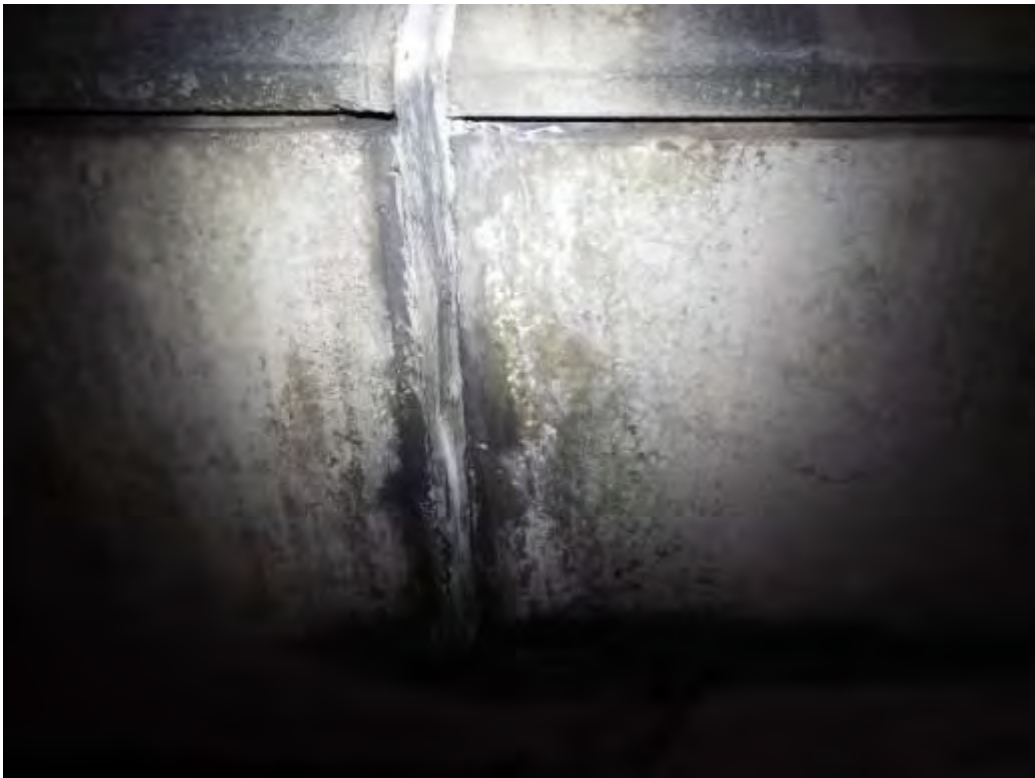
Photograph No.45 - Polysulphide sealant de bonded at both sides of half joint in span 3.

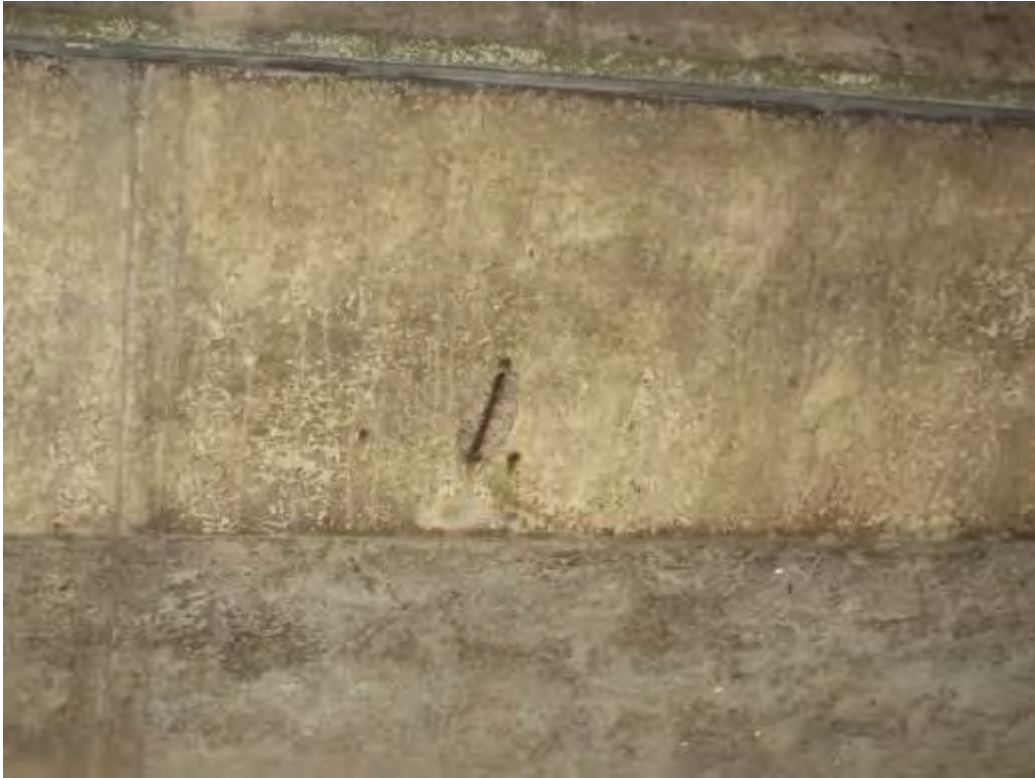
Photograph No.46 - Localised spall on deck slab exposing reinforcement at LHS of span No3.

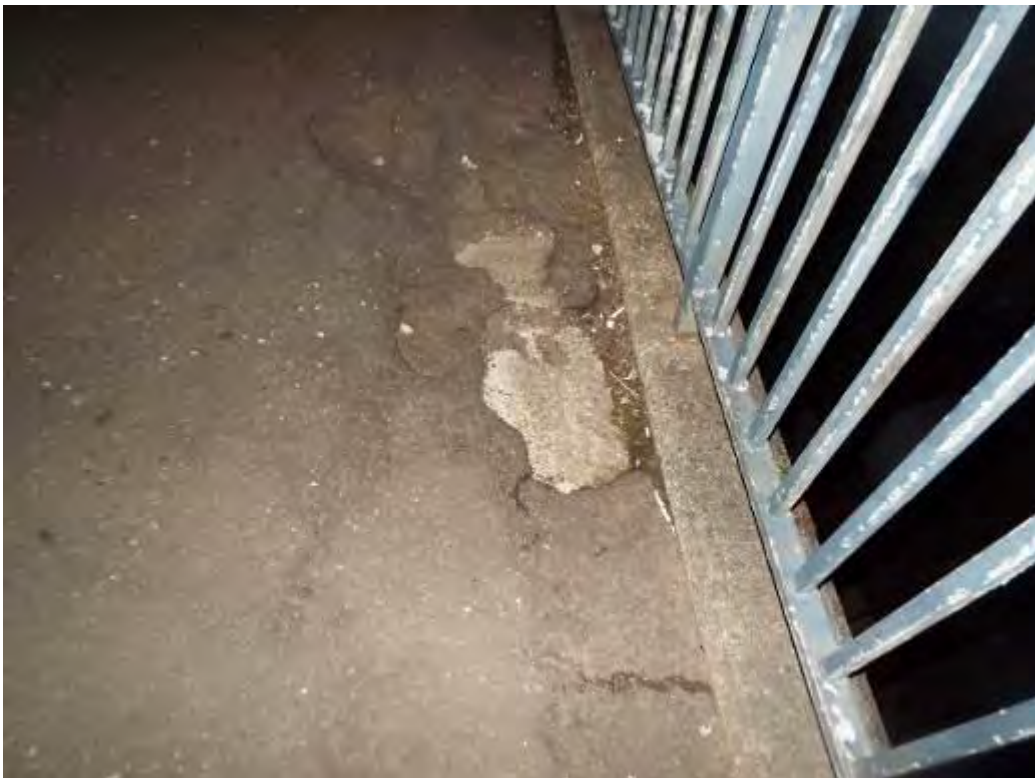
Photograph No.47 - Footpath surfacing is breaking up exposing localised areas of concrete. Waterproofing is not present at localised areas due to weathering and foot traffic on the structure.

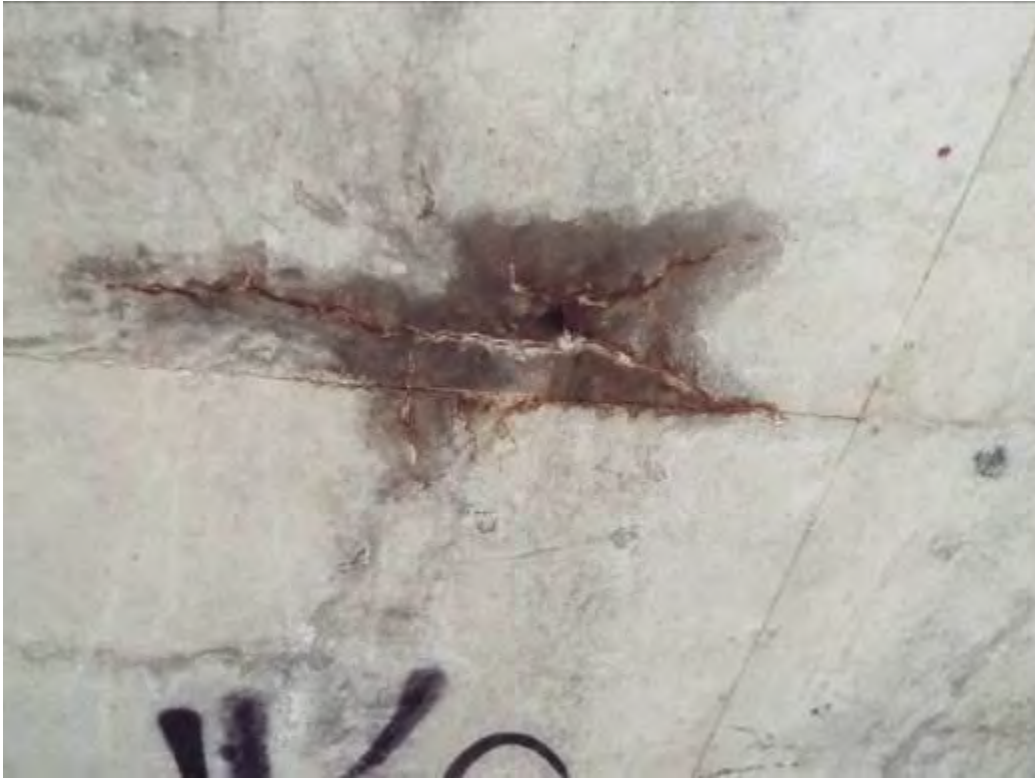
Photograph No.48 - Transverse cracking with leaching on reinforced concrete deck soffit >0.3mm in places.

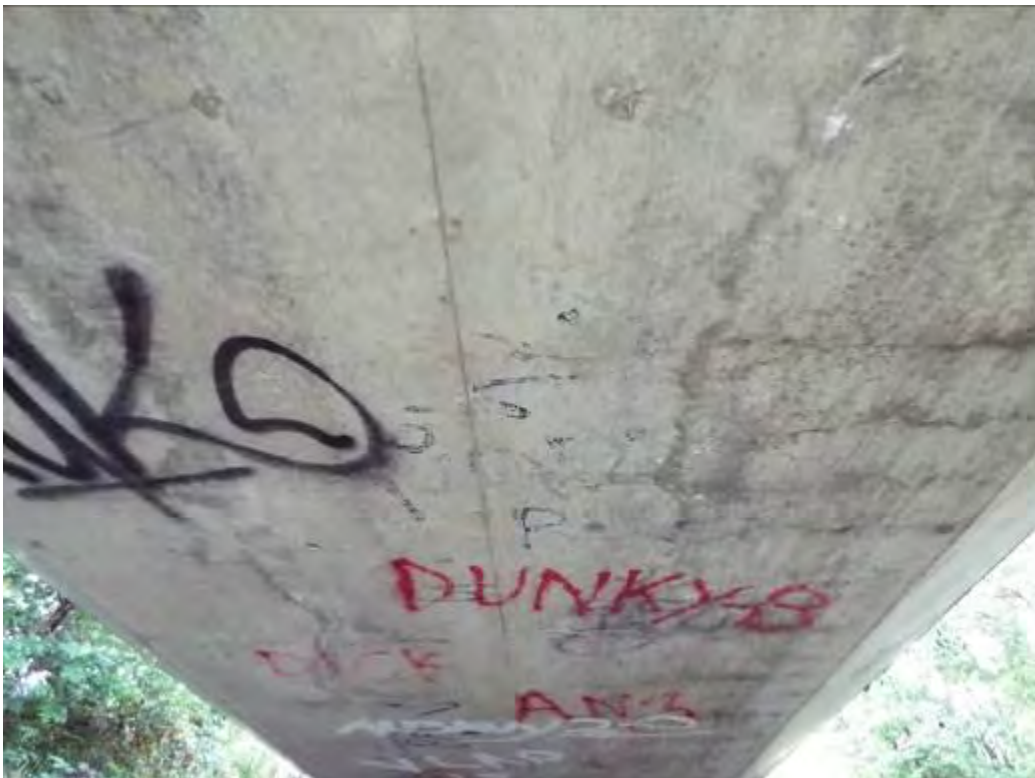
Photograph No.49 - Longitudinal cracking on reinforced concrete deck soffit >0.3mm in places.

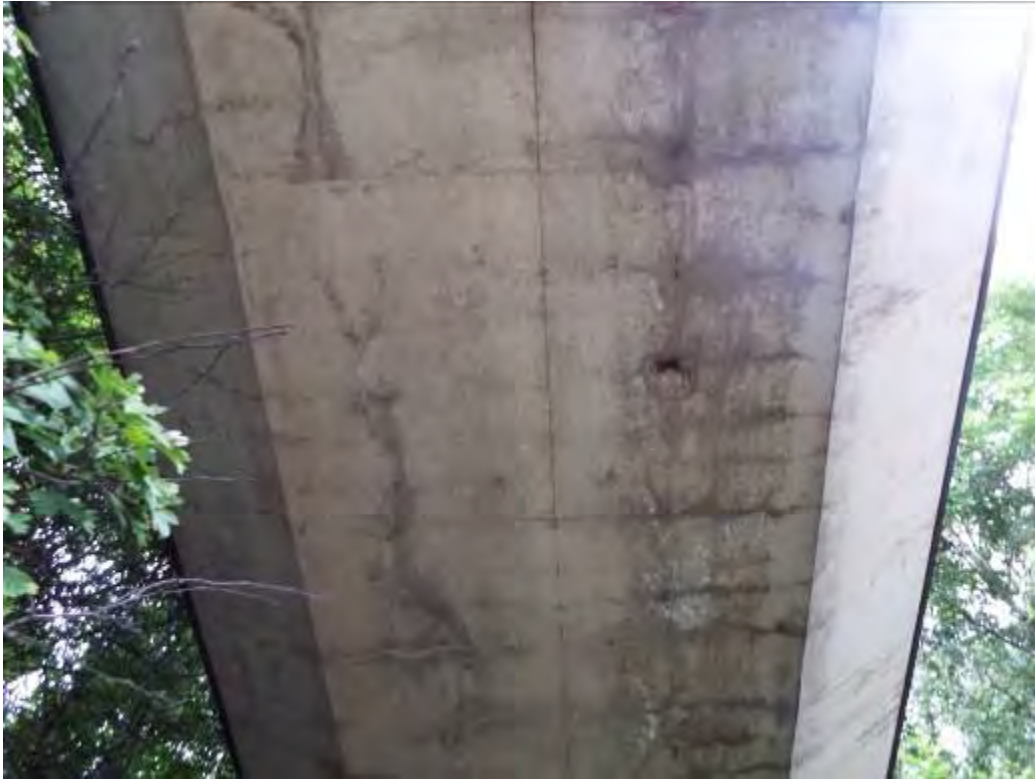
Photograph No.50 - Longitudinal and transverse cracking on reinforced concrete deck slab and soffit >0.3mm in places.

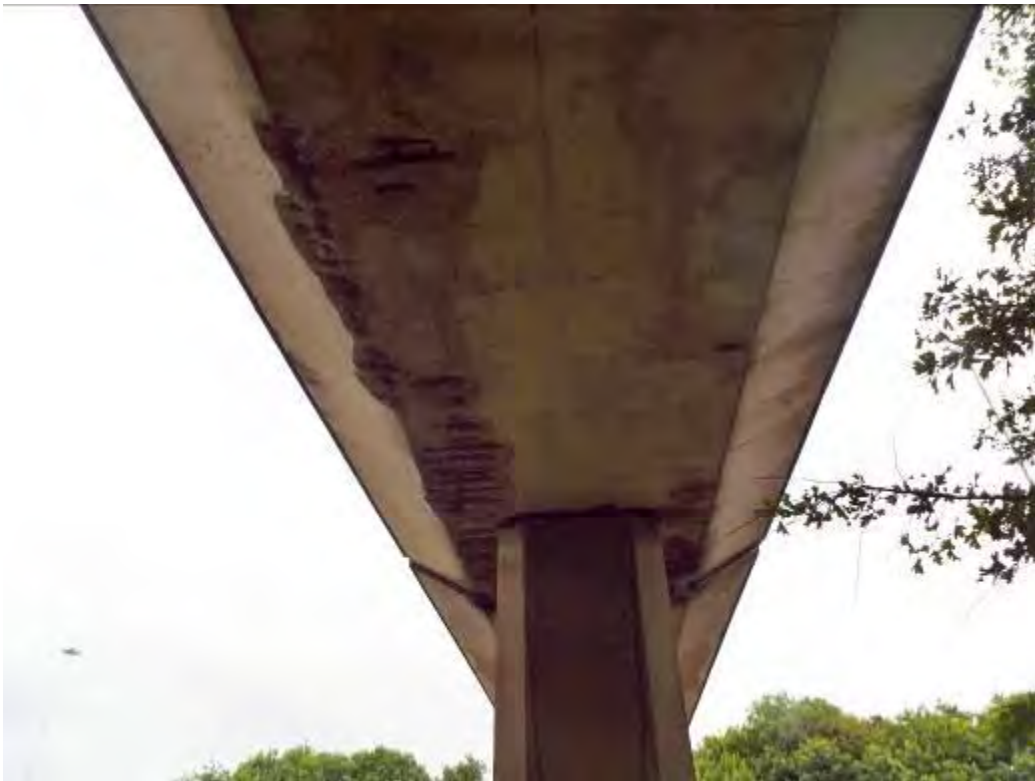
Photograph No.51 - Localised areas of spalled concrete on soffit and deck slab exposing reinforcement in span No4.

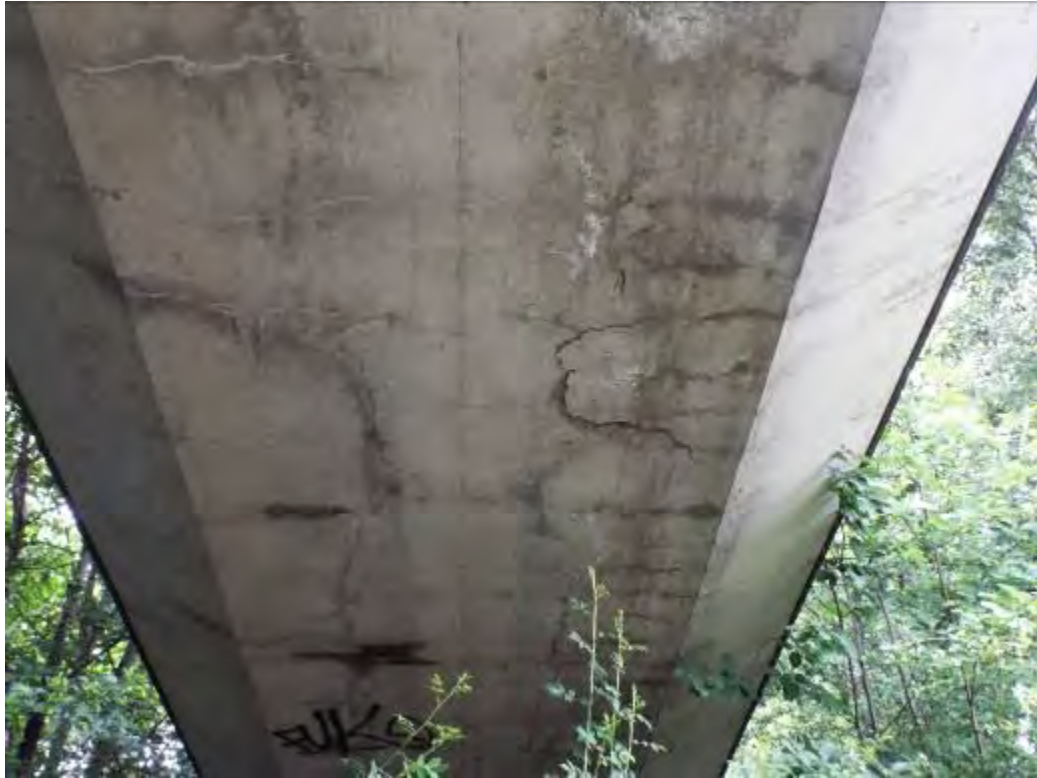
Photograph No.52 - Expansive corrosion of embedded reinforcement resulting in delamination and spalling exposing reinforcement on the soffit of the RC slab.

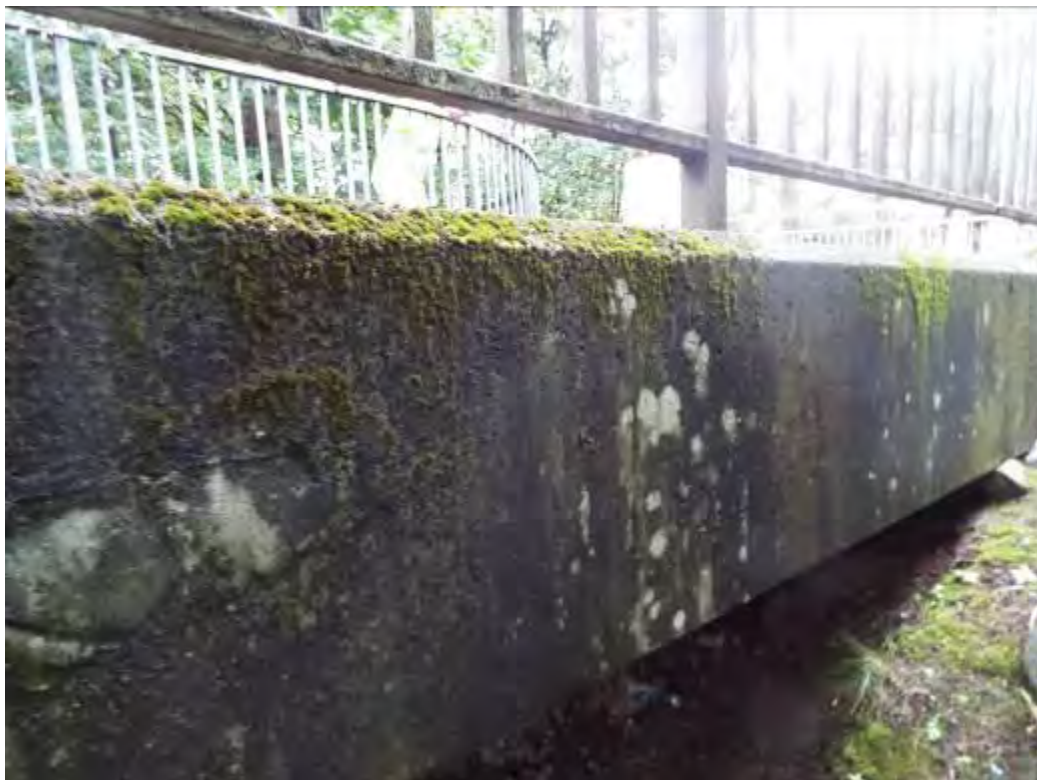
Photograph No.53 Moss growth on parapet upstand and fascia at both sides of span 4.

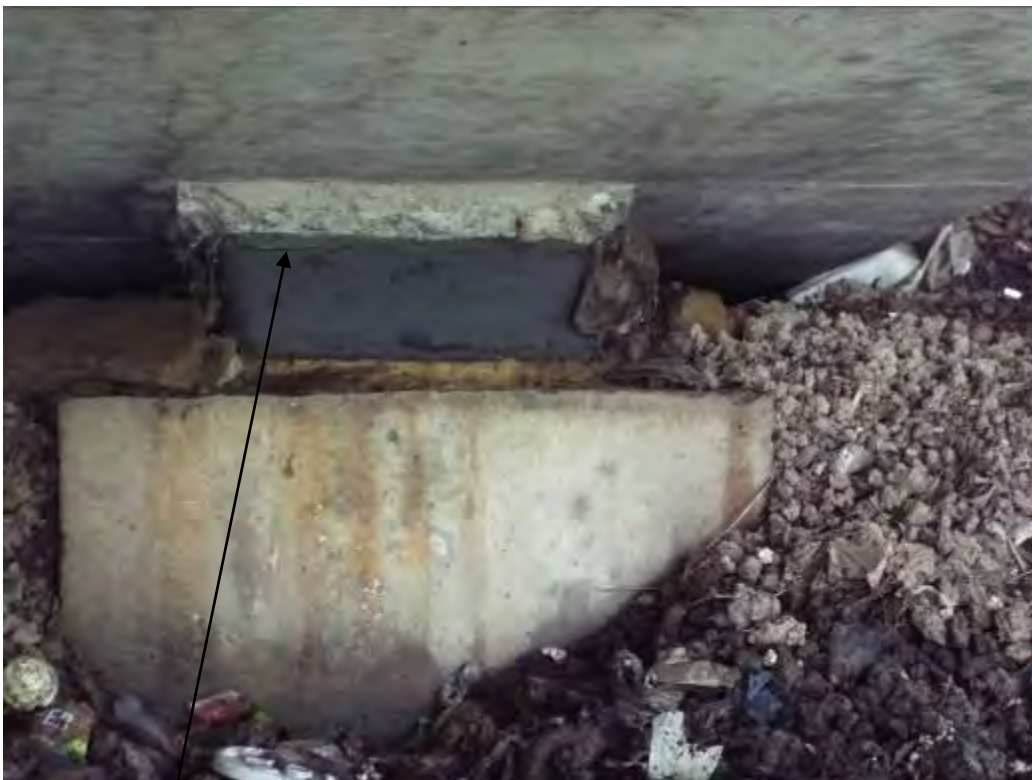
Photograph No.55 - Minor cracking to top of elastomeric pad on bearing No.2 at ESP 5. Detailed inspection restricted due to access beneath soffit and bearing plinths.
