SCOTLAND TRANSERV SOUTH WEST

PRINCIPAL INSPECTION REPORT

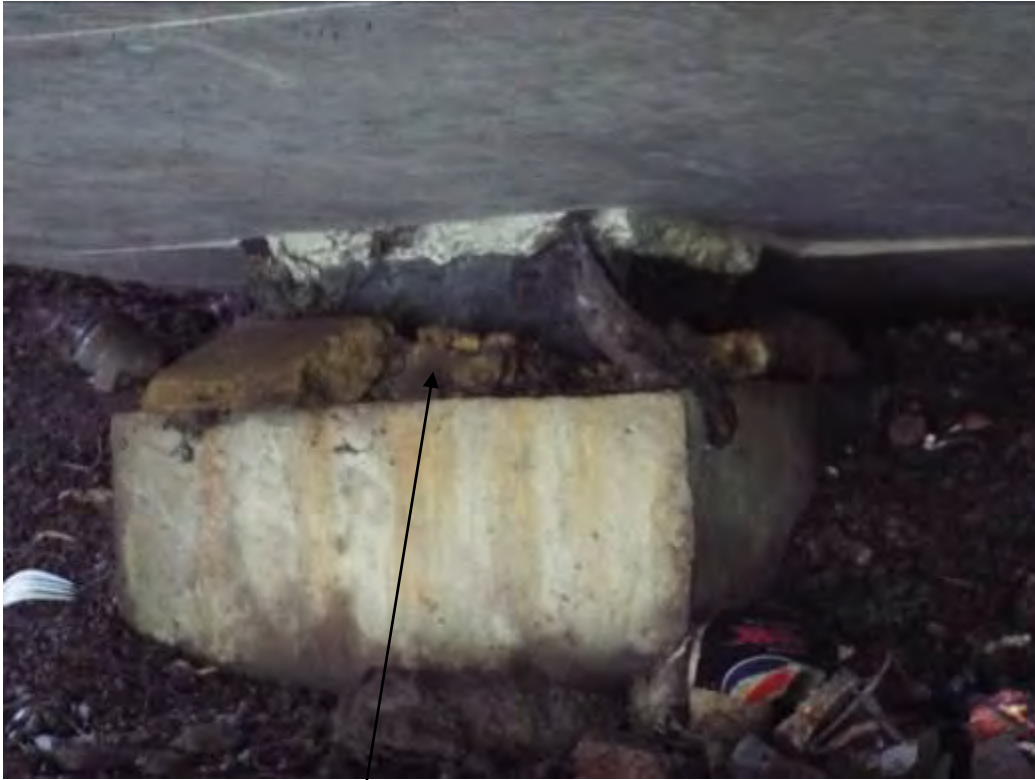
Photograph No.56 - Minor spalling of the mortar base around the bearings at ESP 5.

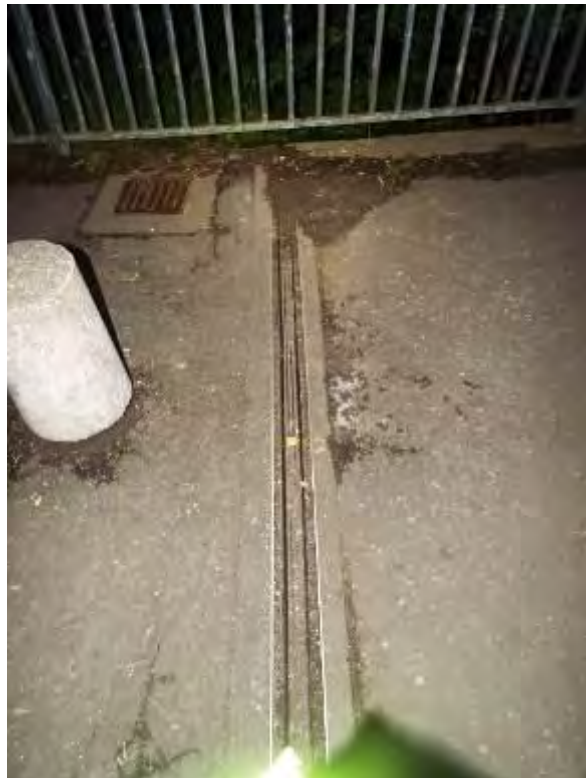
Photograph No.57 - Expansion joint rubber inserts at end support No5 joint in span No4 blocked with debris.

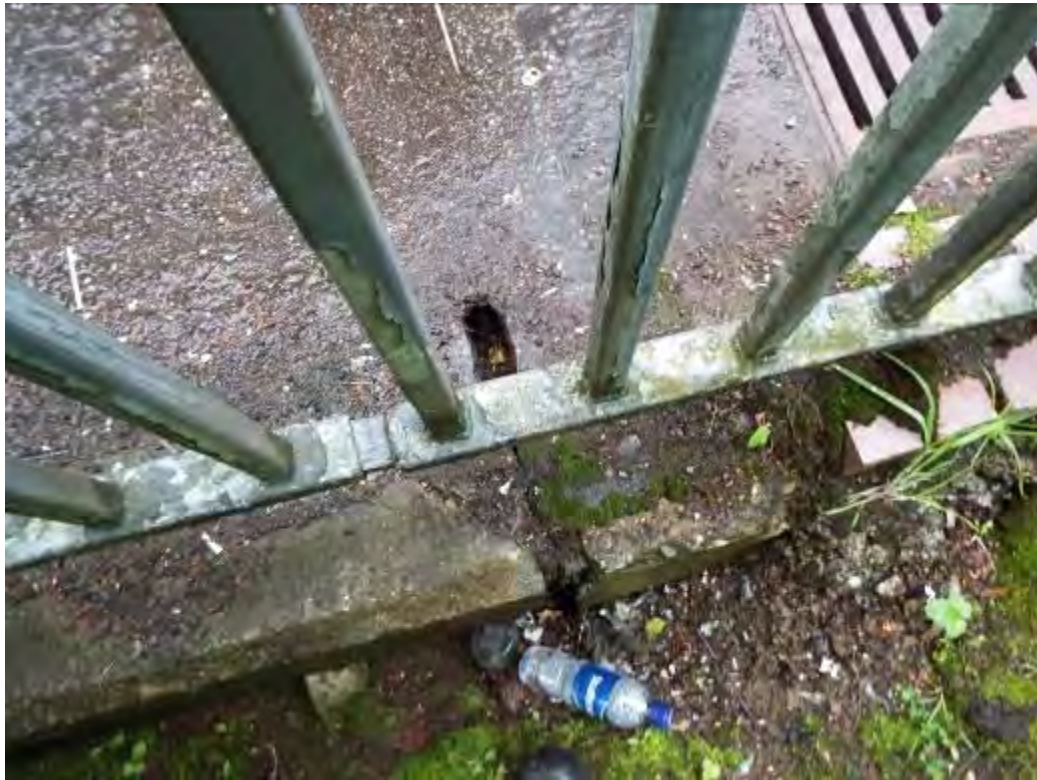
Photograph No.58 - Missing polysulphide sealant at both sides of ESP 5 parapet upstand.

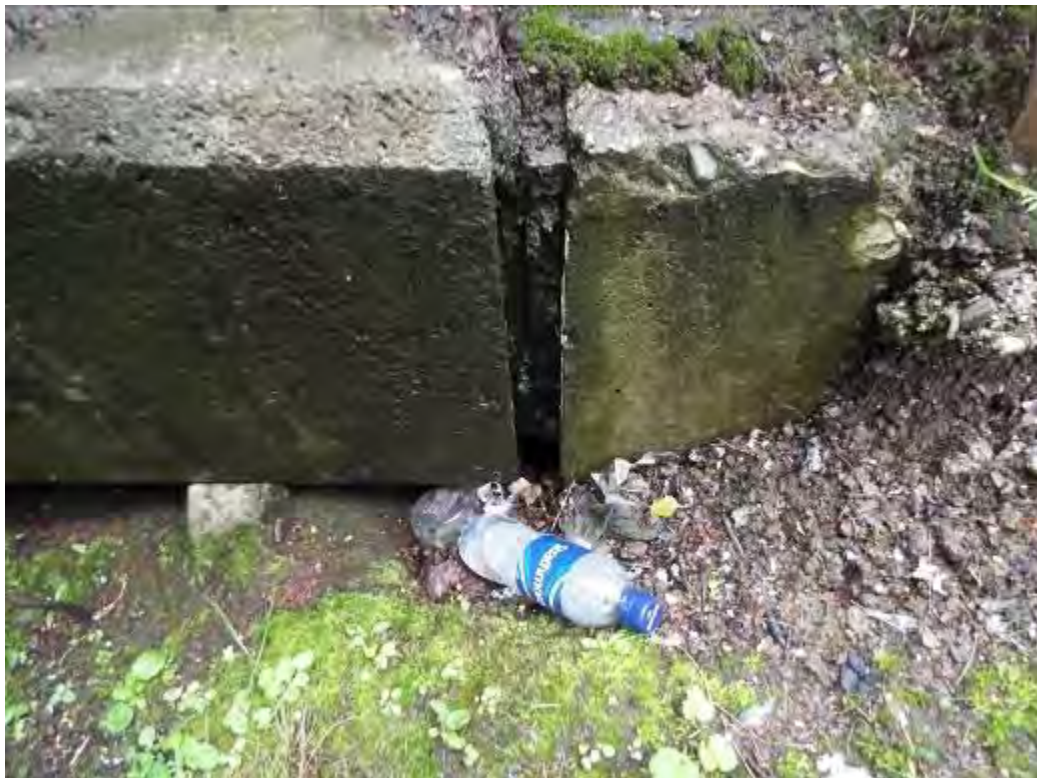
Photograph No.59 - Missing polysulphide sealant at both sides of ESP 5 on parapet fascia.

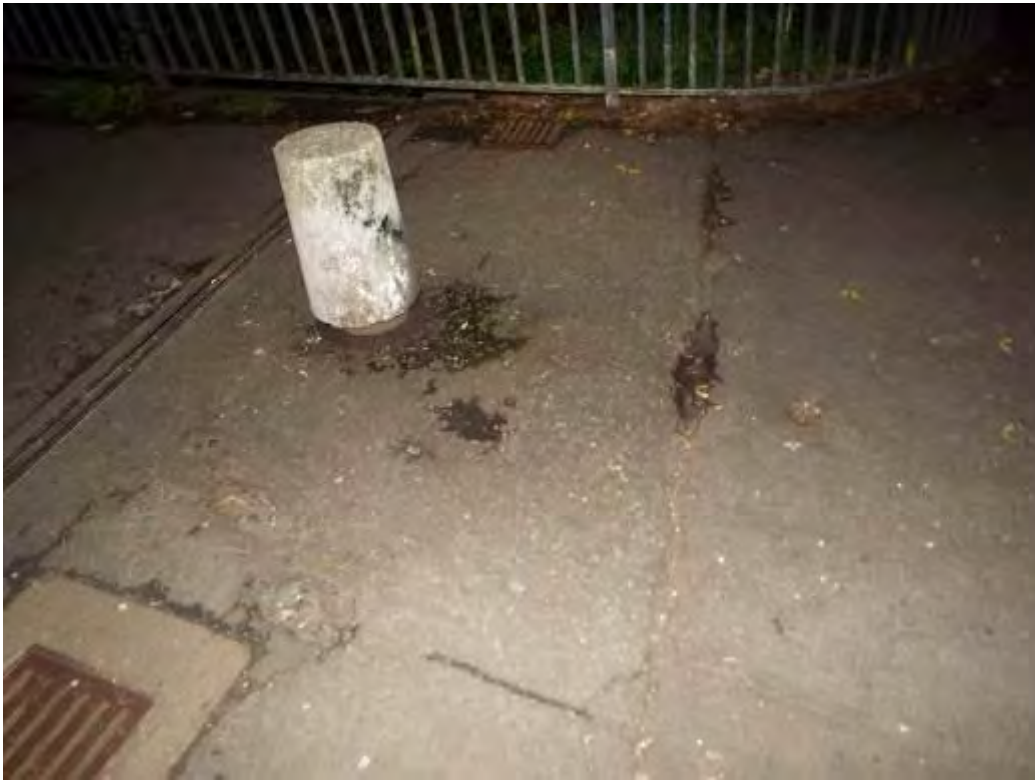
Photograph No.60 - Footpath surfacing appears to have been treated with road salts / grit making it uneven in areas.
