Inspector: Redacted	Date: 14-September-2021	Next inspection type/date: General due 14/09/2023			
Bridge Name: BEECH AVENUE F/B	Bridge Ref No: M8 22-23 F62	Road Ref No: M8	Primary Deck Form (G4)	11	
BICS Inspector Level: INSPECTOR	Map Ref: OSE 255,766	OSN 664,157	Primary Deck Material (G6)	A	
Span 1 of 12	Span Width (m) 3.50	Span Length (m) 10.67	Deck Overall Length (m): 162.22	Secondary Deck Form (G5) 20	
All above ground elements inspected: Yes		Photographs? No		Secondary Deck Material (G6) P	
Number of construction forms in bridge span		<input checked="" type="checkbox"/> 1	<input type="checkbox"/> 2	<input type="checkbox"/> 3	<input type="checkbox"/> More

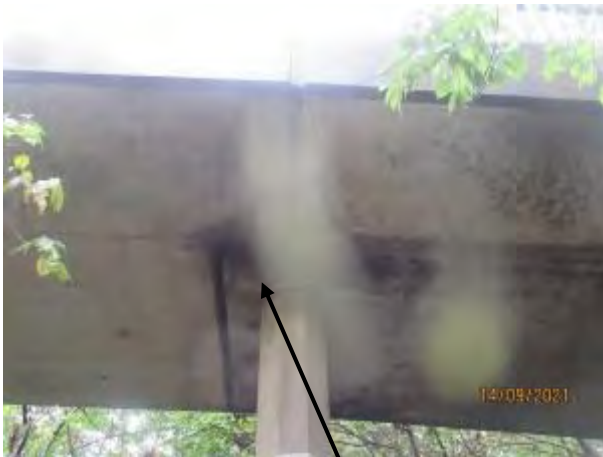
Photograph No. 1 - Minor localised spall on the IS8 half joint.

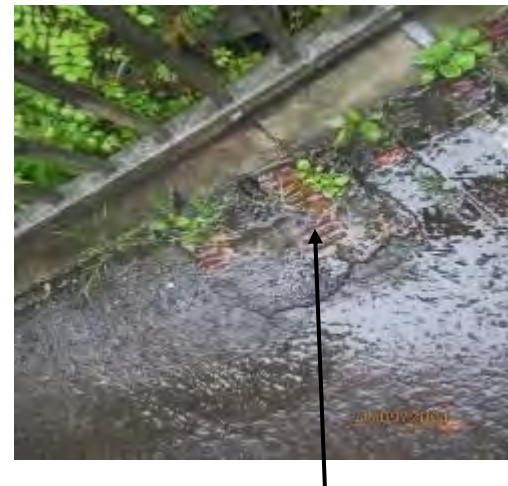
Photograph No.2 – Gully's totally blocked at ESP 13.

15	Cyclic Maint- Drainage - Photograph No.2 - Gully totally blocked at ESP 13 This should be cleaned and clear during the next Cyclic Maintenance visit.	3	£1	No
----	---	---	----	----
