**PRINCIPAL INSPECTION REPORT**

**Structure: M8 22-23 F62, BEECH AVENUE F/B**

**Inspection date: 28-May-2019**

**Prepared by SCOTLAND TRANSERV SOUTH WEST**

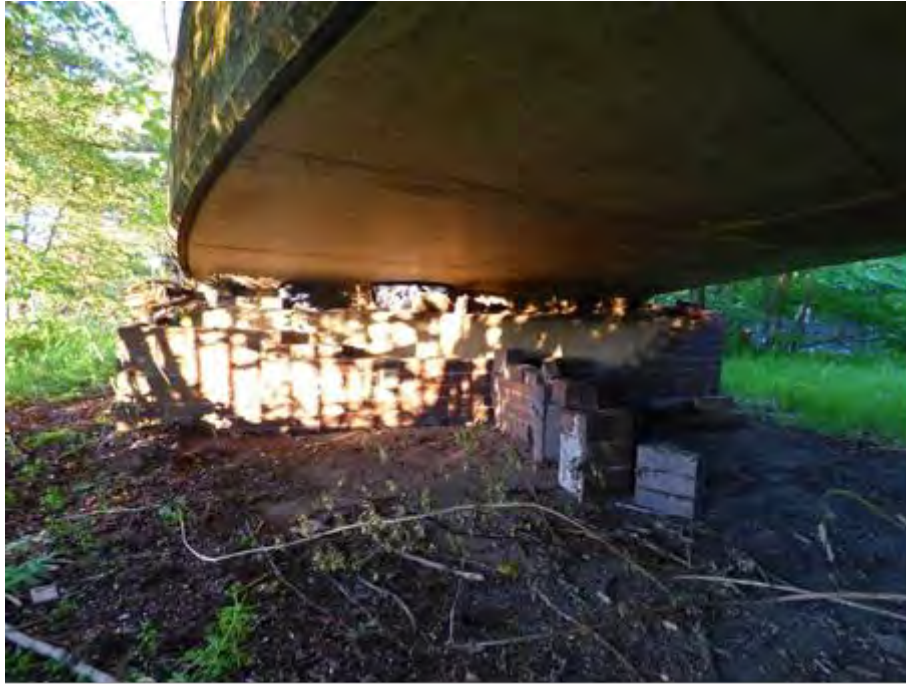
ES1 and ES13 bearing shelves in good condition. However there is evidence of a vagrant living on the ES1 bearing shelf.

*Photo 3 – Evidence of vagrant living on ES1 bearing shelf and brickwork façade damaged.*

- Sleeping bag to be cleared from ES1 bearing shelf during Cyclic Maintenance (item 13)
- ES1 and ES13 gullies to be cleared during Cyclic Maintenance (item 14)
- Debris to be removed from rail joints during Cyclic Maintenance (item 15)

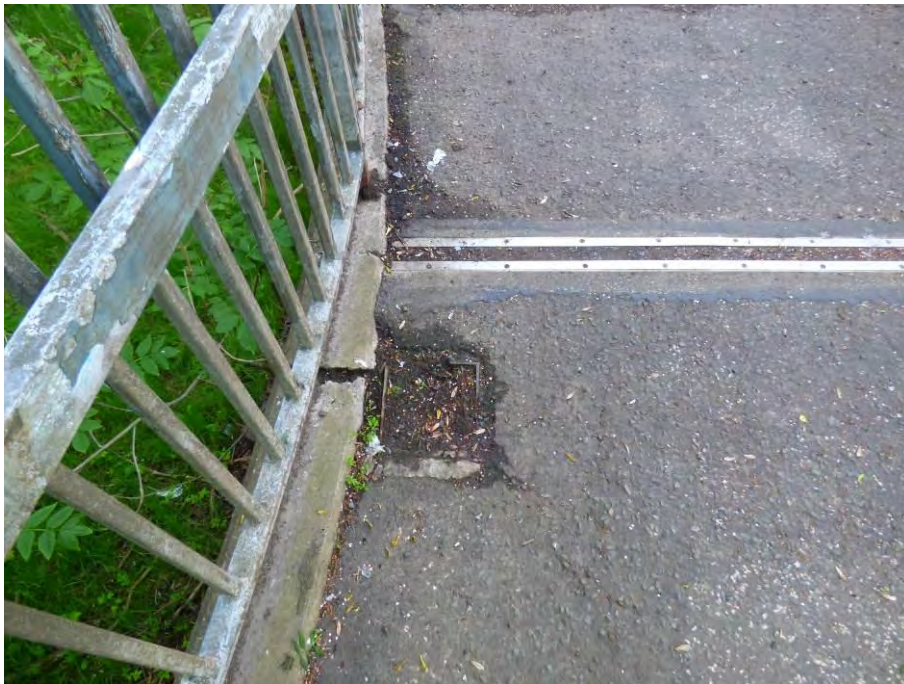
Gullies adjacent to ES1 and ES13 rail joints blocked and require to be cleared during cyclic maintenance.

**Photo 7 – LHS gully completely blocked at ES1 rail joint**

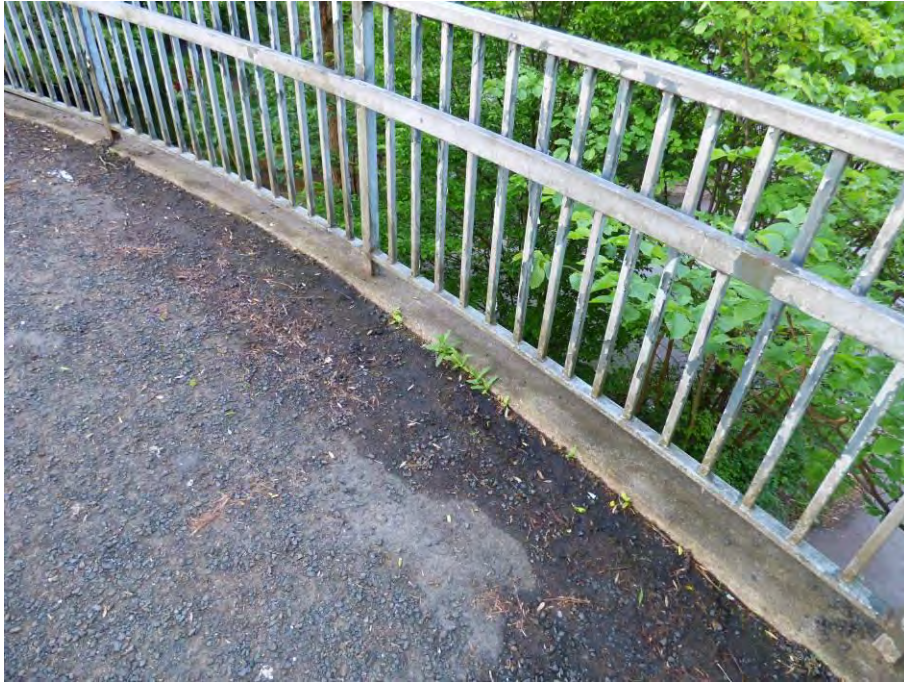
Protecting paint system on both parapets failed on all spans. Parapets should be painted to prevent further deterioration.

**Photo 9 – Protective paint system of both parapets failed throughout structure**

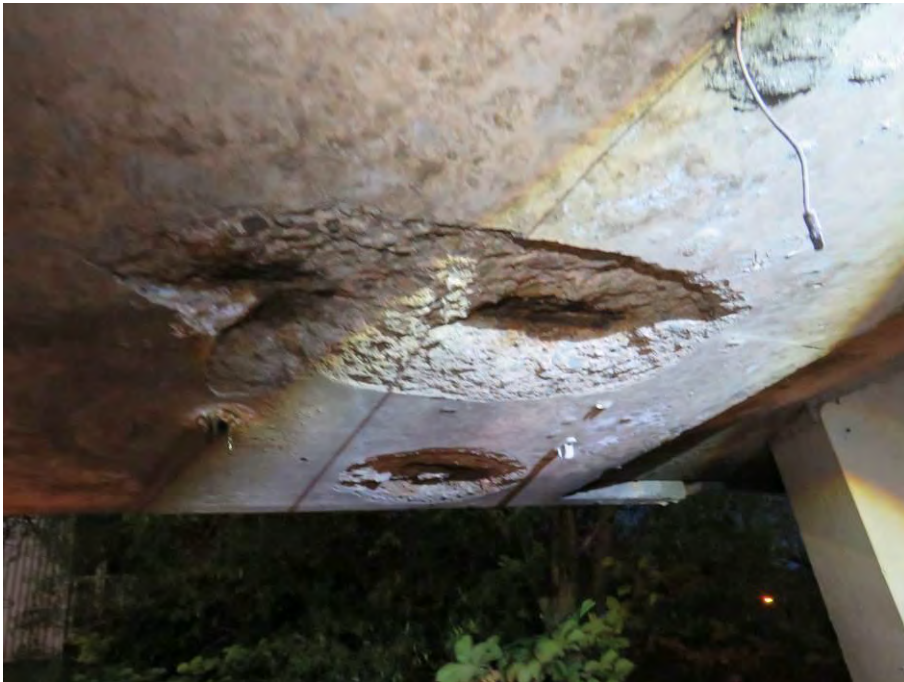
Minor spalls on half joints at IS6 and IS8.

**Photo 17 – Localised spall exposing reinforcement at IS6 half joint and span 6 bridge deck**

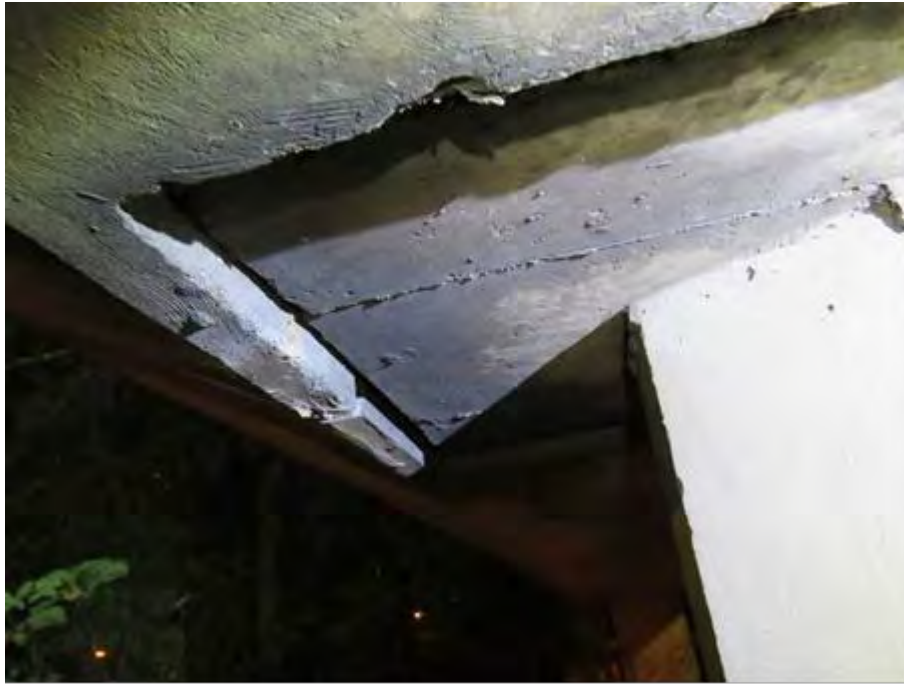
Span 6 and 7 appear to be twisting at the relevant half joint and an investigation is required to discover the cause of the defect.

**Photo 18 – Span 6 bridge deck appears to be twisted at DL RHS adjacent to IS6 half joint**

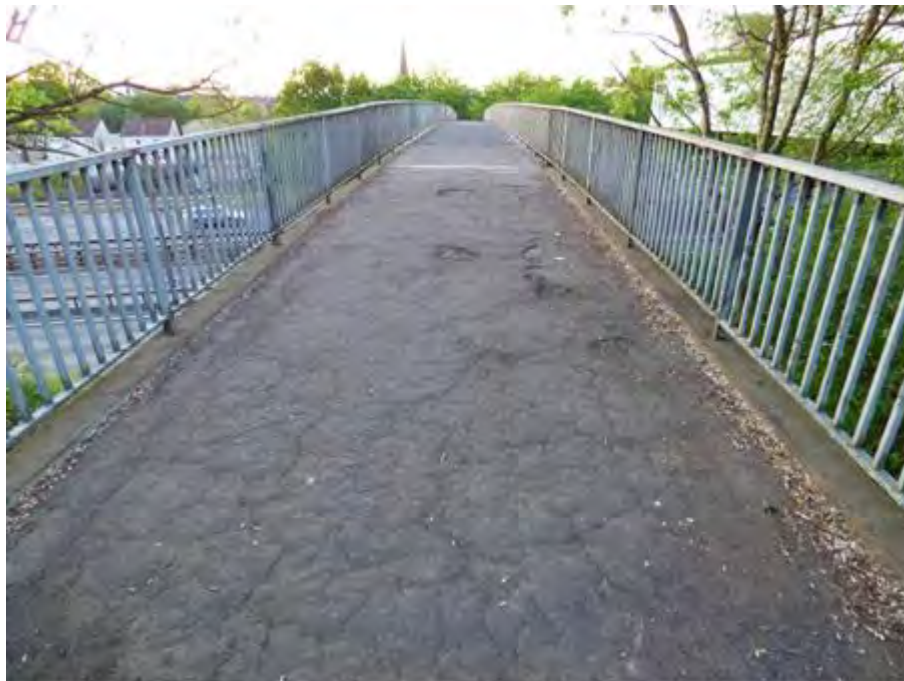
Loss of material and general weathering throughout leading to uneven surfacing. Deep cracking and potholing present on span 5.

**Photo 19 – Deep cracks and potholing to span 5 surfacing**

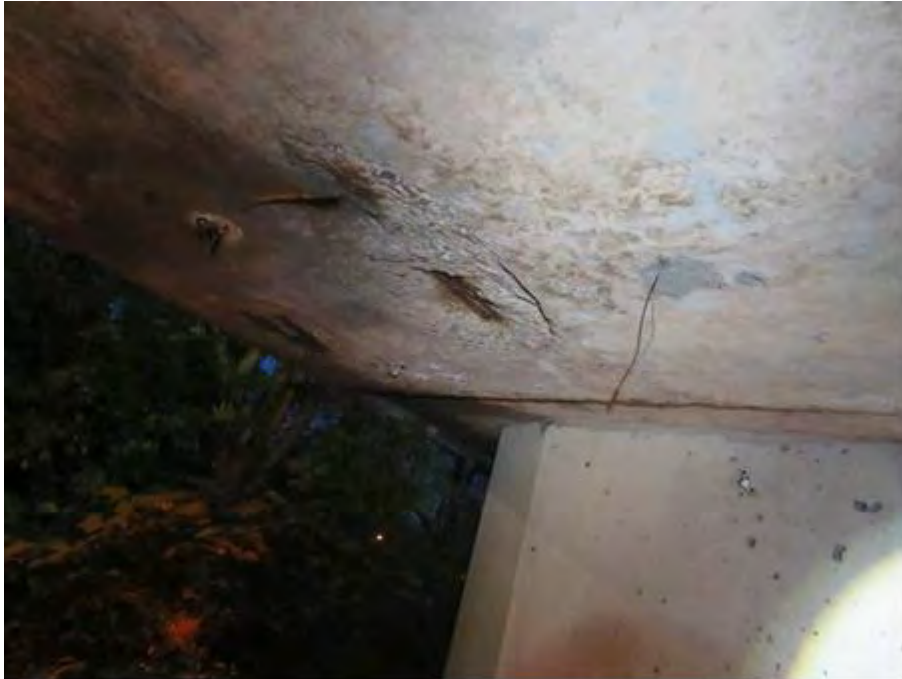
**Photo 20 – Localised spall adjacent to IS8 half joint and span 7**

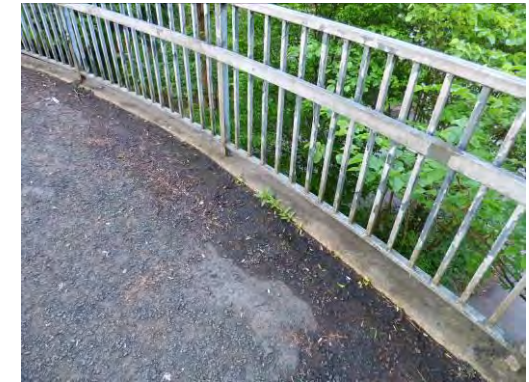
Photo 9 - Paint system failed on parapet system throughout structure. This has lead to surface rusting on the parapets. Parapets should be painted to prevent further deterioration.

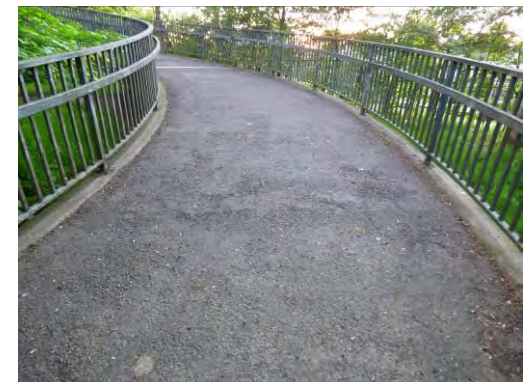
Photo 10 - Areas of cracking and weathering throughout footbridge surfacing creating possible trip hazards. If the footbridge is to be resurface this should be done as a waterproofing scheme and the cost is included in the waterproofing element.
