COUNCIL EXECUTIVE

REINFORCED AUTOCLAVED AERATED CONCRETE ROOFS

REPORT BY HEAD OF FINANCE AND PROPERTY SERVICES

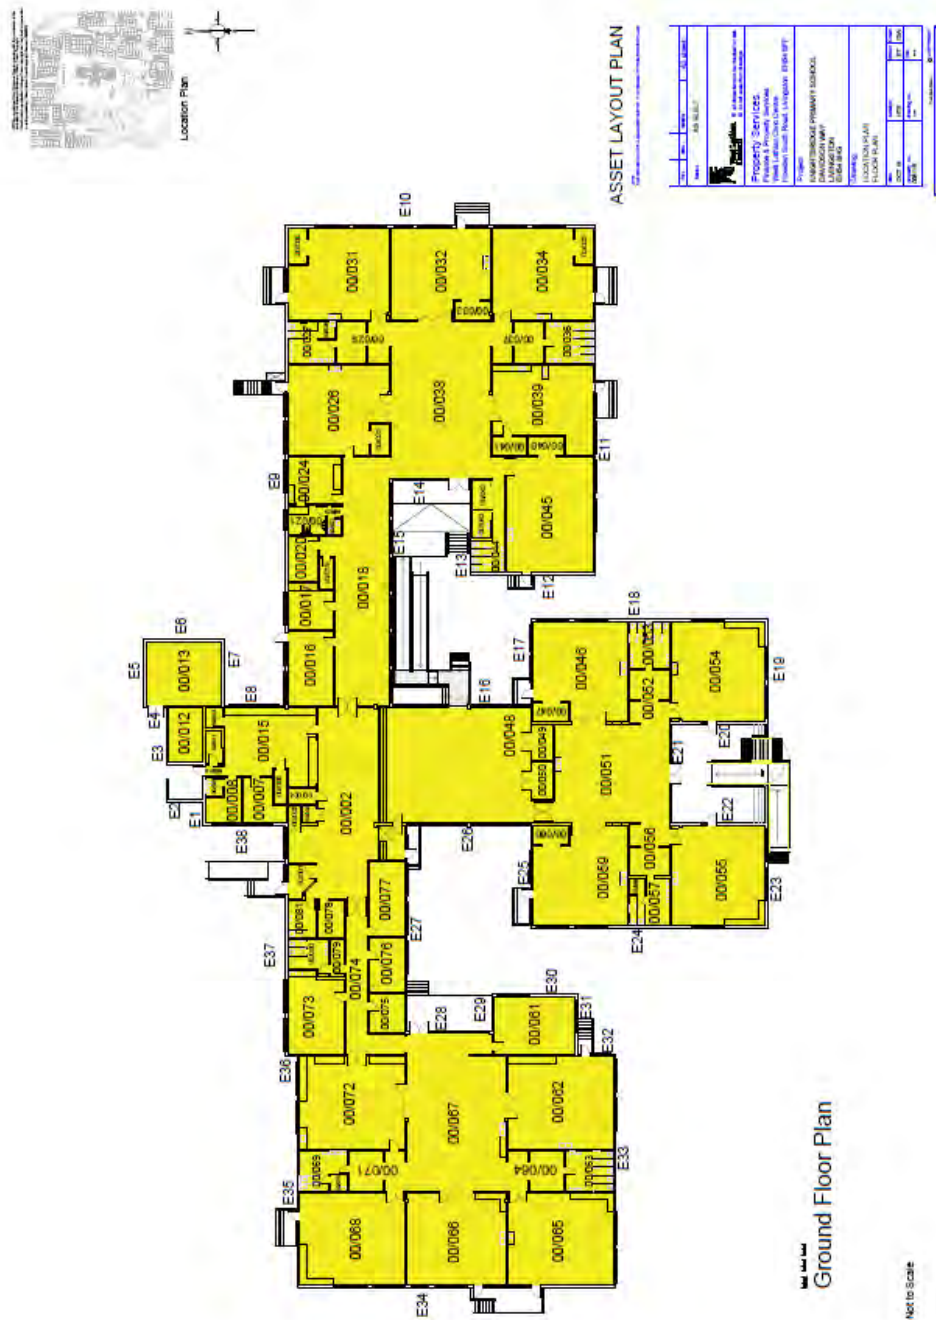
Knightsridge Primary School, Livingston

RAAC roof planks are present in all roof areas as shown in diagram below. However, the roof over the school was converted to a pitched roof in 2016/17. The RAAC roof planks remained in place but have become structurally redundant as they no longer carry the weight of the roof or any imposed loads such as snow in the winter. The pitched roof above also protects the RAAC planks from water ingress.

As the roof planks are now structurally redundant due to the pitched roof conversions there is no requirement at this time to consider replacing the RAAC roof planks.

Despite this, the RAAC planks will be inspected annually by a qualified structural engineer.

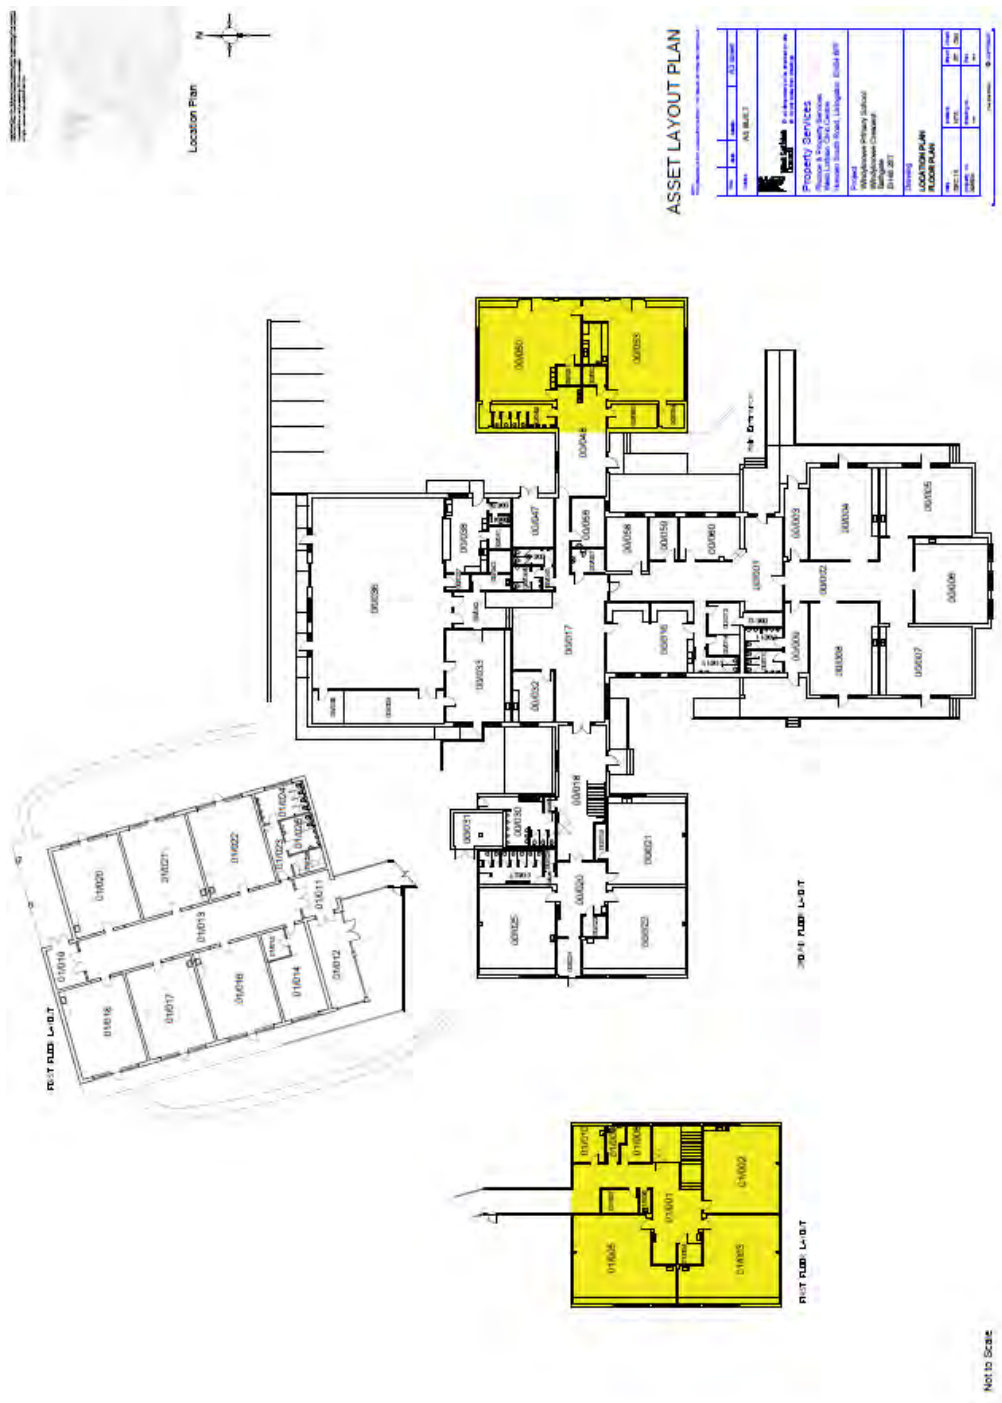
Windyknowe Primary School, Bathgate

RAAC roof planks are present in the Nursery and two storey classroom block as shown in diagram below. These roof planks were found to be in good condition generally but with evidence of historical water staining.

The roofs above the Nursery and two storey classroom block have had a flat to pitched roof conversion as part of previous major refurbishment work. The roof planks are now structurally redundant due to the pitched roof conversions and there is no requirement at this time to consider replacing the RAAC roof planks.

The RAAC planks will be inspected annually by a qualified structural engineer.

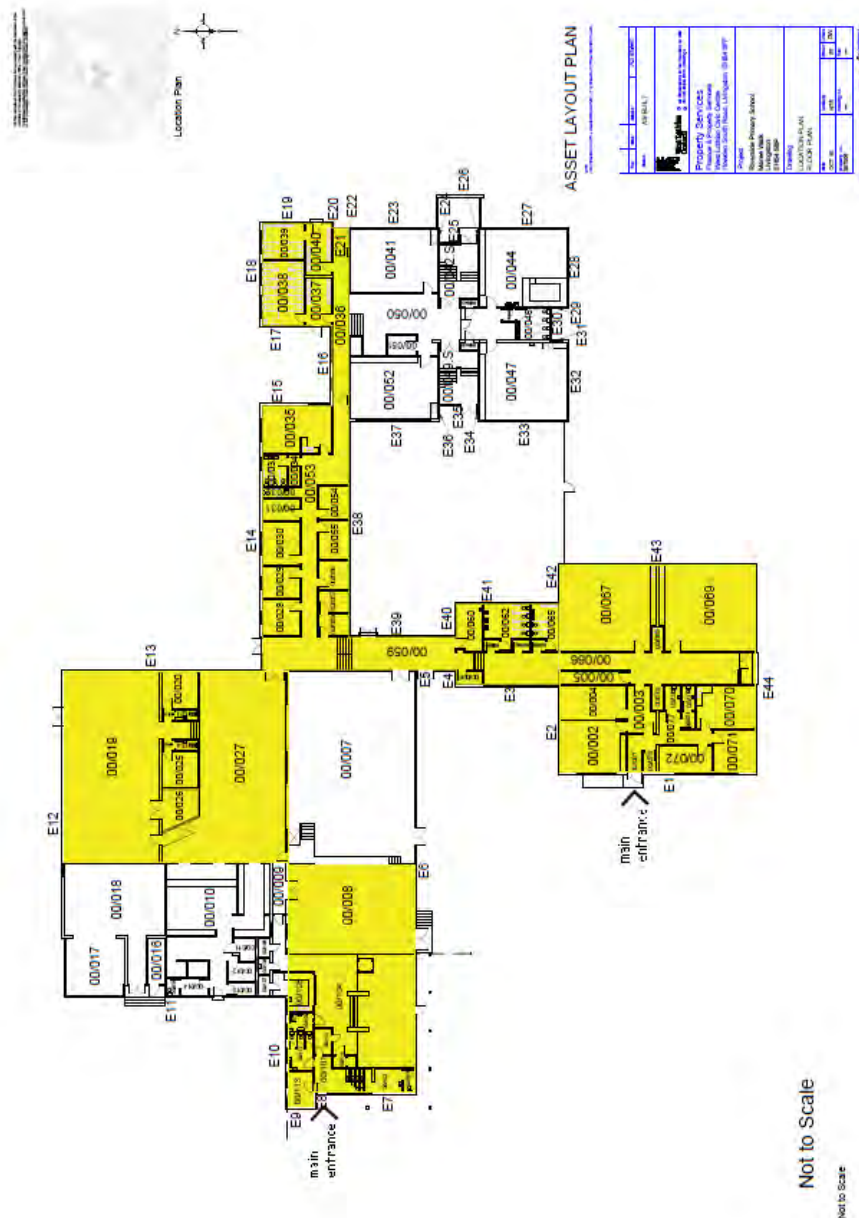
Riverside Primary School, Livingston

RAAC roof planks area present in to all roof areas as shown in diagram below. Structural strengthening and stabilisation works were carried to provide support to the roof planks during the summer of 2019. Strengthening works were carried out to all areas with the exception of the single storey entrance block which is not required by the school is due to be demolished during 2021.

The remedial works carried out summer 2019 has extended the life of the roof deck, however the RAAC planks are still be present. It is recommended that RAAC roof planks should be replaced within 5-10 years.

Due to the wider construction quality of the school, its age and layout officers are now progressing options for its replacement Council Executive on 9 February 2021 instructed officers to progress with detailed options appraisals and business case development for the replacement of the school.

The RAAC planks will be inspected annually by a qualified structural engineer.

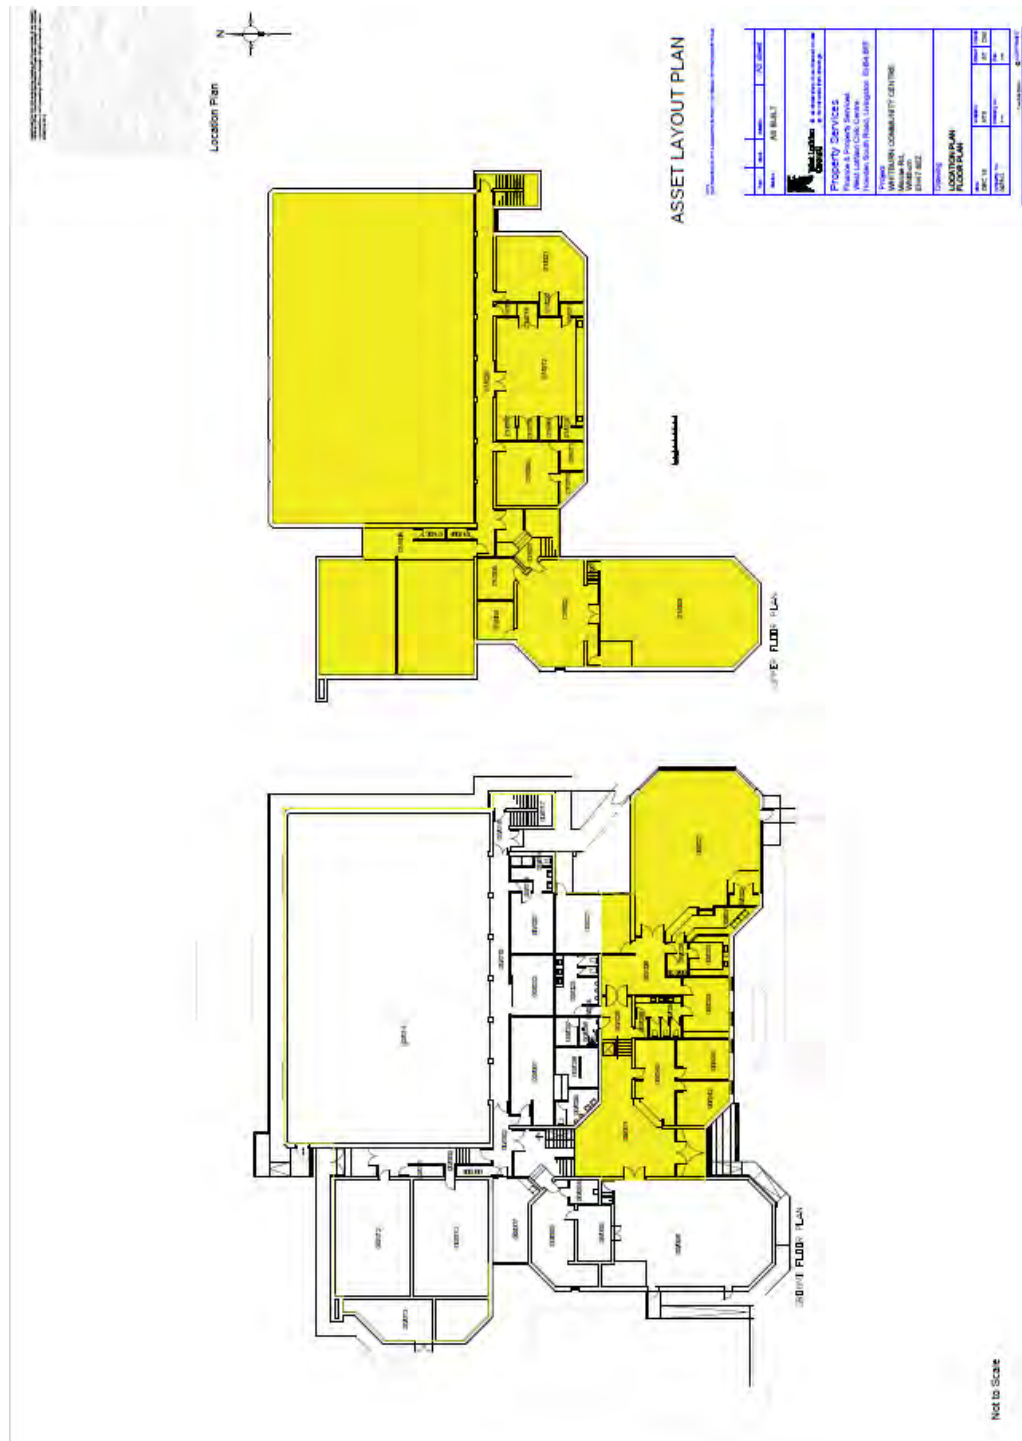
Whitburn Community Education Centre, Whitburn

RAAC roof planks area present in to all roof areas as shown in diagram below. Significant structural issues were identified in the roof planks over the Games Hall.

RAAC roof planks in other areas of the building were identified as not being at immediate risk of failure and will be inspected every 6 months by a qualified structural engineer.

Council Executive 20 April 2021 instructed offers to progress with the replacement of the roof the Games Hall and first floor meeting rooms. Works are programmed to commence summer / autumn 2021 and be completed March 2022. The costs associated with the works are £1.05 million.

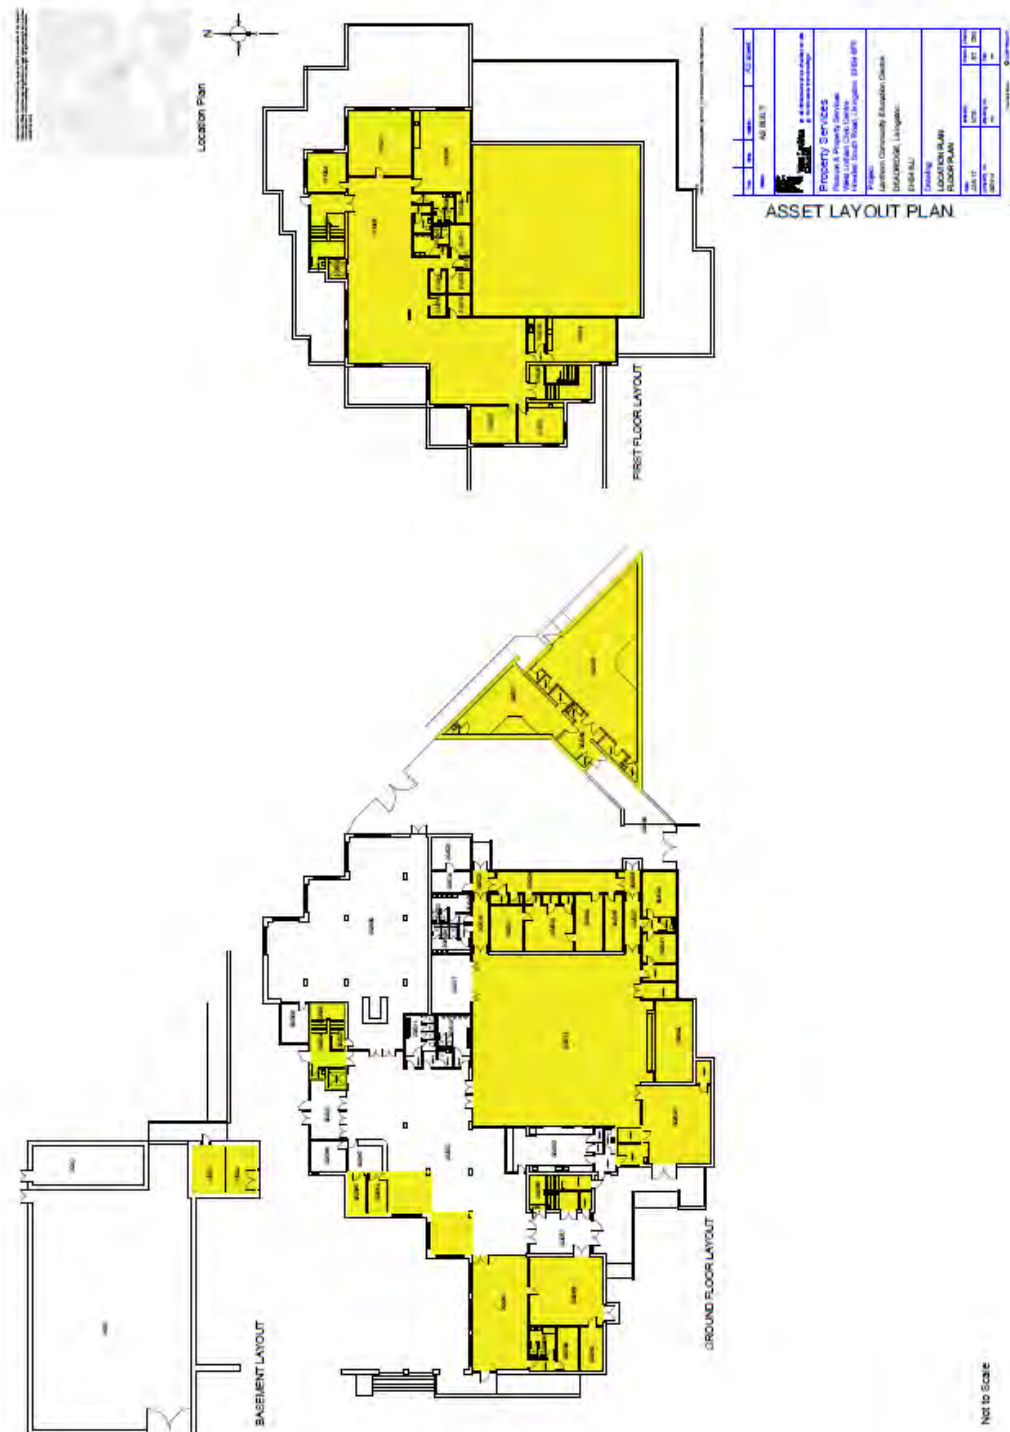
The Lanthorn Centre, Livingston

RAAC roof planks are present in all roof areas as shown in diagram below. Council Executive 23 March 2021 due to the structural issues associated with the RAAC roof area agreed to the closure of the property from 2 April 2021. It was noted that officers would progress with design development and investigations and report to finalise a programme of works and that these would be presented to Council Executive for consideration.

Council Executive report on agenda outlines the programme of works to replace the roof with commencement occurring in early 2022 and completion in summer 2023. The estimated cost of the works is £3.15million

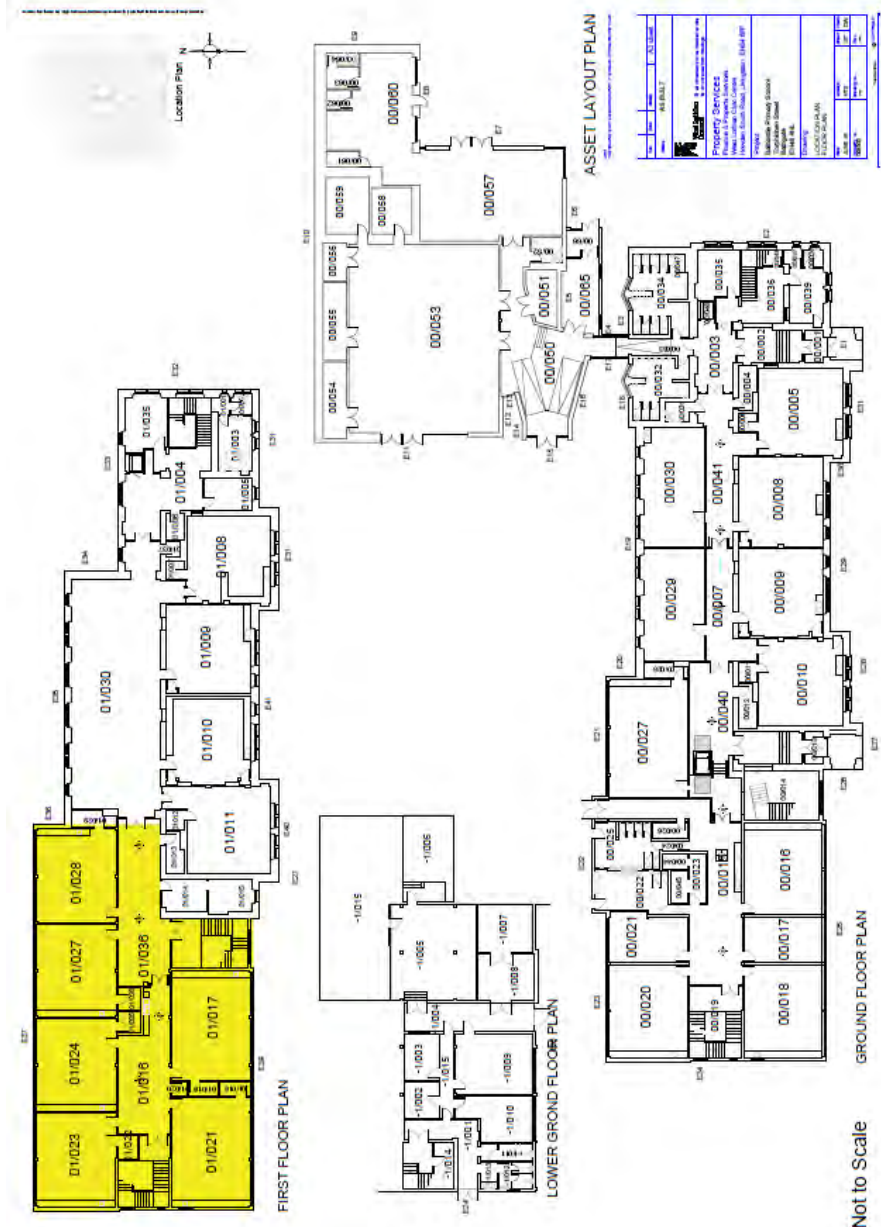
Balbardie Primary School, Bathgate

RAAC roof planks area present to the 1960s teaching block as shown in the diagram below.

Structural engineers have identified potential structural issues with the roof planks during an inspection in May 2021. They concluded that the roof planks are safe and that there was no requirement to restrict access at this time. However, they recommended that urgent remedial repairs be carried out during summer 2021 to reduce deterioration of the planks.

On completion of the remedial works, the RAAC planks should be inspected annually by a qualified structural engineer.

The remedial works will extend the life of the roof deck, however the RAAC planks will still be present. It is recommended that RAAC roof planks should be replaced within 5-10 years. Council Executive report on agenda outlines the programme of works to replace the roof.

Estimated cost of the initial stabilisation and replacement roof works is £1.6million

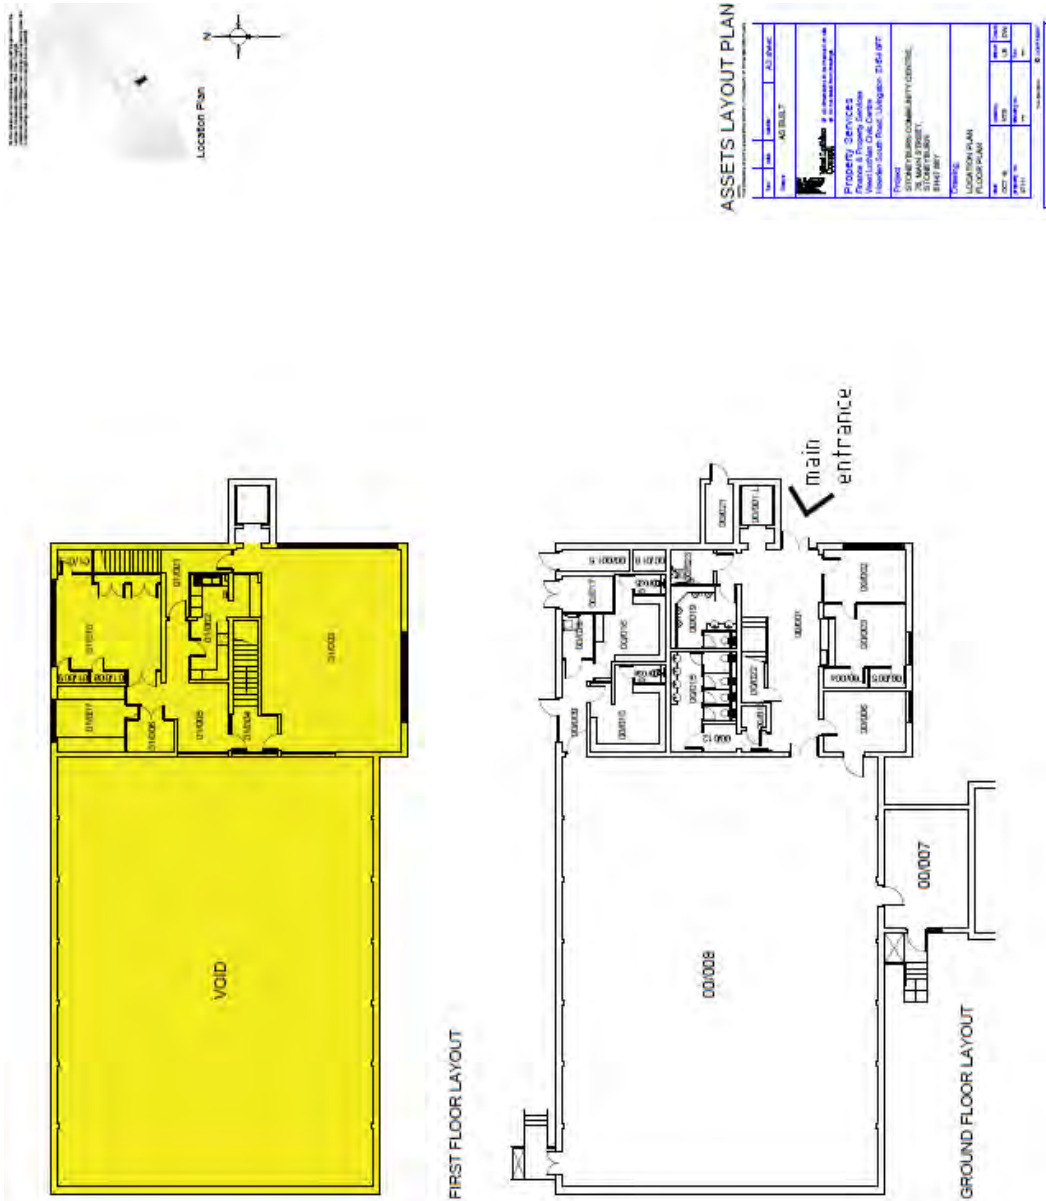
Stoneyburn Community Education Centre, Stoneyburn

RAAC roof planks area present in to all roof areas as shown in the diagram below. The roof planks were found to be in good condition generally when inspected in November 2020. There were signs of historical water ingress were noted throughout the building. As a result, a roof inspection has been carried out and any necessary roof repairs undertaken.

The RAAC planks will be inspected every six months by a qualified structural engineer.

Given the age of the RAAC roof planks and the potential for continuing difficulties with water ingress it is recommended that areas with RAAC roof planks should be replaced within 5 years.

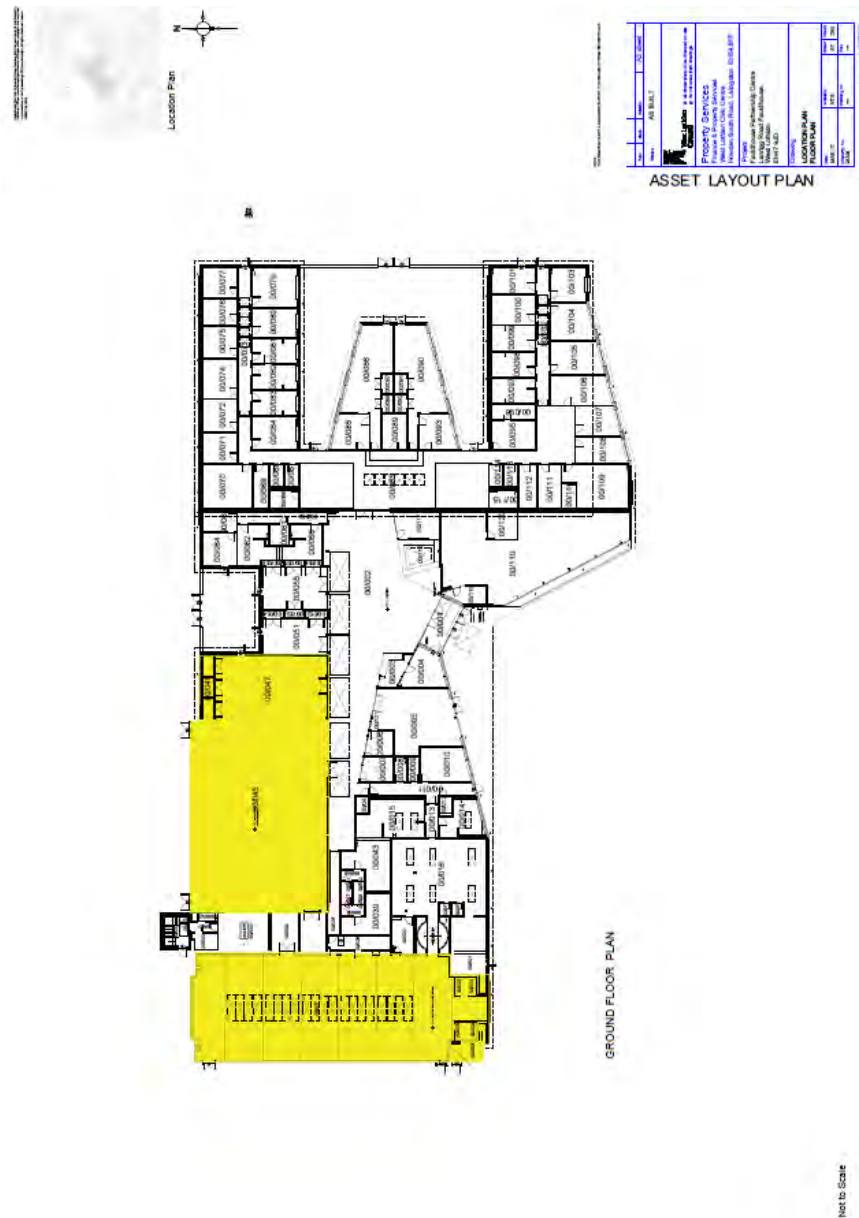
Fauldhouse Partnership Centre, Fauldhouse

RAAC roof planks area present to the Games Hall and the Swimming Pool Hall as shown in the diagram below. Access to the RAAC planks in the Swimming Pool Hall area is not possible due to the presence of a fixed ceiling above the swimming pool.

The roof planks in the Games Hall were found to be in good condition generally when inspected in December 2020. However, signs of water ingress were noted throughout the building. As a result, roof repairs have been carried out and ongoing monitoring and maintenance will take place.

The RAAC planks will be inspected every six months by a qualified structural engineer.

Given the age of the RAAC roof planks and the potential for continuing difficulties with water ingress it is recommended that areas with RAAC roof planks should be replaced within 5 years.

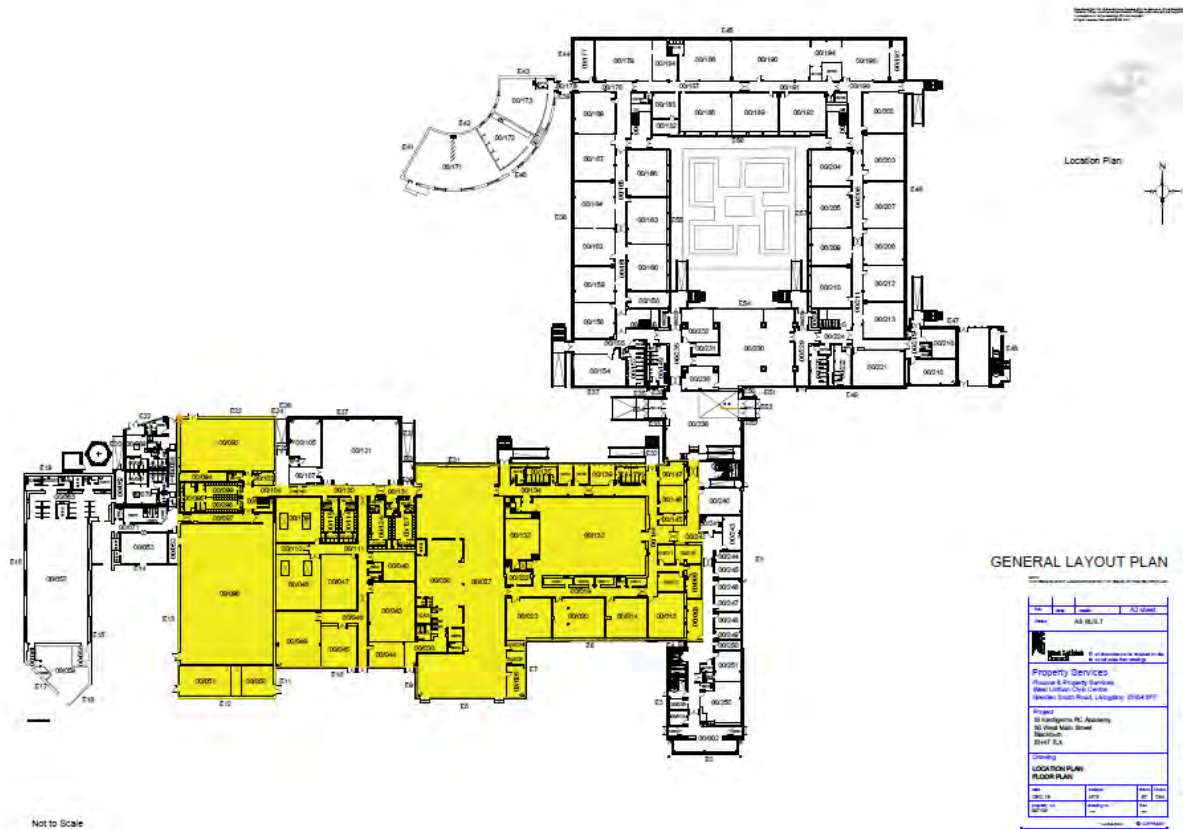
St Kentigerns Academy, Blackburn

RAAC roof planks are present in the original part of the school dating from 1973 as shown in the diagram below. The RAAC planks were found to be in good condition and reflect the age of the building. Remedial repairs were identified to the dining hall and plant room and these works were completed in October 2020.

The RAAC planks will be inspected every six months by a qualified structural engineer.

Given the age of the RAAC roof planks and the continuing difficulties with water ingress it is recommended that areas with RAAC roof planks should be replaced within 5 years.
