Case No: 2020-0344 Date of visit: 28/08/2020

Site No: FS1176 Site Name: Eilean Grianain
Business No: FB0119 Business Name: Mowi Scotland Ltd

Case No: **2020-0344** Site No: **FS1176**  
 Date of Visit: **28/08/2020** Inspector(s): **[REDACTED]**

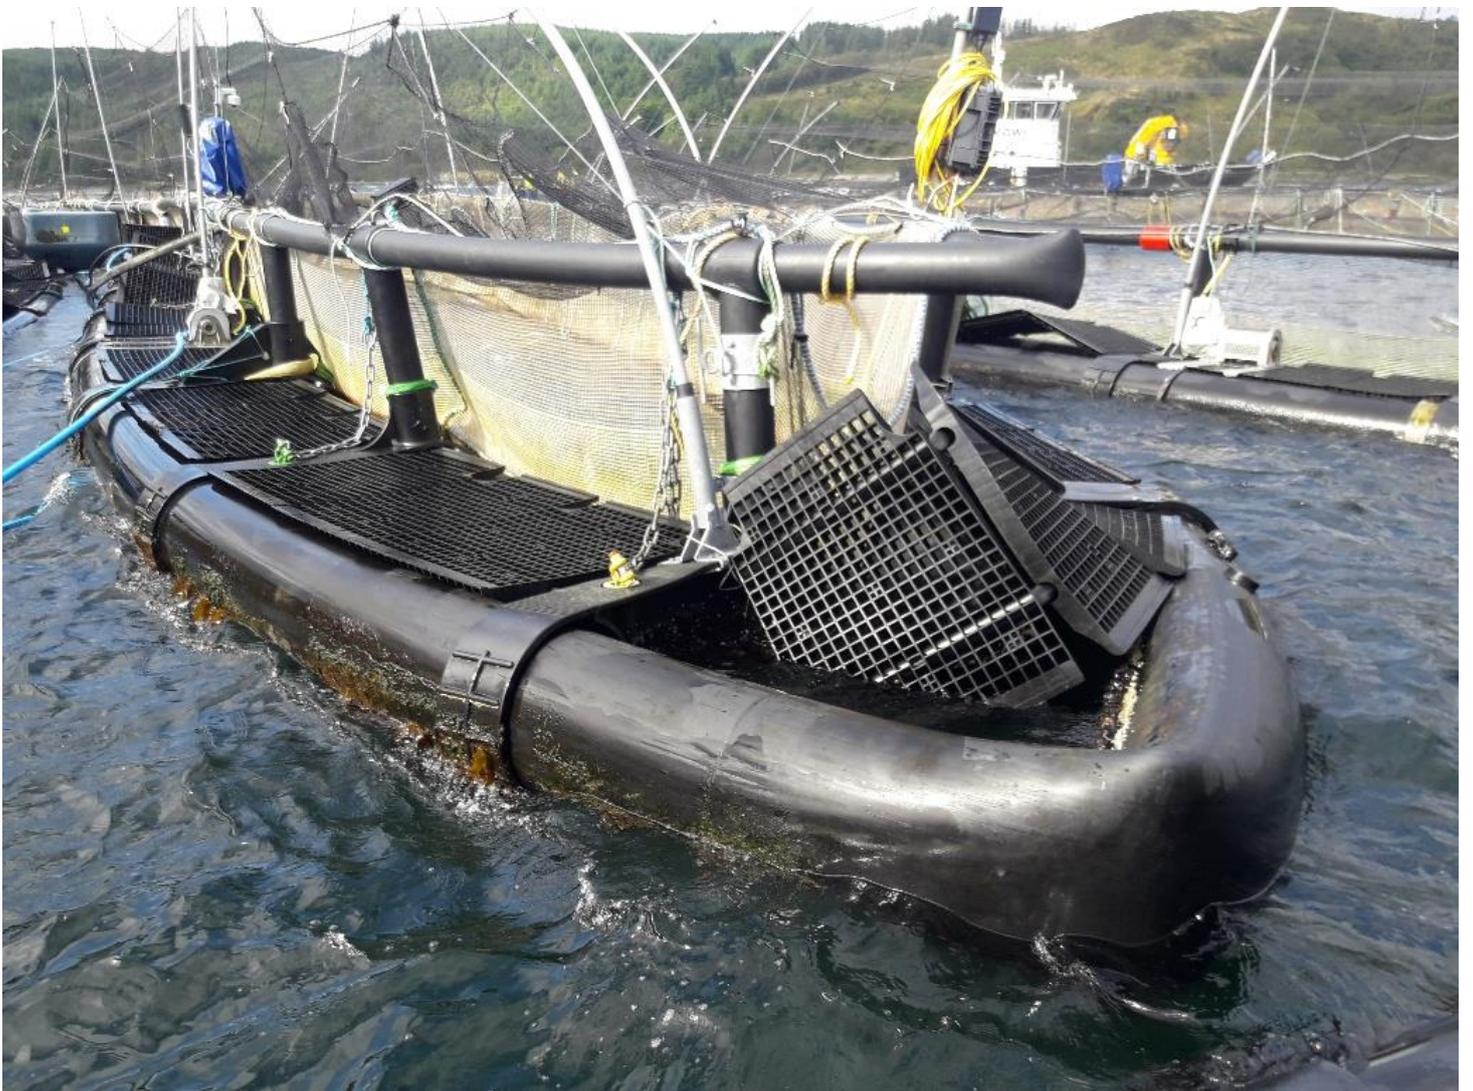
What caused holes is unknown on pen 1. Pens 4 had a buoy wash into it causing a hole. The deformation of pen 1 probably meant that the net had undue stress in places that it wasn't supposed to causing a hole to rip. However this is unconfirmed. Broken mooring ropes has been sent to Aberdeen for assessment. Multiple mooring lines snapped. Once one went that put more stress on other ropes causing a chain reaction, this is also unconfirmed. Unknown at present how many ropes snapped.

Figure 1: Cage 1 the day following the incident (21/08/2020)

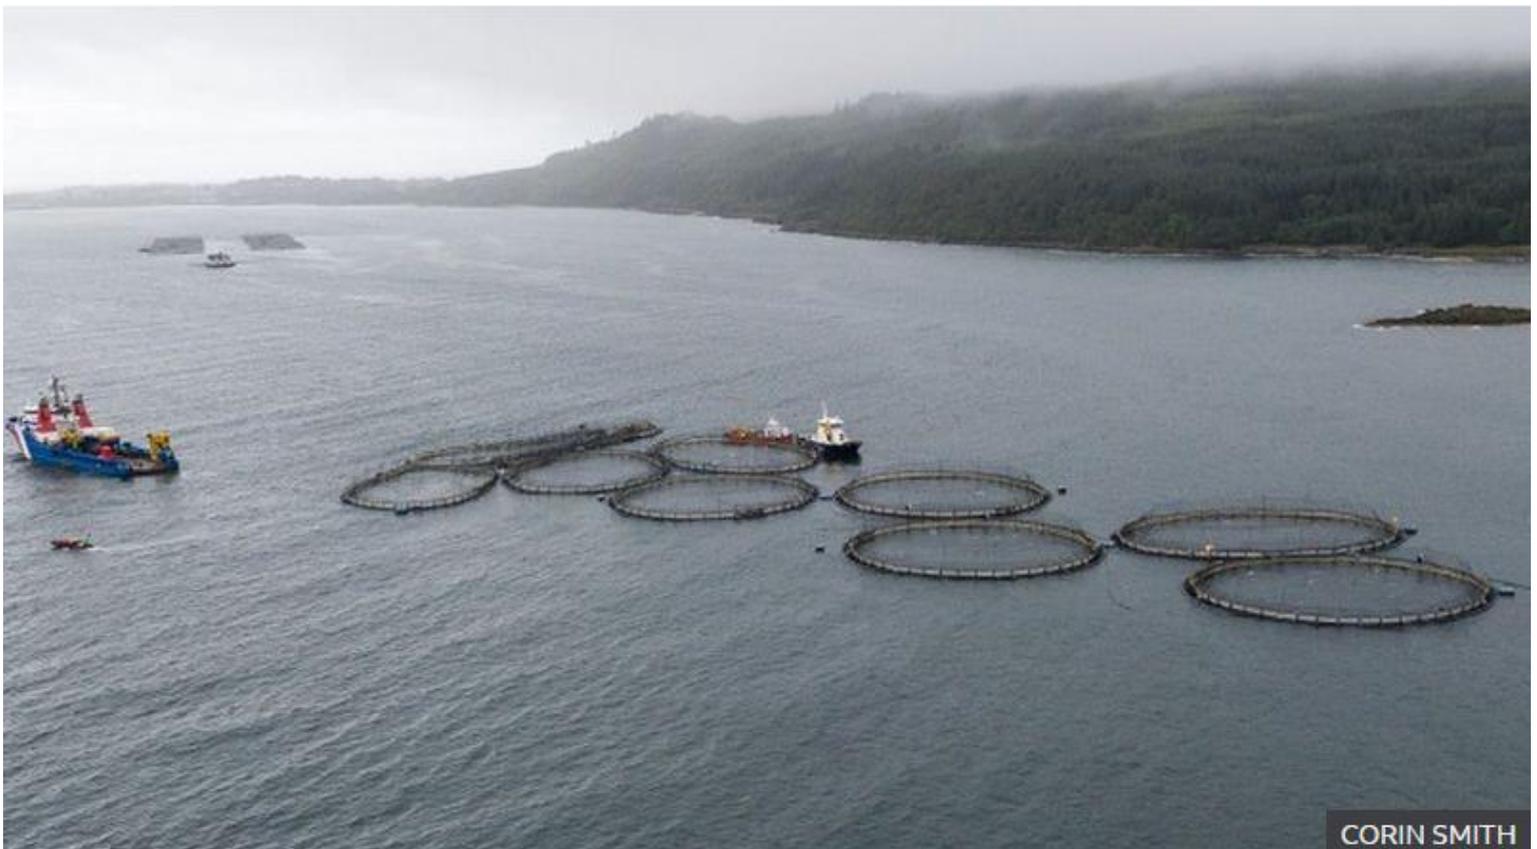
Cages moved approx. 200-300m.

Figure 2: Drone photo of the cages following the incident (from BBC website)

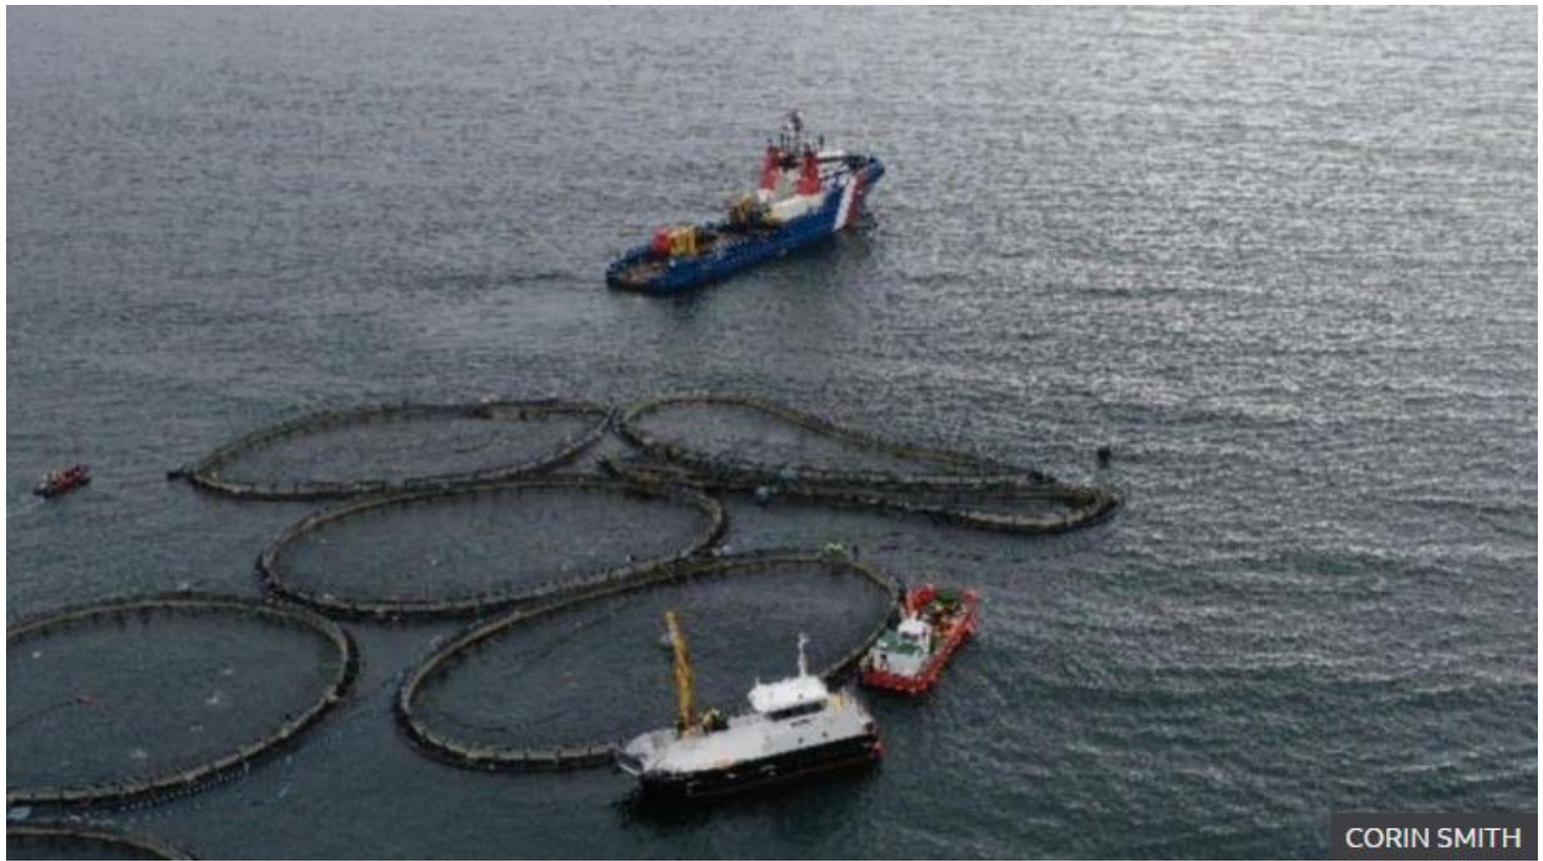
Figure 3: Drone photo of cages following the incident (from BBC website)

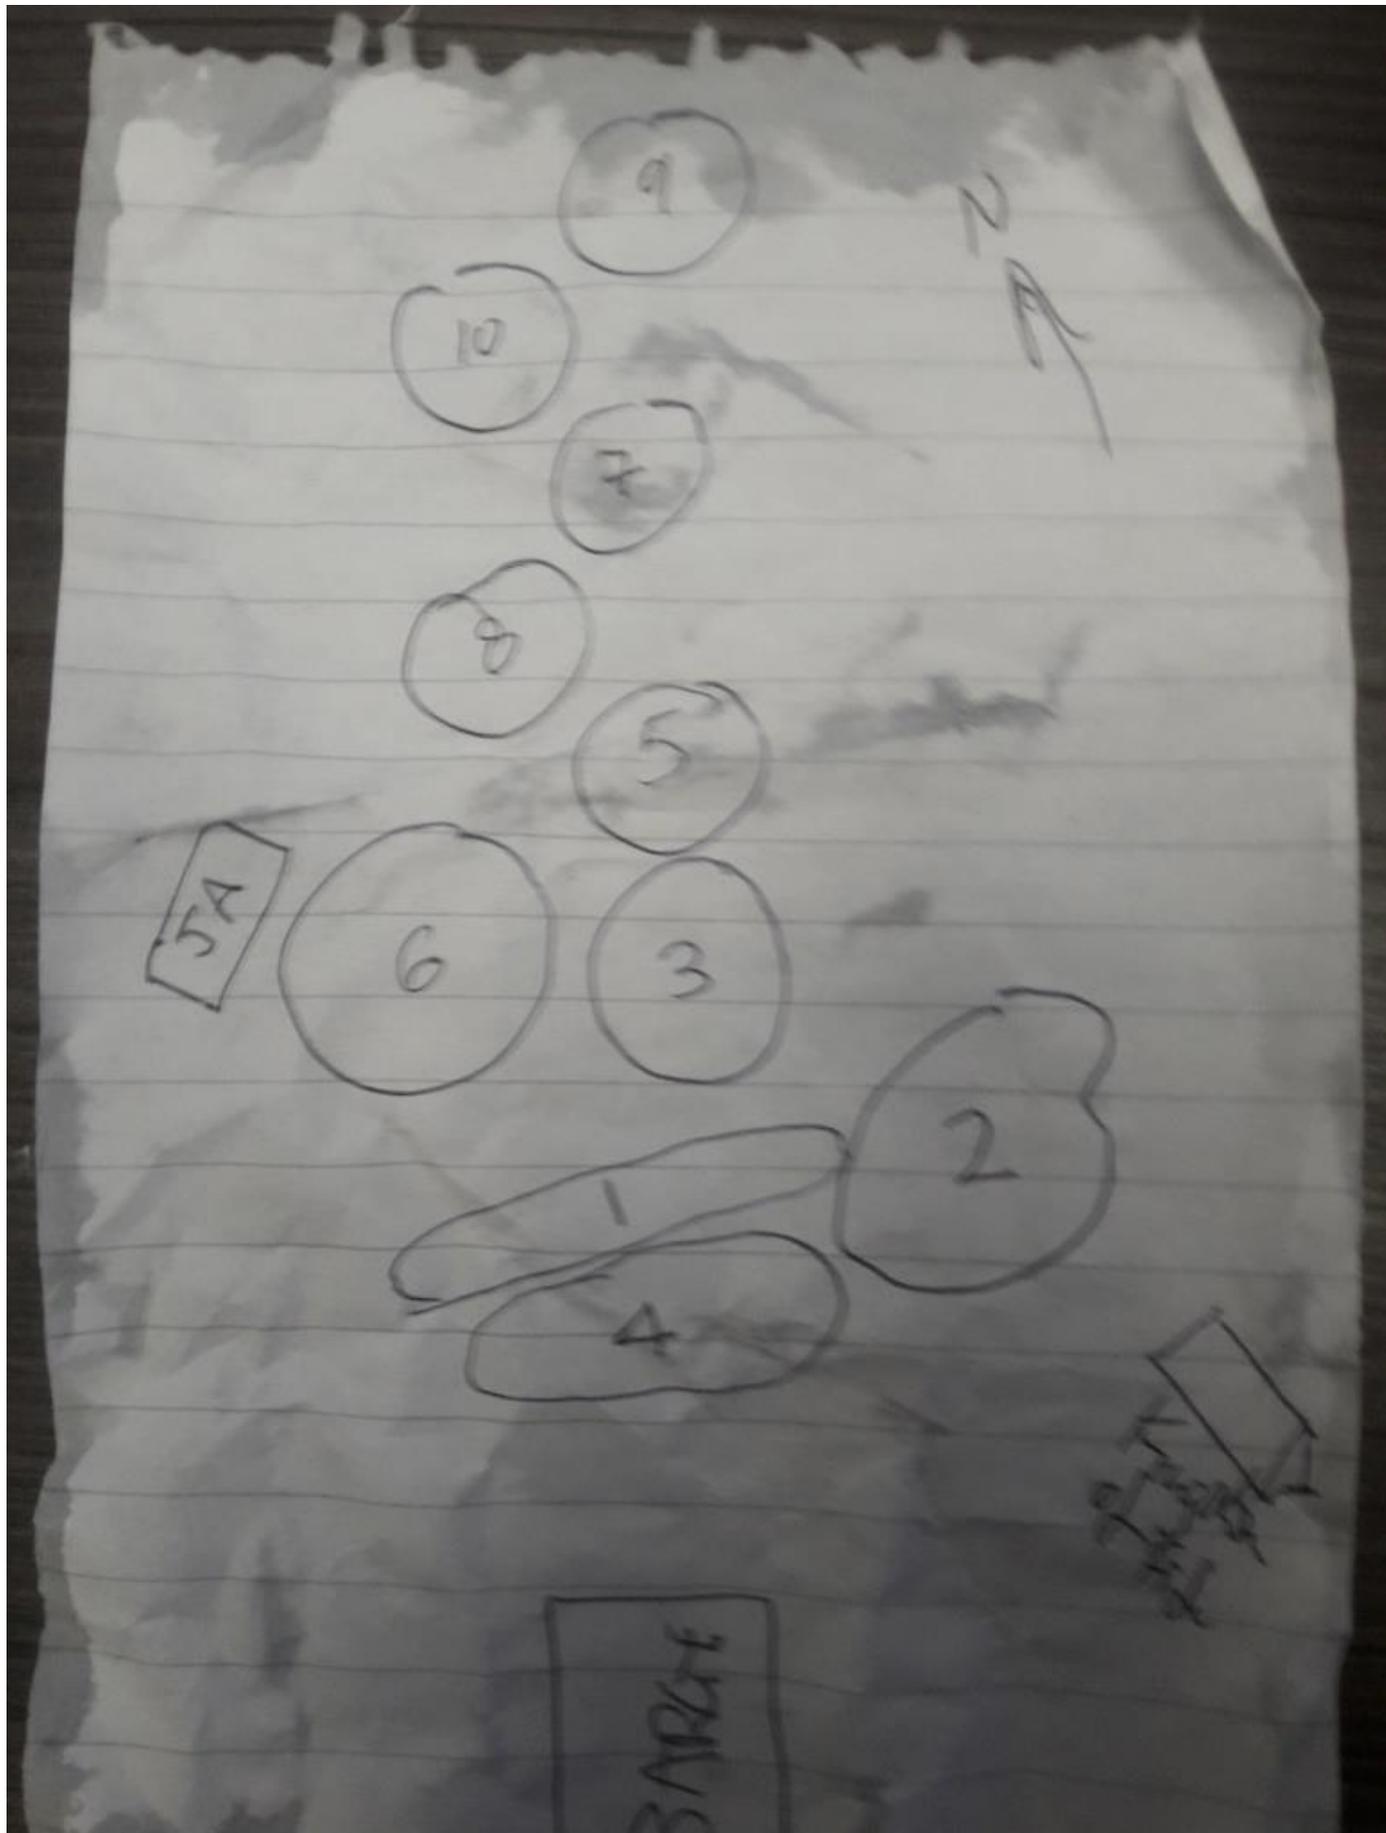
Last Thursday 10:00-10:30 call from site letting senior management know that the whole group of cages in the northern half of the site were moving north. Thursday the group was secured by a well boat and tug boat. 6 pens were intact, 4 were damaged (in the northern half of the site). Divers were in on Friday together with an ROV. Holes in pen 1 (which was written off) and 4 were detected. Four pens were harvested and morted (figures below)

Figure 4: Diagram drawn by a member of site staff depicting how the cages lay following the incident

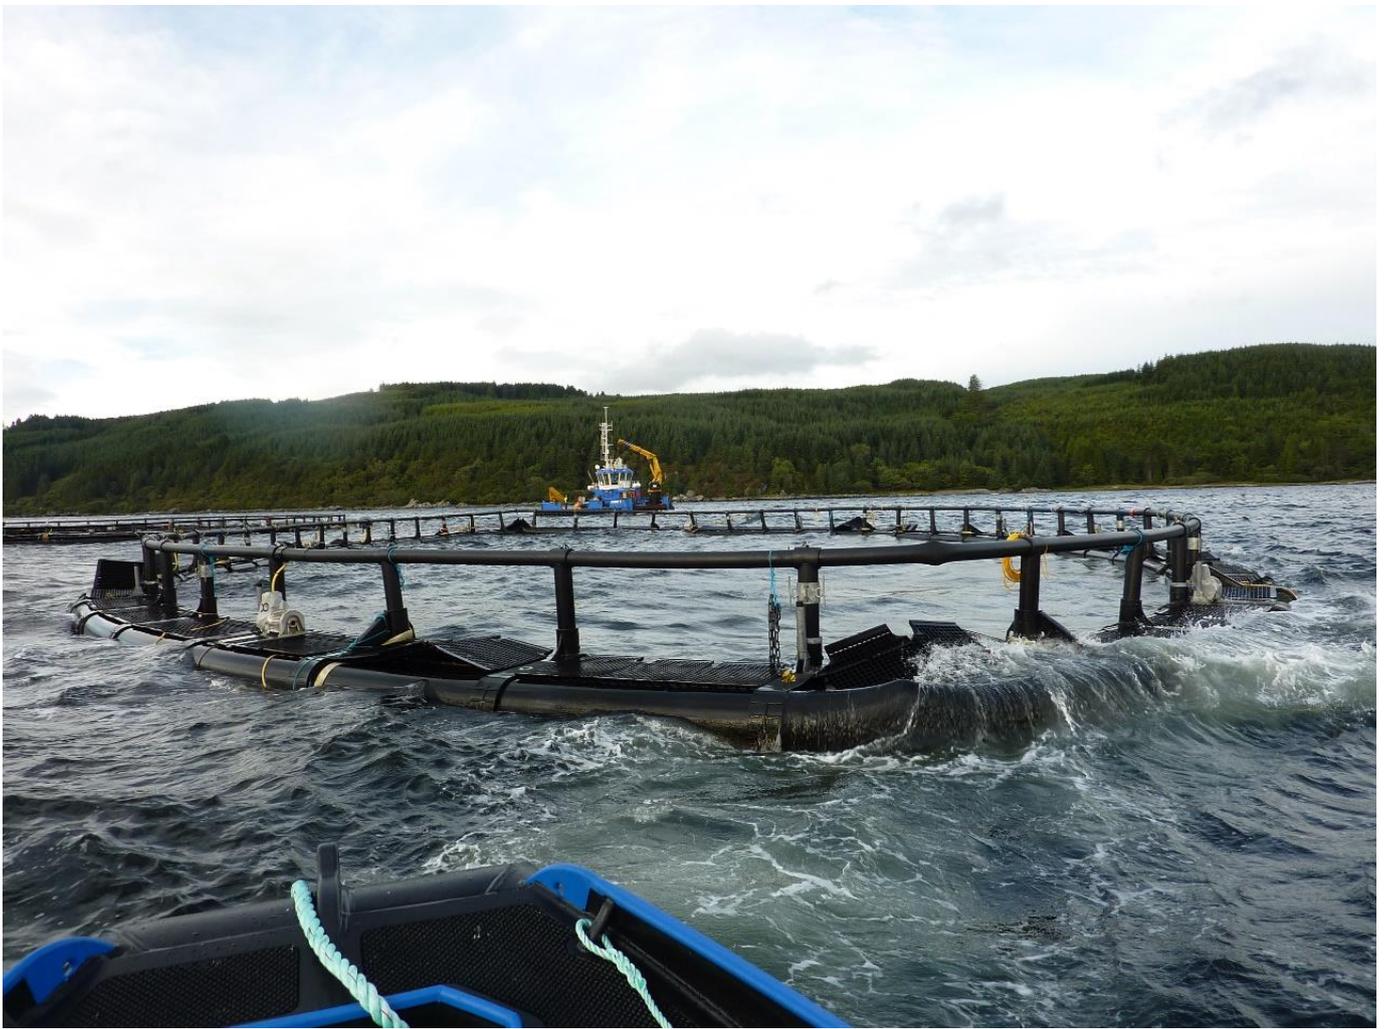
Four damaged cages to move off the site the day of the physical inspection. These will go to Kishorn for repair. Since the aerial footage the cages have 'sprung back' into a circular or near circular shape. Nets sent to Knox base in Kilbernie for washing and repair. If the nets are not repairable they will be disposed of by Knox.

Figure 5: Cage 1 on the day of the physical inspection

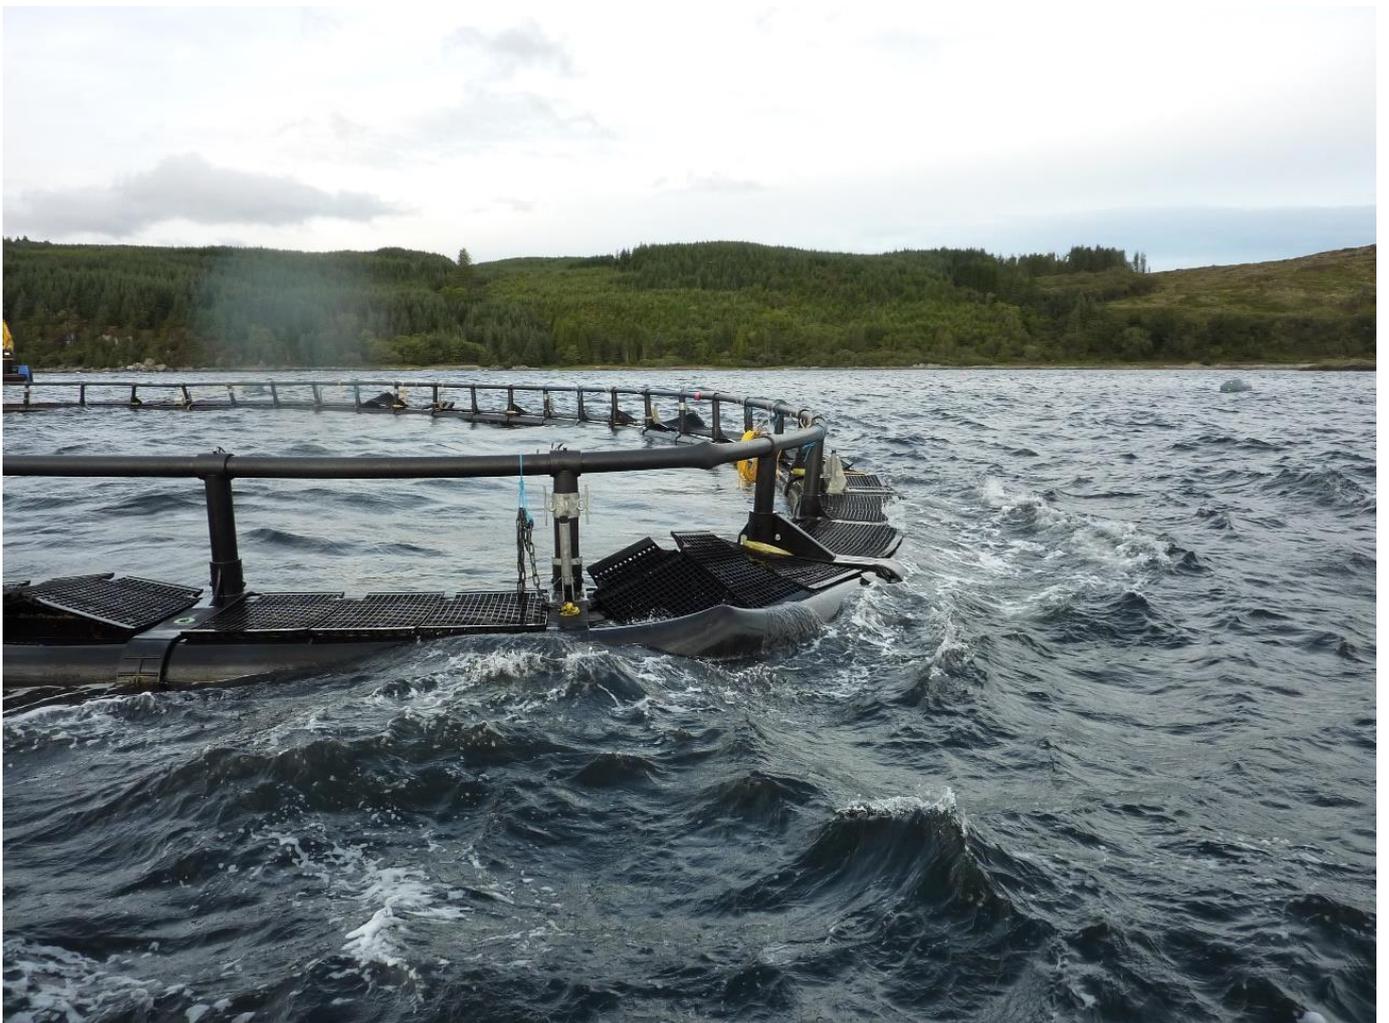
Figure 6: Cage 1 on the day of the physical inspection
