FISH HEALTH INSPECTORATE VISIT REPORT

BUSINESS NO FIB0014
SITE NO FIS0019
CASE NO 20230259

DATE OF VISIT 14/06/2023 SITE NAME Delgatie Ca

In addition, the fishery detailed above was visited following reports of rainbow trout, *Oncorhynchus mykiss* and brook trout, *Salvelinus fontinalis* being caught in the River Deveron.

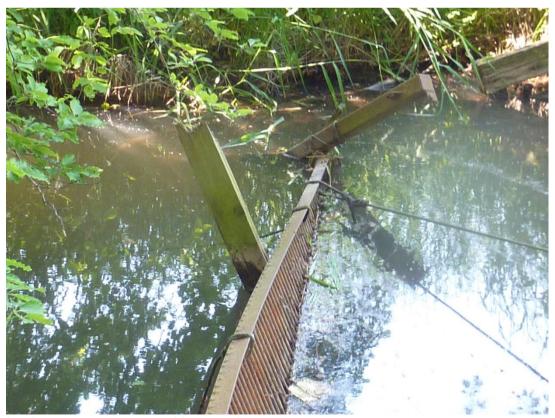
Intake water grate – awaiting repair
