Schedule of Significant Features Report

Bute House, 6 Charlotte Square, Edinburgh, EH2 4DR

The National Trust for Scotland

August 2017

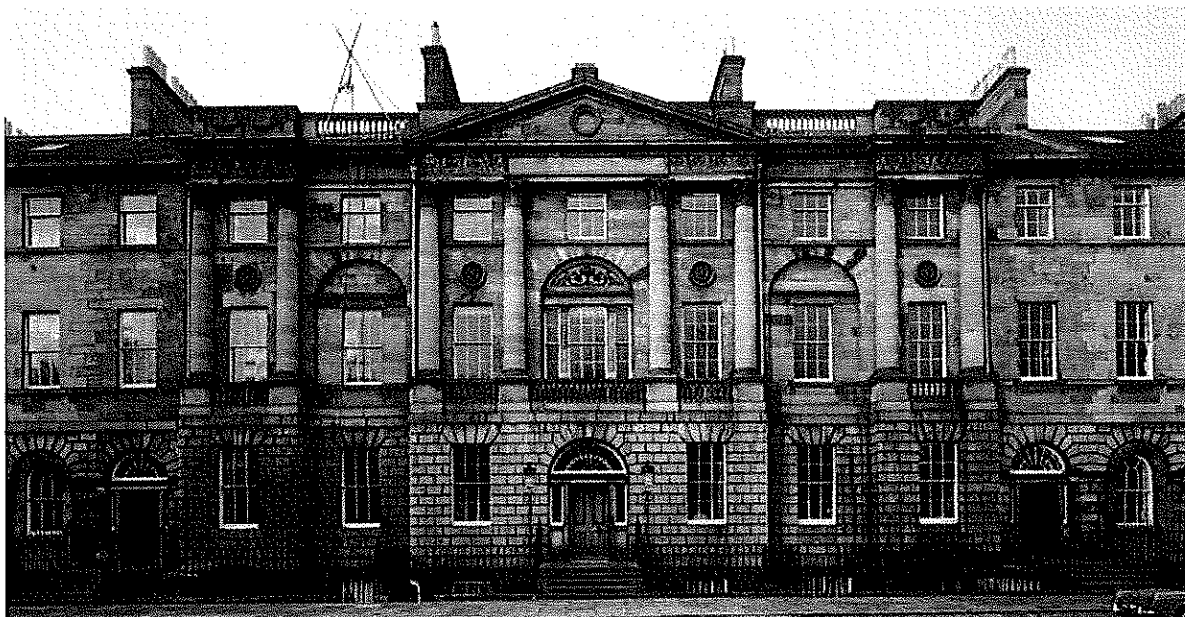
The principal south facing façade of the north side of Charlotte Square, 1967. External survey, monitoring and maintenance should continue to preserve the highly significant exterior of the property. (HES)

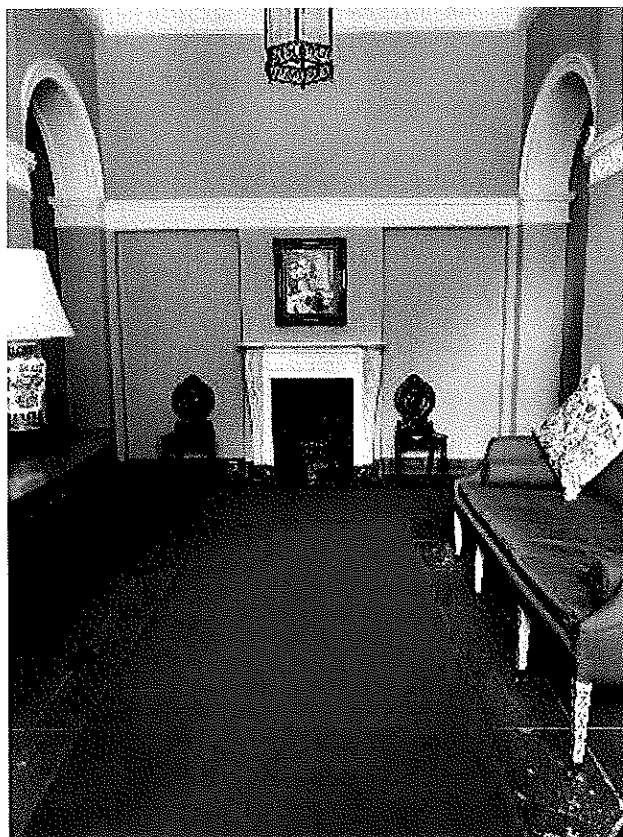
The Entrance Hall, although altered in the 1920s, retains much significance and should be preserved.

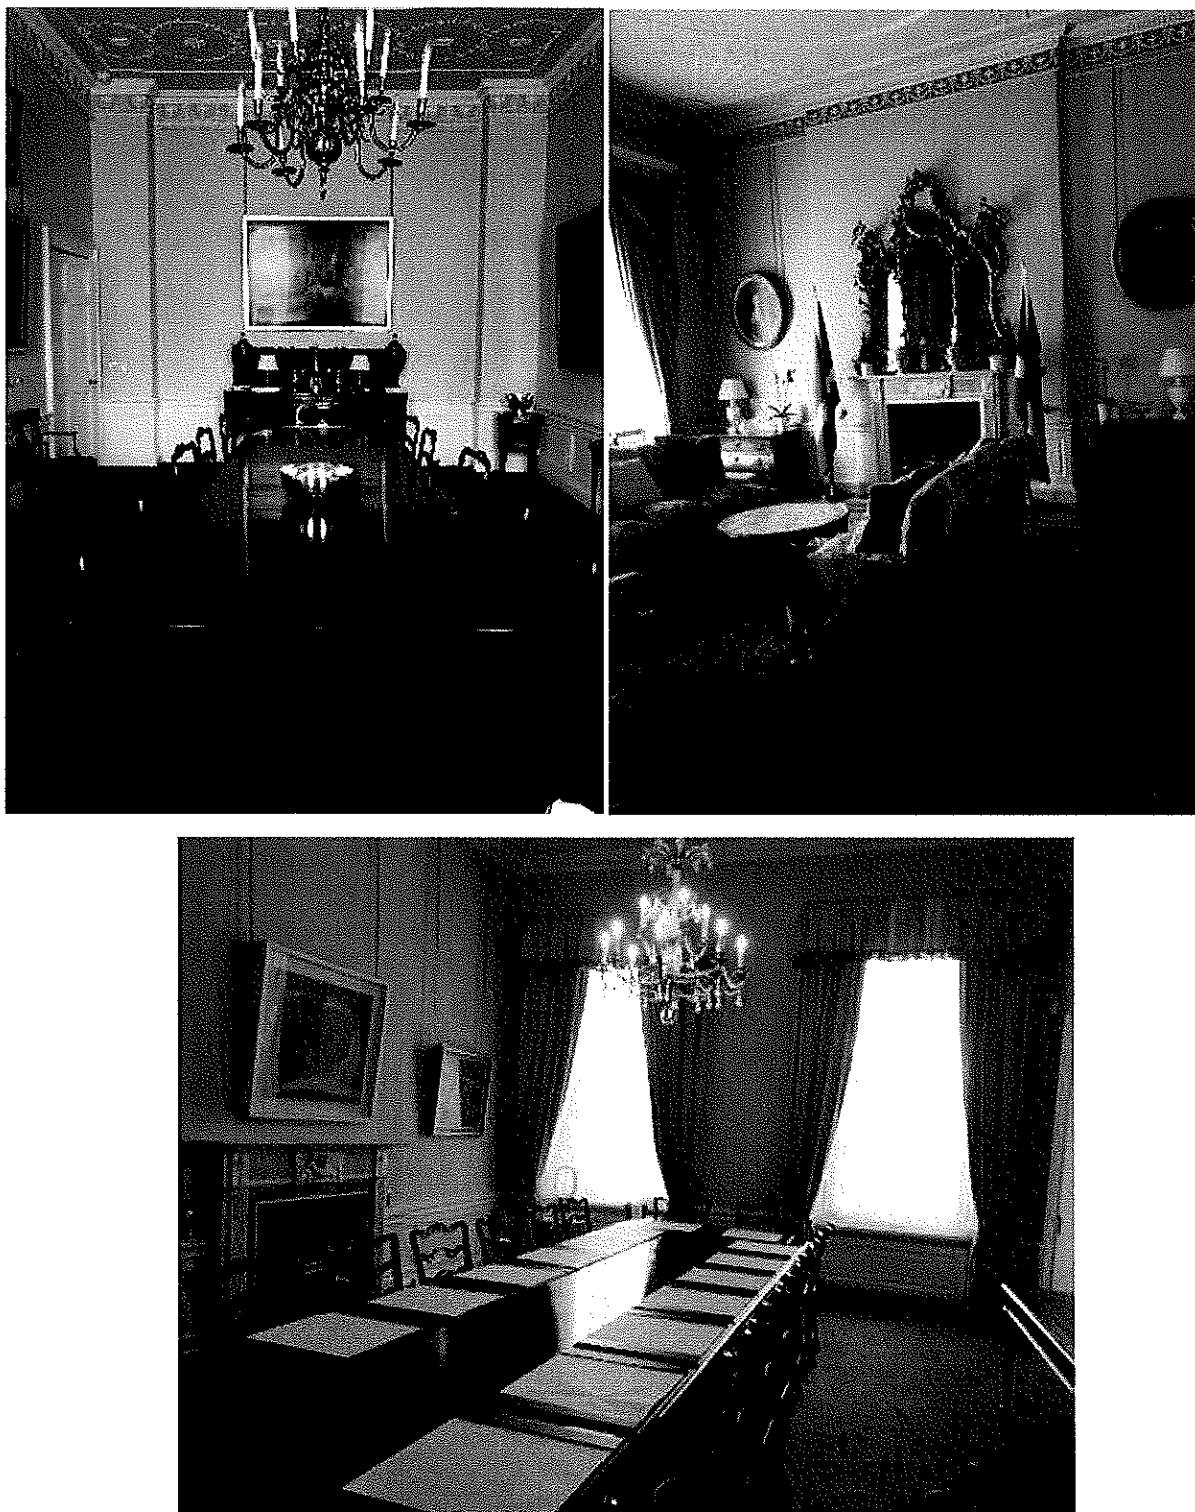
Any future refurbishment works programmed within the house should be planned to avoid risk of key features such as decorative plasterwork, chimney pieces and joinery fixtures and finishes with the principal rooms of the ground and first floors. Where possible, historic paint analysis will help inform future decorative schemes.

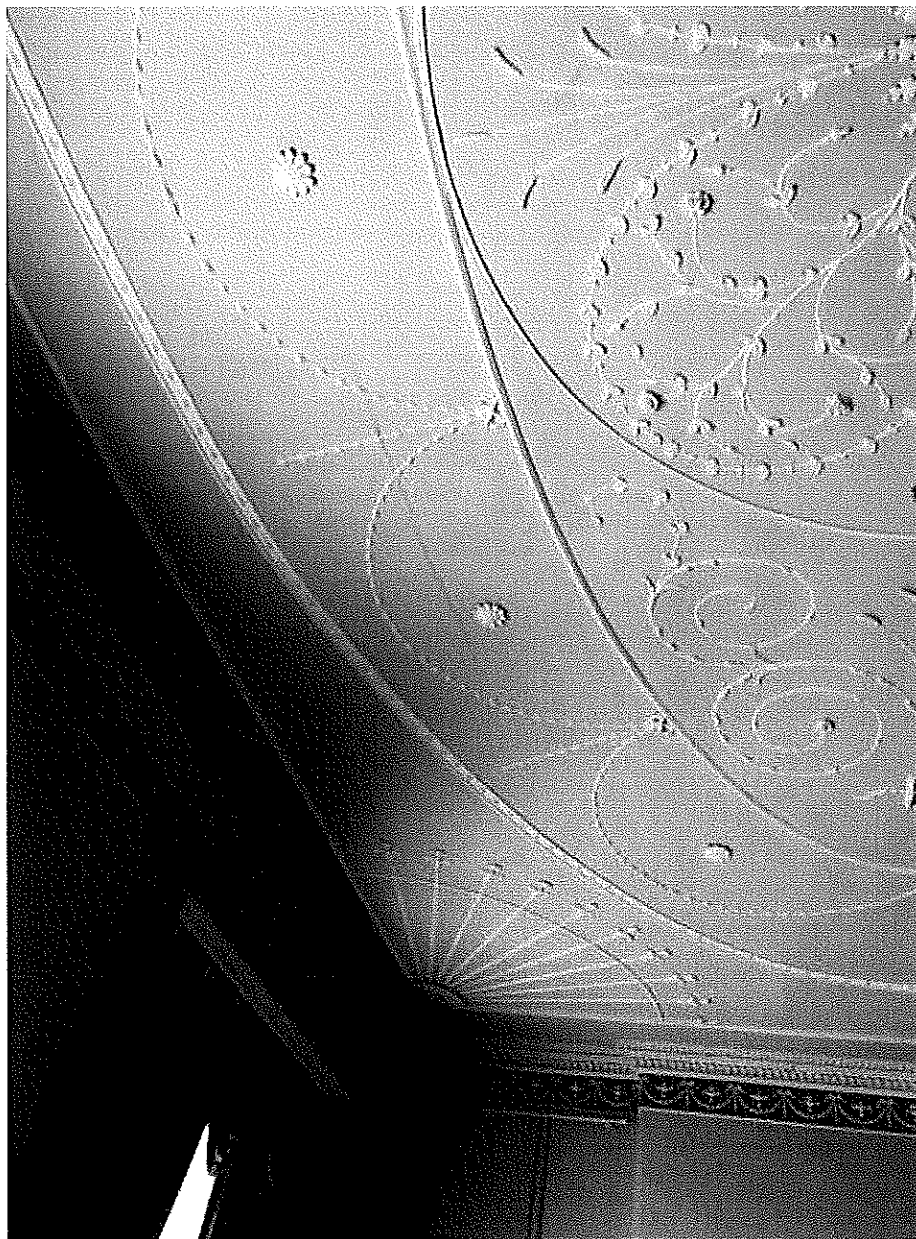
The cause of cracking in the ceiling of the Drawing Room should be investigated and made good prior to decoration. Similarly, investigations to determine the causes of movement and deflection in floors at first and second floor levels should proceed timeously.

[REDACTED] Similarly, investigations should take place to assess the impact of floor deflections and movement at first and second floor levels.

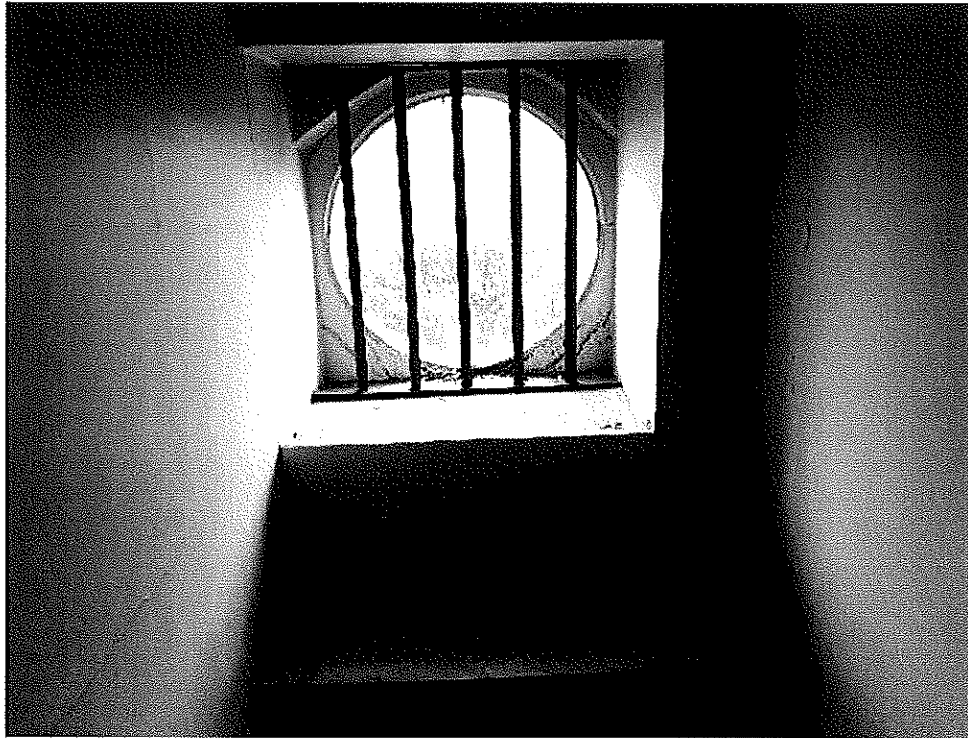
A temporary repair to arrest rot to the window in the attic coomb cupboard should be planned ahead of longer lasting repairs when access is available.
