PROJECT :
CLYDEPORT PROPERTIES Limited
HUNTERSTON QUAY

TITLE :
SITE LAYOUT

Hunterston Quay Remedial Works Eelgrass and Horse Mussel Intertidal Survey

Hunterston Quay Remedial Works Eelgrass and Blue Mussel Intertidal Survey

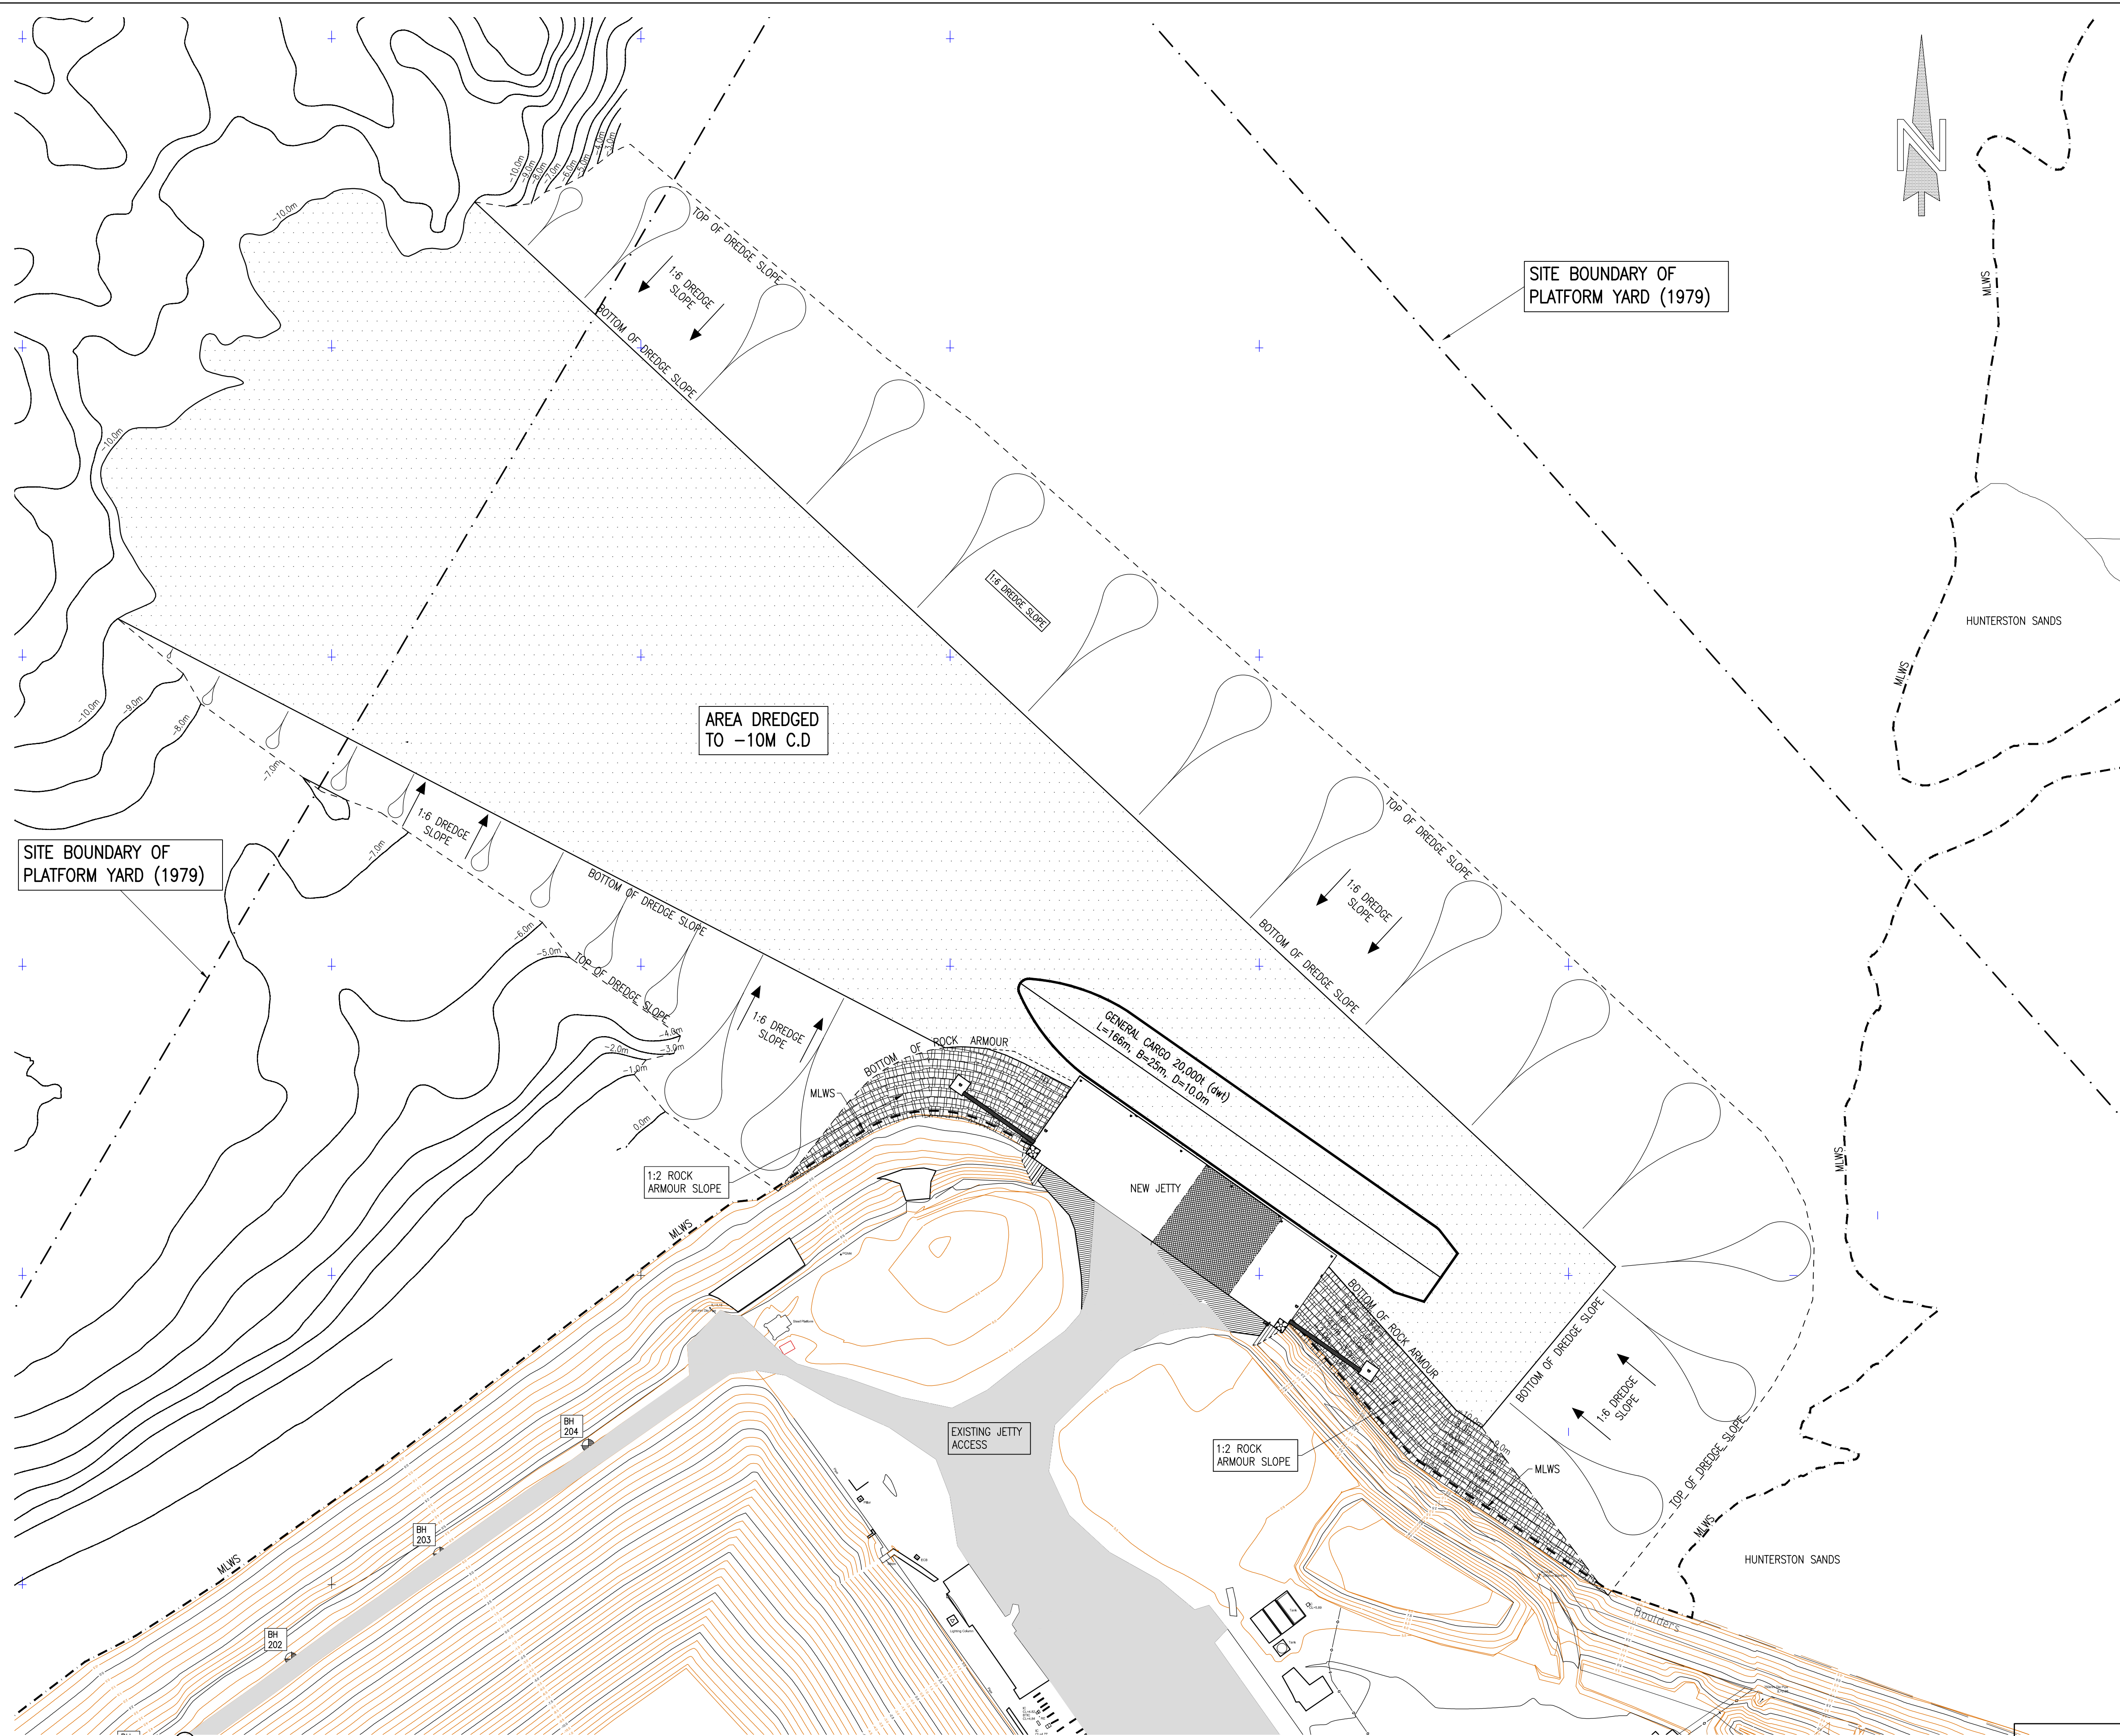
DRAWING No : 105069/002	REV : A
----------------------------	------------

NOTES
1 FOR DETAILS OF NEW JETTY, REFER TO Drg. No. 105069/003.

Drawing No 105069/002 Rev A, Appendix A shows the site layout.

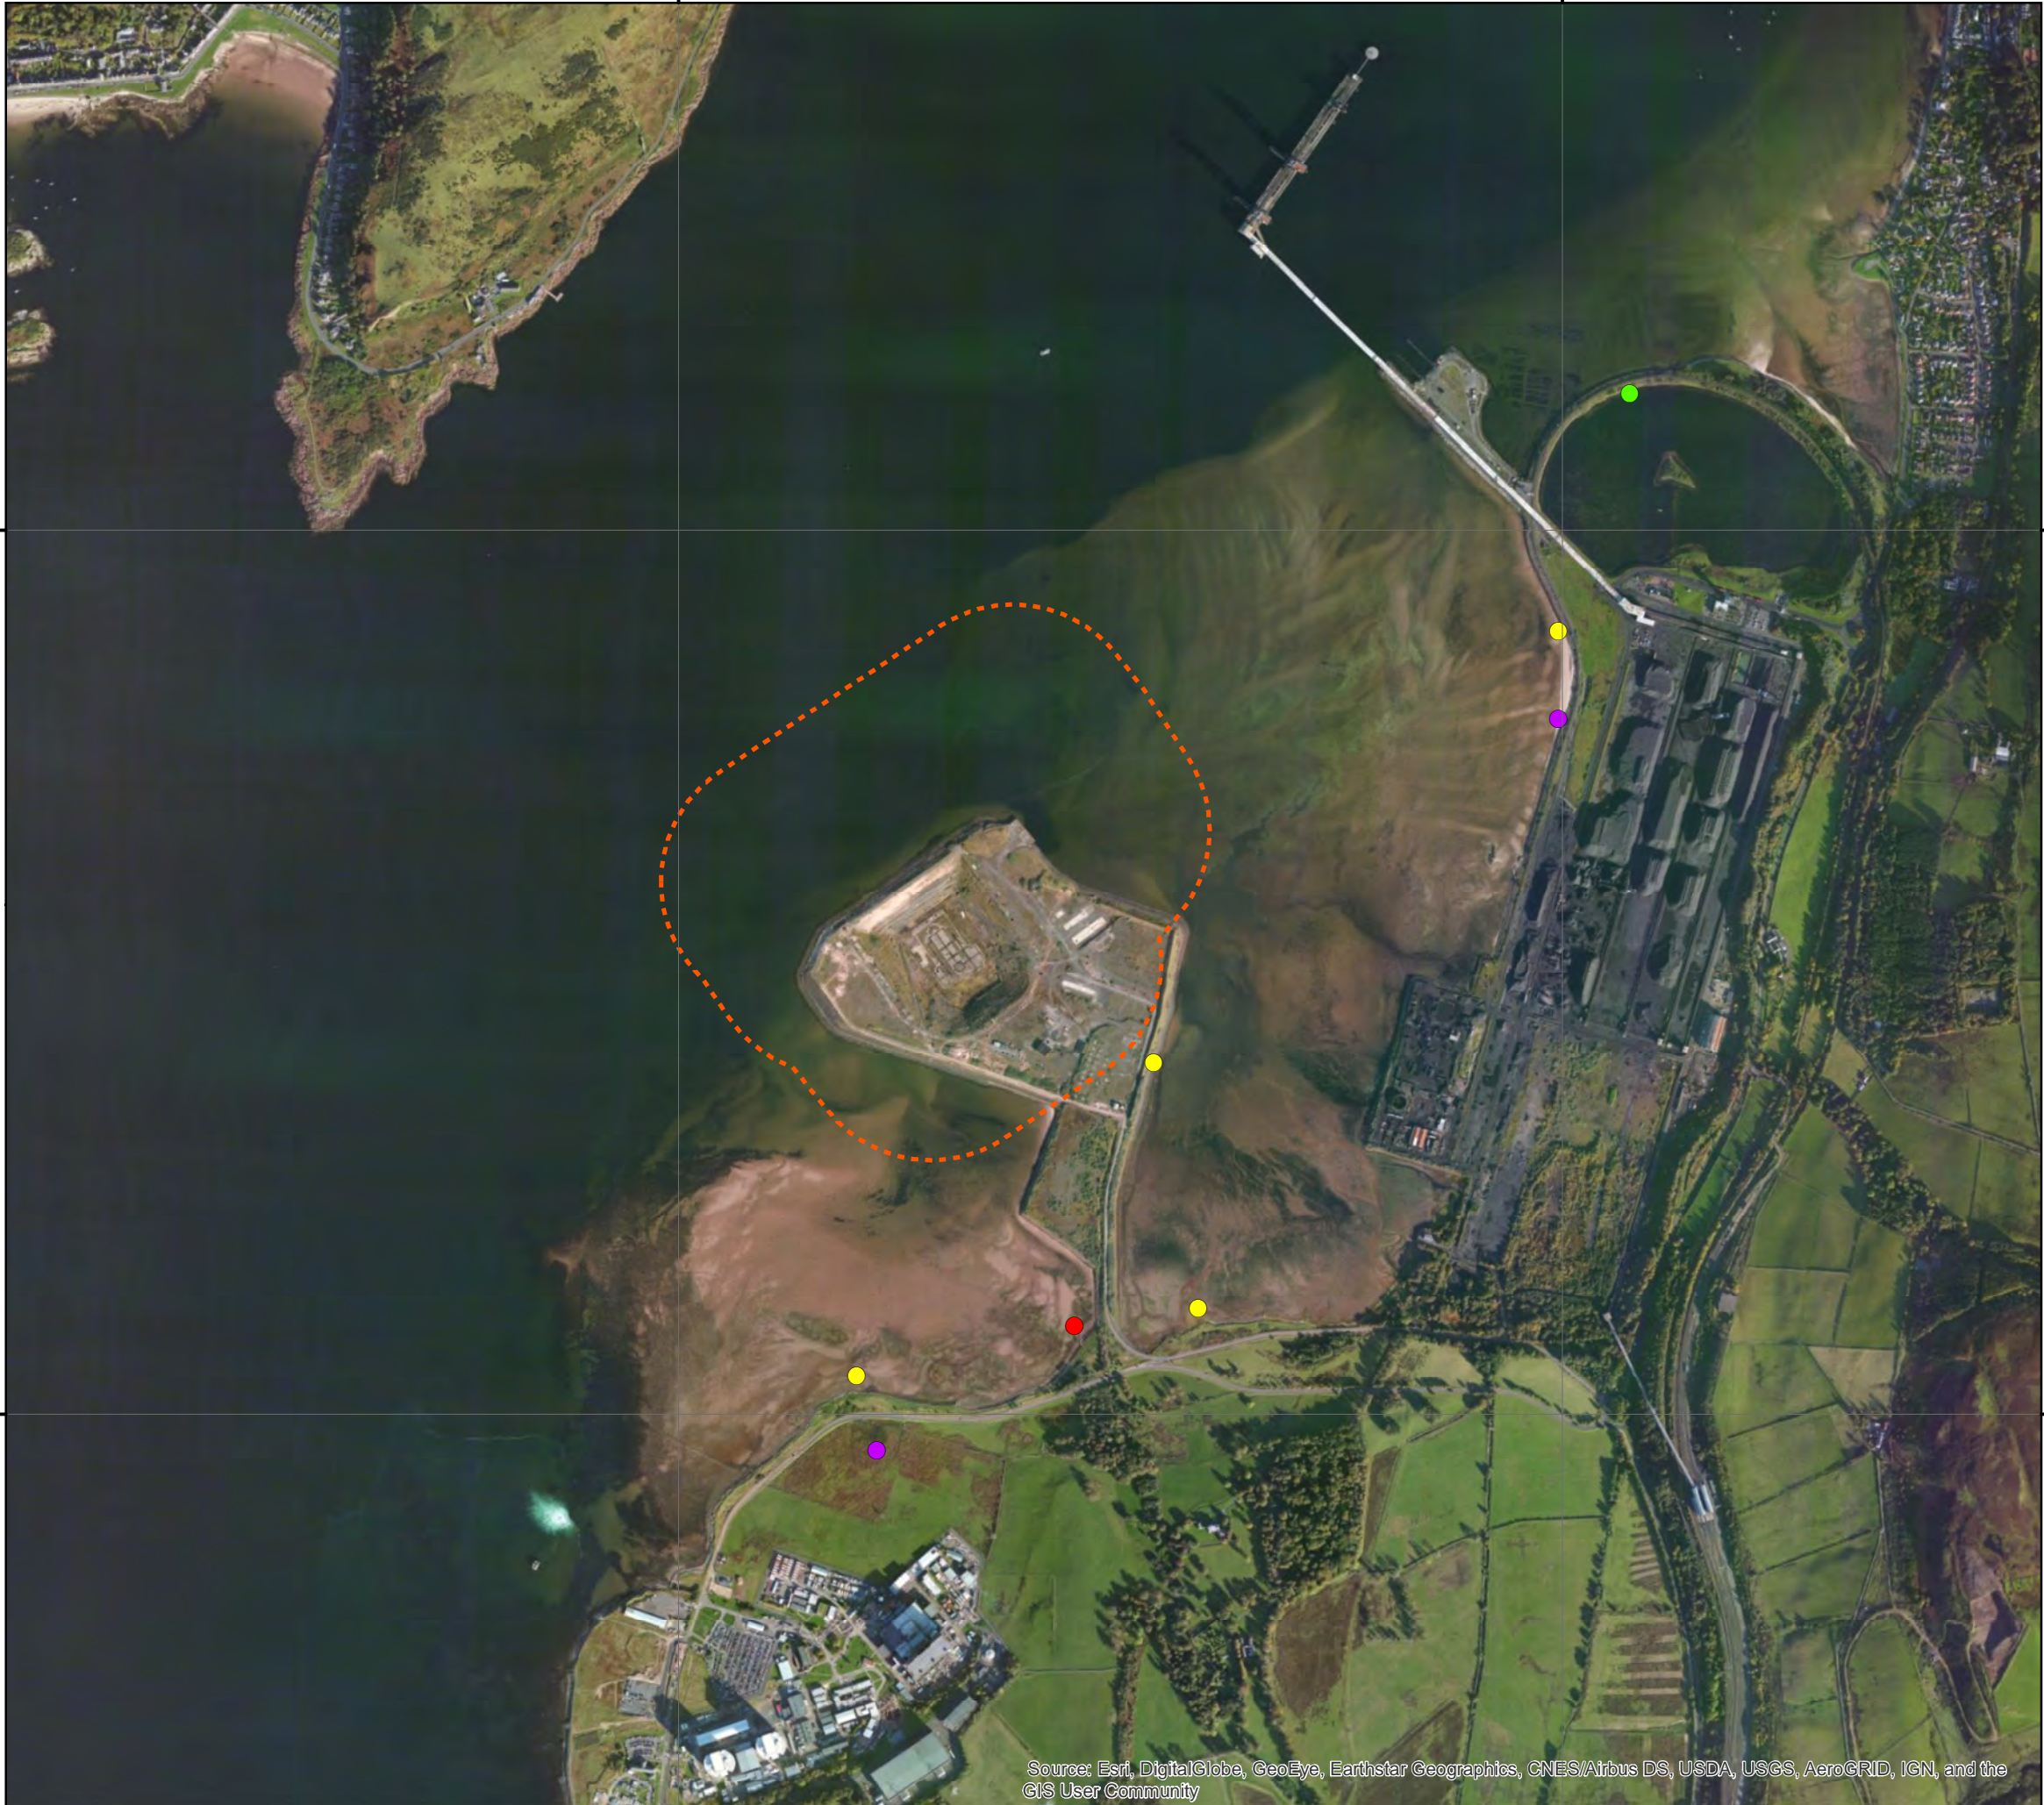
Title
High Tide Wader Roost Sites

Construction Area 300m Buffer Zone
- High Tide Wader Roost Sites
 -

Curlew Roost Site
 -

Oystercatcher Roost Site
 -

Redshank Roost Site
 -

Wader Roost (Several Species)

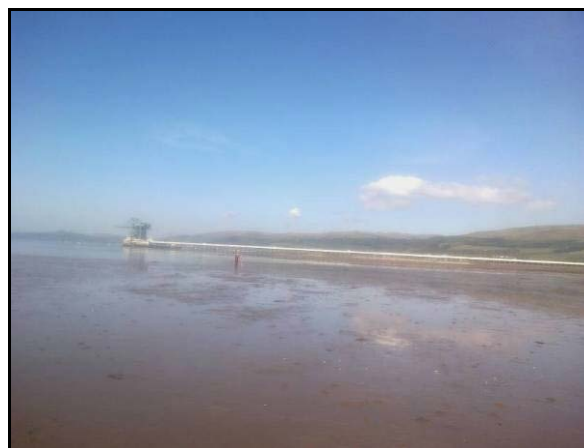
Photo 1: Optimal survey conditions

The survey was completed on 3rd May 2012 during optimal survey conditions, low tide (0.4m), flat sea, excellent visibility (Photo 1).

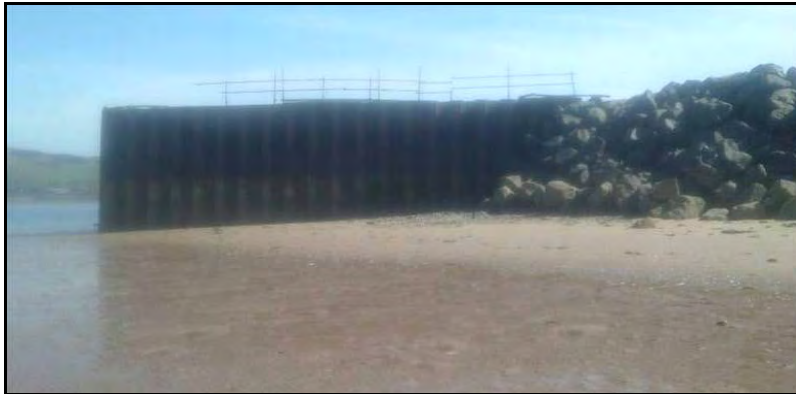
Photo 2: Foreshore where extended rock armour and dredging will occur.

The survey area is characterised by fine sand and sandy mud substrates with occasional cobbles and pebbles close to the strandline and bordering the rock armour that forms the landward survey boundary (Photos 2 and 3).

1. Consideration should be given to the use of a suction hoe dredger as this will reduce the quantity of sediments in the water column.
2. Activities where there is a higher risk of sediment being released in larger quantities could be undertaken when the tide is receding thus sediments would not be washed onto the shoreline.

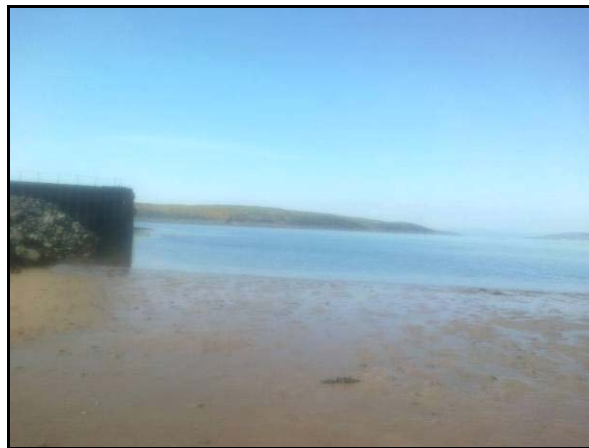
Photo 3: Area in front of existing quay to be dredged.

There is an area of subtidal habitat located immediately in front of the existing quay that has previously been dredged. This area was too deep to safely wade and the sea bed could not be viewed with the glass-bottomed bucket. The grapnel was thrown out into the dredge area to check for the target species. However, it was not possible to reach all areas of the dredge footprint due to the depth of the channel. This restriction was not considered to significantly affect the survey results for the following reasons:
