### 7.0 Buildability Constraints – Junction 12 to 15

# 7.0 Buildability Constraints – Junction 12 to 15 (Contd) Scotland Tran Serv

#### 8.0 Possible Solutions

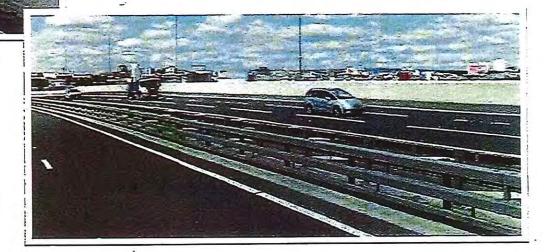
Two main types of barrier on the market, concrete or steel.

- Jct 12 15 Requirements WW1,
   VI1, H4a containment
- Is this type of system available?

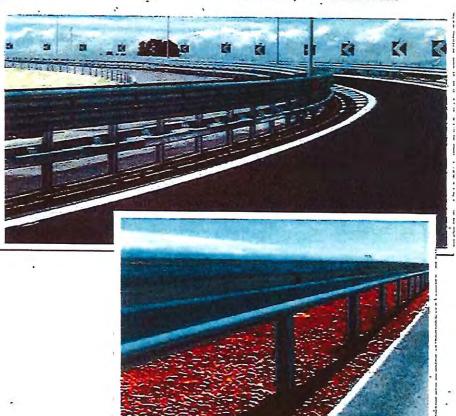
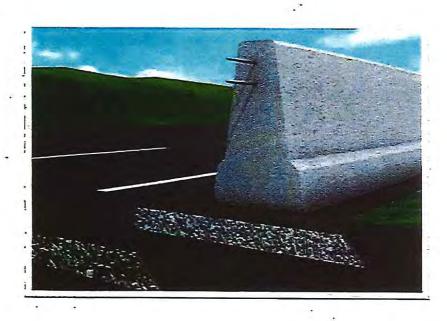
- H1 Containment WW2, VI3 1 product sourced
- H2 Containment WW2, VI2 2 products sourced
- H4a Containment WW5, VI5 (1 safety barrier sourced, all rest are classified as parapet)
- Limited products available
