NW – A85 Fowlis Wester to Gilmerton

Bear Scotland Landscape.

NW – A85 NEAR FOWLIS WESTER TO GILMERTON

To look at failing and leaning trees in this location in Transport Scotland and Landowner Areas, and complete visual report with a summary action.

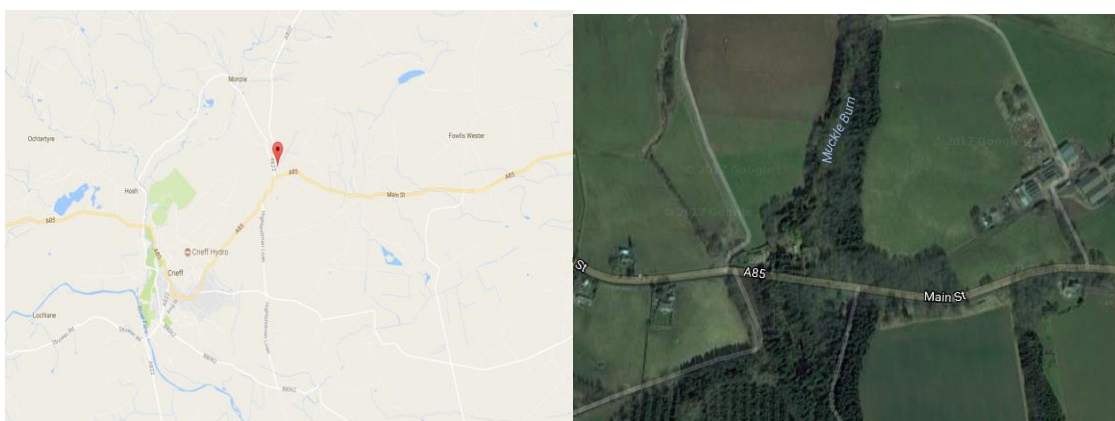
1. Woodland Area – Inspection 18/06/17

The Woodland Area sits on the North Side of the A85, to the East of Gilmerton. Near the Abercairny Estate Offices.

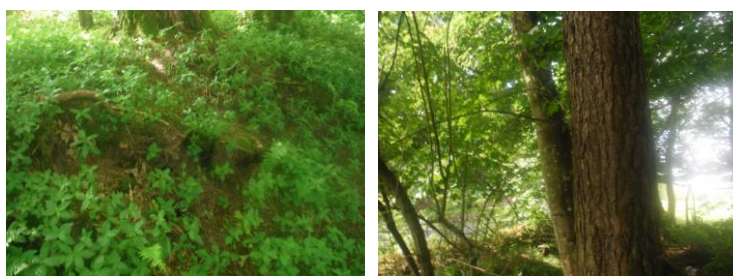
Picture trees and root.

- A. After inspection of the location on 20/06/17, there are 2 trees noted that have immediate leaning issues and as a result of evidencing tree root lifting, have advised the owner and factor that these should be felled immediately.

The 2 potentially dangerous trees at the west corner that could come down in the next gale, were visited by the Landowner and the Factor. Bear Scotland Ltd offered Traffic Management and support, and advised that these be attended to as a matter of priority.

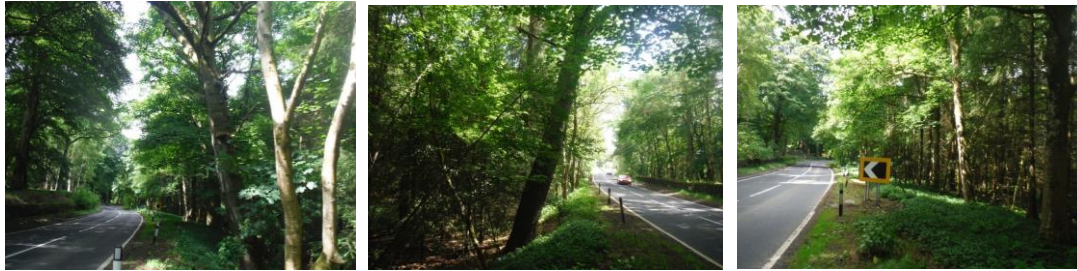
Pictures trees

- B. The Woodland sits in wet conditions for part of the area, many trees within the Woodland are failing some have blown over during the years. Approx. 12 trees appear to have a reasonable lean towards the road, and recommendation would be to fell as soon as possible, due to any unforeseen gales.

The Landowner has been advised that trees within the woodland are a potential issue, and he suggested that he would look at best felling options.

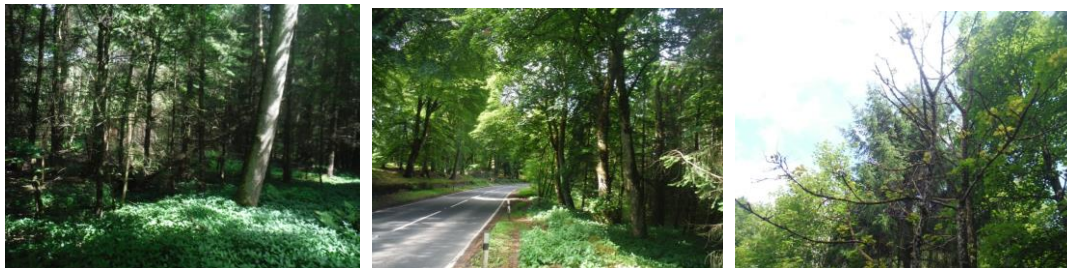
Pictures on edge of Woodland.

C. The rest of the woodland would be advised for felling as the impact of the creating open areas within may cause other trees within the woodland to blow.

Landowner to confirm Felling Plan.

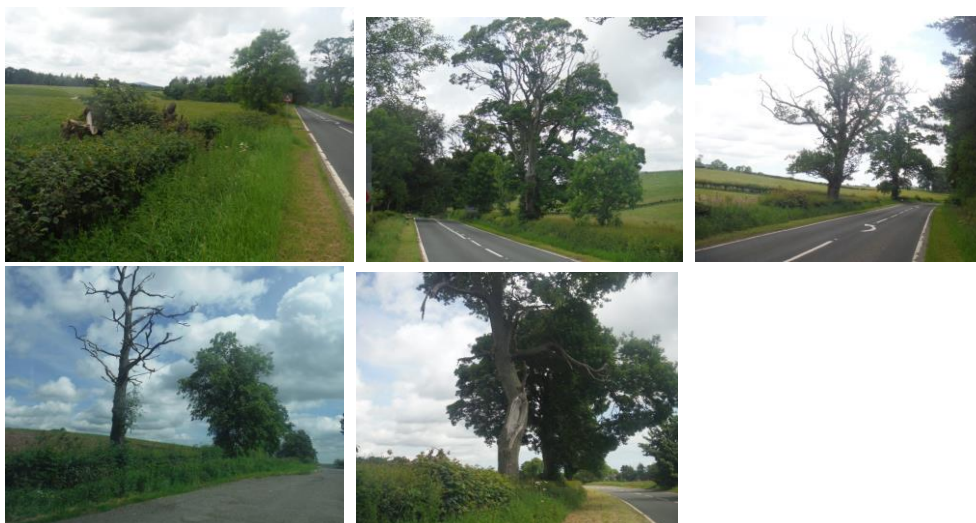
Pictures.

2. There also appears to be a potential issue with various trees on the hedge lines from Methven to Gilmerton, some of which have had fallen branches and some windblown.

A. The Line of Statement trees which run with the hedgeline appear to have been affected by wind, poor growth, spraying, etc and there are many with potential issues.
