## DDA defects associated with Footway(FW) &amp; Cycle Facility(CT) Inventory

**Category 1 Defects include but shall not be limited to the following Defects:**

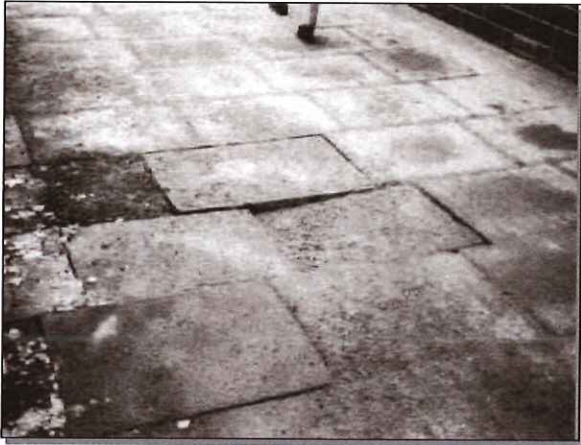
**SLPF** Slab profile – uneven/trips

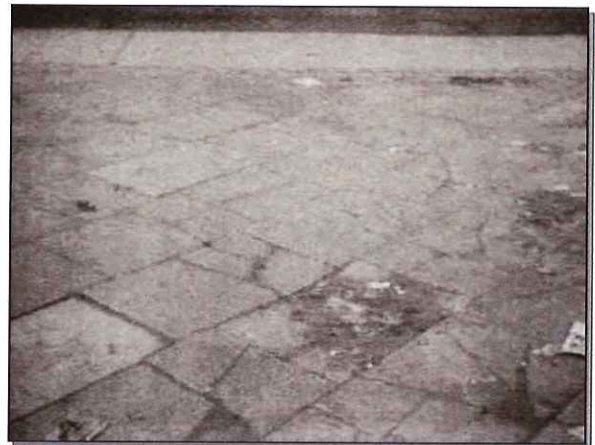
**SLCK** Slab Cracking

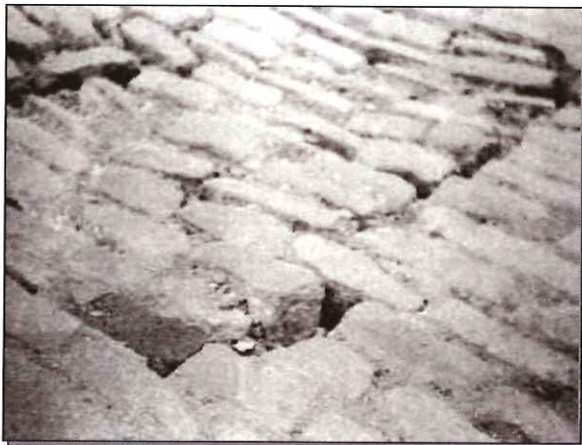
**BKPF** Block Profile

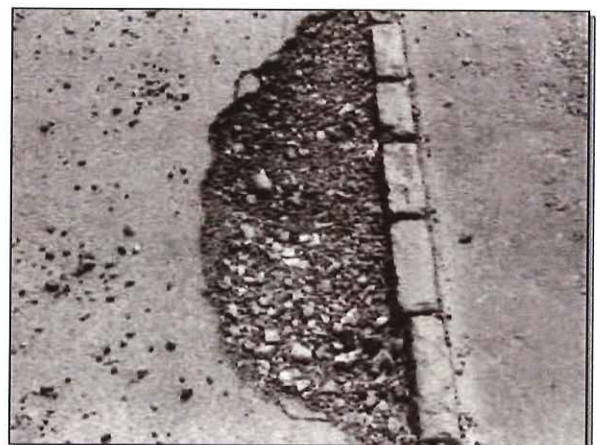
**BPOT** Bituminous surfacing – potholes

BPOT	Pothole $\geq$ 25mm deep, regardless of size. For shallower potholes, factors such as pedestrian/cycle flows, and the position of the pothole in the footway/cycle track relative to the normal track taken by pedestrians/cyclists must also be considered when categorising the Defect.
FDLV, RDLV	Abrupt difference in level between the footway and any trench, repair or ironwork.
SROK, SLPF	Rocking, uneven or missing/broken slabs resulting in a trip hazard.
STWT	Standing water which obstructs the footway to such an extent that pedestrians are likely to step off the footway to pass.

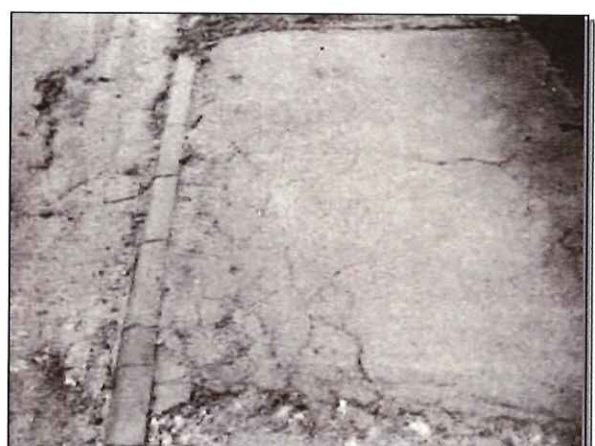
**BECK** Bituminous Surfacing – Extensive Cracking

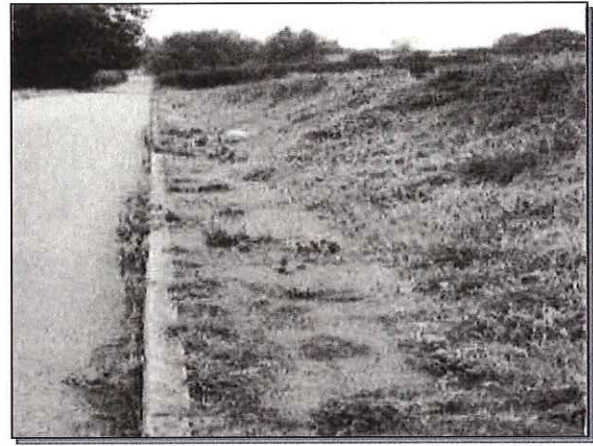
**OVGV** Overgrown by vegetation

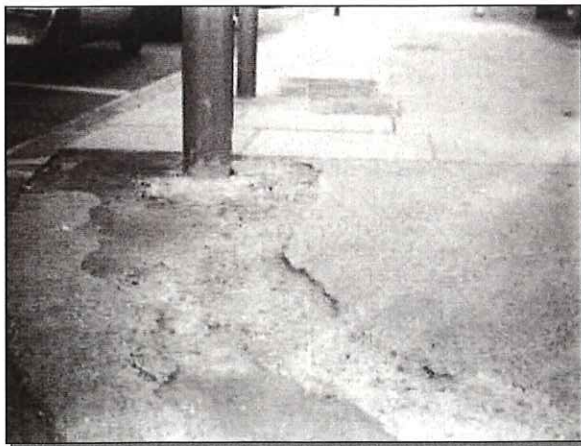
**RLMT** Trench RI – loss of material

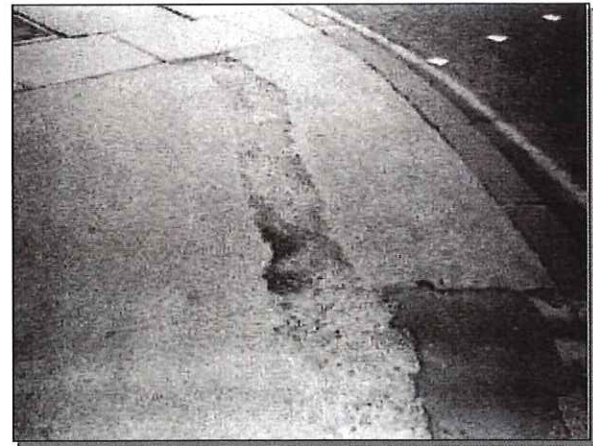
**RDLV** Trench RI – difference in level
