Road Safety Audit Stage 2-Designer's Response **A7 Guthrie Drive Pedestrian Improvements**

RSA/16/005/RSA2 /001

Project Name:	A7 Guthrie Drive Pedestrian Improvements
Project Number:	RSA/16/005/RSA2
Report Title:	Road Safety Audit Stage 2-Designer's Response
Report Number:	001

- 1.1.1. This report results from a Stage 2 (Design Phase) Road Safety Audit (referred to as a Stage 2 Audit) carried out on the following scheme: installation of two new pedestrian refuge island crossings; extension of footpaths including new dropped kerbs and tactile paving; warning signs associated with the new crossings; and resurfacing works at A7 Guthrie Drive on the north side of Hawick.

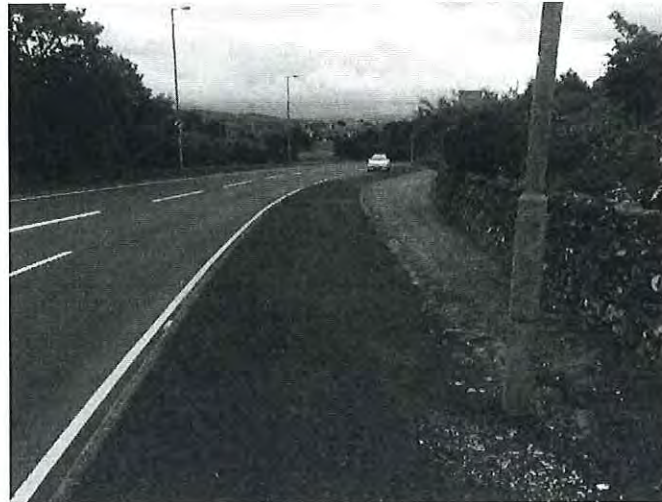
Location: Pedestrian crossing location 2

Summary: Vegetation overhanging the west verge restricts visibility for pedestrians looking to the south when crossing at this point. This could result in pedestrians coming into conflict with vehicles approaching the Galalaw roundabout at speed.

Cut back the vegetation overhanging the west verge to provide the maximum sightline for pedestrians crossing

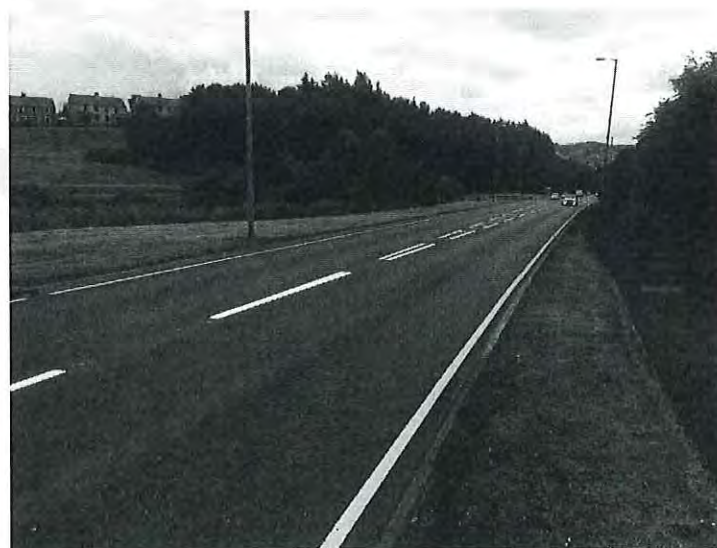
Location: Pedestrian crossing location 3

Summary: The new refuge island will be installed on a steep gradient and lies within a section of the trunk road where vehicle speeds would be expected to be high. To make drivers aware of the presence of the island particularly in poor light conditions it would be beneficial to have a beacon installed to aid visibility of pedestrians waiting at the refuge island.

Install a refuge beacon at the new refuge island

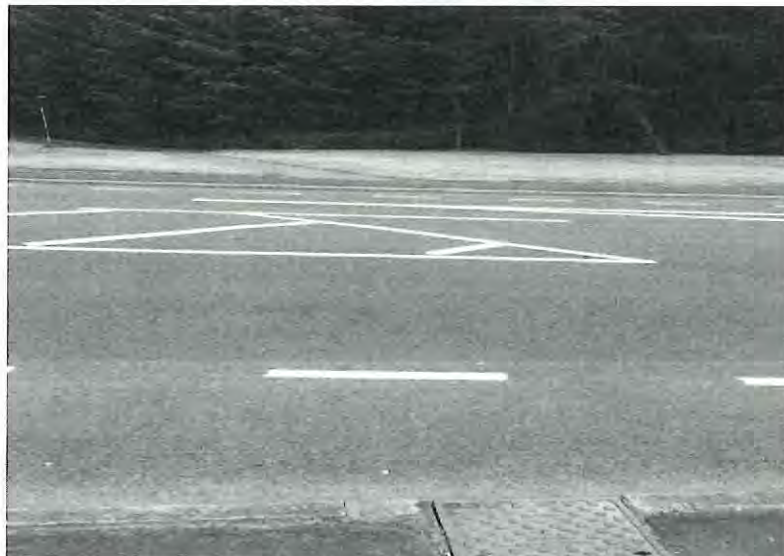
Location: Pedestrian crossing location 3

Summary: The new refuge island will not lie on the pedestrian desire line for users travelling from the east side of the trunk road. This may result in pedestrians crossing outwith the refuge island with the consequences that they could come into contact with motorised traffic turning at the two junctions.

Position the new refuge island to meet the pedestrian desire line

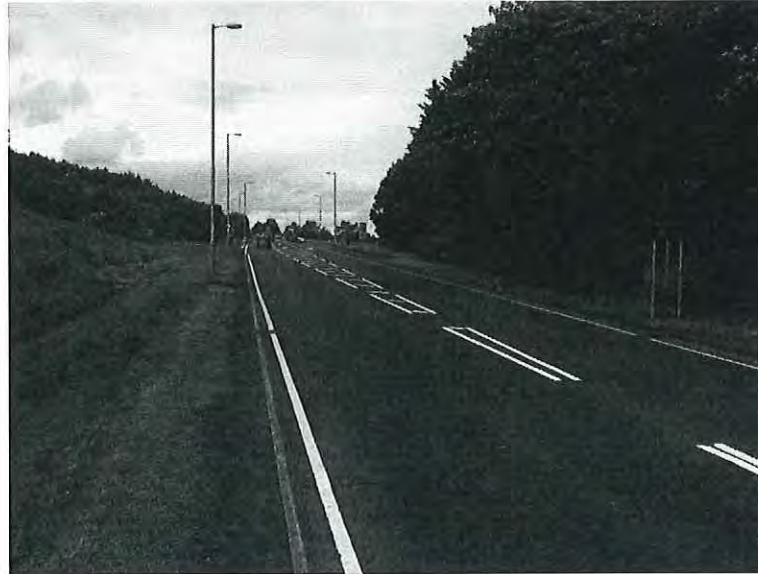
Location: Pedestrian crossing location 4

Summary: The proposed crossing point 4 is not on the desire line for users of the A7. This is likely to result in pedestrians crossing at the bell mouth of Guthrie Drive bringing them into conflict with vehicles turning at speed into the junction.

Create a crossing point on the trunk road desire line incorporating a refuge island

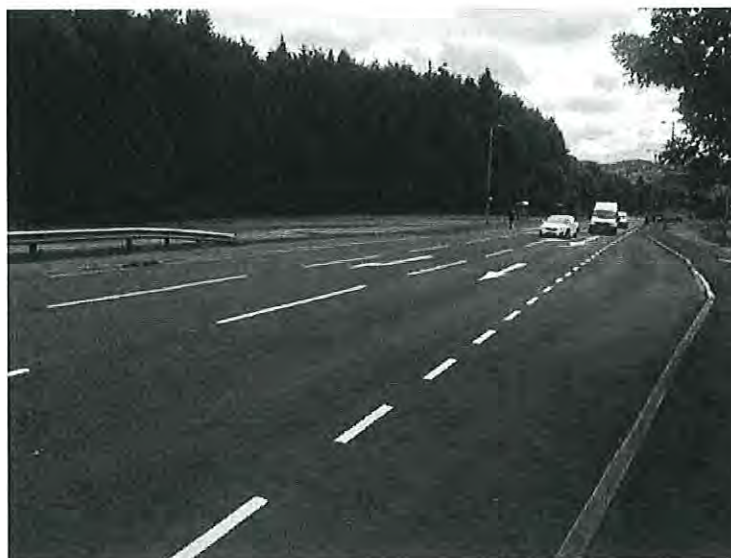
Location: Pedestrian crossing location 3

Summary: There is clear evidence of vehicles overrunning the existing central hatching when turning right into the B6359 road. The scheme will introduce a refuge island where the markings currently exist resulting in the potential of it being stuck by vehicles.

Ensure that the central hatched markings reflect vehicle swept paths and the stacking length required for the two side road junctions

Agreed – A traffic survey was undertaken during the peak hour between 08:30 and 09:30, at the start of August term time, to observe traffic volume and maximum queuing on both turning lanes. It was observed that traffic turning into both minor roads was able to turn with relative ease as there were sufficient gaps in mainline traffic. The maximum observed queue was 3 vehicles long and therefore the installation of an island within central hatching will not present an issue with vehicle stacking.

The design for pedestrian refuges includes advanced warning, reboundable keep left bollards and will now include lighting beacons following RSA recommendations. Therefore this will provide drivers with adequate warning about the presence of the new refuge islands and will reduce the risk of vehicle strikes.

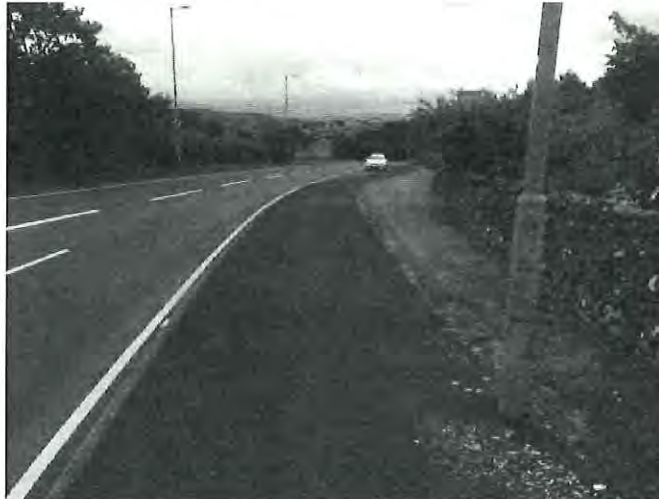
Location: Pedestrian crossing location 2

Summary: Vegetation overhanging the west verge restricts visibility for pedestrians looking to the south when crossing at this point. This could result in pedestrians coming into conflict with vehicles approaching the Galalaw roundabout at speed.

Cut back the vegetation overhanging the west verge to provide the maximum sightline for pedestrians crossing

Agreed – This will be passed onto route engineer in to be incorporated into routine maintenance works

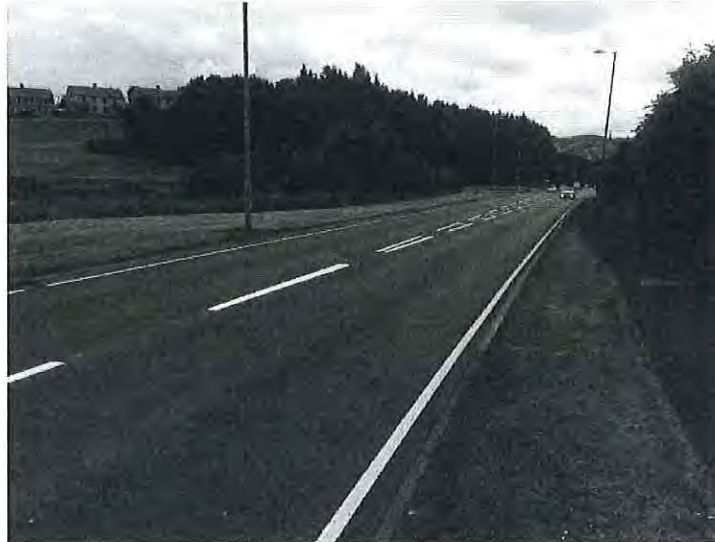
Location: Pedestrian crossing location 3

Summary: The new refuge island will be installed on a steep gradient and lies within a section of the trunk road where vehicle speeds would be expected to be high. To make drivers aware of the presence of the island particularly in poor light conditions it would be beneficial to have a beacon installed to aid visibility of pedestrians waiting at the refuge island.

Install a refuge beacon at the new refuge island

Agreed – The installation of 2 new lighting beacons have been incorporated into the designs for pedestrian refuges.

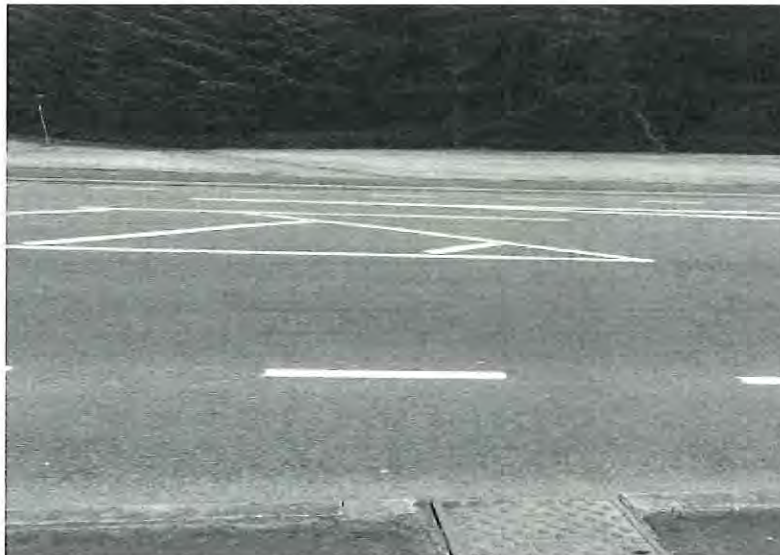
Location: Pedestrian crossing location 3

Summary: The new refuge island will not lie on the pedestrian desire line for users travelling from the east side of the trunk road. This may result in pedestrians crossing outwith the refuge island with the consequences that they could come into contact with motorised traffic turning at the two junctions.

Position the new refuge island to meet the pedestrian desire line

Agreed – The positioning of the refuge has been modified to better meet the desire line for pedestrians using the bus stops, and allows for it to be fully contained within the existing hatched area. The footpath at the back of the east crossing will be reprofiled to meet the new crossing location.

Pedestrians will have the option of crossing at two locations approximately 100m apart. This will meet the desire lines of pedestrians and provide safer crossing opportunities for all NMUs and vulnerable pedestrians, using either bus stop or travelling from the east towards Hawick and Guthrie Drive.

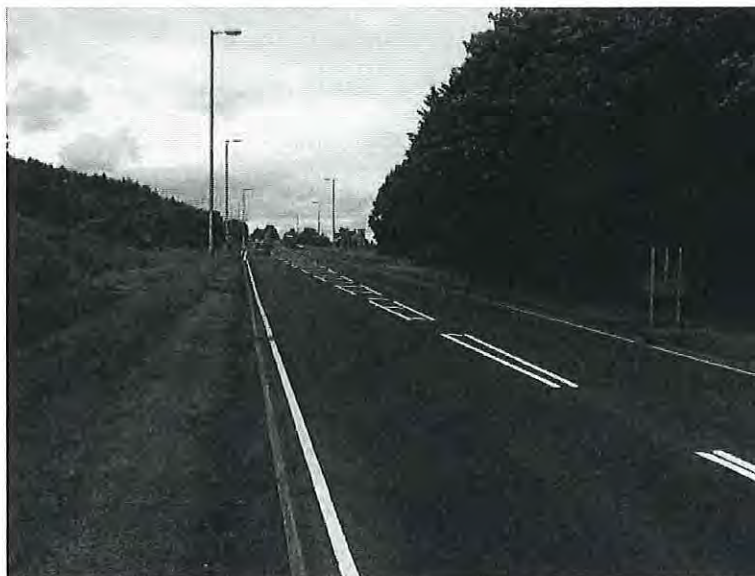
Location: Pedestrian crossing location 4

Summary: The proposed crossing point 4 is not on the desire line for users of the A7. This is likely to result in pedestrians crossing at the bell mouth of Guthrie Drive bringing them into conflict with vehicles turning at speed into the junction.

Create a crossing point on the trunk road desire line incorporating a refuge island

Disagree –

A crossing located at the bell mouth of the junction, assuming a straight line between footpaths, would require pedestrians to cross approximately 35m of carriageway (kerb to kerb). This would result in pedestrians coming into close proximity to traffic travelling on the mainline with a speed limit of 60mph, and entering Guthrie Drive at speed due to the generous bend and carriageway width.

At the proposed location, a crossing will meet the needs of users travelling to/from the Guthrie Drive area. Whilst this location may not be on the exact desire line for pedestrians travelling alongside the A7 northbound carriageway, the location has been selected based on criteria outlined in Transport Scotland design standards and DMRB (Volume 6, Section 2, Part 6 TD42/95 paragraph 5.15) which states "*Defined at-grade pedestrian crossing points on the minor road should be a minimum of 15m back from the "Give Way" line, and should be sited so as to reduce to a minimum the width to be crossed by pedestrians provided they are not involved in excessive detours from their desired paths.*" This would result in a deviation of approximately 20m from the auditor's desire line, which is not considered to be excessive.

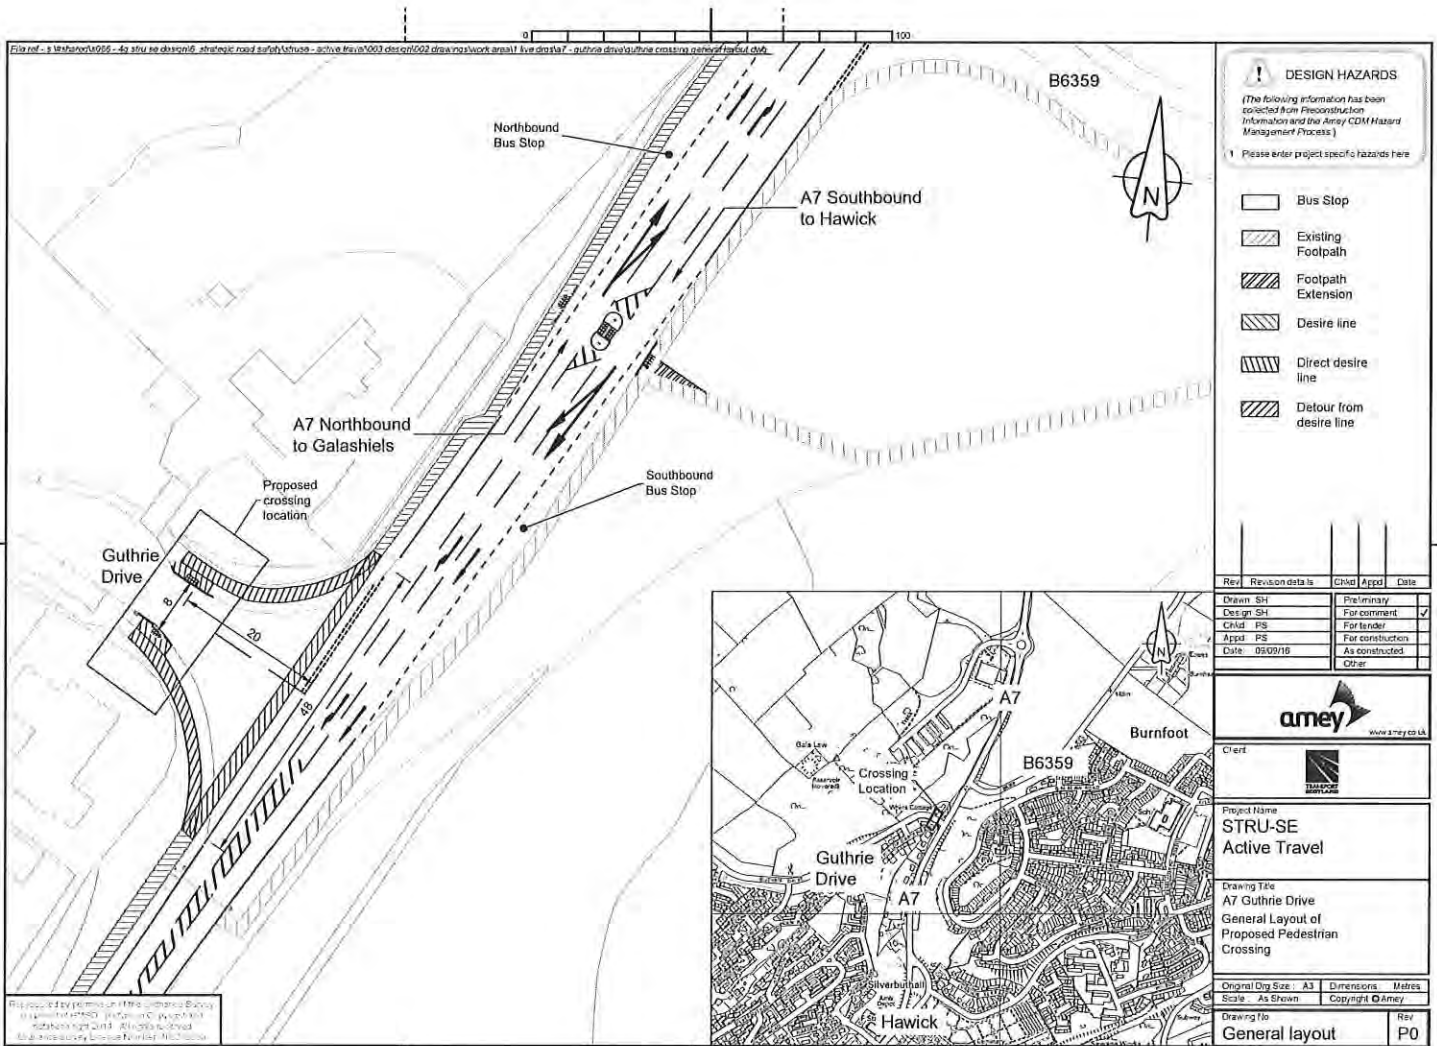
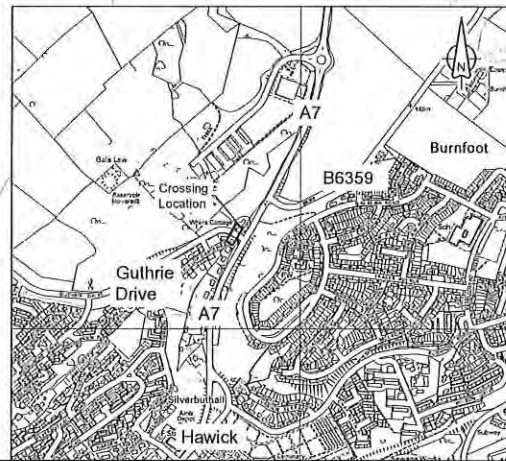
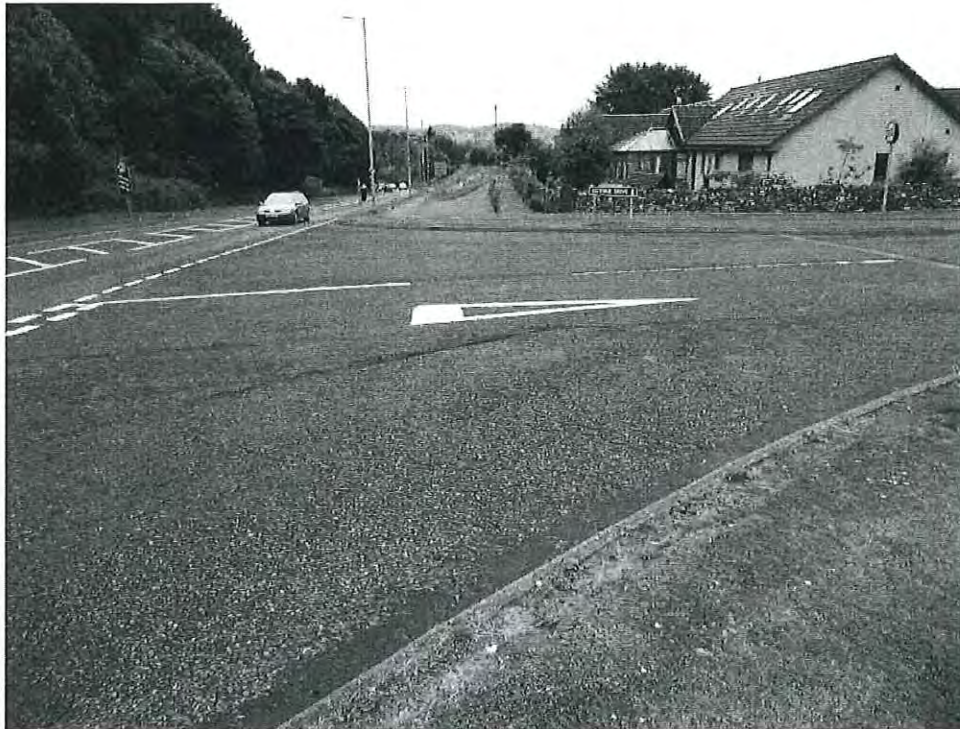
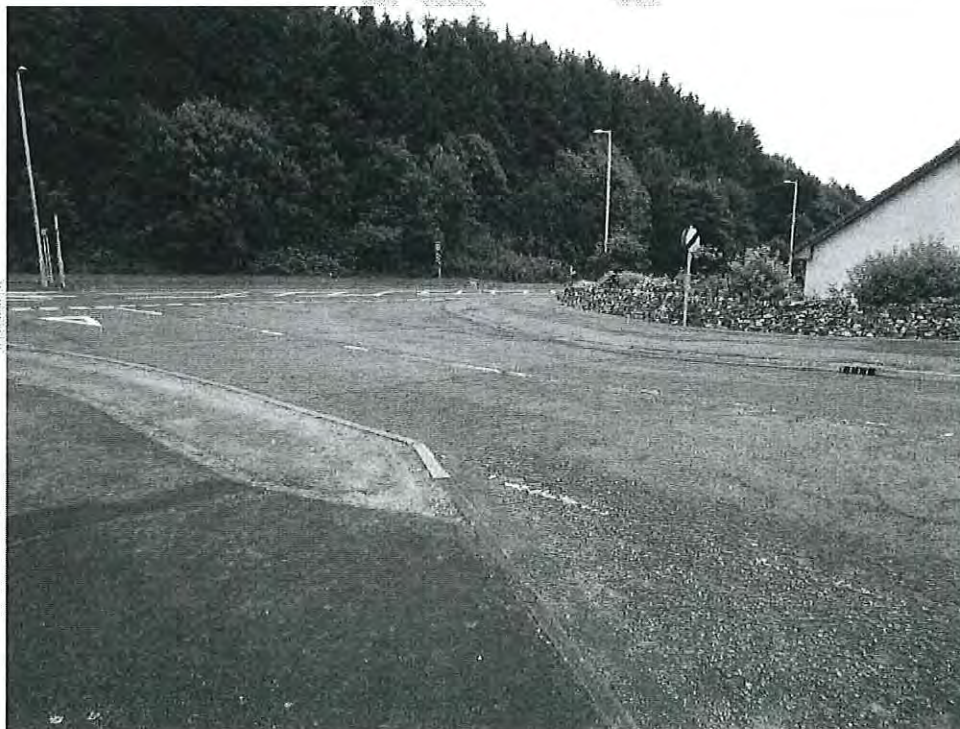
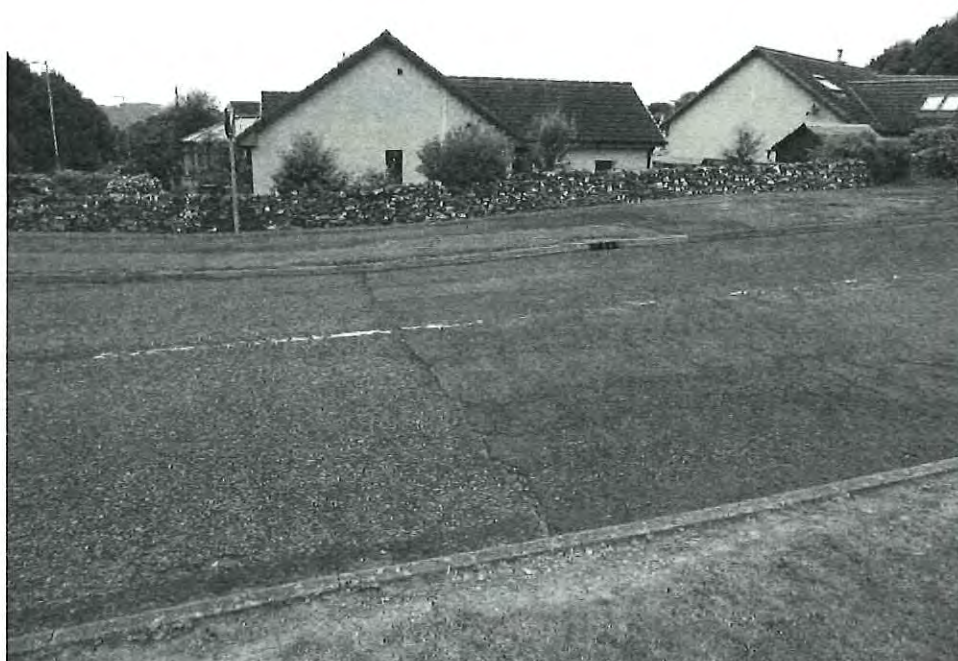
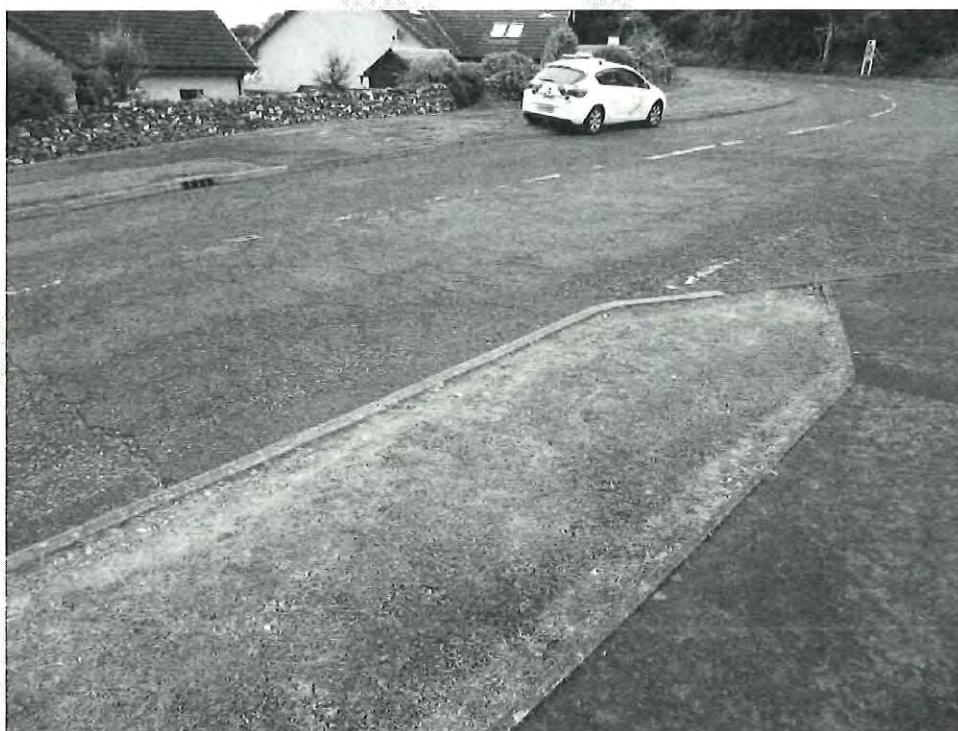
Appendix B

A drawing of the proposed crossing and images of the existing crossing is contained within Appendix B.
