A78 Seamill
Pedestrian Crossing Assessment
20/SW/0323/004
June 2020

Project Title: A78 Seamill
Report Title: Pedestrian Crossing Assessment
Revision: 0
Status: Draft

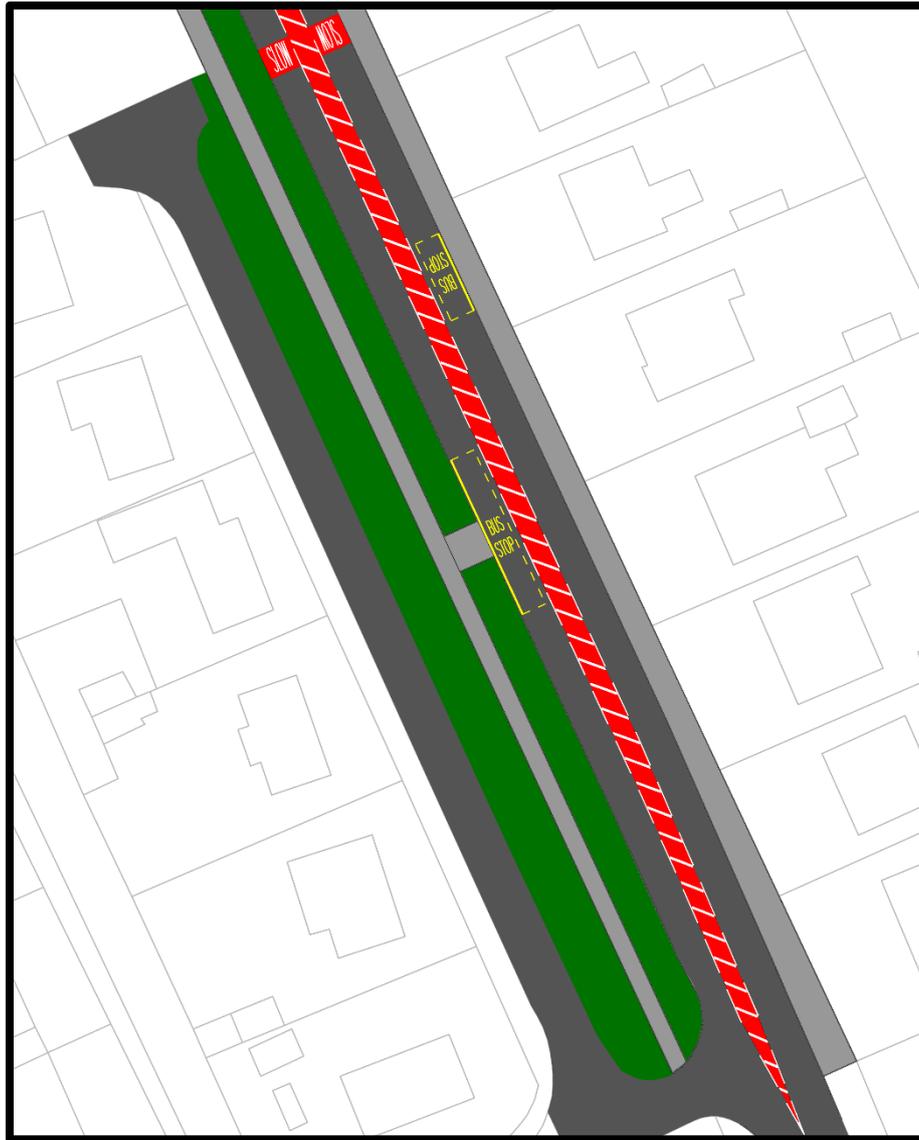
Figure 2.1.1a – A78 Seamill, Existing Road Markings.

As it runs through Seamill the A78 trunk road is an illuminated single carriageway subject to a 30mph speed limit. From the southern end of the assessment location both sides of the carriageway are marked with continuous single white lines to mark the edge of the carriageway, the northbound carriageway then approaches the 30mph gateway which includes dragon's teeth line markings and a red banded 30 roundel. Moving past the gateway there are no stopping/waiting/loading restrictions in place, with the exception of two bus stops which are delineated by Dia. 1025.1 road markings and Dia. 974 sign. The northbound and southbound lanes are separated by 2m wide red hatching throughout the entire assessment area. See *figure 2.1.1a* for a detailed drawing of the road markings and *figure 2.1.1b* is a photo of the site.

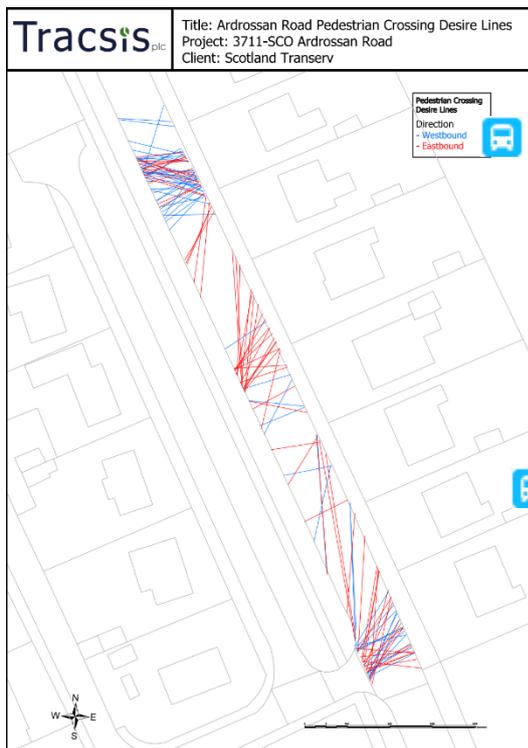
Figure 2.1.2a – Pedestrian Crossing Desire Lines Map

Figure 2.1.2a, below, provides a visual layout of the desire lines across the assessment location. This plan shows the correlation of pedestrian crossing desire lines with the existing road layout. It is shown that the majority of the foot traffic in the area made crossing movements near the bus stops and T-junction to the south which leads to a number of residential premises.

The survey has highlighted that there are two desire lines to and from both bus stops.

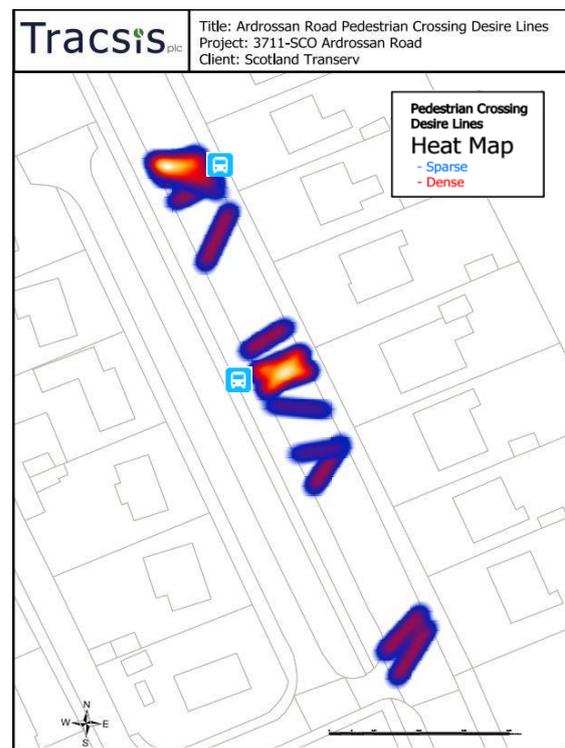
Figure 2.1.2b – Pedestrian Crossing Heat map.

Figure 2.1.2b below correlates with the desire line map showing two predominant locations at the bus stops and further evidence of crossing movements at the T-junction to the south.

This assessment looks to provide a facility within the assessment area. The largest demand, as taken from the crossing desire line trends shown in the Heat-Map (Figure 2.1.2b), highlights 2 locations based at the northbound and southbound bus stops and another 'hot spot' to the south near the junction with Arranview Gardens.

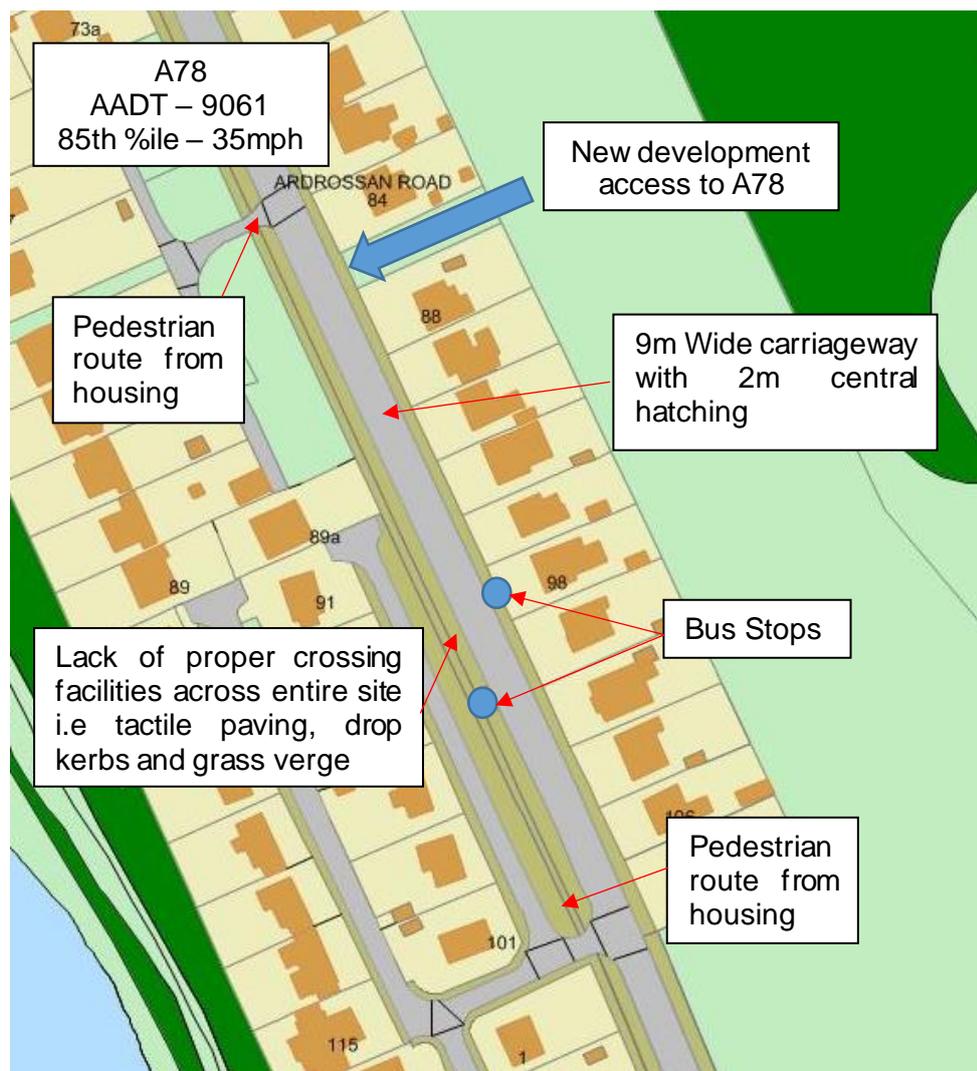
Figure 3.1 – Factors contributing to crossing difficulty for pedestrians using existing crossing facility

The objectives of the improvement should be to remove the barriers currently presented to more vulnerable pedestrians and reduce, to a minimum practical level, the difficulty for all pedestrian users to cross safely at this location. In order to achieve this, options should aim at tackling factors which cause pedestrian difficulty in using the existing environment. These are shown in *Figure 3.1* below;

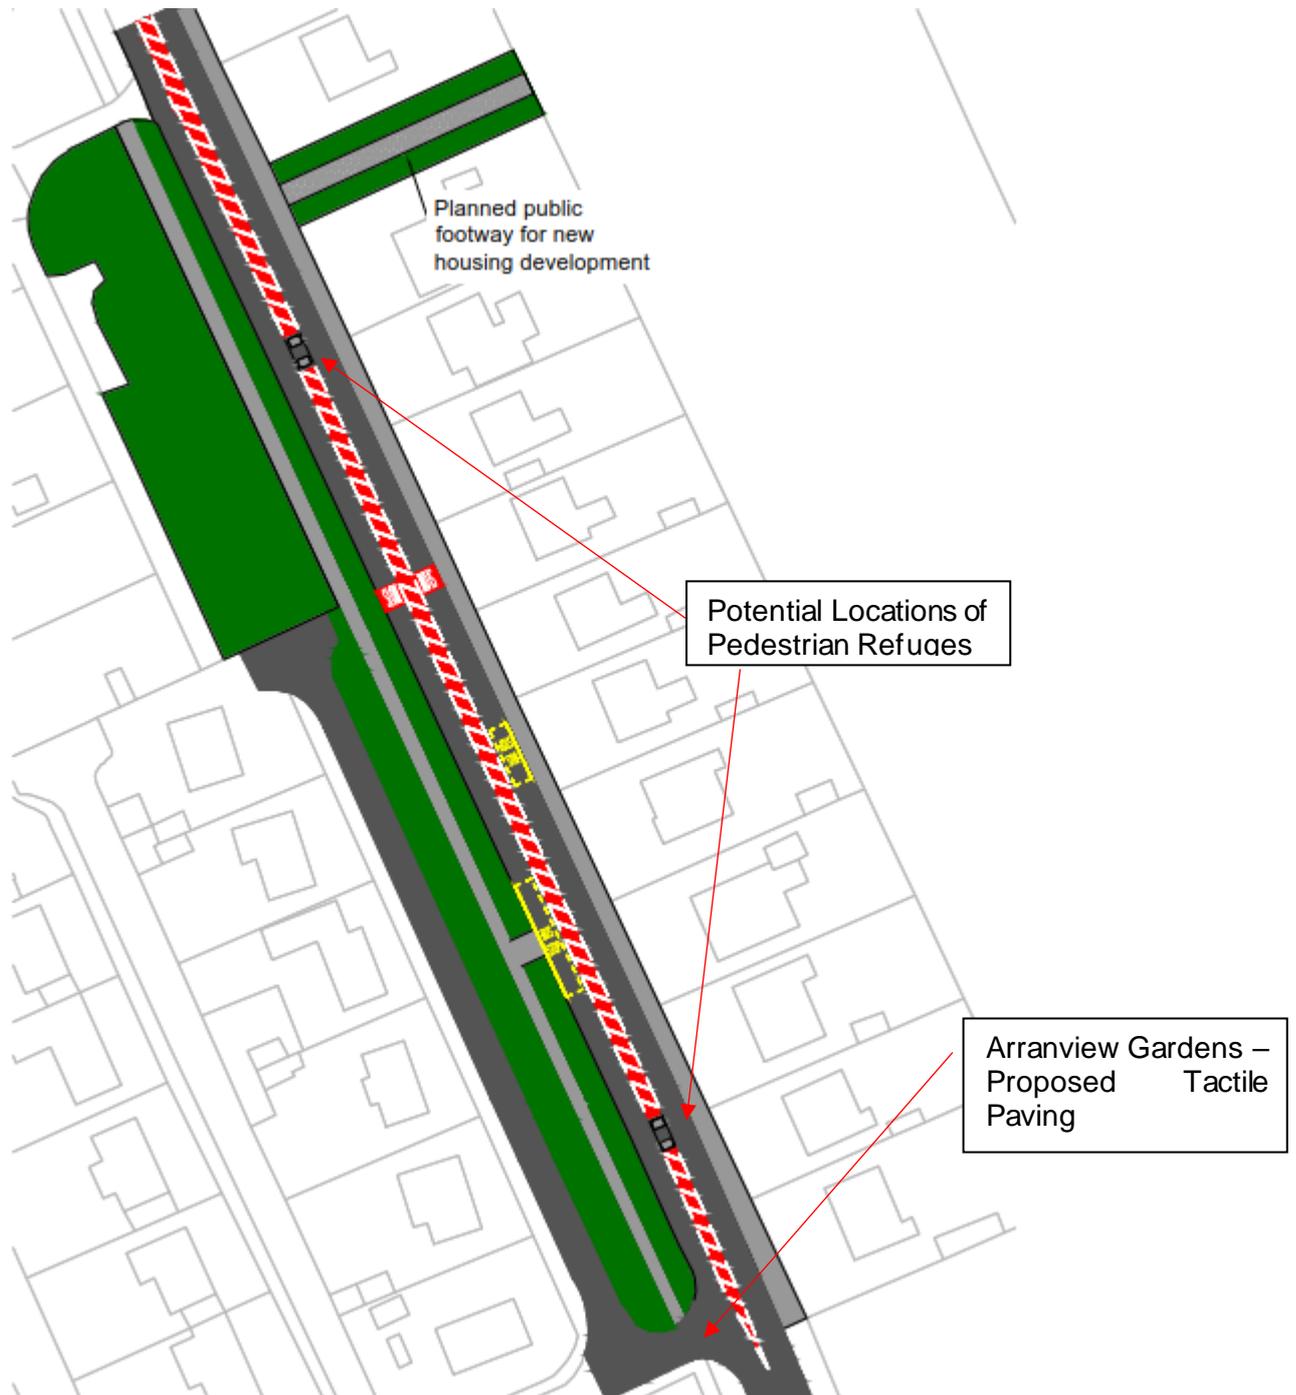
6 Appendix A – Proposed Layout

Two pedestrian refuges are installed either side of the bus stops with associated footways, kerbs and tactile paving. Also to be installed are dropped kerbs and tactile paving at Arranview Gardens.

Given the above, it is recommended that a 2 pedestrian refuges as shown in Appendix A in this report be installed and improvements to the crossing point at the junction with Arranview.

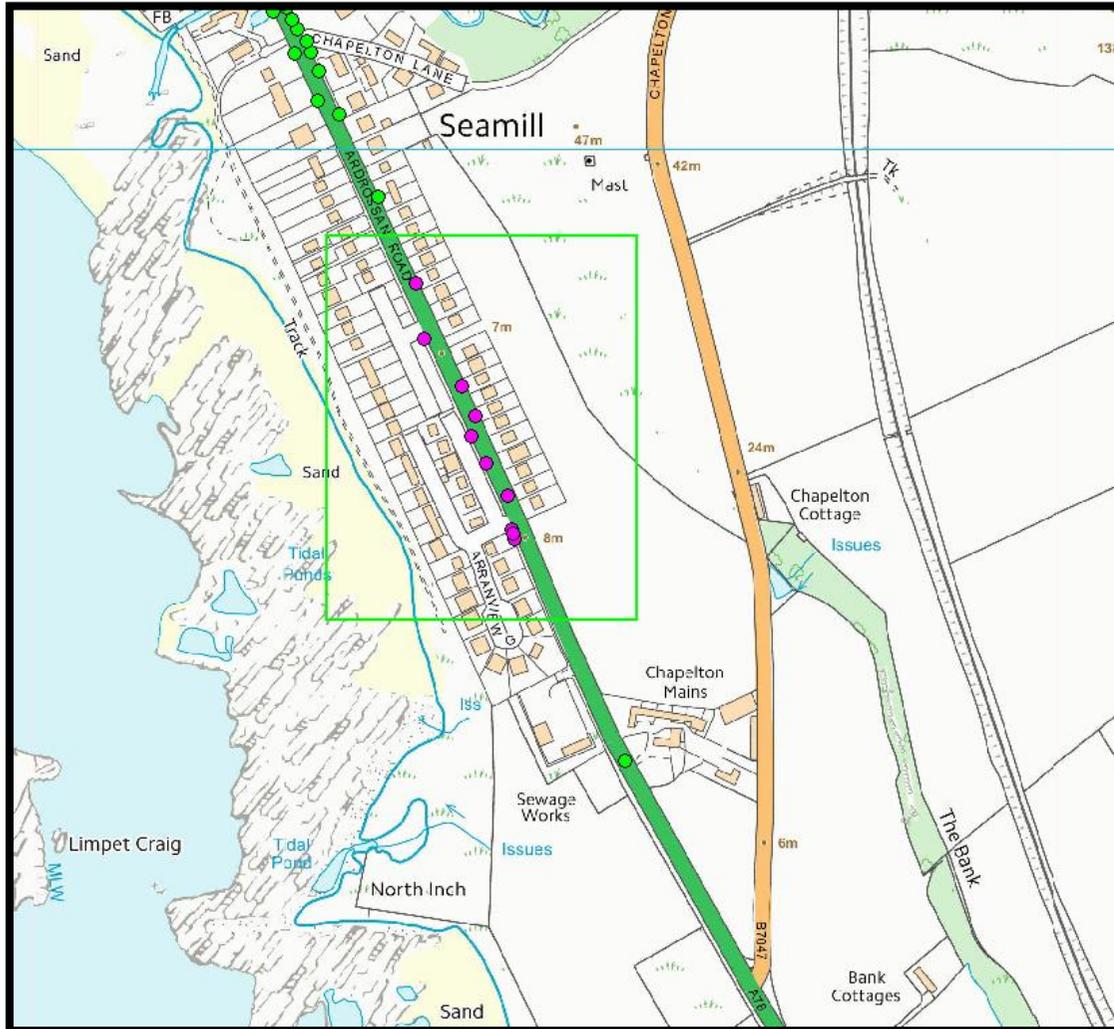
Figure B – DDA Barriers

As shown above, there are 18 DDA barriers in total locally. These will each be assessed and attempts will be made to rectify these along with any future works should they go ahead.
