# Lanarkshire Steelworks

## Soil and Groundwater Contamination Liability Assessment

The Scottish Government

22 April 2016

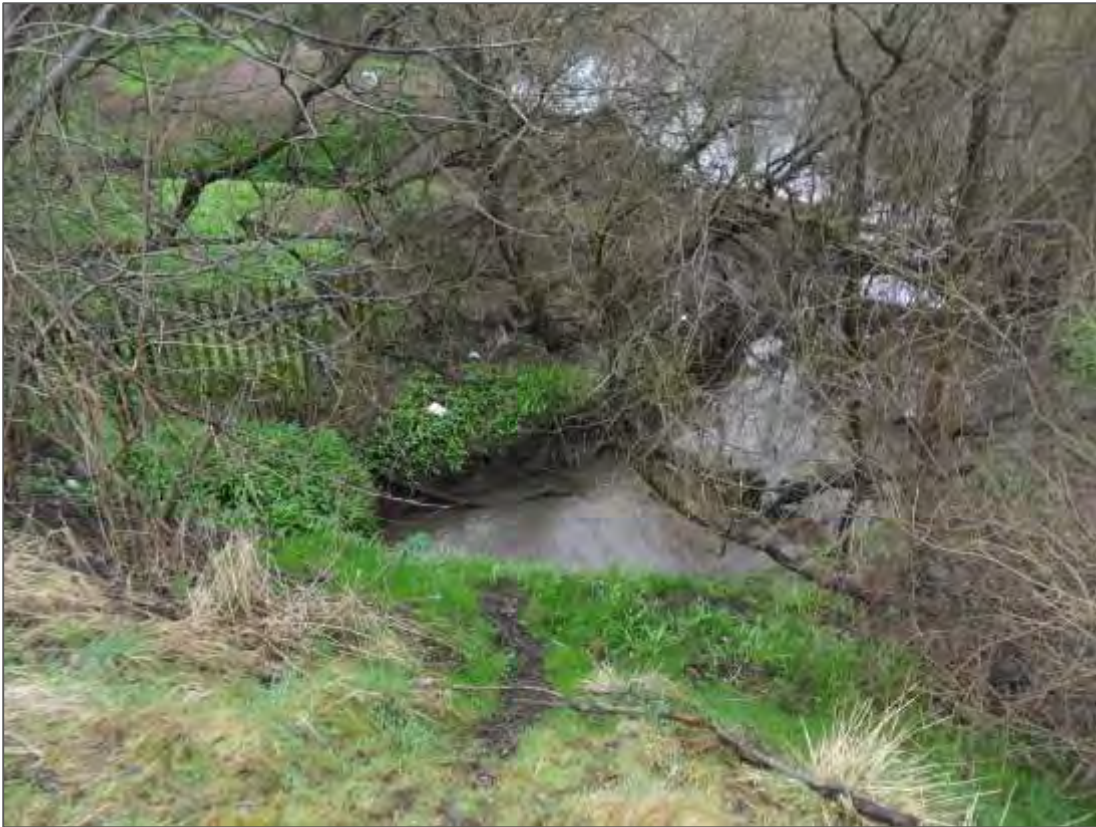
**Photograph 1: View north east of the outfall of Eastfield Burn in to the River Clyde which originates to the south of the site and thought to be culverted under the site and M74.**

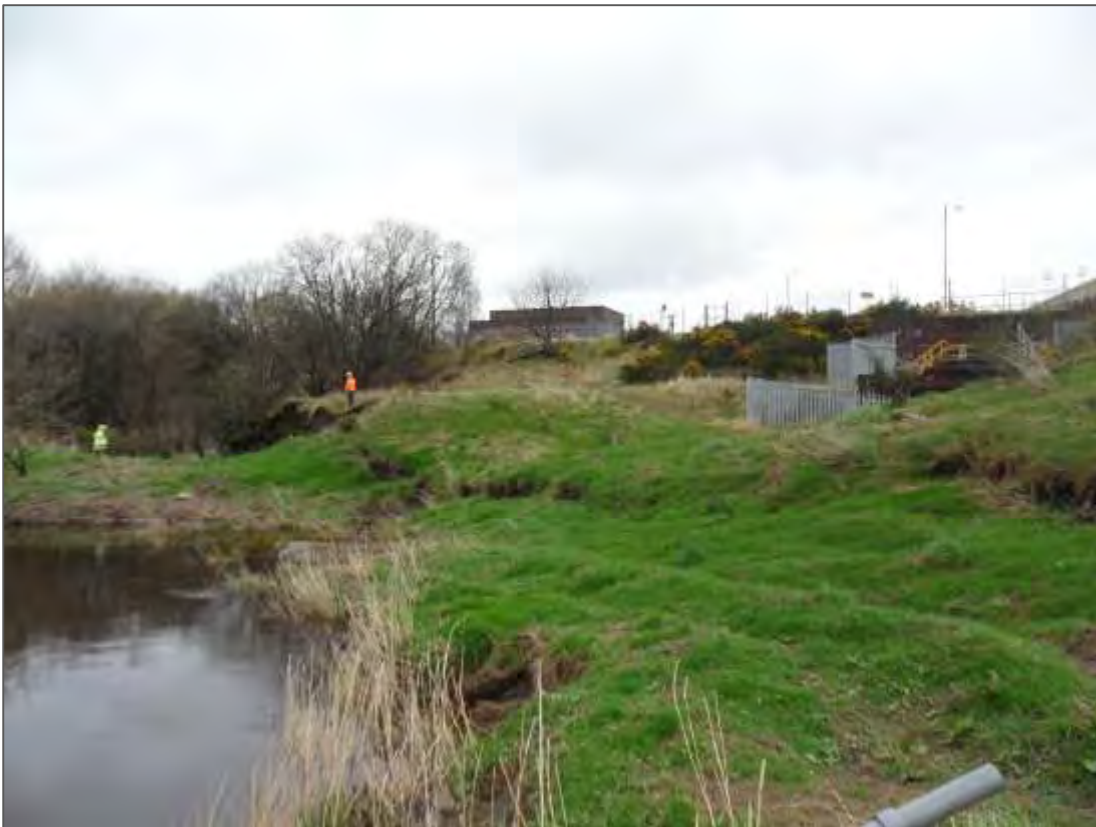
**Photograph 2: View north east of the PPC regulated outfall and substation in the background. Note the relative instability of the river bank highlighted by slip scars.**

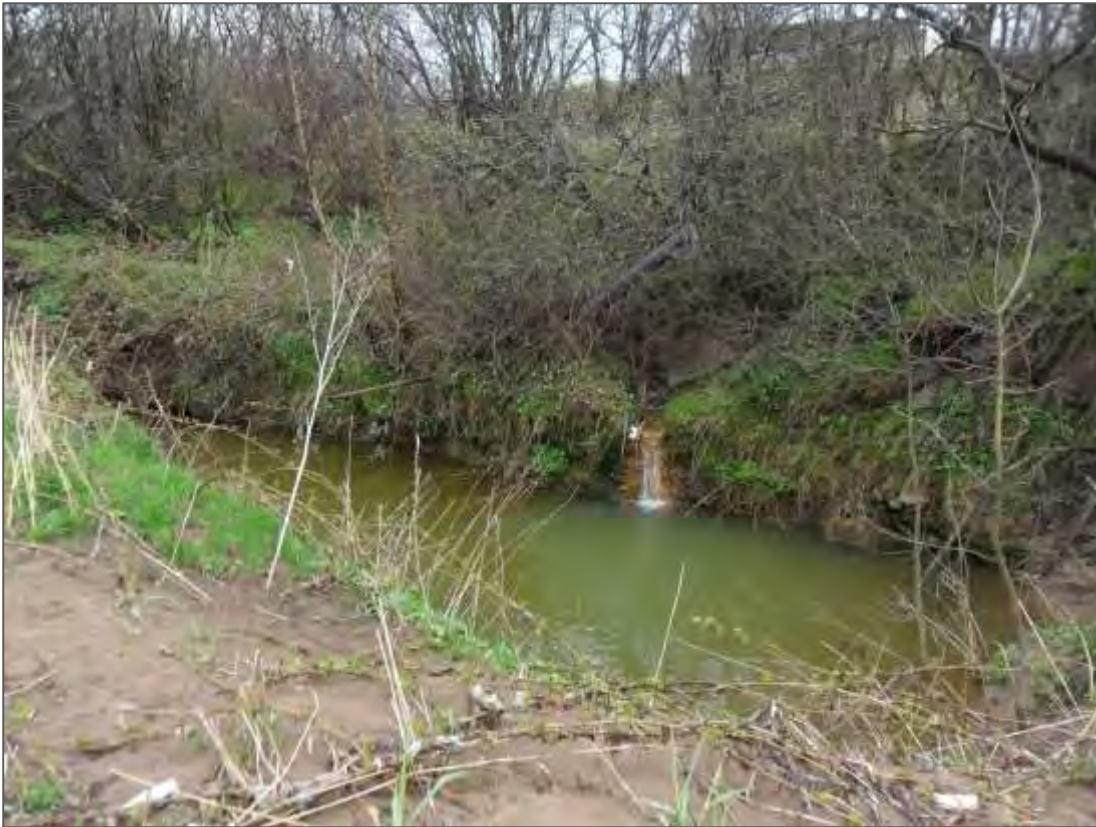
**Photograph 3: Discharge of water believed to be the regulated outfall of the PPC permit.**

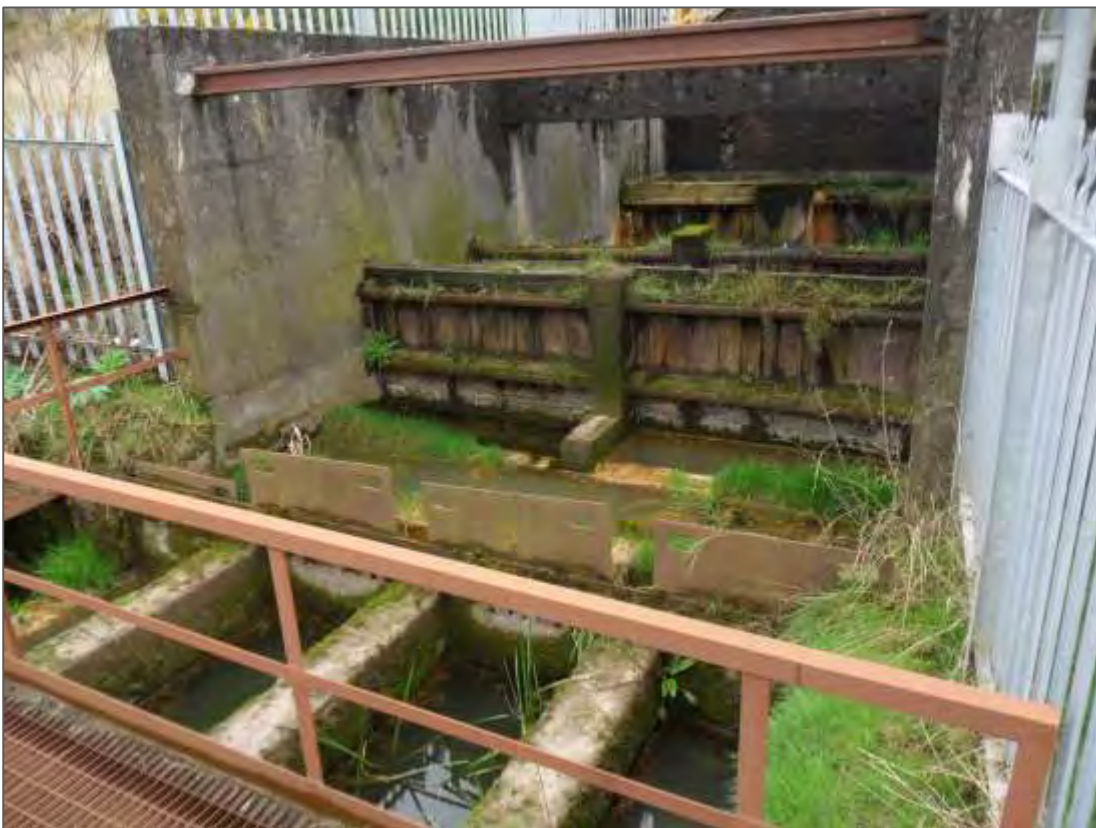
**Photograph 4: View east of the water treatment system included as part of the PPC permit.**

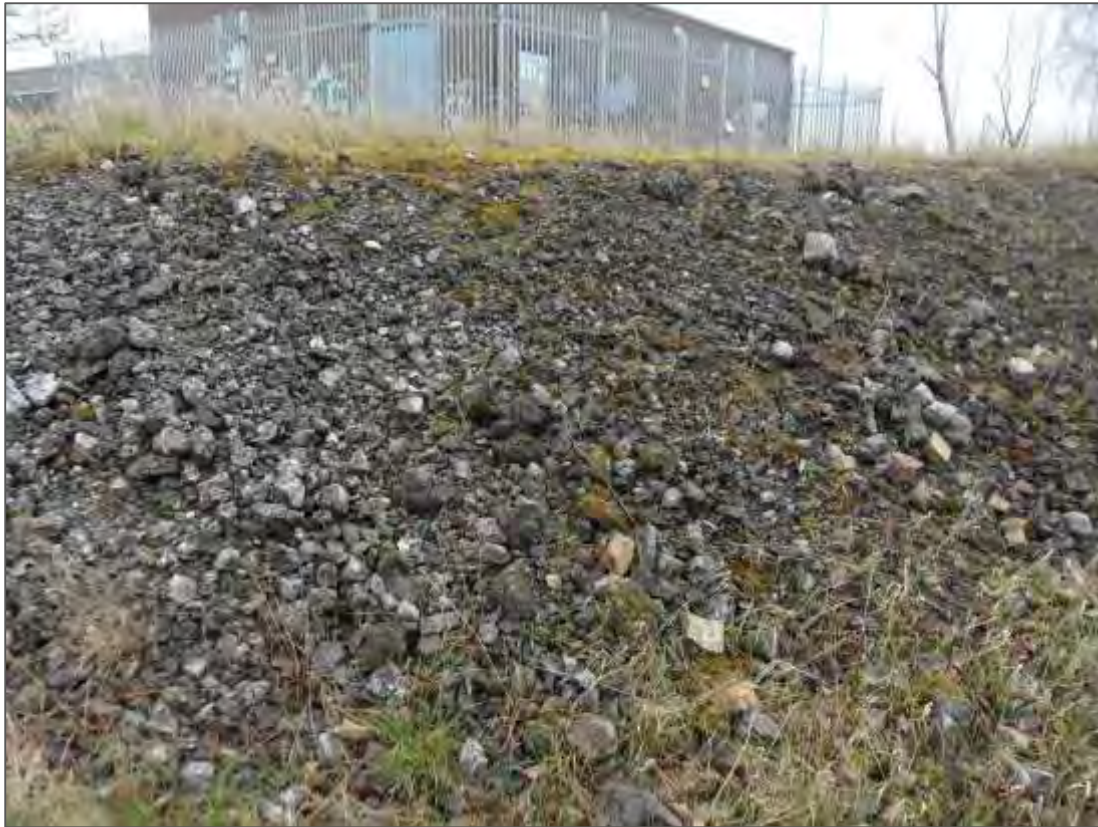
**Photograph 5: View south east of the Made Ground which the substation is built on. Made Ground comprises predominantly slag, refractory and ash.**

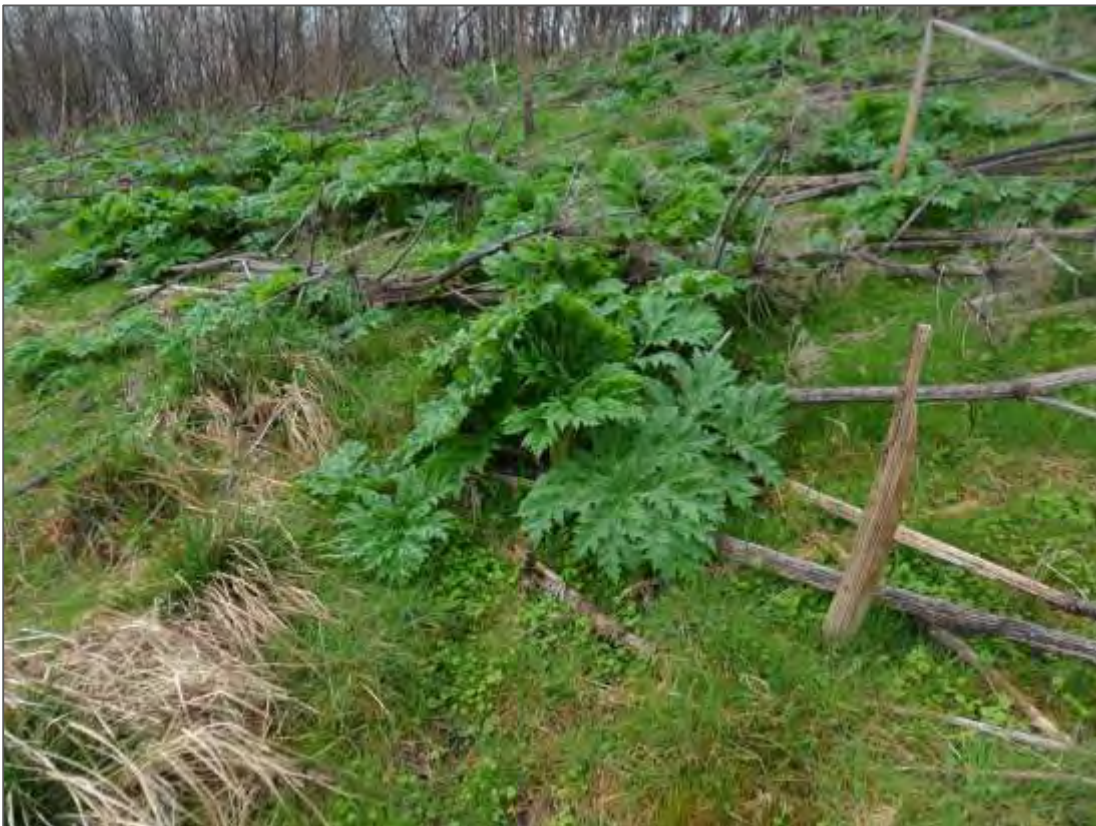
**Photograph 8: View north from the base of the former landfilled area. Suspected Giant Hogweed.**

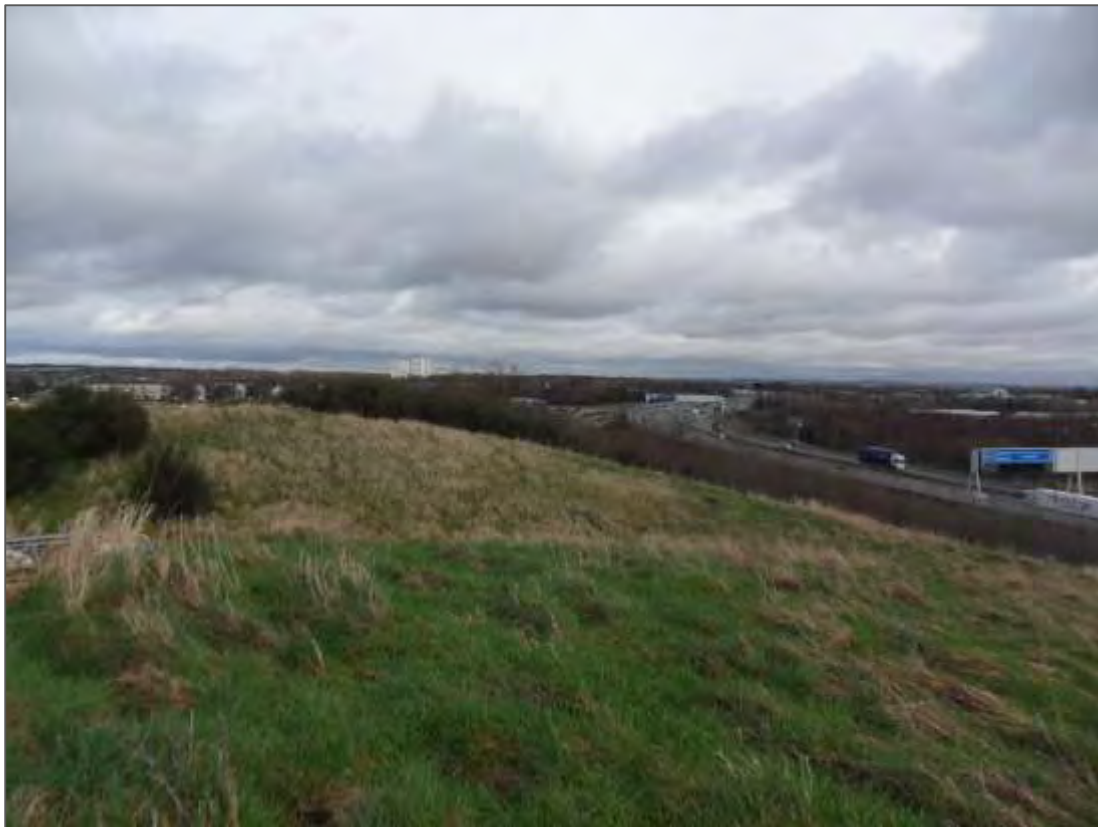
**Photograph 9: View eastwards from the top of the landfill. Note the topographical height difference from the M74.**

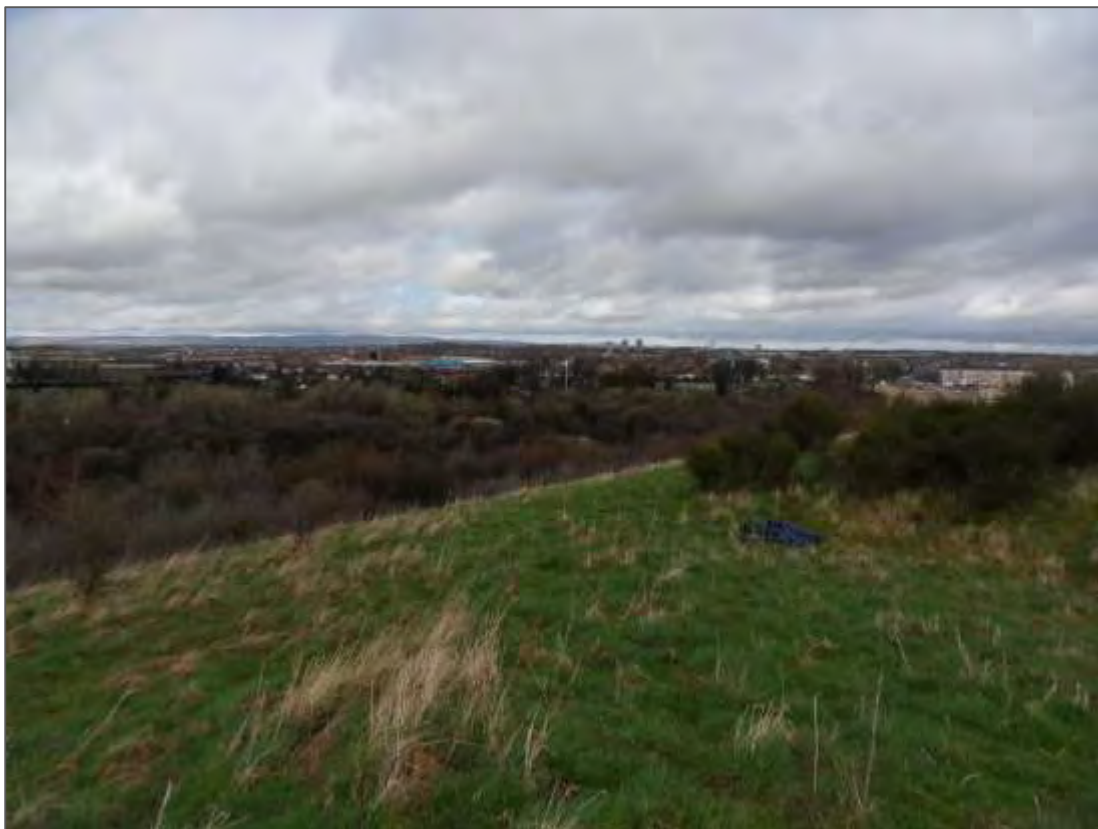
**Photograph 10: View northwards from the top of the landfill. Note the topographical height difference from the River Clyde which is situated in the wooded area at the base.**

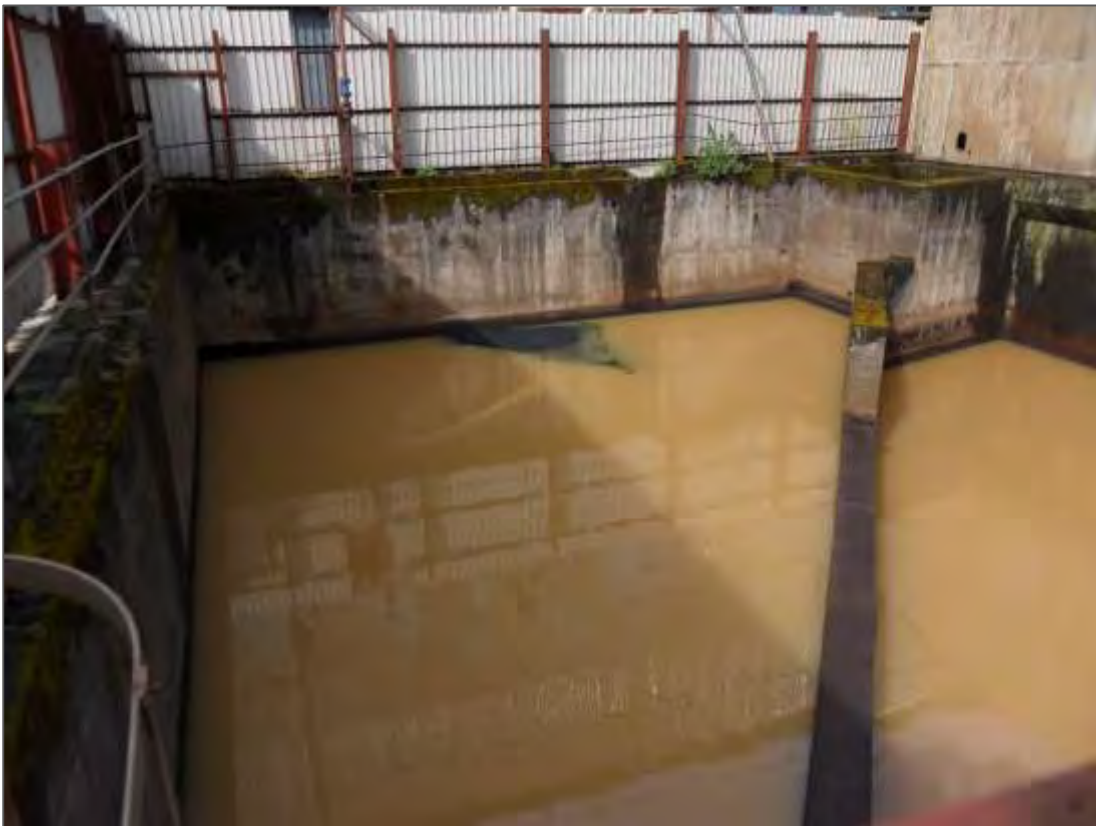
**Photograph 16: Currently inactive quench ponds with some scale evident in the primary compartment on the left.**

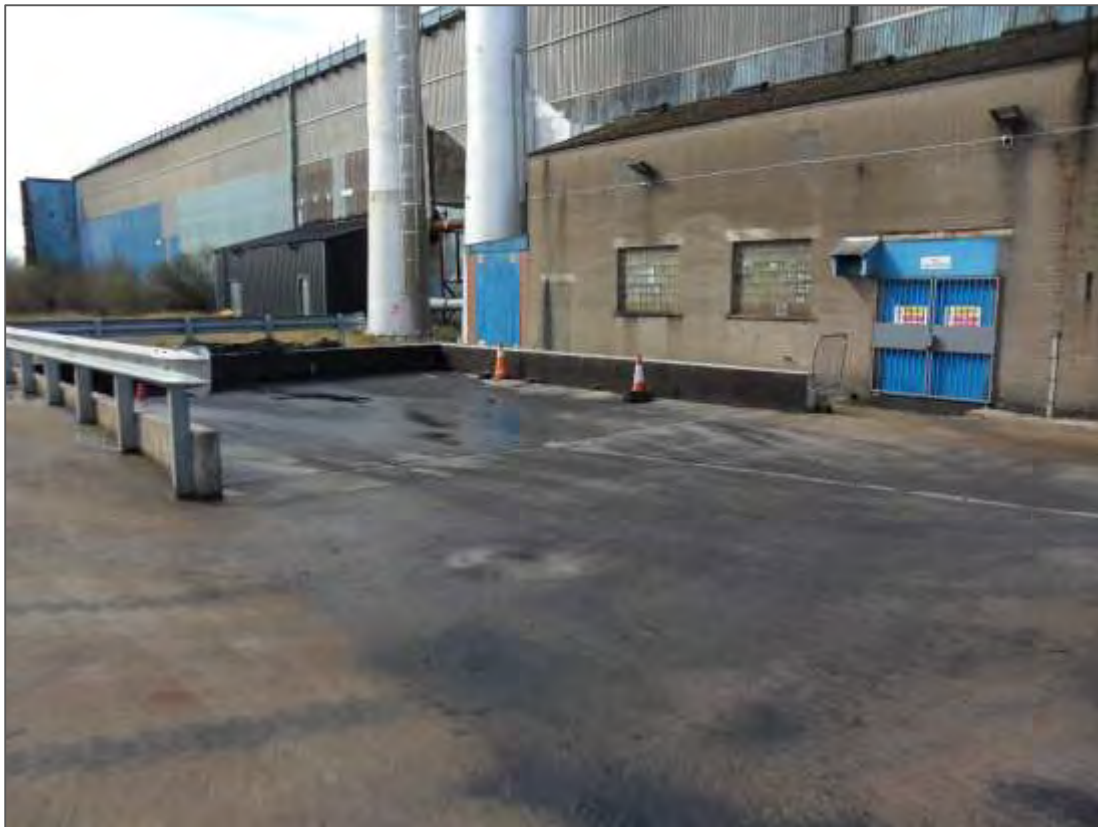
**Photograph 17: Bunded drainage area where the dredged scale from the quench ponds is left to drain prior to recycling.**

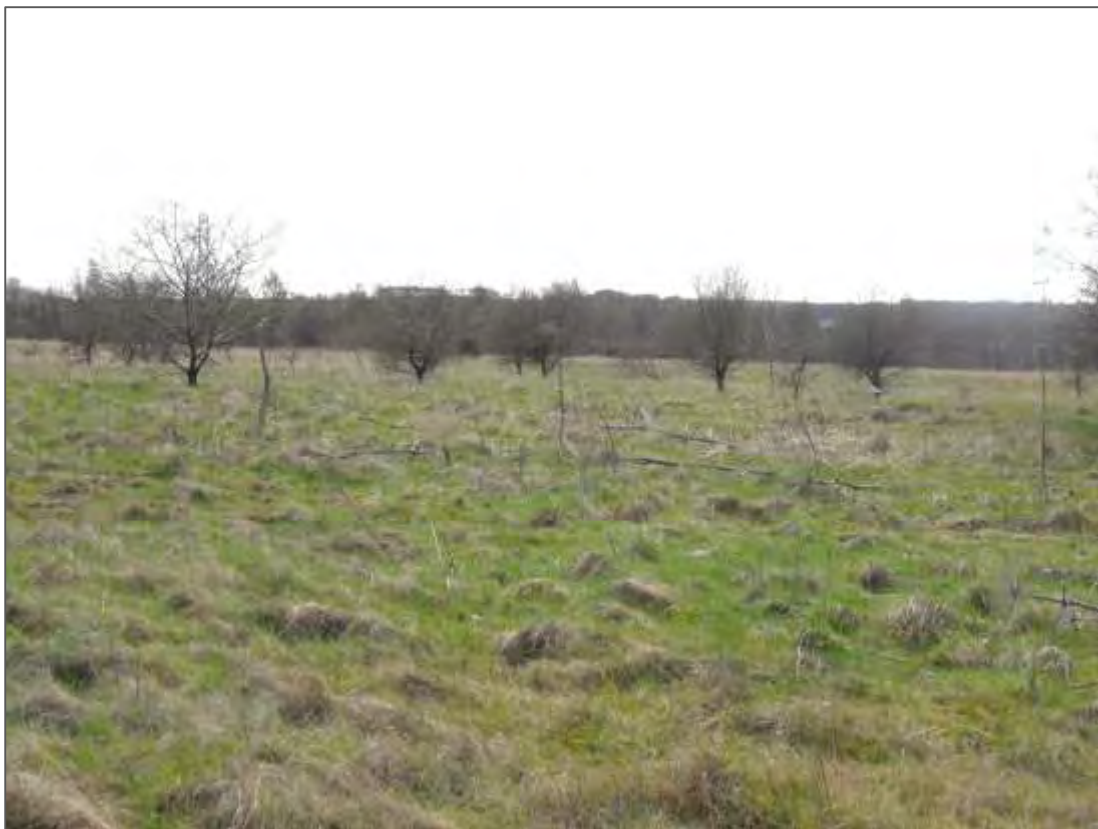
**Photograph 18: View south of the area formerly the location of the furnacing and casting bay. Currently used as open land with potential Giant Hogweed present in places.**

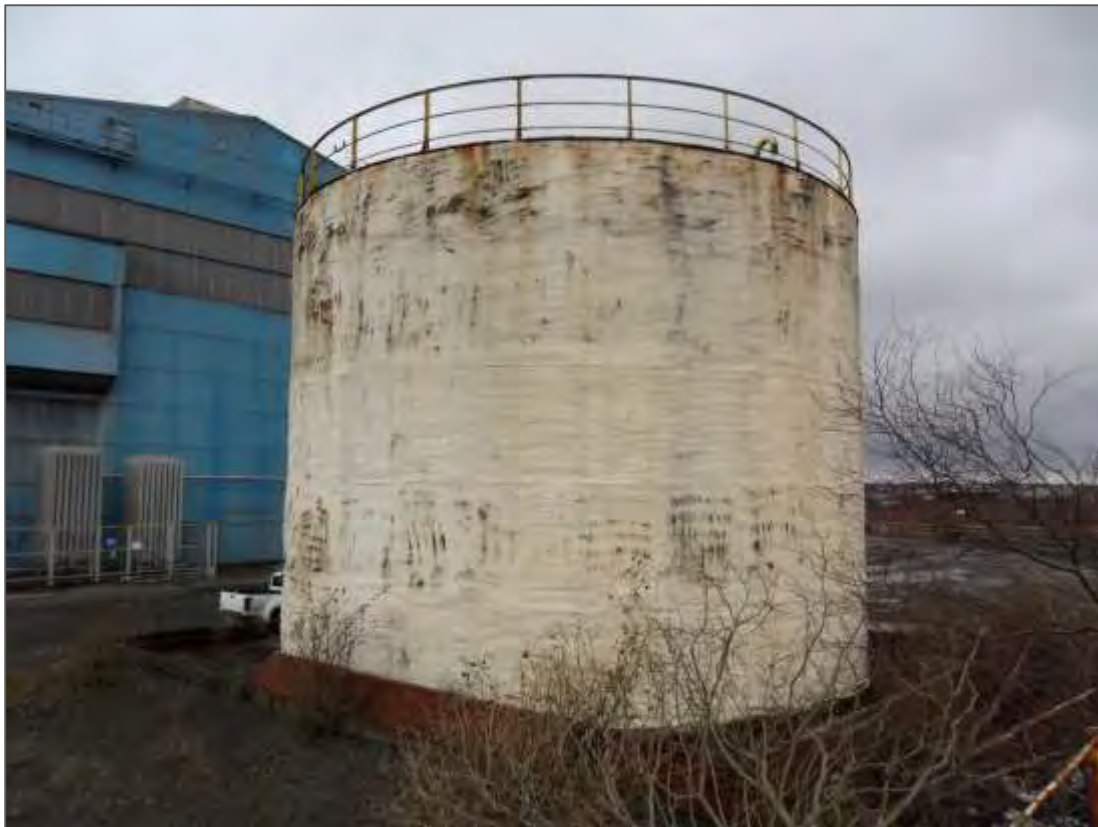
**Photograph 5: 'Former fuel oil' tank which TATA informed was emptied as part of the decommissioning of fuel oil pipelines.**

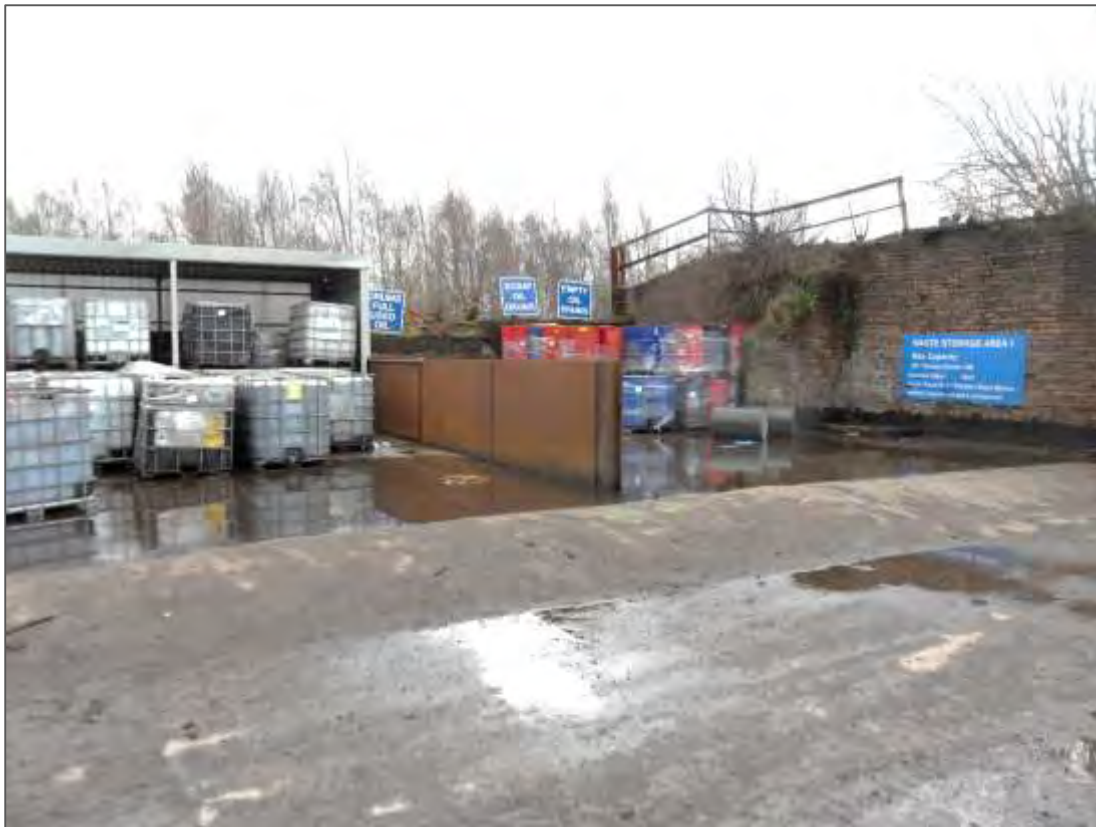
**Photograph 7: Empty barrel and recovered oil storage area awaiting removal from site. Note the flooded and inadequate bunding**

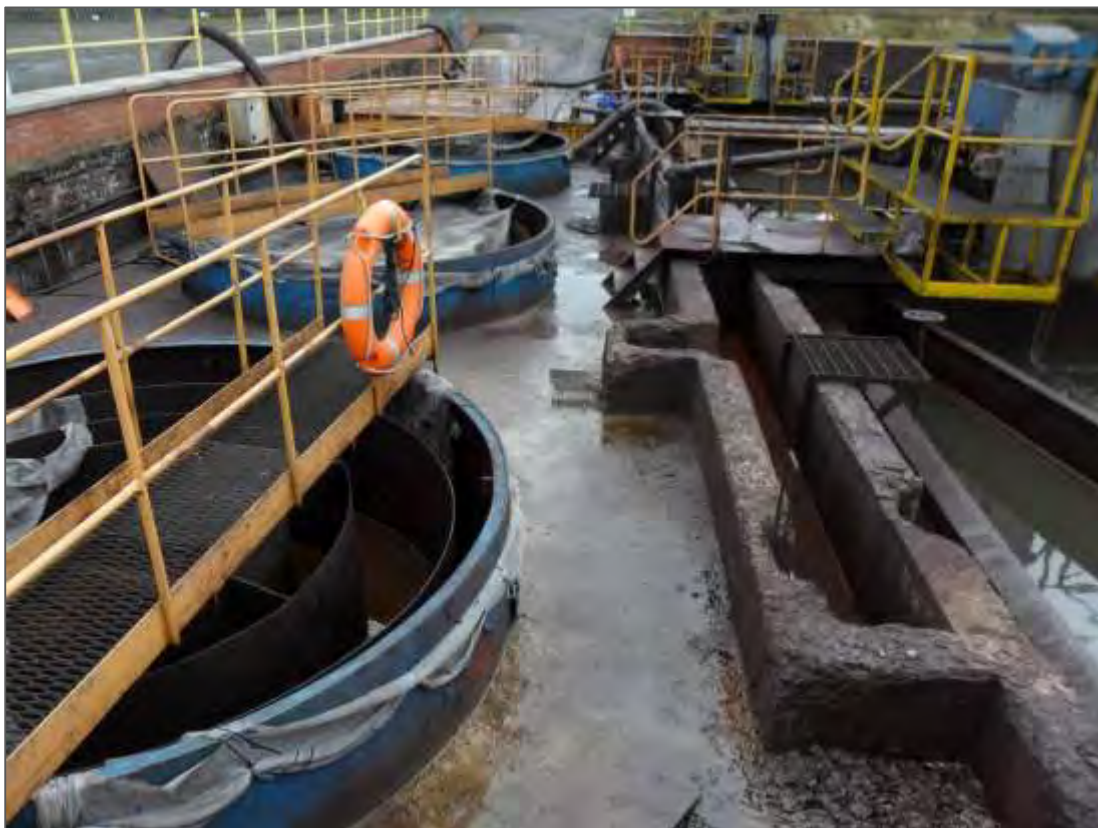
**Photograph 12: View south east of the Meadows water treatment facility with active oil recovery systems (belt skimmers) in action during walkover.**

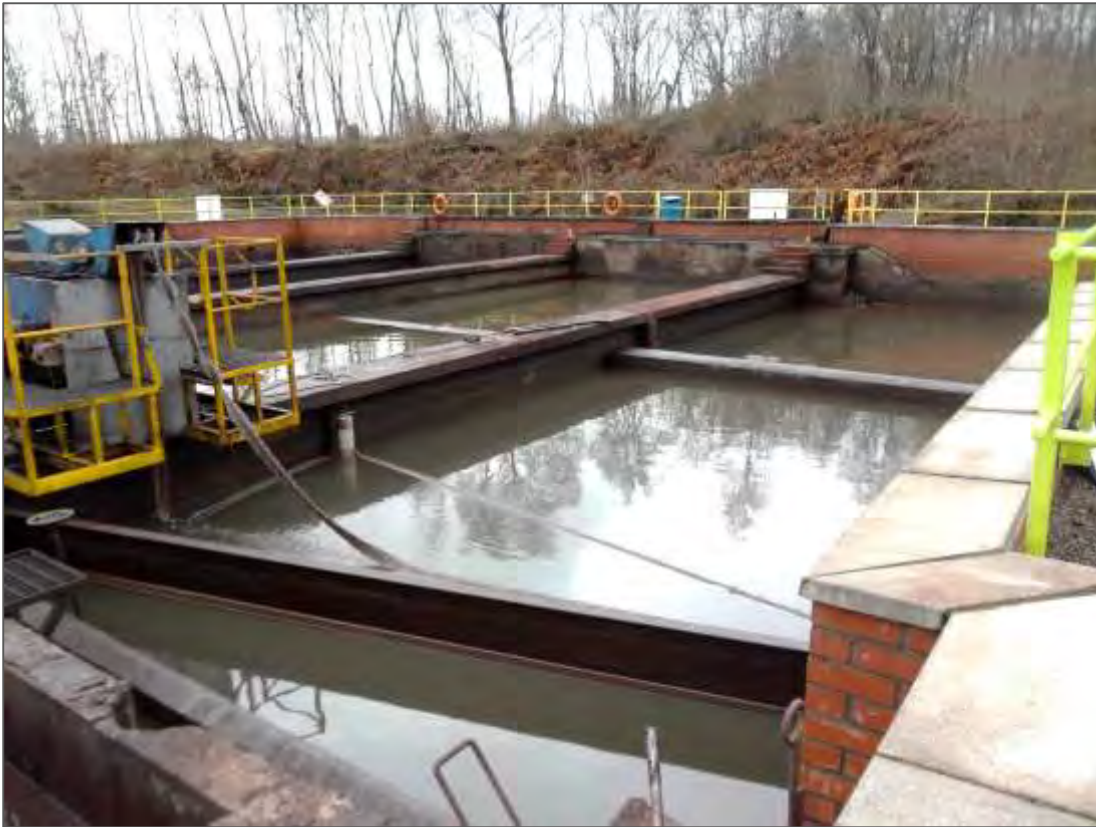
**Photograph 13: View south of the Meadows water treatment facility with active oil recovery systems (belt skimmers) in action during walkover.**

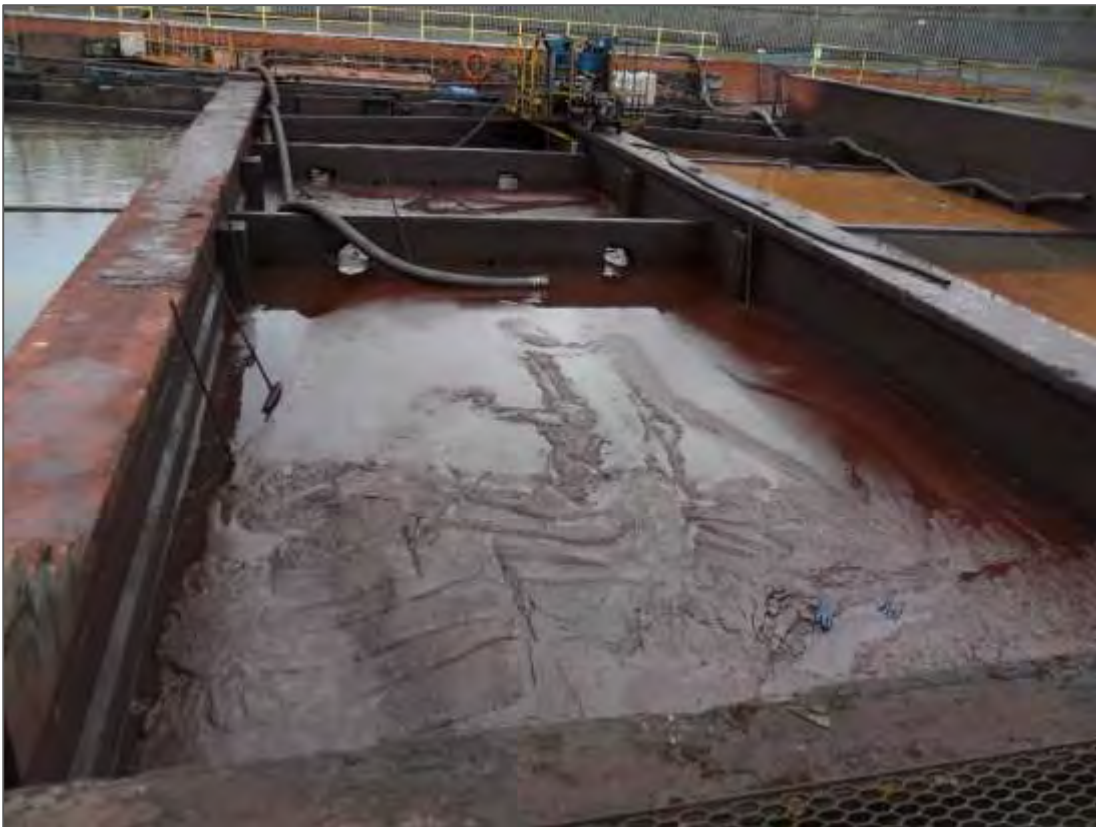
**Photograph 14: View north east of the number 3 compartment of the Meadows water treatment facility which has been drained to recover the reddish brown sludge.**

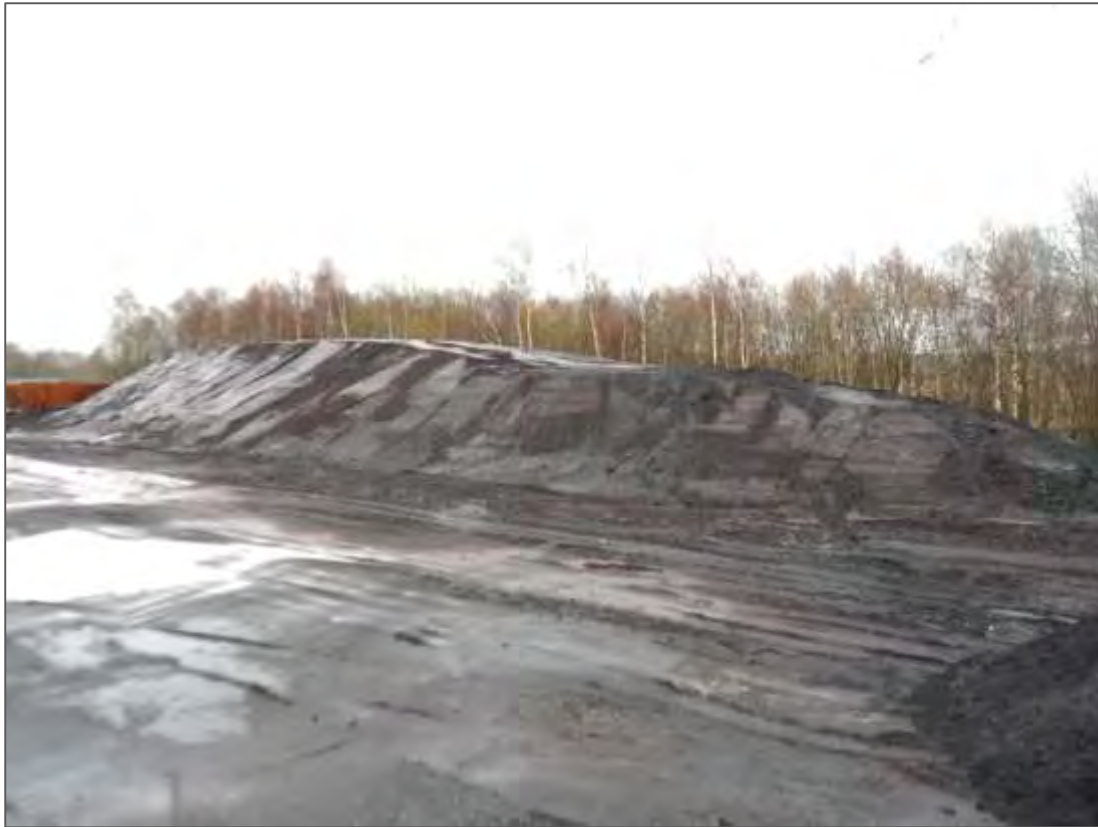
**Photograph 15: View north east of the historical stockpile of scale which TATA informed Atkins during the walkover, had 'some oil in'. Stockpile estimated at approximately 750m<sup>3</sup>.**

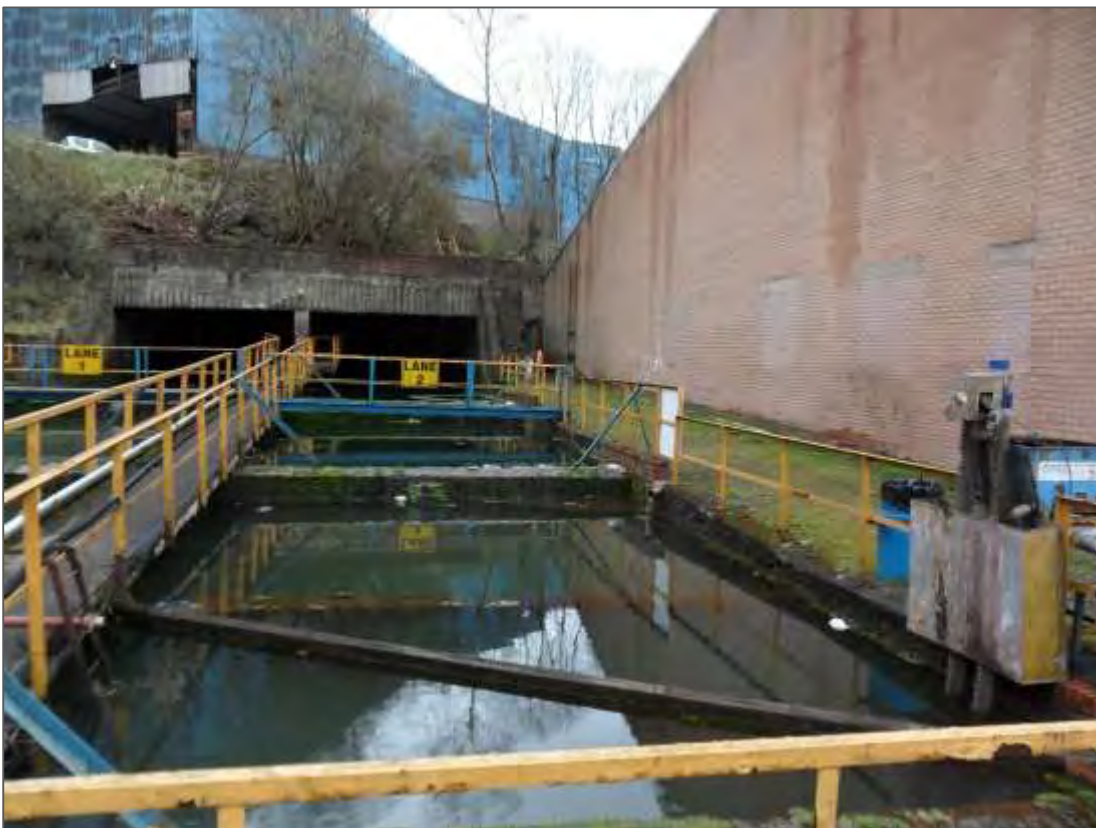
**Photograph 20: View south west of the primary separator facility at the 'Creamery'.**

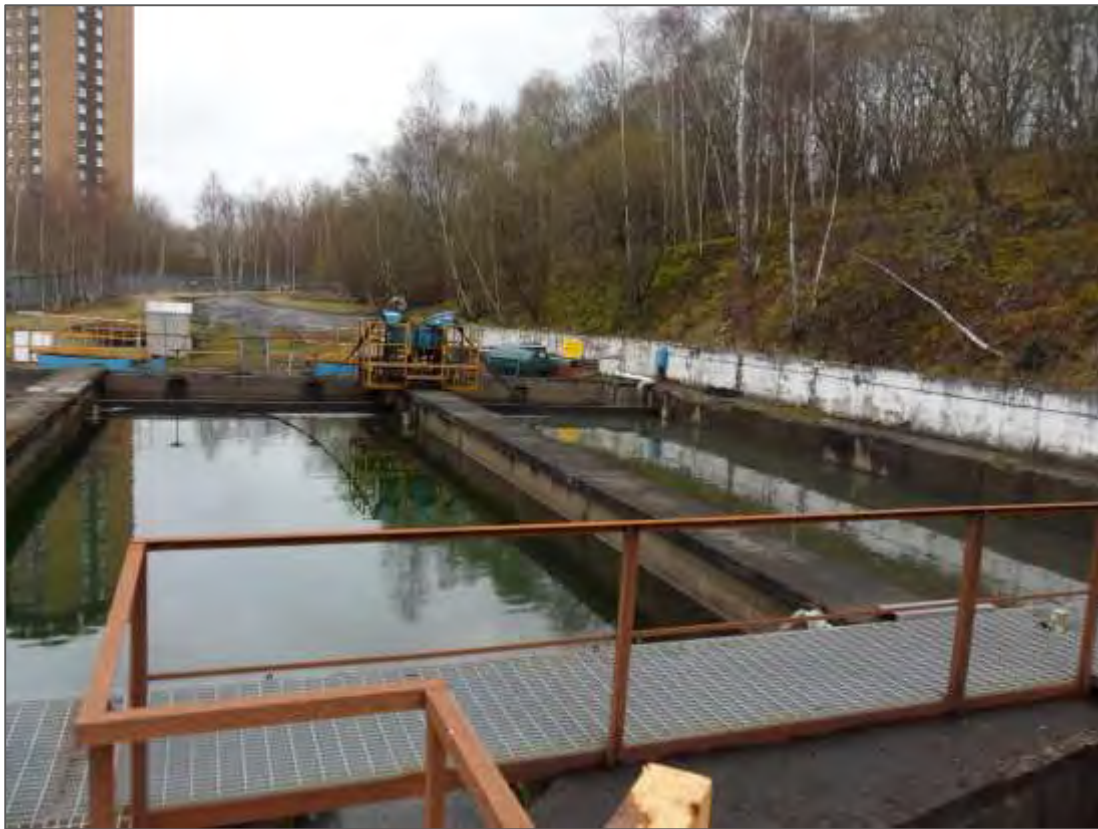
**Photograph 21: View north east of bays 3 and 4 of the water treatment facility with active oil recovery systems (belt skimmers) in action during walkover.**

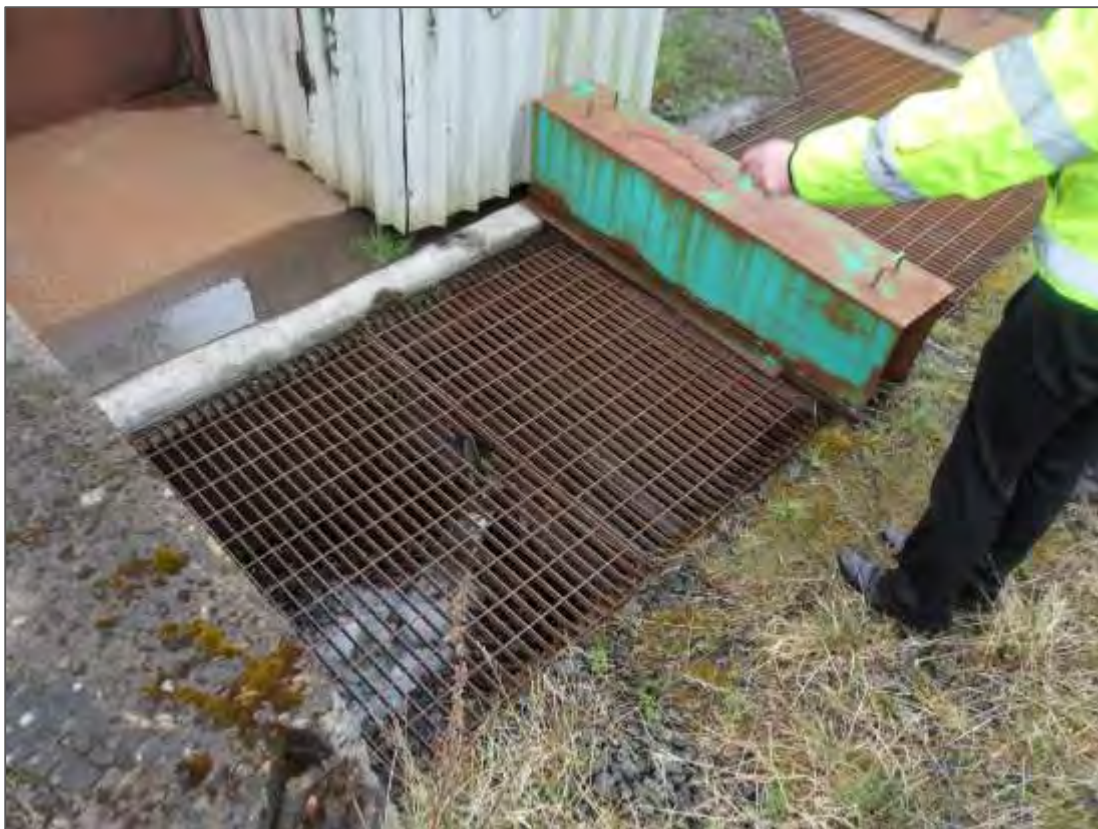
**Photograph 22: The 'v' notch water sampling point of which the creamery effluent is sampled prior to discharge to the Calder to the north.**

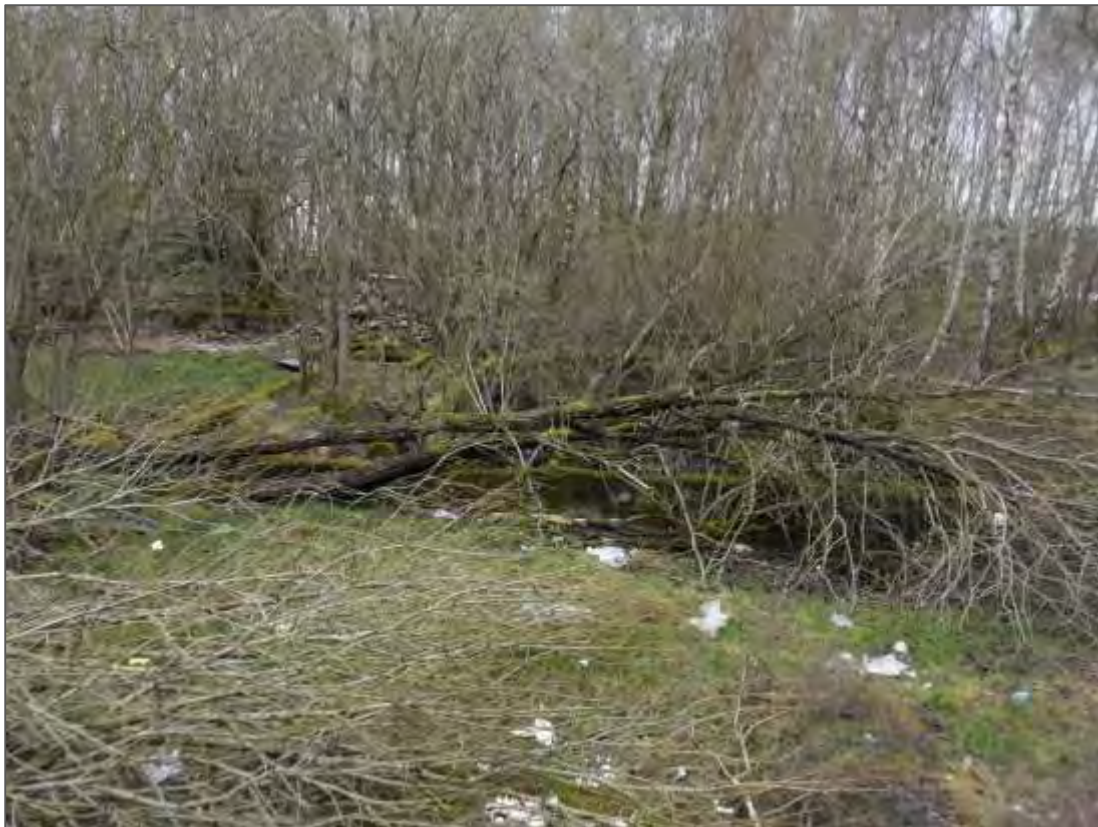
**Photograph 24: View north west showing the overgrown derelict footings of a former substation.**
