Annex A – NHS Update Meeting Paper for Ministerial Working Group on Building and Fire Safety (December 2022 but rescheduled for January 2023)

REINFORCED AUTOCLAVED AERATED CONCRETE (RAAC) – NHS POSITION

Annex B – Slightly amended NHS Update Meeting Paper for Ministerial Working Group on Building and Fire Safety (December 2022 but rescheduled for January 2023)

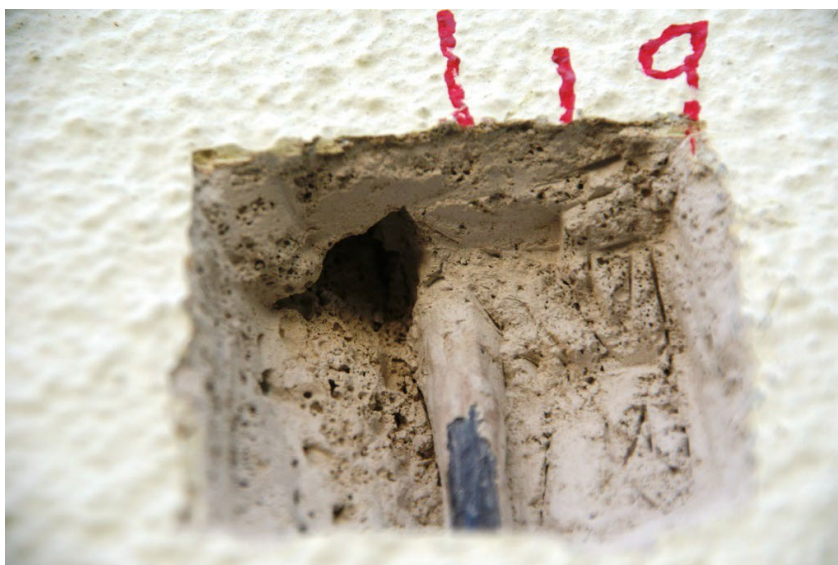
These include a variety of behaviours and phenomenon, including ghosting adjacent certain reinforcing bars, localised corrosion of the reinforcement particularly in wall panels bordering areas of high relative humidity and where water ingress has/is occurring, debonding of rebar coatings and/or failure of the AAC to bond with the coating etc. An example of ghosting is shown in the image included below.

An example of ghosting associated with a reinforcing bar in a wall panel

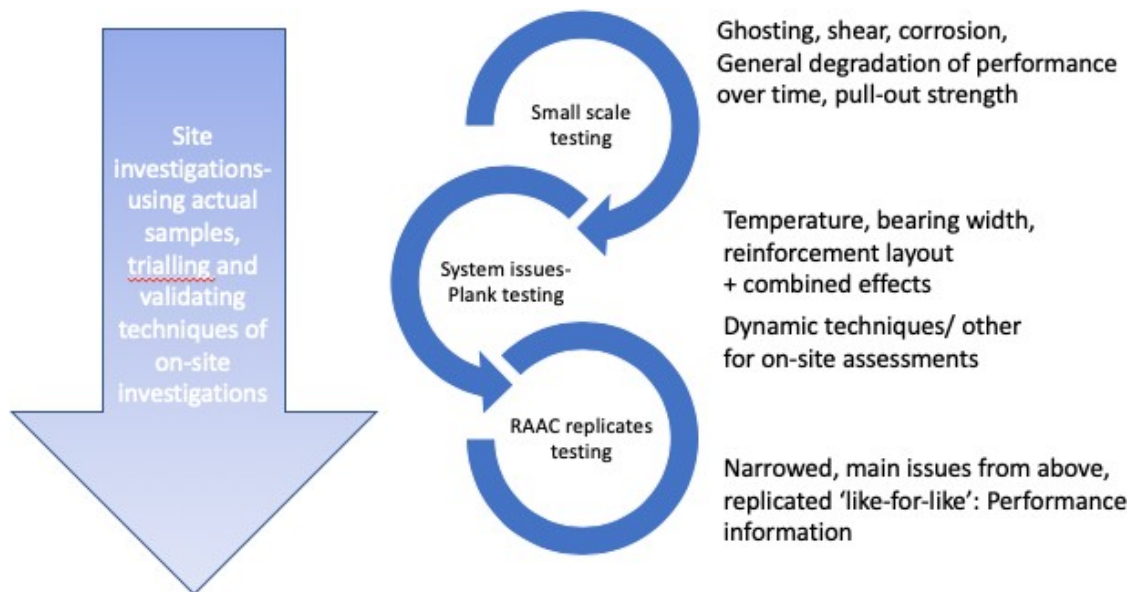
The following programme stages are envisaged, noting for each stage the main, potentially performance affecting, issues. The scale of samples to be tested is aligned with the issue being investigated, namely small-scale testing where material issues are being reviewed and larger plank testing for investigating global system, interacting performance factors. The fullscale bespoke RAAC plank testing is reserved for the final stages of testing, as some of the main performance factors have been confirmed and quantified. The design of these planks is intended to incorporate the 'worst-case' combination of issues where possible.

As much as possible, site material will be sourced and tested, aligned with the programme shown here. An additional key aspect of the work is to trial non-destructive assessment techniques, such as dynamic testing and radar technology. This study is aimed at creating a database of benchmark results established on material with 'known' defects, so as to aid future on-site investigations and analysis of findings on RAAC buildings in practice.

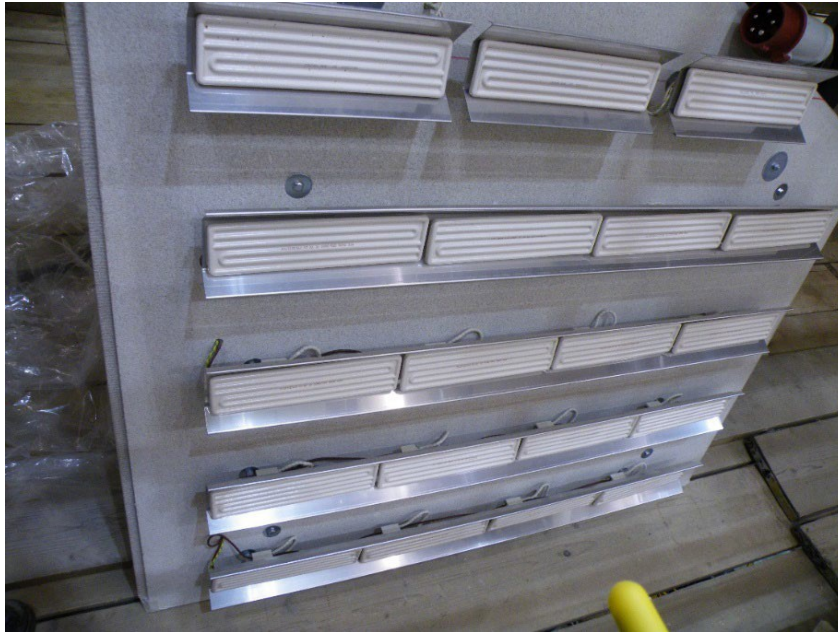
Typical heating array panel

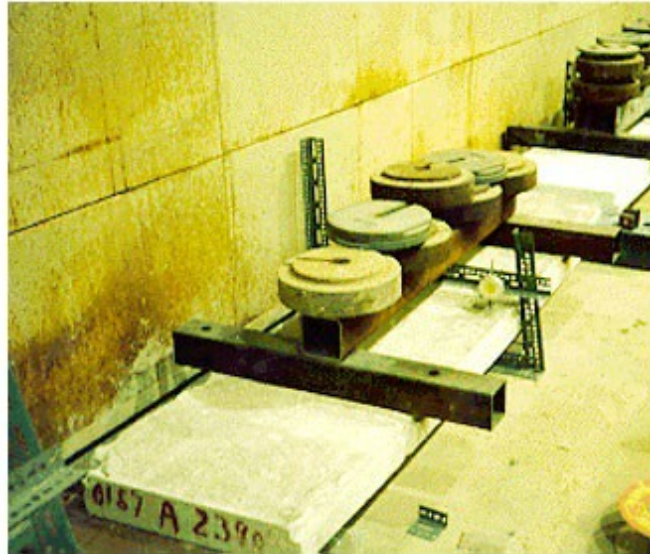
For the system testing, test planks and RAAC replica, as well as RAAC whole planks removed site, a 1/4 point static loading configuration will be used, matching BRE's method used in the 1995 test programme.

Medium-duration (7 weeks) testing of RAAC panel loaded with panel design load during the first series of 1995 tests

Displacement transducers will continuously monitor the mid span and end bearing displacements whilst high level and bearing level videos will record the behaviour of each test plank during the loading cycle and up to failure.
