Inspection Defect Summary Report

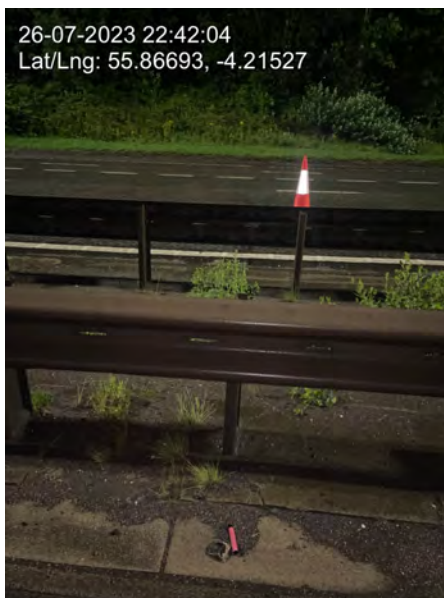
26/07/2023

3a - Are the posts at the correct spacing?	No
3a - If no, state location and degree of issue: Incorrect spacing in post.

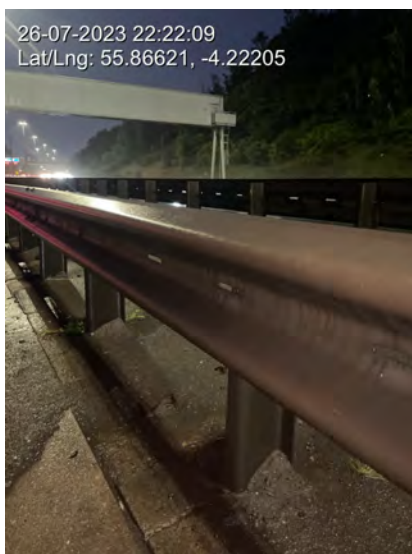
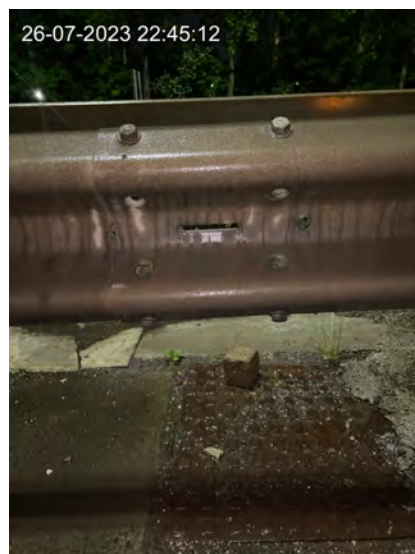
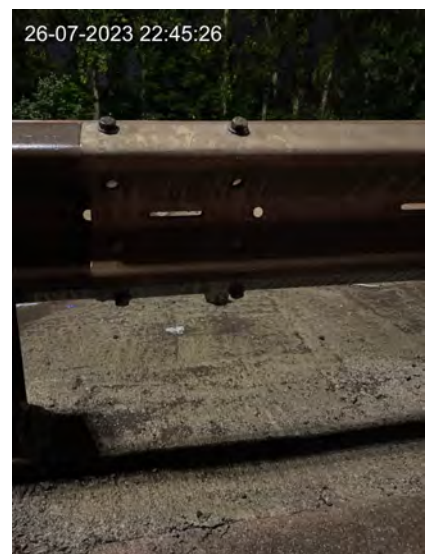
4a - Do beams overlap in the correct direction?	Yes
4b - On standard beams have the correct size of post screws been used and assembled correctly?	No
4b - If no, state location and degree of issue: Missing post bolts and multiple missing lap bolts

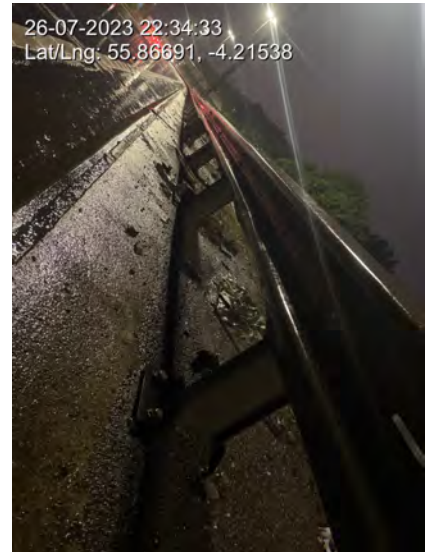
4d - Are the beams in a satisfactory condition?	No
4d - If no, state location and degree of issue: Multiple hit/damaged beams

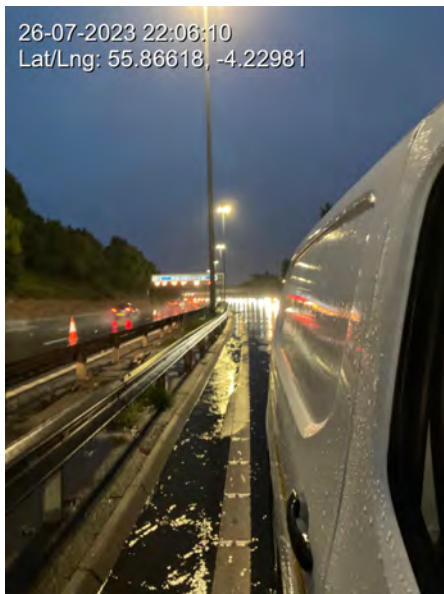
26/07/2023

Rate the severity of the corrosion generally (1 = No Corrosion, 5 = Severe Corrosion)	1
Rate the extent of corrosion (0% = No corrosion evident anywhere on system, 100% = Corrosion evident throughout entire installation)	0%
Average thickness of galvanising (microns)	80
General commentary on corrosion: No corrosion present

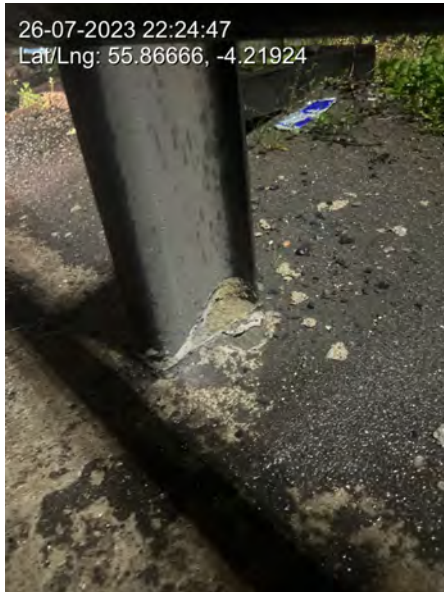
26/07/2023

3a - Are the posts at the correct spacing?	Yes
3b - Are the post foundations secure?	Yes
3c - Is the top of each concrete foundation less than 75 mm above ground level?	Yes
3d - Are the posts correctly orientated, i.e. radiused edge of post presented to direction of traffic flow?	Yes
3e - Are the post beddings secure?	Yes
3f - Where surface mounted posts are used, are the anchor bolts secure and in satisfactory condition?	Yes
3g - Are the voids for the socketed posts suitably filled?	No

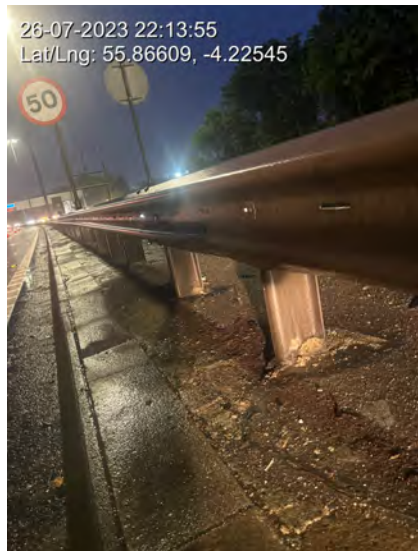
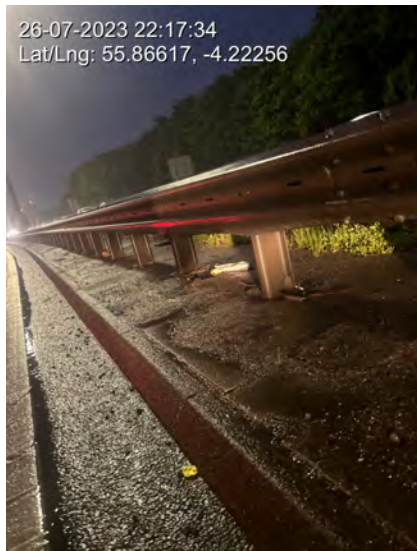
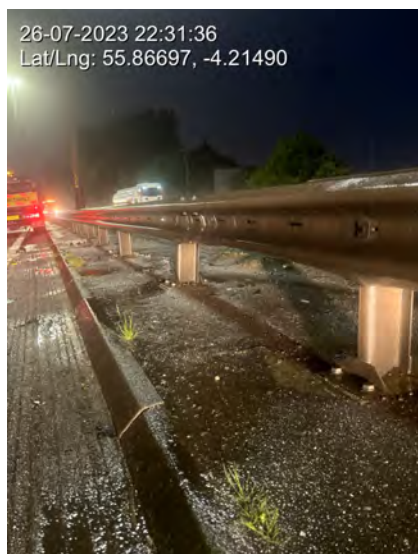
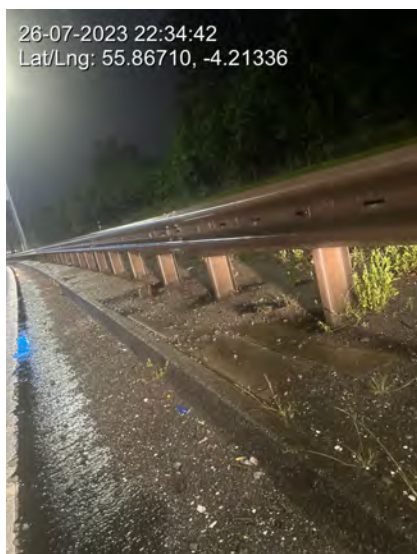
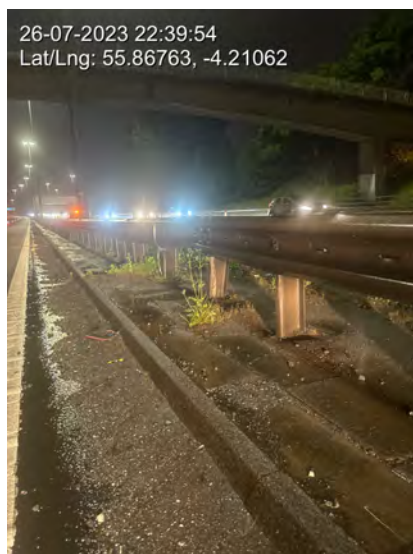
4a - Do beams overlap in the correct direction?	Yes
4b - On standard beams have the correct size of post screws been used and assembled correctly?	Yes
4c - If present, is the antiglare fencing in good condition?	N/A
4d - Are the beams in a satisfactory condition?	No
4d - If no, state location and degree of issue:

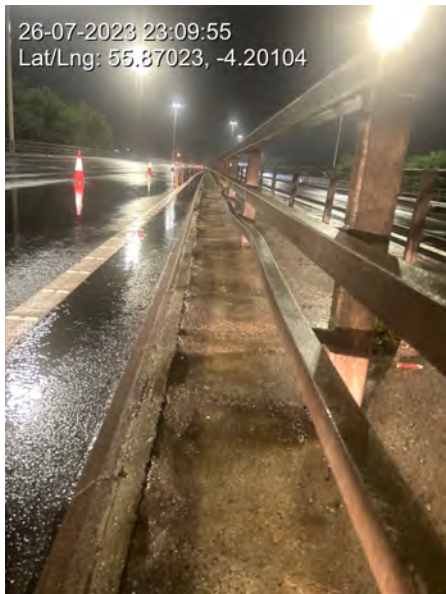
26/07/2023

Is there any impact damage to the parapet?	Yes
If yes state extent of damage: Bottom rail damaged

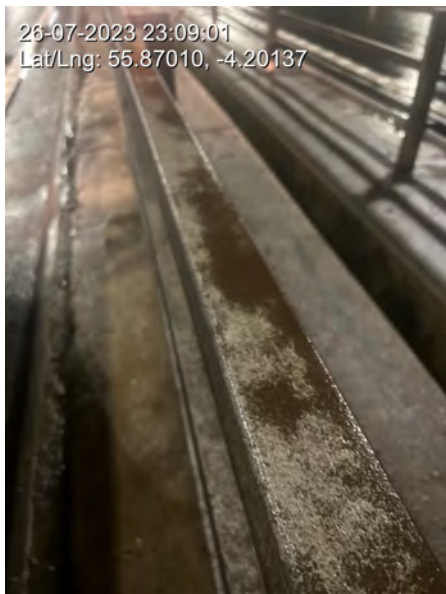
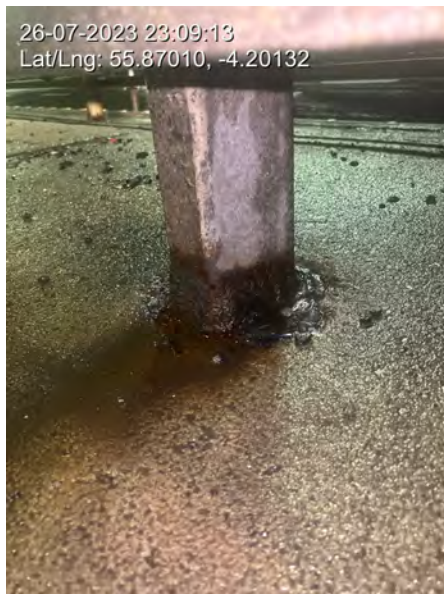
Rate the severity of the corrosion generally (1 = No Corrosion, 5 = Severe Corrosion)	3
Rate the extent of corrosion (0% = No corrosion evident anywhere on system, 100% = Corrosion evident throughout entire installation)	30%
Average thickness of galvanising (microns)	80
General commentary on corrosion: Bottom of posts starting to corrode and beam showing signs of it
