Case No: 2025-0389 Date of visit: 09/10/2025

Site No: FS0237 Site Name: Gorsten
Business No: FB0119 Business Name: Mowi Scotland Ltd

Fish Health Inspectorate visit report

ENHANCED CONTAINMENT INSPECTION

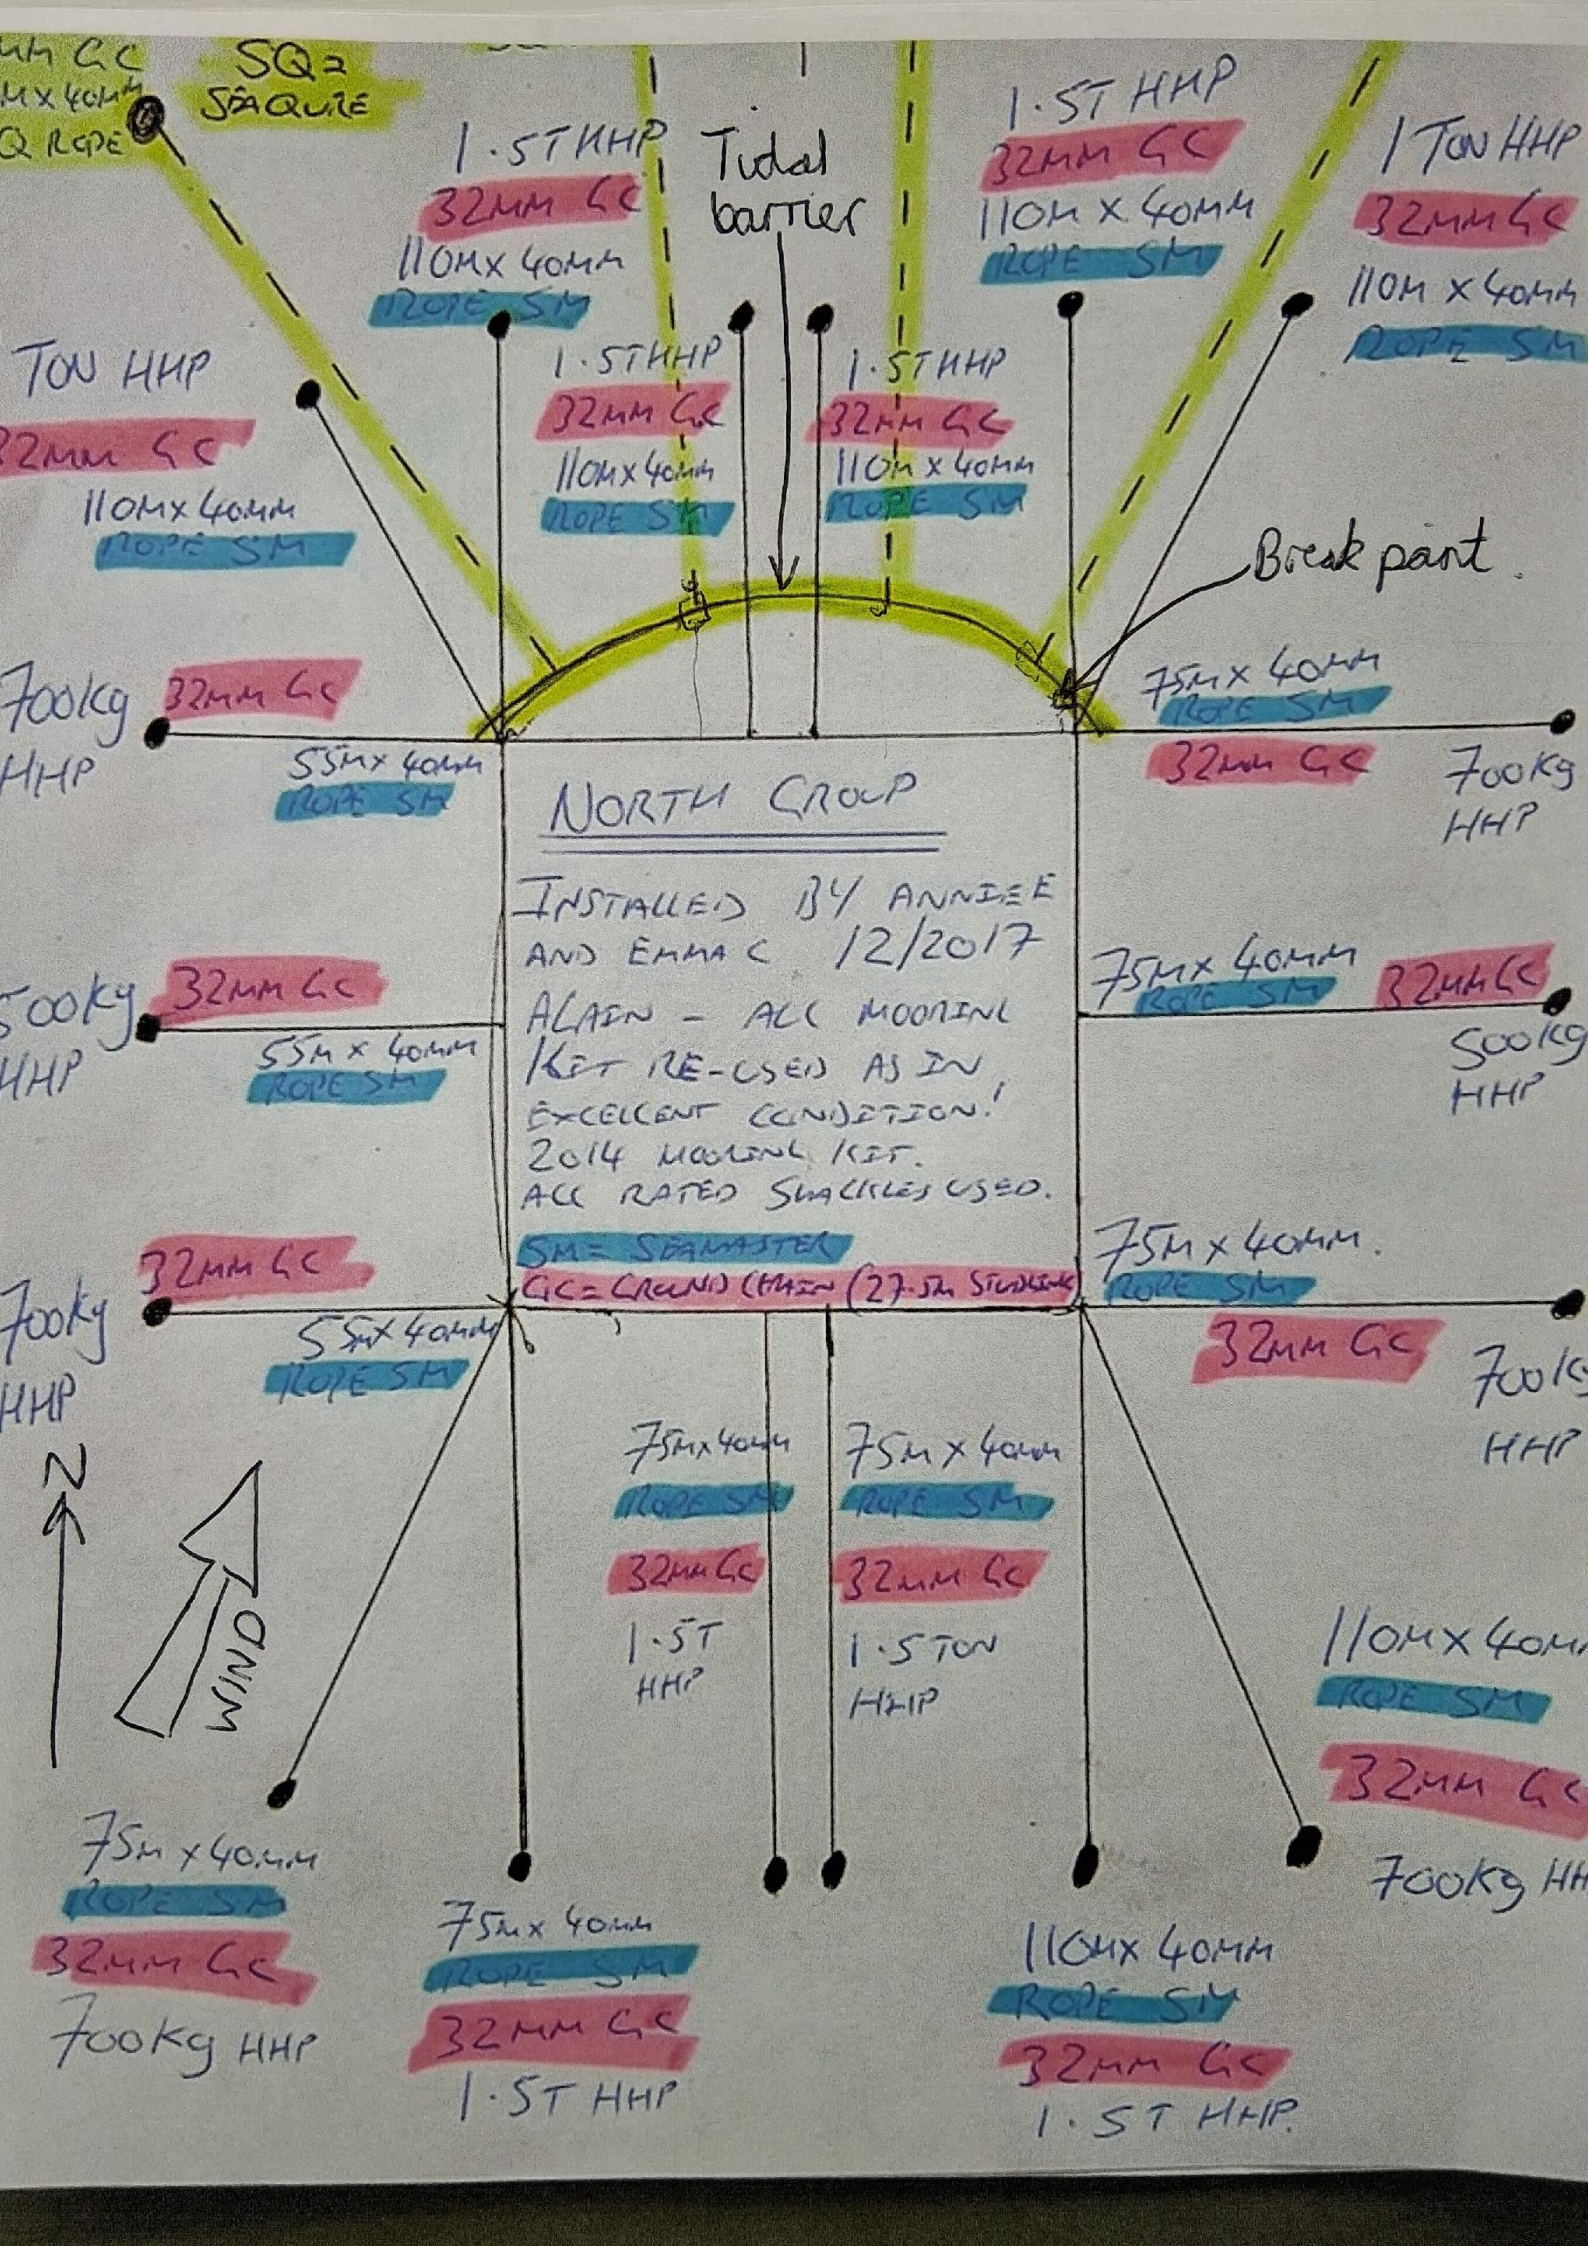
Breach in containment discovered Saturday (04/10/2025) morning. All power to the cameras lost during the storm as these are powered using mains power. The breach in containment was discovered by [redacted]. The tidal barrier at the north of the site remained in place and the cage group moved north, blown by the wind and tide, towards the barrier. It is estimated by the site manager the site moved at least 10m, although individual anchors moved varying distances. A metal bracket that connected the tidal barrier to an anchor chain broke (see diagram in attachments) and the chains that connected the tidal barrier to the cages also broke in the storm. The tidal barrier itself is not thought to have broken, it is the bracket and chains that are thought to have broken causing the eastern end of the barrier to move in the waves and tide freely. The tidal barrier has been submerged since the incident and inspection has been difficult due to bad weather. The end of the tidal barrier came in contact with the cage net causing approximately four holes along the northern side of cage 2. The plastic at the end of the tidal barrier had developed sharp projections due to the tidal barrier striking the metal cage group. According to the area manager, mobile phone signal was down at the time of the incident which is thought to have hampered getting boats together to stabilize the cages. A wellboat, two mooring boats and a large multipurpose boat from Inverlussa arrived on site Sunday (05/10/25). The wellboat began to remove fish at 12:20 on Sunday. According to the wellboat log, 5,028 fish were recovered from the cage from the 80,591 that were thought to be in the cage making a total loss of 75,563 fish. The remaining fish were moved to pen 8. Mooring boats began work on repositioning the mooring anchors on Sunday. The damaged net and tidal barrier are still on site. The tidal barrier maybe removed completely later in cycle. The plans for the tidal barrier will be discussed in the meeting in mid-October. No attempt to recapture fish was made due to bad weather. Samples from the remaining fish from cage 2 were sent for emergency sampling at the Mowi lab to establish if antibiotic residue are still present in the fish. Results from these tests have not been reported yet. There has reportedly been no increase in seal activity since the incident. Seals have been continually observed since August and are thought to have killed fish. Manager does not think any salmon will get past the Corran narrows due to high seal activity in the area. A known seal haulout is present close to the narrows with reportedly more than 100 seals active in the area. Reportedly many fishermen have been fishing in the area for salmon since Saturday but the manager is not aware of any fishermen catching any salmon. Reportedly no additional checks were done on barrier before the incident. The barrier is too heavy to inspect with the work boat usually used on the site.

Four holes found in total on the north side of the net closest to the tidal barrier. Two of these bigger holes are rectangular and approximately 4-5 meters wide and between 1-5 meters below the water line. Two of the smaller holes were about 2 metres wide at about 4 metres from the bottom of the net. Net is 12m deep. Damage reported at 8am on Saturday. According to site staff, mobile phone signal was reportedly OK at the site on Saturday morning. Mobile signal in other areas of the west coast of Scotland may have been poor or absent

SQ2 SQUARE
1.5T HHP
32MM GC
110M X 40MM ROPE SM
Tidal barrier
1 TON HHP
32MM GC
110M X 40MM ROPE SM
Break part
700KG HHP
32MM GC
55M X 40MM ROPE SM
75M X 40MM ROPE SM
NORTH CROP
INSTALLED BY ANNIEE AND EMMA C 12/2017
ALAIN - ALL MOORING KIT RE-USED AS IN EXCELLENT CONDITION!
2014 MOORING KIT.
ALL RATED SHACKLES USED.
SM = SEAMASTER
GC = GROUND CHAIN (27.5M STUDLINK)
500KG HHP
700KG HHP
N
WIND

Photo 1: Clamps used to attach tidal barrier floatation tube to mooring chain. One of these clamps broke during the storm.

Photo 2: Holes in the net of cage 2. A member of site staff stands next to one of the larger holes

Photo 3: Holes in cage 2. The hole in the centre of the photo is one of the smaller holes.

Photo 4: Most eastern end of the tidal barrier floatation tube, partially sunken with a metal fixing (which was used to secure the floatation tube to the cage group using chains).

Photo 5: Close up of the eastern end of the floatation tube with metal fixing.

It is recommended that in accordance with A Code of Good Practice for Scottish Finfish Aquaculture (CoGP) (Chapter 4, section 4.11) procedures and records should be put in place to demonstrate that a suitably qualified and experienced person(s) must inspect and approve pen systems and the attached tidal barrier.

It is recommended that in accordance with A Code of Good Practice for Scottish Finfish Aquaculture (CoGP) (Chapter 4, section 4.16) procedures should be developed and implemented to ensure the tidal barrier attached to the facilities and its mooring components are inspected in accordance with a documented standard operating procedure and a documented inspection plan which is based on risk assessment.
