Central Belt Barrier Strategy - Workshop

24th November 2014

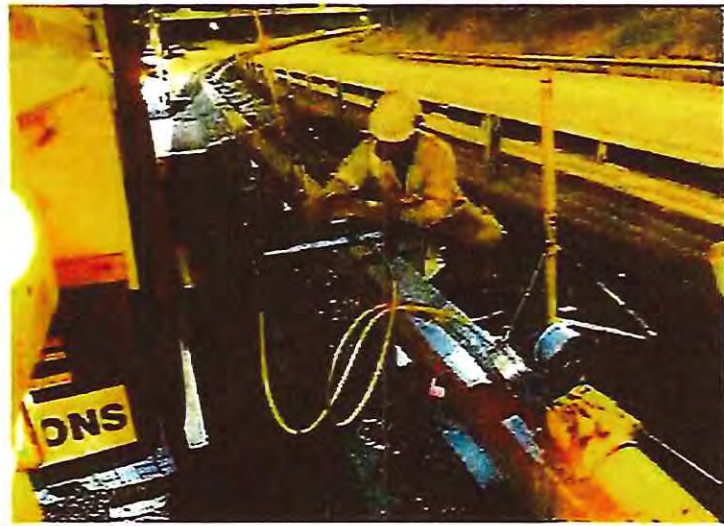
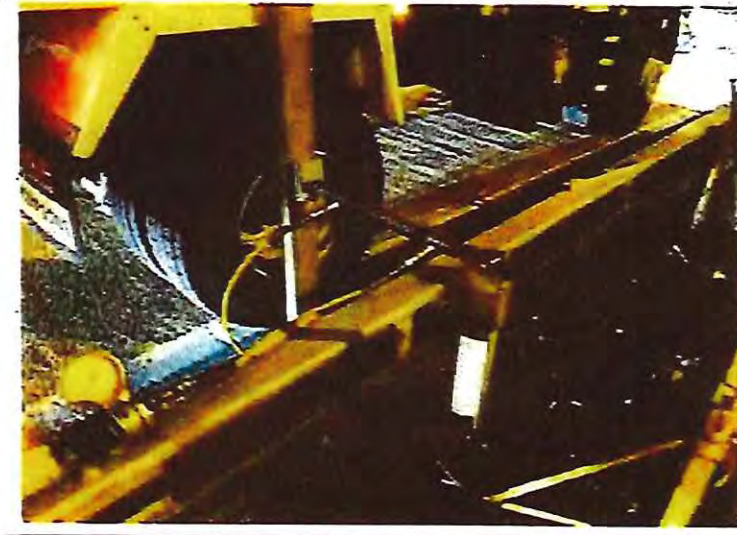
4.0 Push Testing

- A load is applied to the post in 1000N increments and the deflection of the post, in reference to a datum peg, is measured.
- For the type of barrier and size of posts on the network if a deflection of greater than 100mm is recorded then the post is deemed to have failed.
