Freedom of Information Request
Reference FOI/19/02250

From: redacted 11(2)
Sent: 01 May 2019 12:45
To: redacted 11(2)
Cc: redacted 11(2)
Subject: redacted - SW - Lesmahagow - redacted 11(2)
Follow Up Flag: Follow up
Flag Status: Flagged

Subject: M74 jct 10 Manhole

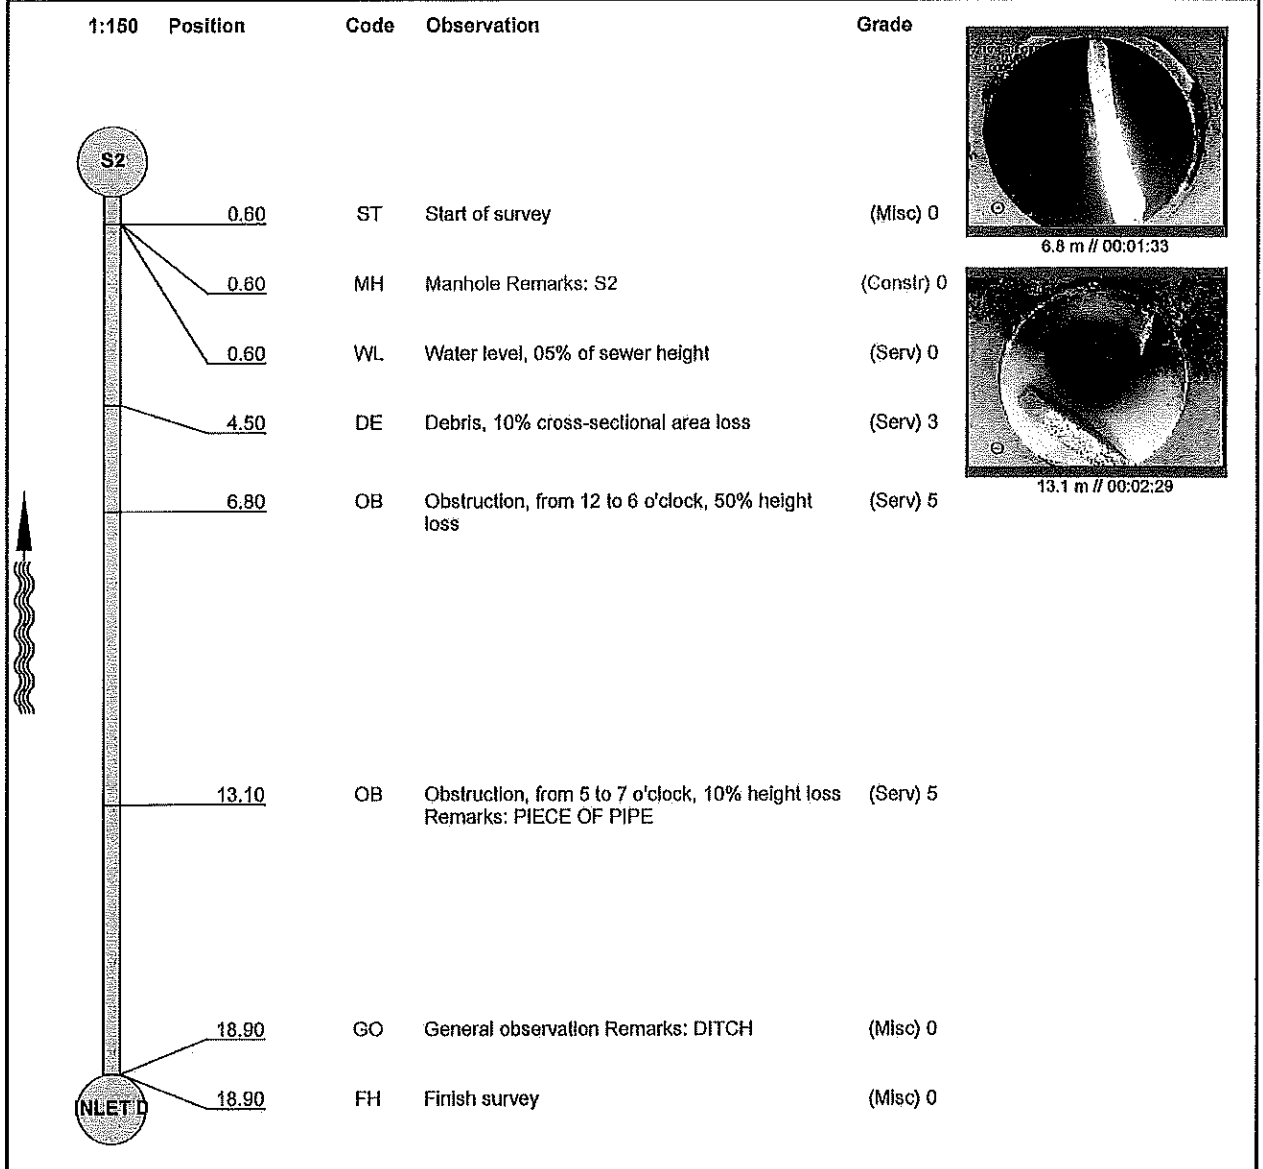
Use: Surface water Year laid : Z Purpose : Sample survey to determin asset condition Total length :	Pipe shape : Circular Pipe size : 225 mm Pipe material : Vitrified clay Lining :
--	---

Structural Defects					Constructional Features				
Service Defects					Miscellaneous Features				
STR no def	STR peak	STR mean	STR total	STR grade	SER no def	SER peak	SER mean	SER total	SER grade
0	0	0	0	1	3	10	1.16	22	6
