## Port of Ardrossan Asset Condition Survey

20 April 2016  
Final Report  
PB3783

Document title Port of Ardrossan  
Asset Condition Survey  
Document short title Ardrossan Asset Condition Survey  
Status Final Report  
Date 20 April 2016  
Project name Ardrossan Asset Condition Survey  
Project number PB3783  
Client CMAL  
Reference PB3783/R106/301998/Edin

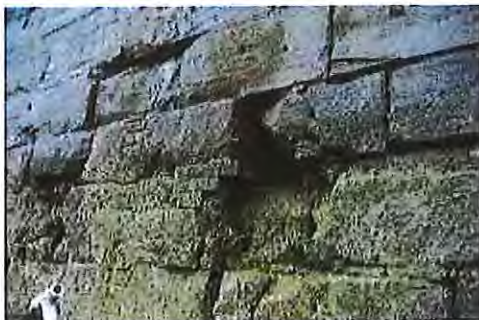
Photo 2

The 30m long section of masonry wall is in a reasonable condition for its age (photo 1). There are however a number of small voids and gaps between the blocks apparent along its length (photos 2 & 3). The largest such void identified measured 450mm x 500mm x 410mm deep.

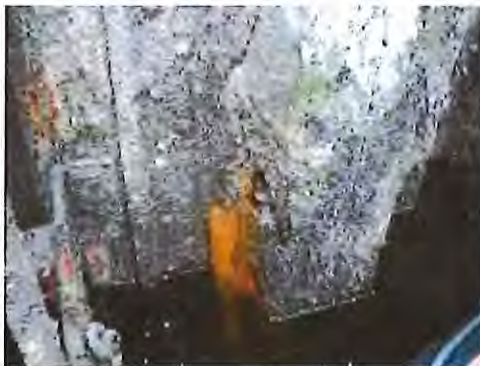
Photo 6

In the intertidal zone and splash zone the orange deposit associated with ALWC is clearly evident along the length of the wall (photo 5). The piles were holed in a number of locations including adjacent to fender 2, at the ladder between fenders 5 and 6 (photo 6) and at the ladder between fenders 6 and 7 (photo 7). Each of these holes was typically of the order of  $100\text{mm} \times 100\text{mm}$  although one measured  $600\text{mm} \times 100\text{mm}$ .

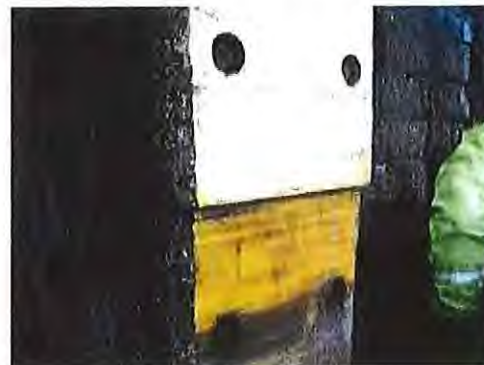
Photo 9

The fenders are generally in a fair condition however a number of defects were observed. These defects include loose and missing bolts at the connections between the MV elements and the quay (photo 12), face shields pulling from the MV elements (photo 9), abrasion damage to face shields and missing bolts at the connection between the MV elements and the face shield. In addition fenders 10 and 14 on the roundhead structure have been completely removed (photo 8).

The UHMW-PE face shield is intended to act as a structural component of the fender and is bolted directly to the MV element. This should generally be a single length to facilitate transfer of berthing energy loads between elements. It was observed on the fenders along the Calmac Berth that many have two or more shorter lengths of shield making up the necessary length. In addition to the failure to transfer load this makes the shield more susceptible to being pulled from the MV elements (photos 9 & 10).

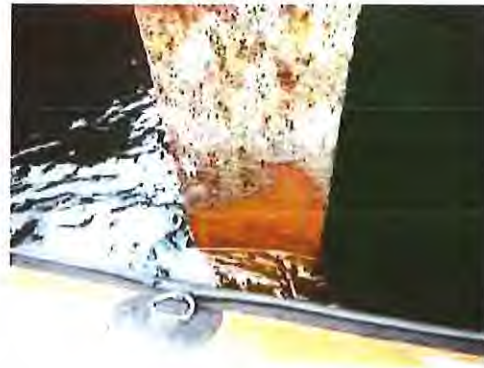
Photo 15

The steel piles are generally in a fair condition above the tidal zone and towards the deck soffit. There is rust staining but there does not appear to be significant loss of section (photo 16). Within the intertidal zone the piles are generally covered in hard and soft marine growth with orange deposit indicative of ALWC to the flanges over the full length of the piles (photos 14 & 15).

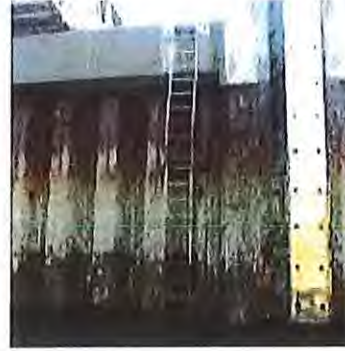
Photo 19

The ladder between fenders 3 and 4 is corroding and covered in marine growth (photo 19). It is slightly misaligned following an impact but remains secure. There are however traces of ALWC to the ladder stiles and brackets.

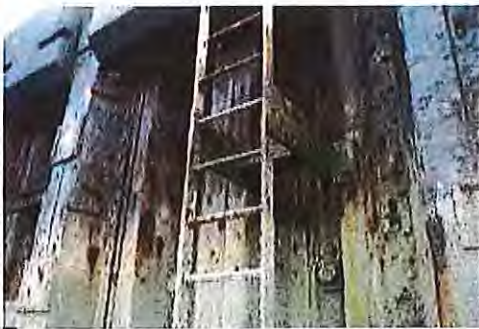
Photo 20

The ladders between fenders 5 and 6 (photo 20) and fenders 6 and 7 are corroding and covered in marine growth but remain secure. There are again traces of ALWC to the ladder stiles and brackets.

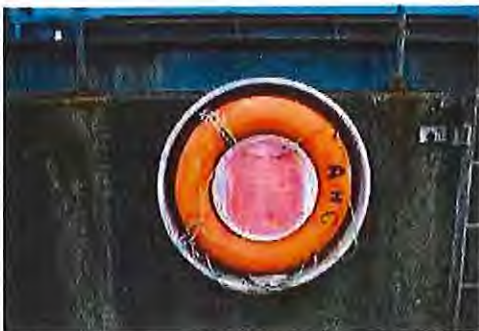
Photo 22

There are two life buoys located on the Calmac Berth. The first is located adjacent to the linkspan (photo 22). The instructions are fading and not clearly legible and the rope is weathered. The second is located adjacent to fender 4 (photo 23). This has no instructions and again the rope is weathered. Furthermore the position of this life buoy is not clearly visible.

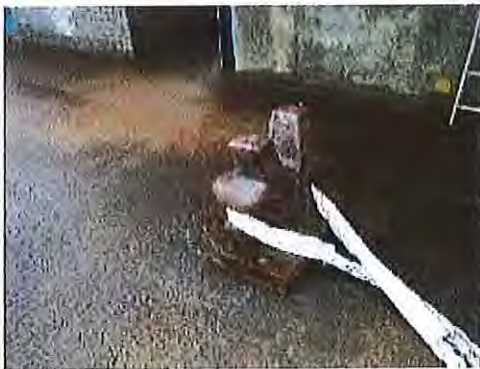
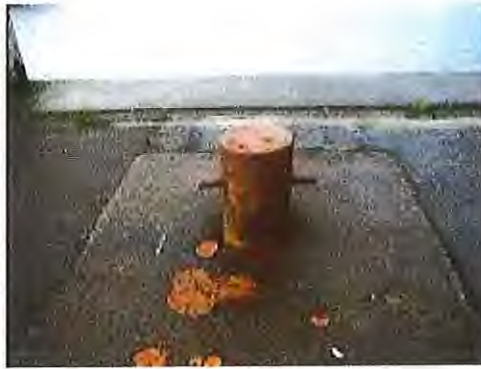
There are ten mooring bollards located along the length of the berth (photo s 30 & 31). The capacity of these is unknown. All of the bollards remain in sound condition with no defects apparent.

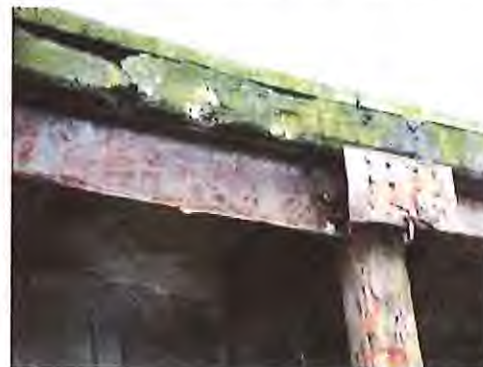
Photo 33

The section of suspended deck is in an extremely poor condition throughout its length. The longitudinal edge beams are extremely corroded with significant loss of section evident (photo 33). This is especially prominent at the North end of the berth above the old stairs. This first section of deck is supported by a single H-section steel pile and the longitudinal beam has completely corroded away on either side of the pile (photo 32).

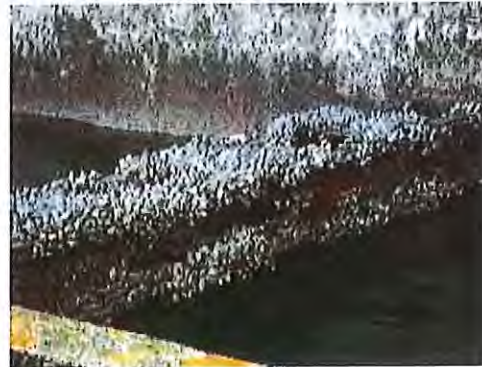
Photo 35

The transverse bracing members are also corroding with loss of section evident. This is particularly prominent to the lower braces (photo 35). These are in the intertidal zone and orange deposits are clearly visible. One of the members towards the linkspan end has failed completely and is no longer connected to the pile (photo 34) whilst another has become detached from the quay wall.

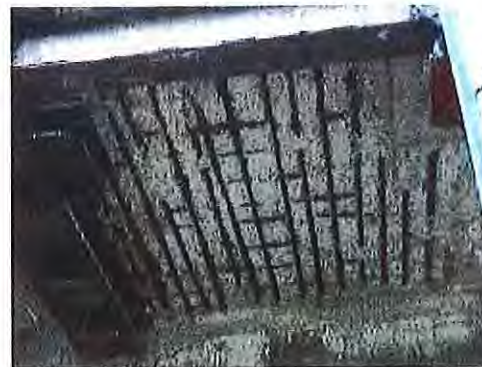
Photo 37

There are numerous patches on the suspended deck soffit where concrete has spalled (photos 36 & 37). At each of these locations the reinforcement is clearly corroding. It would appear that there is minimal cover to the reinforcement at these locations and this may be a significant contributing factor.

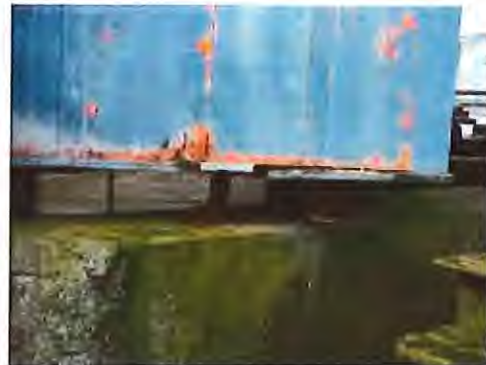
Photo 39

The linkspan operator and equipment buildings are generally in a fair-poor condition. Defects observed include corroded supports (photo 39), dry and weathered exterior paintwork (photo 38), blocked roof gutters. The gully in the area outside the buildings is blocked and a large amount of standing water was evident (photo 43).

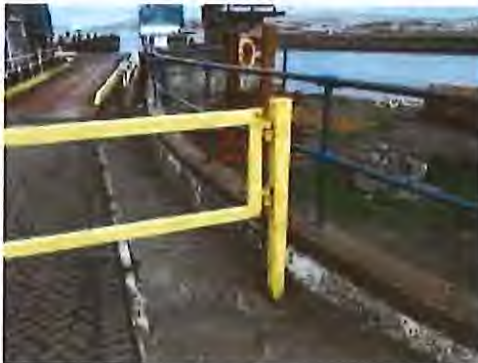
Photo 40

The gate at the entrance to the linkspan and the handrailing along the ramp are corroding (photo 40) with impact damage to the handrails at the nose of the ramp (photo 41).

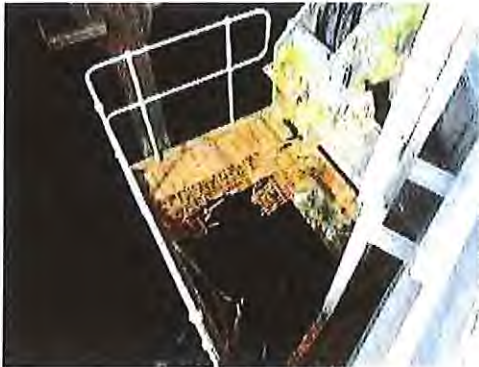
Photo 42

The fixed access equipment is generally in a poor condition, especially an open grate platform on the landward face which has completely corroded away and presents a hazard (photo 42).

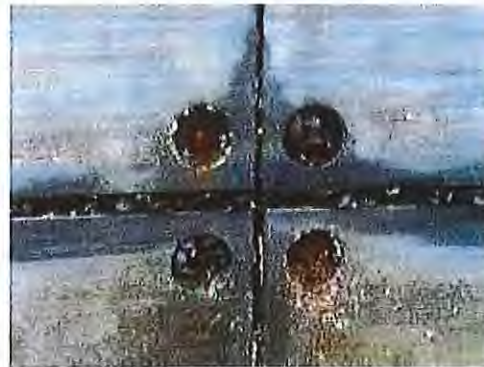
Photo 45

The fendering along the berth is generally in a fair condition. It is noted however that the bolts to each of the individual HDPE panels are not stainless steel. These bolts have completely corroded in the lower tidal zone (photo 45) and one panel is missing from fender 45, two panels missing from fender 49 (photo 44) and one panel loose on fender 40.

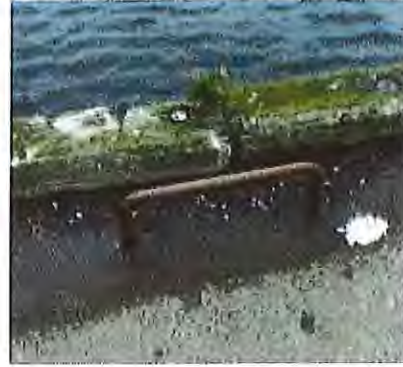
Photo 52

It was observed that the ladder grab rails on the deck have been positioned behind the timber cope making their use more difficult for an ascending climber (photo 52).

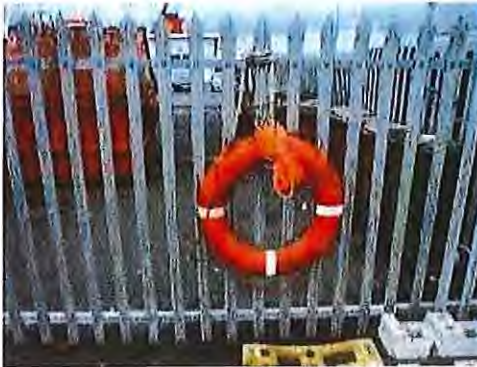
Photo 53

There are two life buoys located on the Irish Berth. The first is located between fenders 47 and 48 on a fence approximately 20m from the cope (photo 53). The other is hung on the mobile gangway (photo 54). Neither of the life buoys are located in a particularly prominent position nor do they have instructions on display. In addition the ropes are weathered.

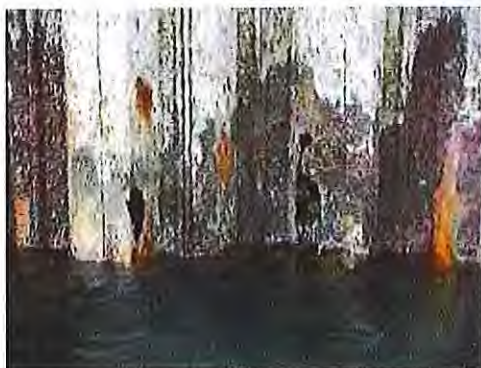
Photo 59

In the intertidal zone and splash zone the orange deposit associated with Accelerated Low Water Corrosion (ALWC) is clearly visible along the entire length of the wall. The piles were holed in a number of locations along the berth (photos 59 - 62). The most significant of these holes measured approximately 900mm x 260mm x 600mm deep.

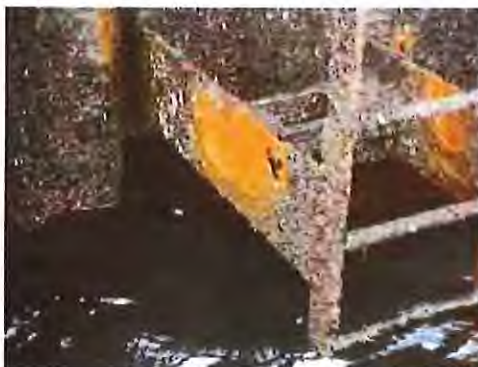
Photo 67

There are five emergency ladders situated along the length of the Overnight Berth. The ladders are all generally covered in marine growth and corrosion. The southernmost ladder has suffered minor impact damage yet remains secure and serviceable (photo 68). The second ladder is free from defects. The bottom bracket to the third ladder is covered in orange deposit and is holed (photo 67). The two remaining ladders remain free from defects and are serviceable.

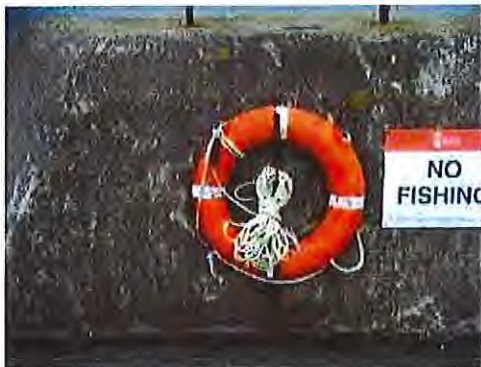
Photo 69

There are two life buoys located on the Overnight Berth. The first is located adjacent to the fender 19 and the second is located on a concrete sponson 50m North East along the berth (photo 69). Neither of these life buoys has instructions displayed and the ropes to both are weathered. Both life buoys are in prominent positions and are clearly visible.

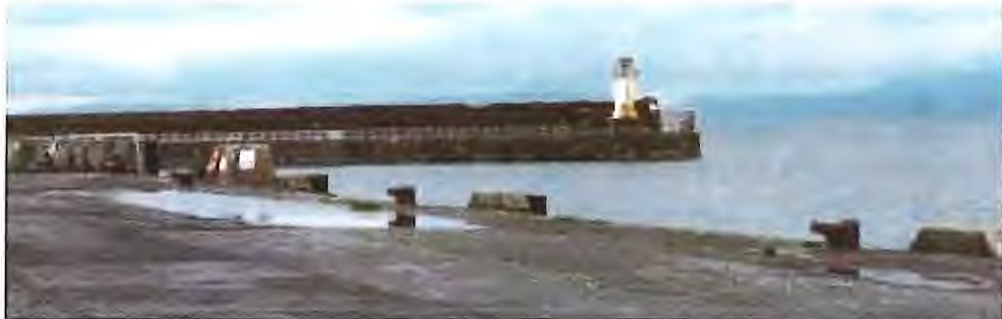
Photo 73

There are nine mooring bollards located along the length of the berth (photo 73). The capacity of these is unknown. All of the bollards remain in sound condition with no defects apparent.

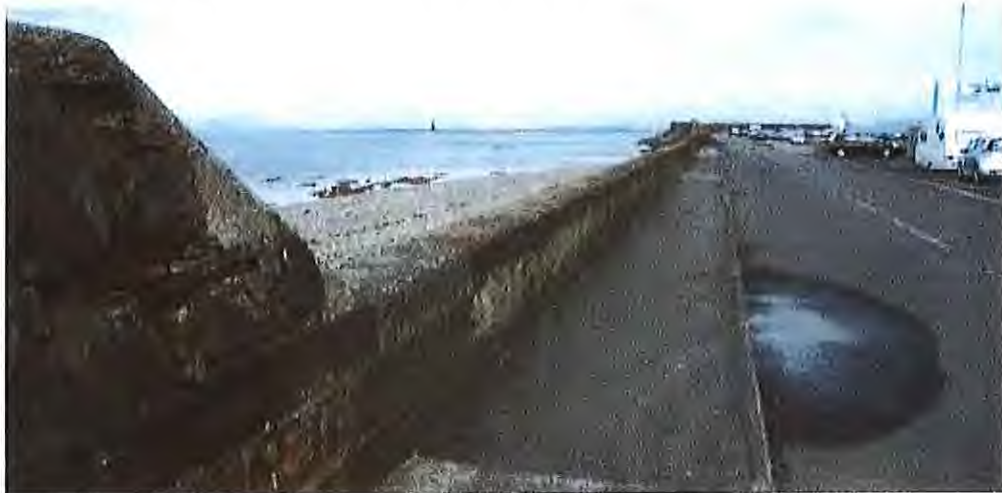
Photo 74

The second section of wall is 0.9m high (on the landward face) and is constructed from stone block (photo 74). This section of the wall is generally in a good condition with no observed defects.

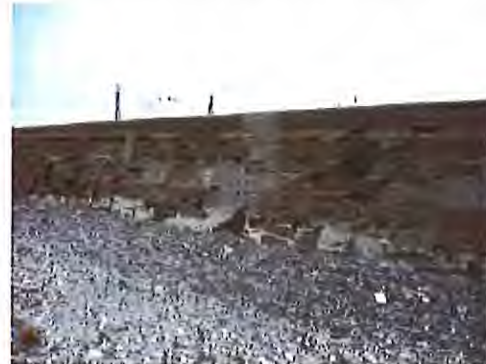
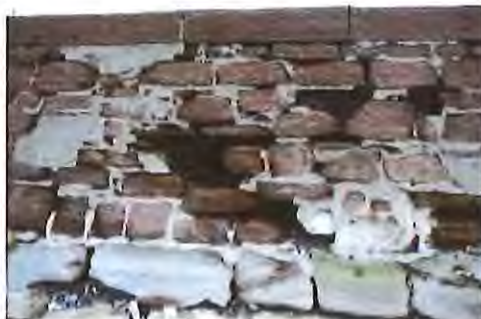
This section of wall is 1.15m high (on the landward face) and is constructed from stone block (photo 75). There is moderate erosion of the stone blocks on the seaward face of the wall and much of the pointing has failed and is missing. Several of the stone blocks have fallen from the wall leaving substantial voids (photos 76 & 77).

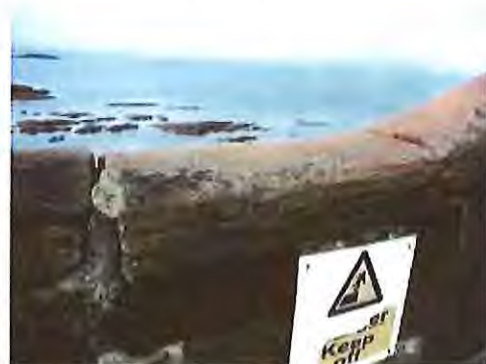
Photo 78

The coping stone at the steps leading to the next section of wall is loose (photo 78).

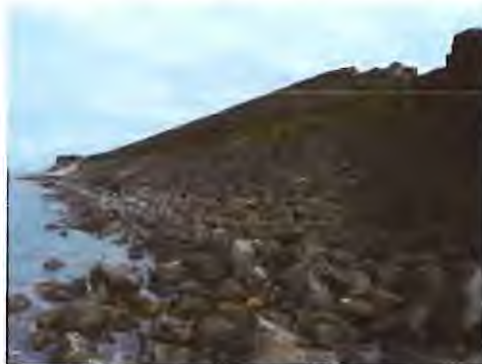
Photo 83

This section of wall is a continuation of the previous section. This section however has a rock revetment to the seaward face to offer protection and provide stability (photo 83). There is some minor erosion of the blocks on the seaward face however the revetment and its concrete infill to the seaward face remain sound with no defects observed.

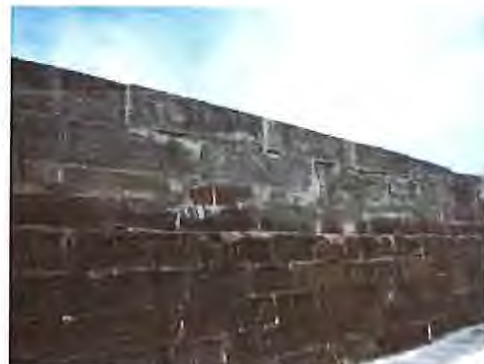
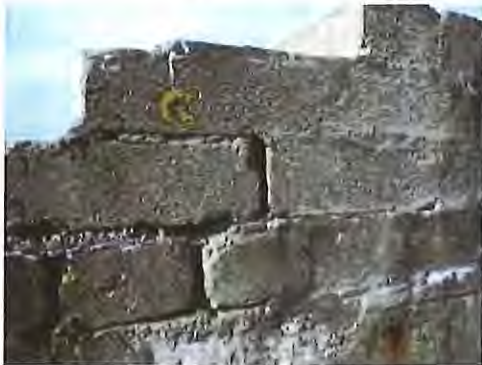
The final 25m length of the wall to the junction with the breakwater has had concrete blocks built into the upper section. The joints between these blocks are beginning to fail and some movement of the blocks is apparent (photos 84 & 85).

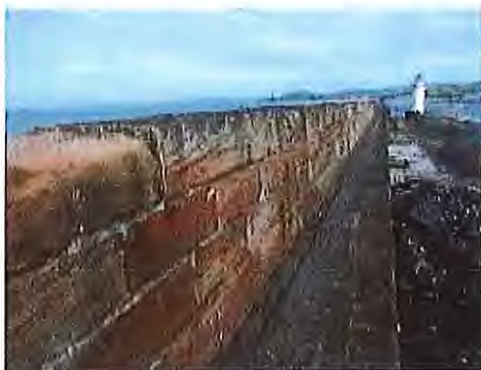
Photo 87

The landward face of the breakwater is a 4.2m high two tier block wall (photo 87). The seaward face is partially protected by a rock revetment with concrete infill.

The breakwater is generally in a good condition with minor erosion of the block work and some failed and missing pointing.

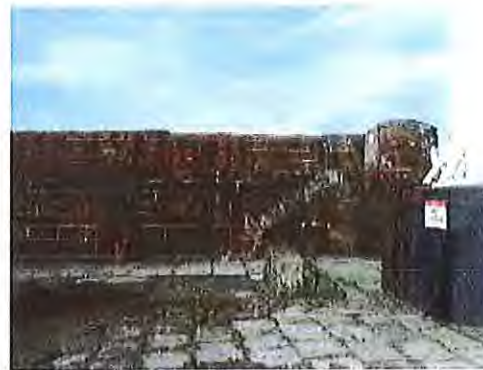
Photo 88

The bottom steps have been removed at the far end of the breakwater, presumably to deter the public from climbing on the structure (photo 88).

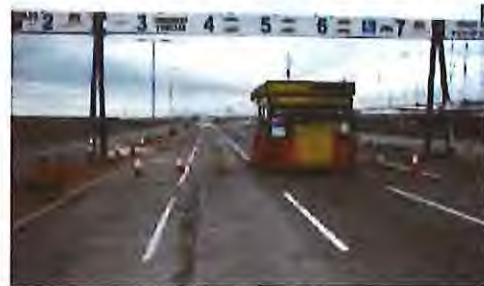
Photo 92

A small modular building serves as a check-in booth at the entrance to lanes 3 to 7. This appears to be in a good condition (photo 92).

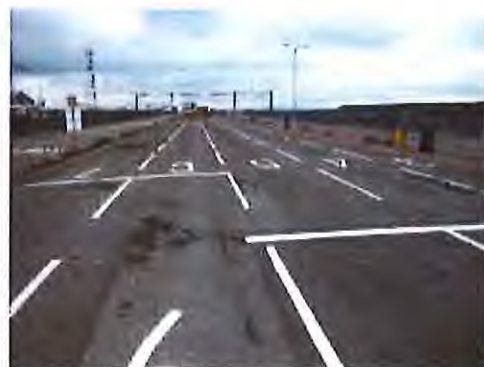
Photo 94

The white lining throughout the marshalling area is clear and in a good condition (photo 94).

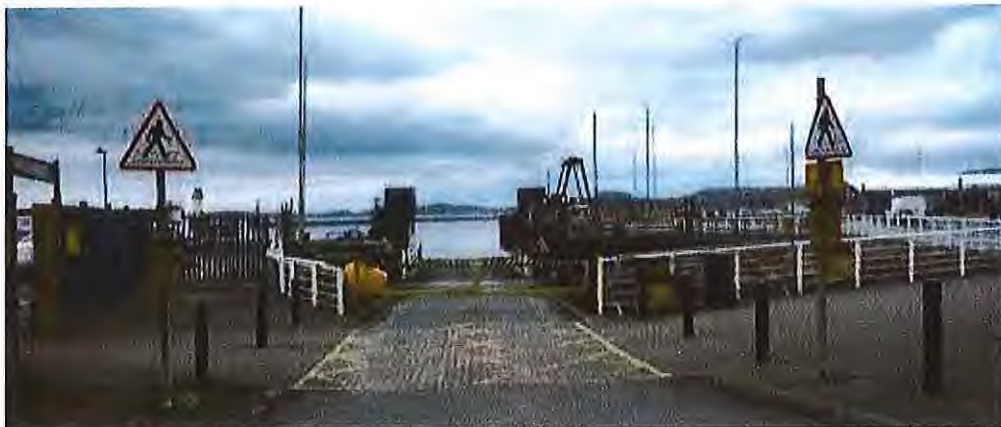
Photo 95

During the visit to Ardrossan it was observed that the pedestrian route from the long stay car park to the terminal building is generally satisfactory. The only place pedestrians have to cross a vehicle road is at the entrance to the Calmac linkspan (photo 95). There are signs warning drivers that pedestrians may be crossing and vice versa. In addition anti-collision bollards are provided on both sides of the crossing area.

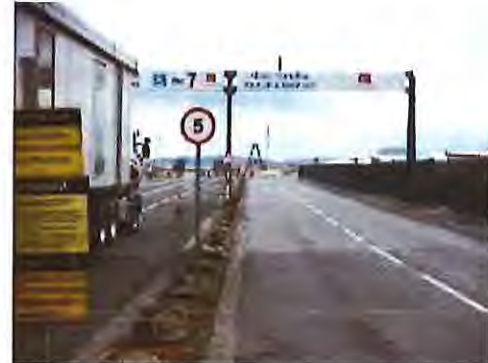
Photo 97

Whilst it is acknowledged that the pedestrian route from the town centre into the ferry terminal is by the walkway past the railway station it should be noted that there is no formal pedestrian access from the marshalling area for motorists wishing to access the terminal building. The only pedestrian routes are either the red chipped area between lanes 2 and 3 (photo 96), the verge between lane 7 and the access road (photo 97) or the unsurfaced path on the far side of the access road.

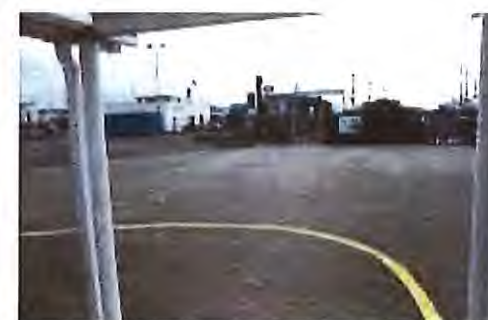
Photo 101

Pedestrians accessing the site via the designated walkway from the railway station and town centre are required to cross a section of the marina yard that is also used as a vehicular access to the Irish Berth linkspan (photo 101). They are further required to cross the road into the staff parking and taxi rank behind the terminal building (photo 100). This crossing is at a junction and there are no formal pedestrian crossings at either of these locations.

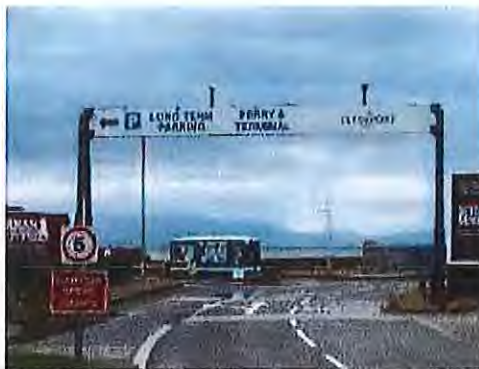
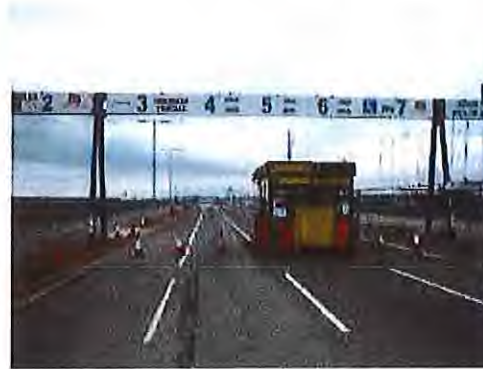
There are two overhead gantry signs that provide clear instruction to vehicles entering the harbour (photos 102 & 103). These initially locate the long term parking, ferry and terminal and latterly the correct lanes within the marshalling area. These signs are reinforced by road markings although these are beginning to wear away (photos 104 & 105).

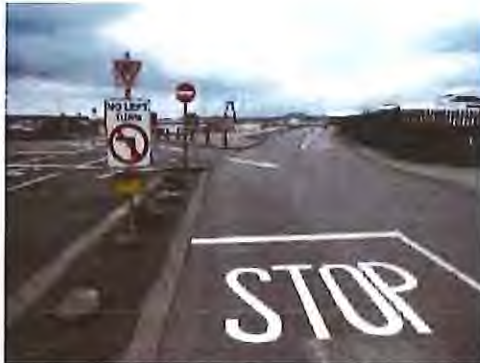
Photo 106

Where the access road crosses the route used by vehicles disembarking the ferry, 'STOP' markings have been provided on the road. The sign used at the junction however is a 'Give Way' sign (photo 106).

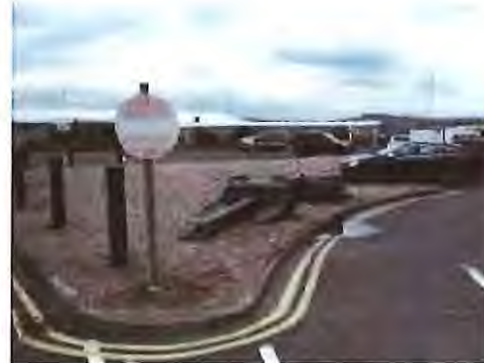
Photo 107

The remainder of the road signage around the one-way system outside the terminal building is considered adequate. There is however a single 'No Entry' sign which has faded and would benefit from replacement (photo 107).

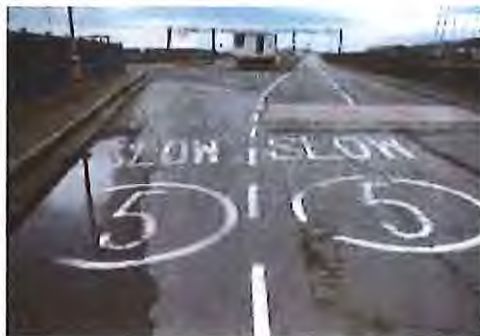
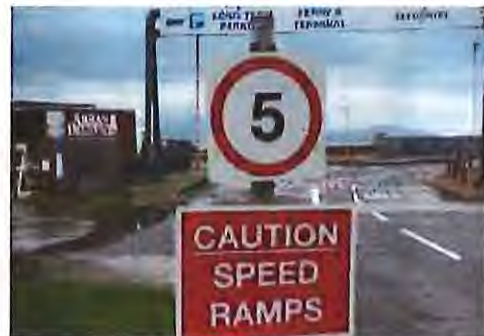
The speed limit within the site is 5mph. This is communicated by both signs and roundels at the entrance to the site (photos 108 & 109).

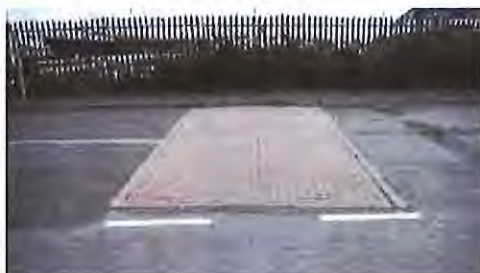
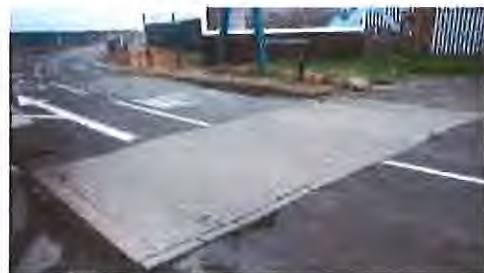
There are only two speed ramps within the site, both located at the entrance. These are mono-block structures and have settled such that they are no longer effective (photos 110 & 111). During the site survey it was clearly apparent that very little traffic obeys the advertised limit.

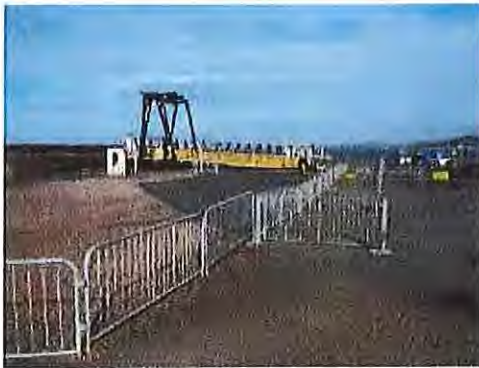
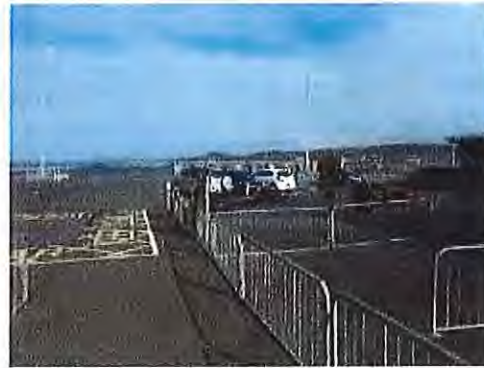
The ACOP states that fencing must be provided to prevent persons walking within 1m of an unprotected edge. Fencing is provided at Ardrossan to prevent members of the public accessing the berth areas (photos 112 & 113). It is noted however that this is only 1m high and none of the pedestrian gates are locked. All staff members entering the berth area are provided with suitable PPE including hard hats and life jackets.

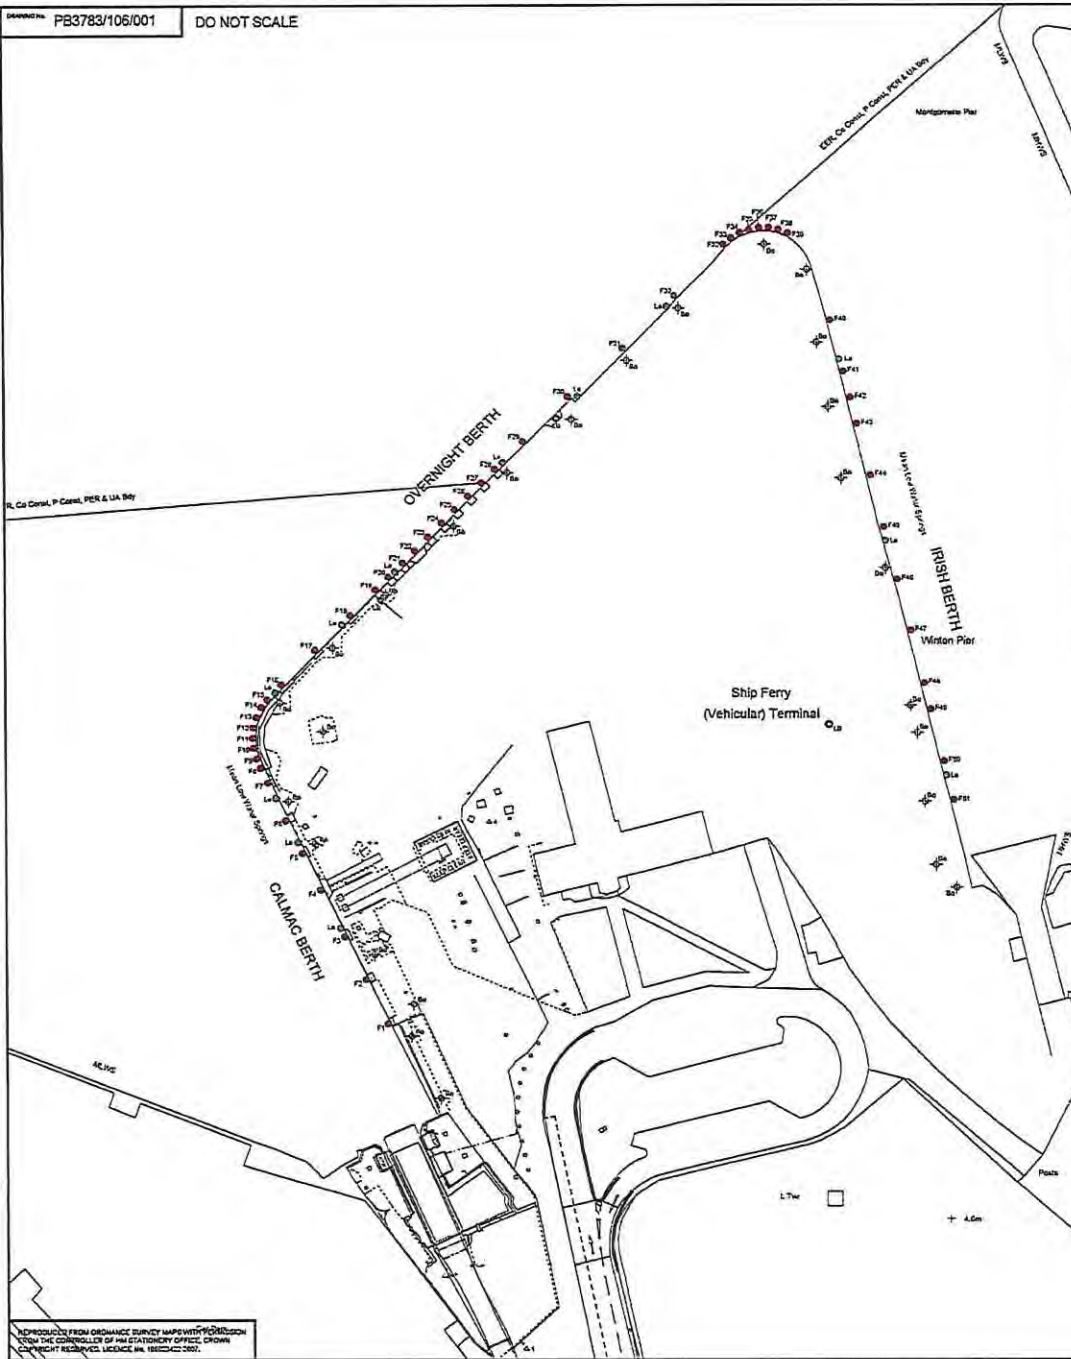
Item No	Item Type	Details	Remarks
1	NY880	4 x 1.5m long UC, 4 x 1.0m long UC, 5.0m x 325mm HDPE Shield	Shut out to NY's missing. This part to be removed
2	NY880	8 x 1.5m long UC, 4 x 1.0m long UC, 6.0m x 325mm HDPE Shield	Numbered items and missing bolts to NY's. NY's removed and in recycling park. Shut out to NY's missing. Face should be 2 sections. This part to be removed. This part to be removed.
3	NY880	4 x 1.5m long UC, 4 x 1.0m long UC, 5.0m x 325mm HDPE Shield	Shut out to NY's missing including 3 of 4 in section 1m section. This part to be removed.
4	NY880	4 x 1.5m long UC, 4 x 1.0m long UC, 6.0m x 325mm HDPE Shield	Shut out to NY's missing. Face should be in 2 sections and joined off slightly at 2nd part.
5	NY880	4 x 1.5m long UC, 4 x 1.0m long UC, 5.0m x 325mm HDPE Shield	Shut out to NY's missing. Should pulling off at corner, with protruding.
6	NY880	8 x 1.5m long UC, 4 x 1.0m long UC, 6.0m x 325mm HDPE Shield	Like bolts to NY's missing. Face should be 4 sections. Section of shield missing and further sections pulling off. This missing bolts to removing face shield sections. NY's there and should be removed.

7	NY880	4 x 1.5m long UC, 4 x 1.0m long UC, 5.0m x 325mm HDPE Shield	Shut out to NY's missing. Face should be 2 sections. This section pulling off.
8	NY880	8 x 1.5m long UC, 4 x 1.0m long UC, 6.0m x 325mm HDPE Shield	Shut out to NY's missing. This NY's removed has some off in fabric. Abrasion to shield.
9	NY750	6 x 1.5m long UC, 4 x 1.0m long UC, 6.0m x 325mm HDPE Shield	PFINDER REMOVED
10	NY750	6 x 1.5m long UC, 4 x 1.0m long UC, 6.0m x 325mm HDPE Shield	Face should be 2 sections. Face should be 2 sections.
11	NY750	6 x 1.5m long UC, 4 x 1.0m long UC, 6.0m x 325mm HDPE Shield	Shut out to NY's missing. Face should be 2 sections and pulling off at end.
12	NY750	6 x 1.5m long UC, 4 x 1.0m long UC, 6.0m x 325mm HDPE Shield	Shut out to NY's missing. Face should be 2 sections.
13	NY750	6 x 1.5m long UC, 4 x 1.0m long UC, 6.0m x 325mm HDPE Shield	Shut out to NY's missing. Face should be 2 sections.
14	NY750	6 x 1.5m long UC, 4 x 1.0m long UC, 6.0m x 325mm HDPE Shield	PFINDER REMOVED

The list of defects in table 2.1 should be addressed to reinstate the existing fender system. This is particularly important to prevent the structure from being overloaded or to prevent any potential damage to a berthing vessel.
