## A83 Tarbet – Campbeltown Trunk Road

### Cairndow to Lochgilphead Road Safety Study

**Scheme Ref: 15/NW/0801/002**

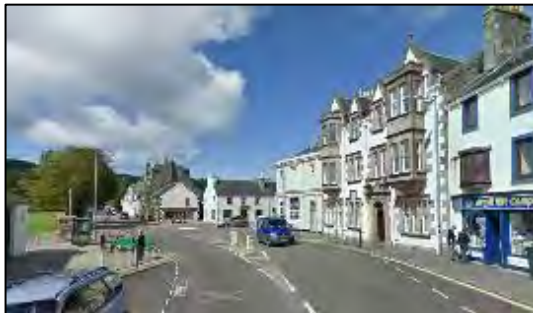
**Photo 31**

Pedestrian movements in Inveraray are primarily focused at the shopping area between the car park adjacent to the harbour and the Jail. The large town car park has pedestrian access points adjacent to the church located in the centre of Main Street and fronting the green adjacent to the harbour. There is on street parking either side of the high street with pedestrians crossing between parked vehicles. Traffic speeds are however low due to the alignment of the carriageway at the harbour and the gyratory at the church.

A report in May 2014 looked at the issue of pedestrians crossing the Main Street in line with *LTN 1/95 The Assessment of Pedestrian Crossings* <sup>(15)</sup>. The conclusion of the report was that an improvement to the existing build outs at either end of Main Street and within the parking bays was the most appropriate option to improve pedestrian safety. However, in order to provide compliant crossing points a number of parking spaces would be lost. These recommendations were shared with the local community and businesses on Main Street and they were not supported. Therefore, to date, the recommendations have not been progressed.

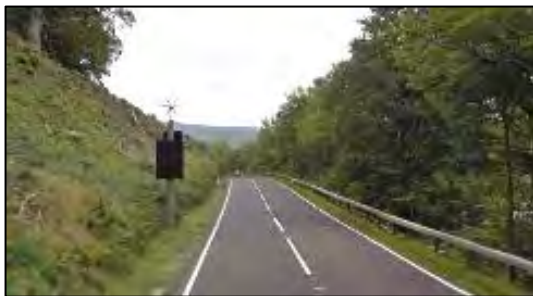
**Photo 37**

The alignment of the road at Strone Point shown in photo 36 has had 10 accidents in the five year study period. A recent scheme has cleared trees and bushes around the bend to provide improved visibility. As part of the scheme, Vehicle Activated signs have been installed for the bend as shown in photo 37, these being to Diag. 512 'Bend ahead' and a message SLOW DOWN in LED's. The trigger speed of the two signs is set at 45mph for West bound and 40mph for East bound, reflecting the approach speeds. A further scheme is planned to carry out a realignment of the carriageway at the bend in 2017. No further actions are therefore recommended for this site.
