A9 redacted 11(2)

Noise Monitoring Report – Non-Technical Summary

May 2023

## BEAR NW Bridges

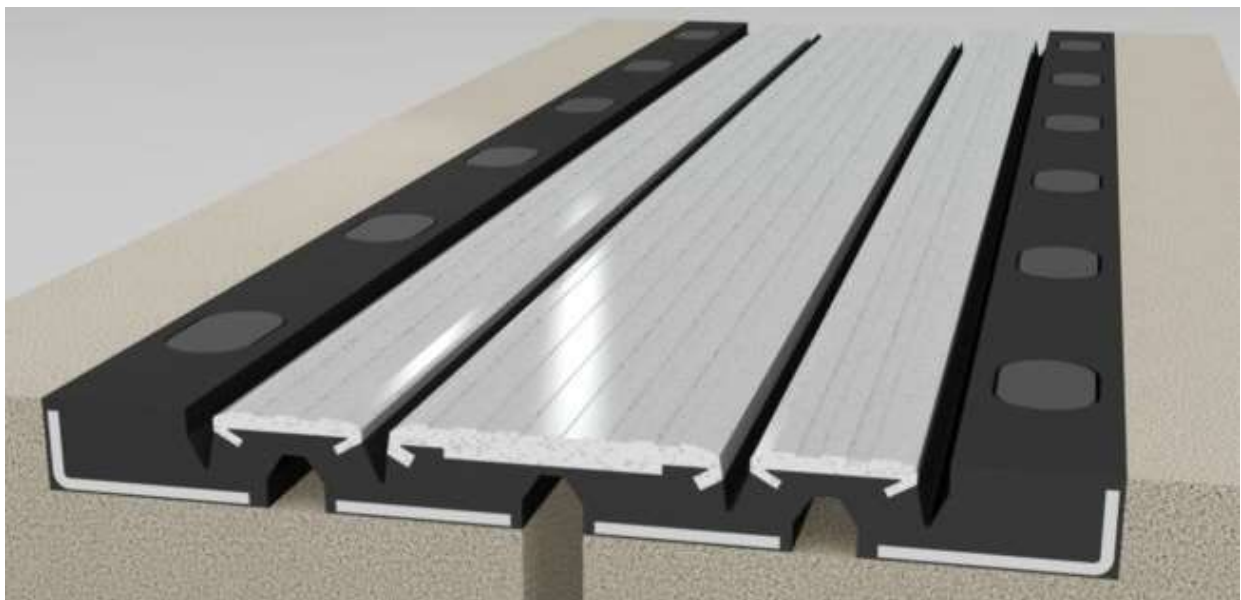
The bridge joints were inspected at the time of the noise survey by the acoustic specialist. The surfacing around the joints appeared to be in good condition, smooth and in-line with the surface of the joint. It was observed that the passage of traffic has led to wear and degradation of the running surface of the joint. This could lead to the increase in noise levels generated by the passage of traffic. When the bridge joints are installed, a rubber surface covering is installed to the edges of the joint, protecting the steel reinforcement of the joint (see Figure 2). During the inspection, it was observed that the joints at both ends are worn in the areas where vehicle tyres run over the joints. Figure 3, on the next page, shows an image of the worn rubber surface, taken during the October 2022 visit.

Figure 2: Section through 'as new' bridge joint, as taken from a manufacturer's website
