A737 St James to  
Kilbarchan Collision Study  
SCOTTISH TRUNK ROAD  
NETWORK - SOUTH WEST UNIT  
22/SW/0801/012/RP/001

December 2022

Project Name:	SCOTTISH TRUNK ROAD NETWORK - SOUTH WEST UNIT
Project Number:	22-SW-0801-22
Report Title:	A737 St James to Kilbarchan Collision Study
Report Number:	22/SW/0801/012/RP/001

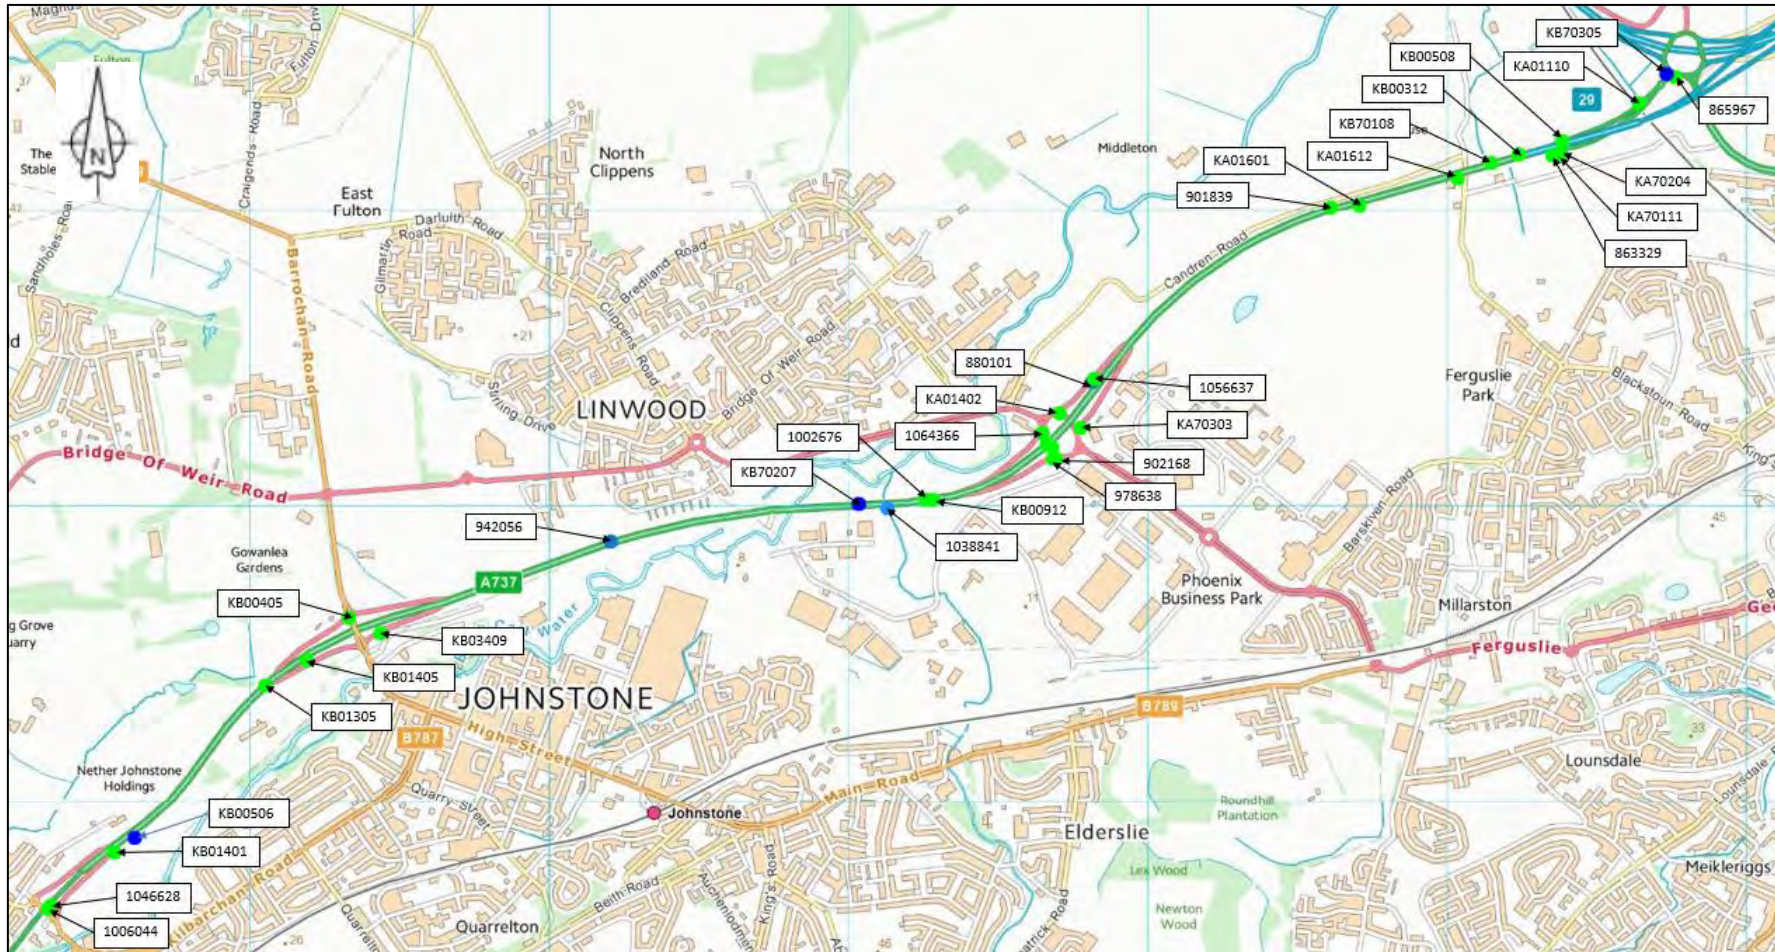
Figure 2-1 – Collision Plot A737 St James to Kilbarchan

2.1.5 The location of the collisions is shown in Figure 2-1 below. A summary of the collision analysis findings has been provided in Table 2-1 below and full details of the collisions are within Appendix A.

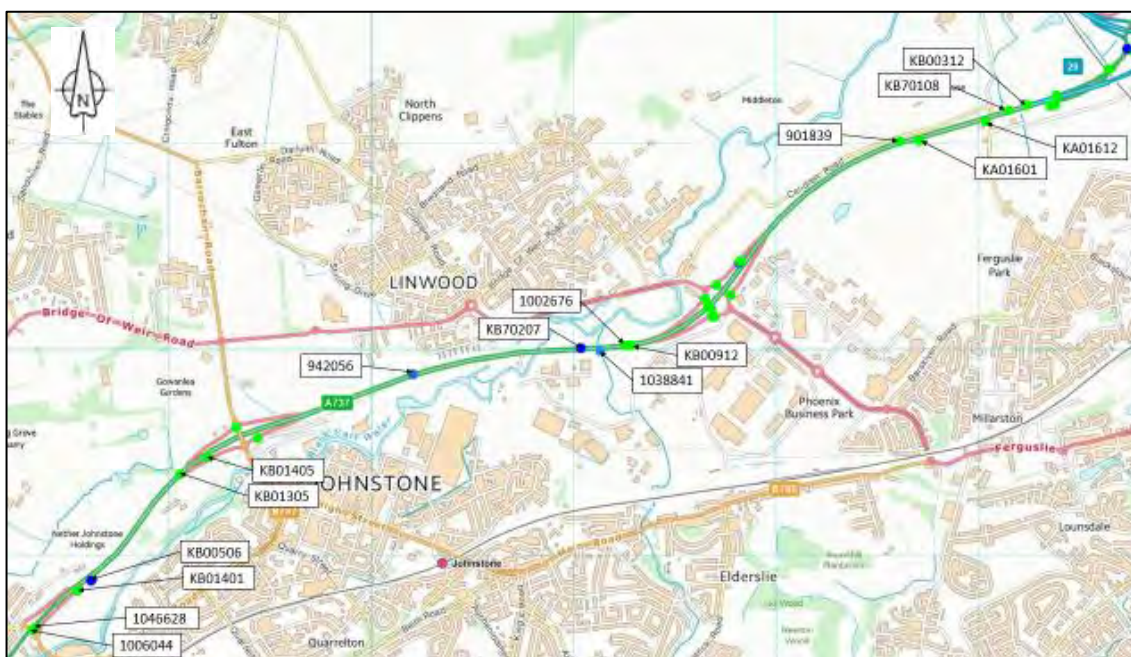
Figure 3-1 – A737 St James to Kilbarchan Mainline Collision Plan

3.1.1 A total of 16 collisions were recorded on the A737 mainline between St James Interchange and Kilbarchan junction. Of these, four were serious injury collisions and 12 were slight in severity. These collisions are shown in Figure 3-1 below.

3.1.2 Of the 16 collisions, seven occurred in the southbound direction and nine collisions occurred northbound. It can be seen from the recorded collisions that there was a total of 23 casualties.

3.1.3 A review of the times of the collisions was undertaken and it was highlighted that five collisions occurred during the typical PM peak traffic hours (16:00 to 18:00) and two collisions during the typical AM peak traffic hours (07:00-09:00). This means that nine of the collisions occurred out with the peak traffic hours.

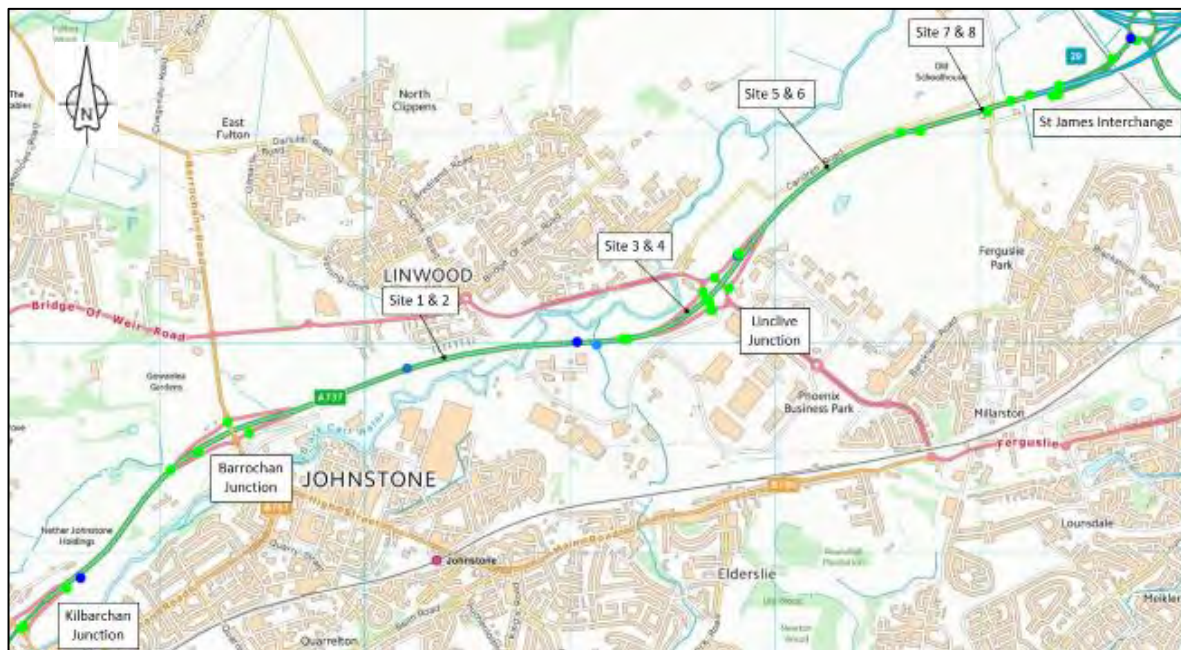
Figure 3-3 – A737 Mainline Speed Survey Sites

3.4.3 Due to speed related contributory factors being overrepresented against RRCS averages, a survey of vehicle speeds was commissioned at various locations on the A737 to provide more details on the speeds throughout this section. A total of four sites were identified, with surveys undertaken in each direction, resulting in eight total locations. The locations and results are shown in Figure 3-3 and the results contained in Table 3-6 below.

3.4.4 It can be seen from Table 3-6 above that there is a varying level of speeding amongst all the vehicle types within the relevant speed limit classes. With the highest being within the 50mph (HGV) class. However, with 21% to 25% of cars/mc/LGVs also speeding, this confirms that inappropriate speed is an issue and could be contributing to collisions on the A737 mainline. Given this, the data was reviewed to understand the levels of vehicles involved in collisions and reviewed against their representation nationally (RRCS) and as part of the traffic surveyed. This can be seen below in Table 3-7.

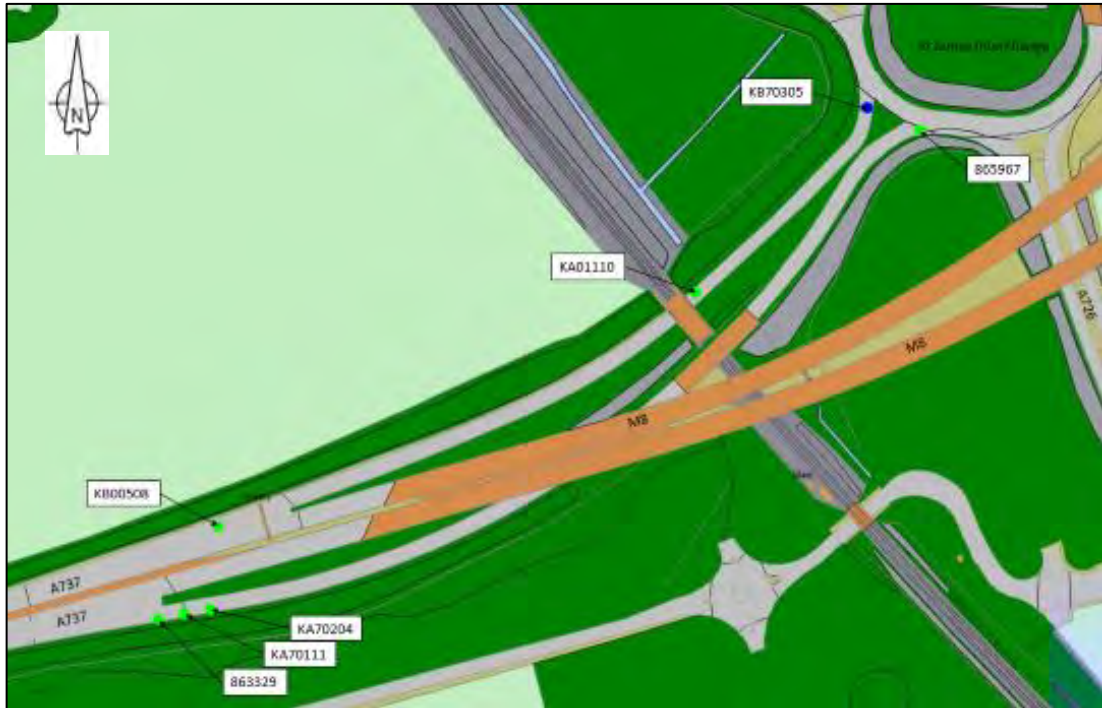
Figure 4-1 – A737 St James Interchange Slip Roads Collision Plan

4.1.1 A total of seven collisions were recorded on the A737 St James Interchange slip roads. Of these one was a serious injury collision and six were slight in severity. The locations of these collisions are shown in Figure 4-1 below.

4.1.6 **It is noted that seven (64%) of the 11 total contributory factors relate to 'driver awareness'. Three (27%) of the remaining four factors are speed related.**

4.2.1 As shown in Figure 4-1 previously, three collisions (KB00508, KA01110 and KB70305) occurred on the A737 St James northbound off-slip. The three collisions occurred at different locations on the off-slip and have no commonality regarding time of day, weather conditions and collision type. Therefore, the collisions have been reviewed individually below.

4.3.1 As shown in Figure 4-1 previously, four collisions (865967, KA70204, KA70111 & 863329) are located on the A737 St James northbound on-slip. Three of the collisions are located at the merge with the A737 mainline while the remaining collision is located at the exit of the A737 St James Interchange roundabout. All the collisions were slight in severity and occurred during daylight, in fine weather and in dry conditions.

4.1.7 Therefore, it appears that measures which will increase driver awareness and reduce speeds on the slip roads should be considered. As such the existing layout of the St James slip roads has been reviewed below to identify any possible improvements.

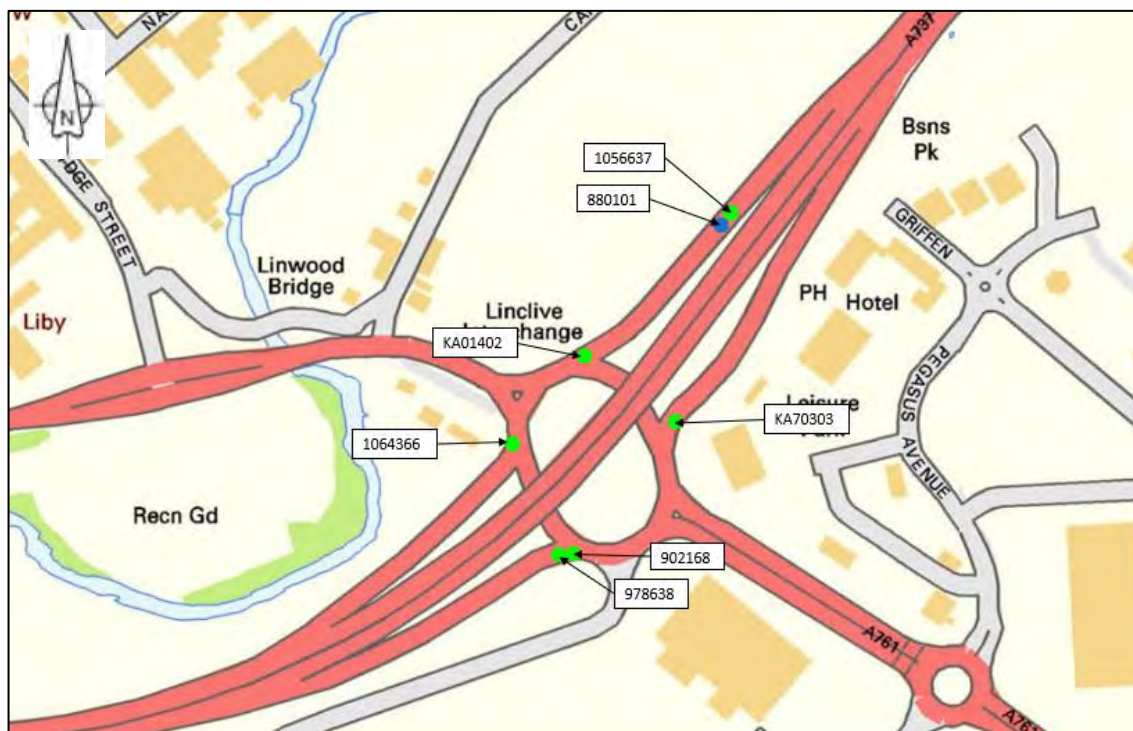
Figure 5-1 – A737 Linclive Junction Slip Roads Collision Plan

5.1.1 A total of seven collisions were recorded on the A737 Linclive Junction slip roads comprising one serious and six slight collisions. The locations of these collisions are shown in Figure 5-1 below.

5.1.7 Four of the seven collisions (57%) occurred in wet conditions with two of those also occurring during darkness. Four of the collisions (57%) have contributory factors which **related to 'driver error/awareness' and three (43%) were speed related.**

5.1.8 Therefore, it appears that measures which will increase driver awareness and reduce speeds on the slip roads should be considered. As such the existing layout of the Linclive junction slip roads and their associated collisions have been reviewed below to identify any possible improvements.

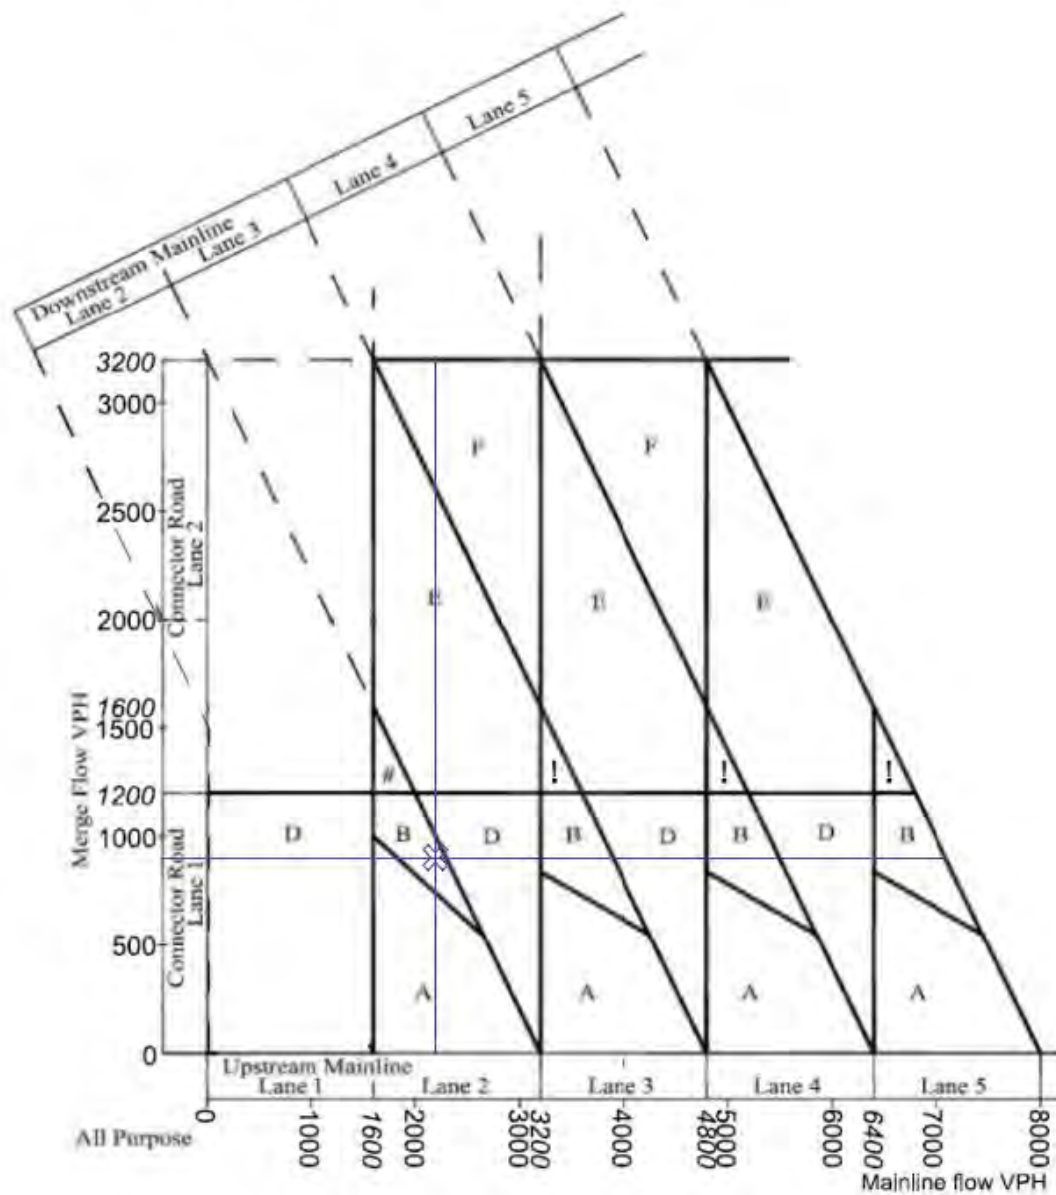
Figure 3.12a All-purpose road merging diagram

- 4.3.13 The existing merge type has been reviewed against Figure 3.12a within CD122 to ascertain whether the merge type is suitable for current vehicles flows on the on-slip and A737 mainline. With a merge flow of 900vph and upstream mainline flow of 2200vph it can be advised that Figure 3.12a (Appendix B) indicates a 'Layout B' parallel merge with single lane merge, auxiliary lane and two lane upstream mainline to be appropriate. Due to the restrictions in land space and an overbridge passing Blackstone Road, it is unlikely that the construction of this type of merge is feasible or cost effective.
