A78 Montfode to Monktonhead
Road Safety Investigation
Pennyburn Roundabout to Eglinton
Interchange
18/SW/0801/035
August 2020

Project Title: A78 Montfode to Monktonhead
Report Title: Road Safety Investigation
Revision: 0
Status: DRAFT

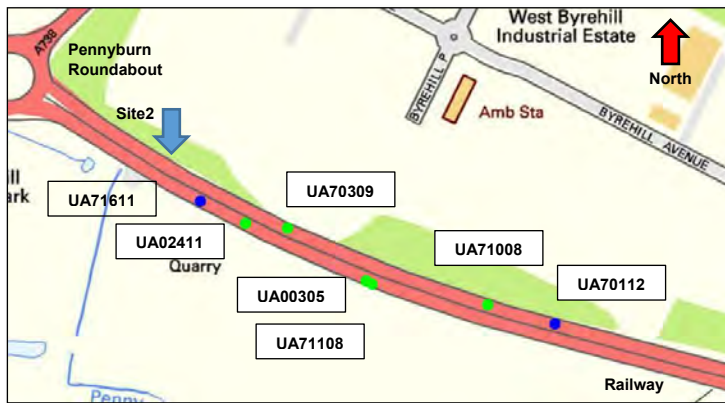
Figure 5.1 Sub-Section 7a Location

Sub-Section 7a above, recorded seven reported road accidents during the five year period investigated. This equated to 50% of all accidents over the whole section, three southbound and four northbound. As previously detailed the accidents were as follows:
