**PRINCIPAL INSPECTION REPORT**

**Structure: M8 22-23 F62, BEECH AVENUE F/B**

**Inspection date: 28-May-2019**

**Prepared by SCOTLAND TRANSERV SOUTH WEST**

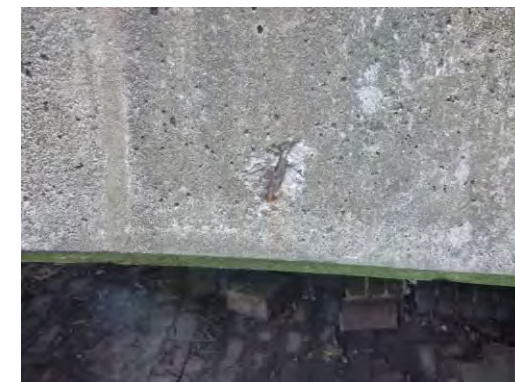
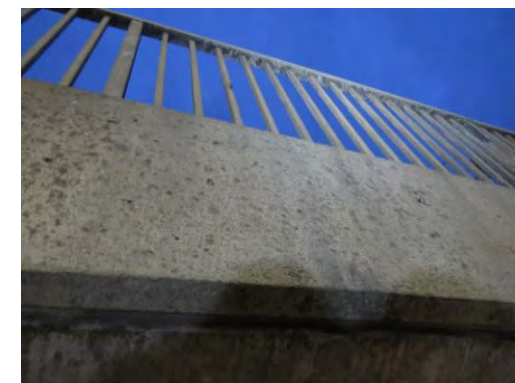
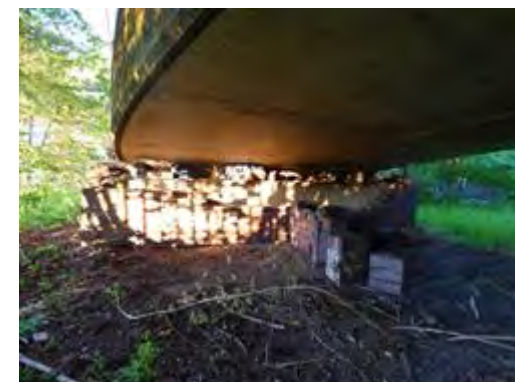
1	Primary Deck Element (Table G4)	1 Hairline cracks, difficult to detect visually	No	1A	0	N No Action Monitor Only	Not Complete	Deck soffit in good condition.
1	Parapet Beam Or Cantilever	2 Minor localised spalls possibly exposing shear links	No	2B	2	N No Action Monitor Only	£ 1	Photo 1 - Very minor spalls on parapet cope.
1	Parapet Beam Or Cantilever	2 Cracks and crazing in areas of low flexural behaviour or cracks less than 0.3mm	Yes	2C	2	N No Action Monitor Only	£ 1	Photo 2 - Minor vertical cracking on both parapet copes on all spans.
1	Bearing Plinth/Shelf	.2 WDM Generic Defect Severity 2	No	2C	3	Cyclic Maint - Bearings & bearing shelves	£ 1	Photo 6 - Evidence of vagrant living under bridge. This should be removed during cyclic maintenance.

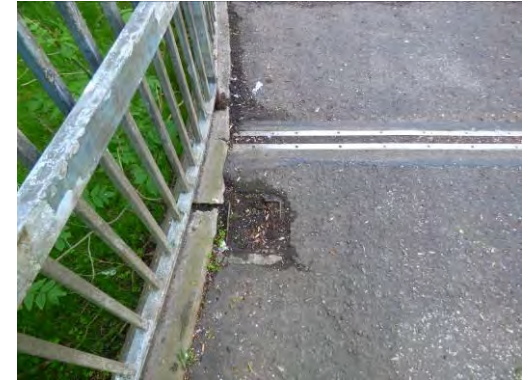
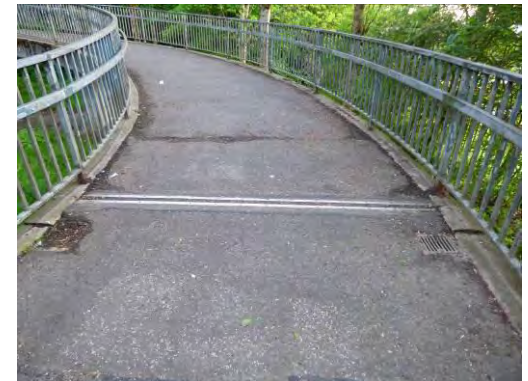
1	Superstructure Drainage	4 Mostly Non-functional (More Than 50% Of Cross Section Blocked)	No	4E	3	Cyclic Maint - Drainage	£ 1	Photo 7 - LHS gully completely blocked with debris on DL side of ES1 rail joint. This should be cleared at next Cyclic Maintenance visit. RHS gully appears functional.
1	Movement/Expansion on Joints	.2 WDM Generic Defect Severity 2	No	2C	2	Cyclic Maint - Expansion joints	£ 1	Photo 8 - Debris build up in ES1 rail joint. This should be removed during next Cyclic Maintenance visit.
1	Surface Finishes: Substructure Elements	4 Severe bulging, leaning or displacement	No	4D	3	?	£ 1,500	See photo 6 - Brick facade wall in front of ES1 abutment in poor condition. Large area of brickwork displaced and requires to be rebuilt.

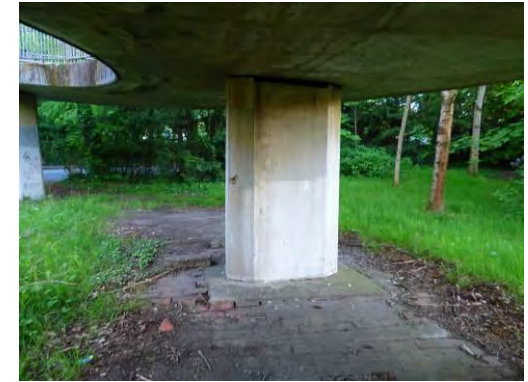
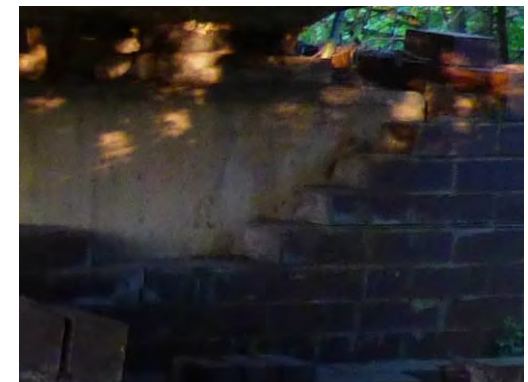
1	Revetment/Batter Paving	2 Minor deformation	No	2B	2	N No Action Monitor Only	£ 1	Photo 11 - Localised area of brickwork missing and dislodged on IS2 revetment.
1	Abutments (Incl. Arch Springing)	2 Cracks and crazing in areas of low flexural behaviour or cracks less than 0.3mm	Yes	2B	2	N No Action Monitor Only	£ 1	Photo 3 - Areas of cracking some with leaching on ES1 abutment.
1	Abutments (Incl. Arch Springing)	.0 Item present but not inspected	No	6F	0	?	Not Complete	The end support is hidden behind a brickwork facing wall. Unable to inspect abutment.

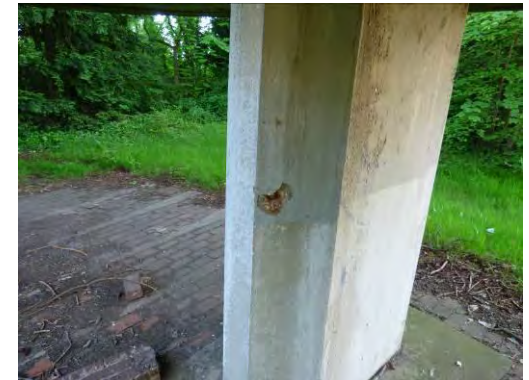
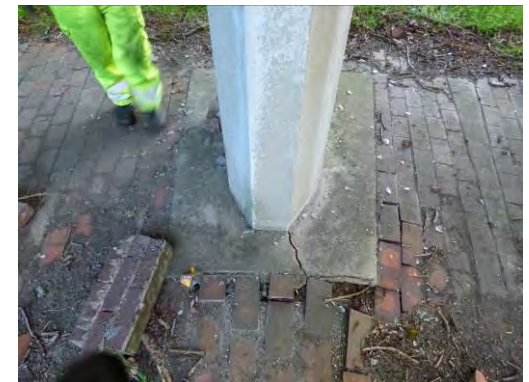
1	Pier/Column	2 Minor localised spalls possibly exposing shear links	Yes	2B	2	N No Action Monitor Only	£ 1	Photo 5 - Minor localised spall at LHS of ISP2.
1	Pier/Column	4 Wide/deep cracks more than 2mm or shear cracks	No	4B	2	Concrete - Crack injection	£ 250	Photo 4 - Crack to base of pier at IS2. Injection required to prevent further deterioration.
2	Foundations	.0 Item present but not inspected	No	6F	0	?	Not Complete	Foundations buried, unable to inspect.
2	Bearings	1 Bearings Sound	No	1A	1	N No Action Monitor Only	£ 1	ISP 3 elastomeric pad is in good condition.

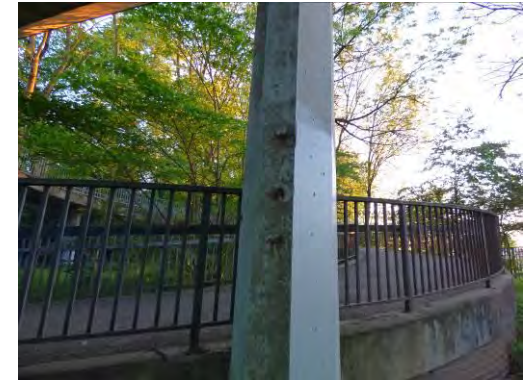
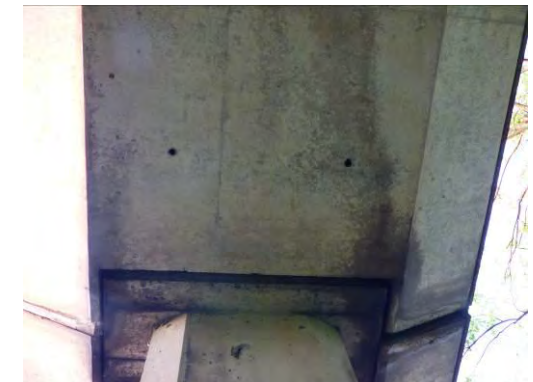
4	Pier/Column	2 Minor localised spalls possibly exposing shear links	No	2B	2	Concrete - Repairs	£ 500	Photo 14 - Minor areas of spalling on RHS of IS5.
5	Foundations	.0 Item present but not inspected	No	6F	0	?	Not Complete	Foundations buried, unable to inspect.
5	Waterproofing	.0 Item present but not inspected	No	6F	2	?	£ 1	Waterproofing is 44 years old and therefore is outwith is expected lifespan and should be considered for replacement. Condition of footway surfacing indicates minor defects to waterproofing. Cost included in span 1.
5	Primary Deck Element (Table G4)	2 Cracks and crazing in areas of low flexural behaviour or cracks less than 0.3mm	No	2B	2	N No Action Monitor Only	£ 1	Photo 15 - Minor crazing on span 5 soffit.

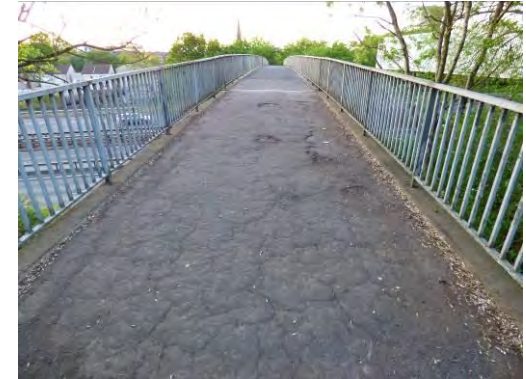
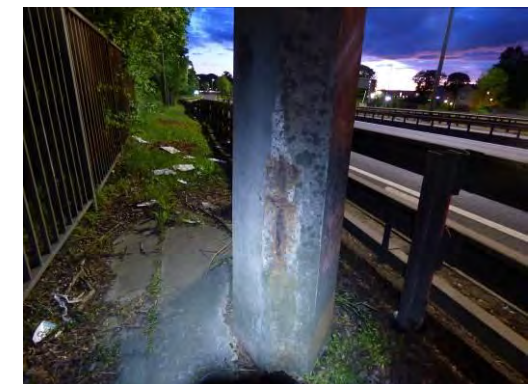
5	Handrail/Parapets/ Safety Fences	2 Minor surface rusting	No	2C	2	N No Action Monitor Only	£ 1	See Photo 9 - Surface rusting on parapets throughout structure. Especially at bottom of parapet posts.
5	Footway/Verge/Foo tbridge Surfacing	4 Deep Cracks And Potholes	Yes	4B	3	Other - Surfacings	£ 500	Photo 19 - Deep cracks and potholing on Span 5 surfacing.
5	Footway/Verge/Foo tbridge Surfacing	2 Cracks In Top Layer	No	2E	2	Other - Surfacings	£ 1	See Photo 10 - Areas of cracking and weathering throughout footbridge surfacing creating possible trip hazards. If the footbridge is to be resurface this should be done as a waterproofing scheme and the cost is included in the waterproofing element.
5	Pier/Column	2 Minor localised spalls possibly exposing shear links	No	2B	2	Concrete - Repairs	£ 500	Photo 16 - Minor spall on RHS of IS6 exposing reinforcement.

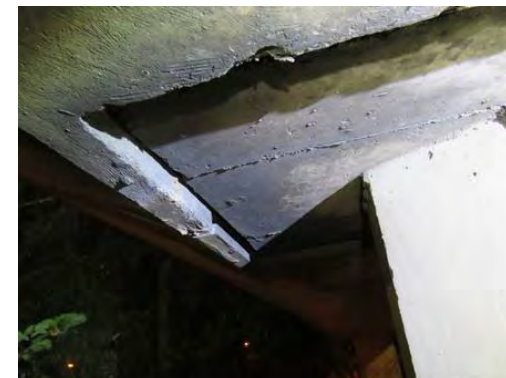
Span 6 and 7 appear to be twisting at the relevant half joint and an investigation is required to discover the cause of the defect.

6	Primary Deck Element (Table G4)	.3 WDM Generic Defect Severity 3	Yes	3C	3	Investigation	£ 1,000	Photo 18 - Span 6 bridge deck appears to be twisted at DL RHS. The deck is 40 mm lower than span 5. An investigation is required to discover the cause of the defect.
6	Half Joints	2 Minor localised spalls possibly exposing shear links	No	2B	3	Concrete - Repairs	£ 3,500	See Photo 17 - Area of spalling to half joint on span 6 and end of primary deck.
6	Parapet Beam Or Cantilever	2 Cracks and crazing in areas of low flexural behaviour or cracks less than 0.3mm	No	2B	2	N No Action Monitor Only	£ 1	See Photo 2 - Minor vertical cracking on both parapet copes on all spans.
6	Movement/Expansion on Joints	1 Strip sealant sound	Yes	1A	1	N No Action Monitor Only	£ 1	Sealants have been replaced and are in good condition.
6	Movement/Expansion on Joints	.2 WDM Generic Defect Severity 2	No	2E	2	Cyclic Maint - Expansion joints	£ 1	See Photo 8 - Rail joint at IS7 is blocked with debris and should be cleared at next cyclic maintenance visit.

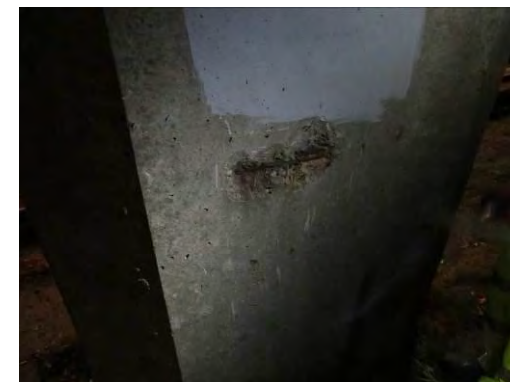
6	Painting: Parapets/Safety Fences	5 All Coats Failed	No	5E	3	P Paint	£ 1	See Photo 9 - Paint system failed on parapet system throughout structure. This has lead to surface rusting on the parapets. Parapets should be painted to prevent further deterioration. Cost included in span 1.
6	Handrail/Parapets/ Safety Fences	2 Minor surface rusting	No	2C	2	N No Action Monitor Only	£ 1	See Photo 9 - Surface rusting on parapets throughout structure. Especially at bottom of parapet posts.
6	Footway/Verge/Foo tbridge Surfacing	2 Cracks In Top Layer	No	2E	2	Other - Surfacings	£ 1	See Photo 10 - Areas of cracking and weathering throughout footbridge surfacing creating possible trip hazards. If the footbridge is to be resurface this should be done as a waterproofing scheme and the cost is included in the waterproofing element.
6	Pier/Column	2 Minor localised spalls possibly exposing shear links	No	2B	2	Concrete - Repairs	£ 500	Photo 19 - Minor areas of spalling on RHS of IS7.

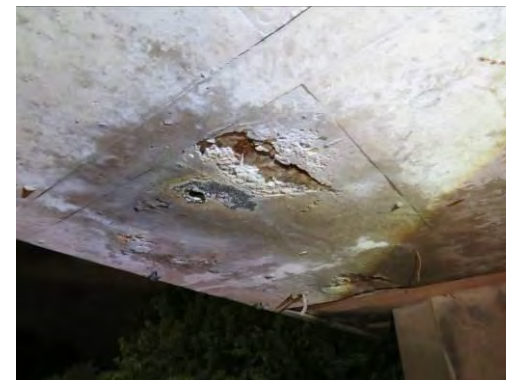
7	Foundations	.0 Item present but not inspected	No	6F	0	?	Not Complete	Foundations buried, unable to inspect.
7	Waterproofing	.0 Item present but not inspected	No	6F	2	?	£ 1	Waterproofing is 44 years old and therefore is outwith its expected lifespan and should be considered for replacement. The condition of the footway surfacing indicates minor defects to the waterproofing. Cost included in span 1.
7	Primary Deck Element (Table G4)	2 Minor localised spalls possibly exposing shear links	No	2B	2	Concrete - Repairs	£ 300	Photo 20 - Minor localised spall to span 7 soffit adjacent to IS8 half joint.
7	Primary Deck Element (Table G4)	2 Cracks and crazing in areas of low flexural behaviour or cracks less than 0.3mm	Yes	2B	2	N No Action Monitor Only	£ 1	Multidirectional cracking to mortar repair for old gantry fixings.
7	Primary Deck Element (Table G4)	.2 WDM Generic Defect Severity 2	Yes	2B	3	Investigation	£ 1,000	See Photo 18 - Span 7 bridge deck has settled by approximately 40mm at UL RHS. An investigation is required to identify the cause of the defect.

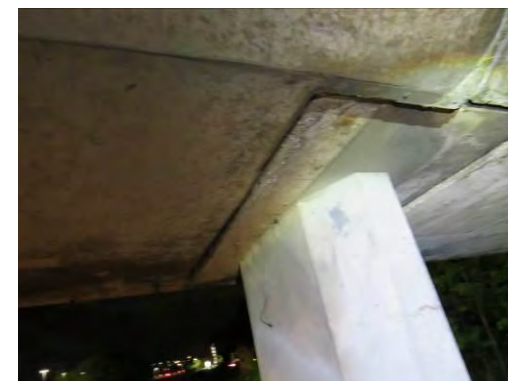
8	Primary Deck Element (Table G4)	2 Cracks and crazing in areas of low flexural behaviour or cracks less than 0.3mm	No	2B	2	N No Action Monitor Only	£ 1	Photo 22 - Minor longitudinal cracks on span 8 soffit.
8	Half Joints	1 Hairline cracks, difficult to detect visually	No	1A	1	N No Action Monitor Only	£ 1	Span 8 half joint in good condition.
8	Parapet Beam Or Cantilever	2 Cracks and crazing in areas of low flexural behaviour or cracks less than 0.3mm	No	2B	2	N No Action Monitor Only	£ 1	See Photo 2 - Minor vertical cracking on both parapet copes on all spans.
8	Movement/Expansion on Joints	1 Strip sealant sound	Yes	1A	1	N No Action Monitor Only	£ 1	Sealants have been replaced and are in good condition.

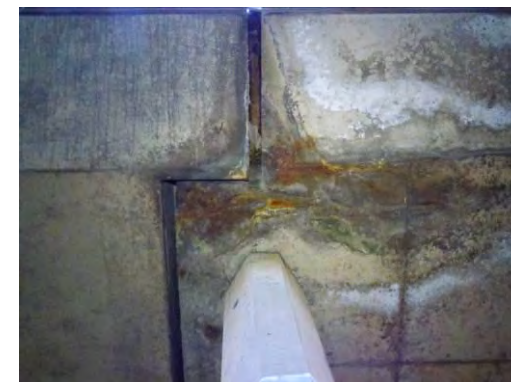
8	Pier/Column	1 Hairline cracks, difficult to detect visually	No	1A	1	N No Action Monitor Only	£ 1	IS9 is in good condition.
9	Foundations	.0 Item present but not inspected	No	6F	0	?	Not Complete	Foundations buried, unable to inspect.
9	Bearings	1 Bearings Sound	No	1A	1	N No Action Monitor Only	£ 1	IS10 elastomeric pad is in good condition.
9	Waterproofing	.0 Item present but not inspected	No	6F	2	?	£ 1	Waterproofing is 44 years old and therefore is outwith is expected lifespan and should be considered for replacement. Condition of the footway surfacing indicates minor defects to the waterproofing. Cost included in span 1.
9	Primary Deck Element (Table G4)	3 Major localised spalls possibly exposing shear links and/or main bars with general corrosion	No	3B	2	Concrete - Repairs	£ 600	Photo 23 - Large localised spall on bridge deck of span 9 adjacent to IS9.
