REPORT ON UPDATED COST AND PROGRAMME FOR VESSELS 801 & 802

ISSUED 09th December 2019

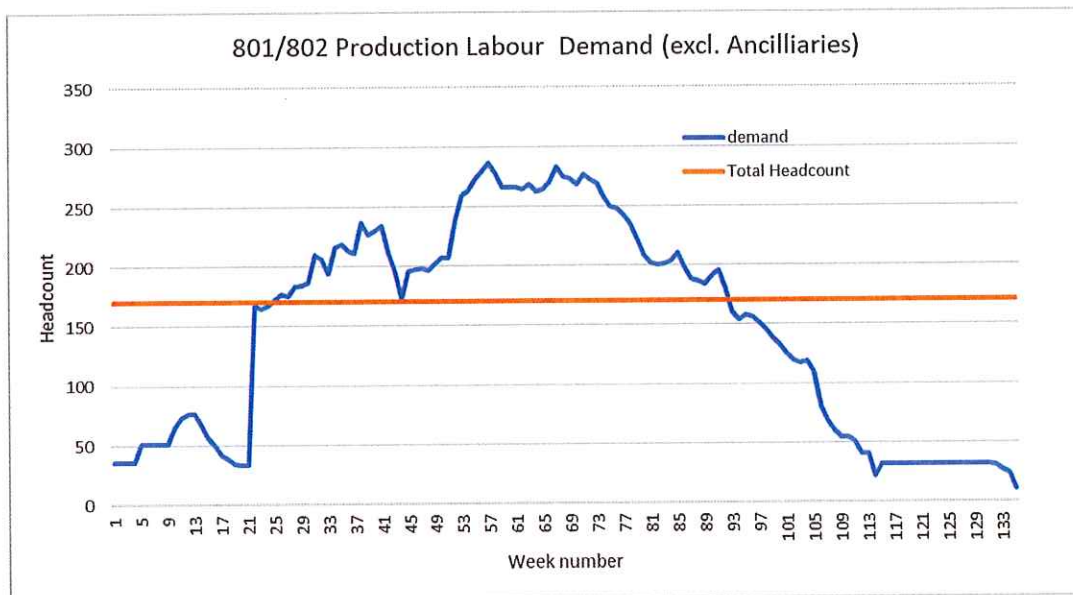
Figure 5 – required headcount for 801/802

The production resource demand from the current programme is shown below.

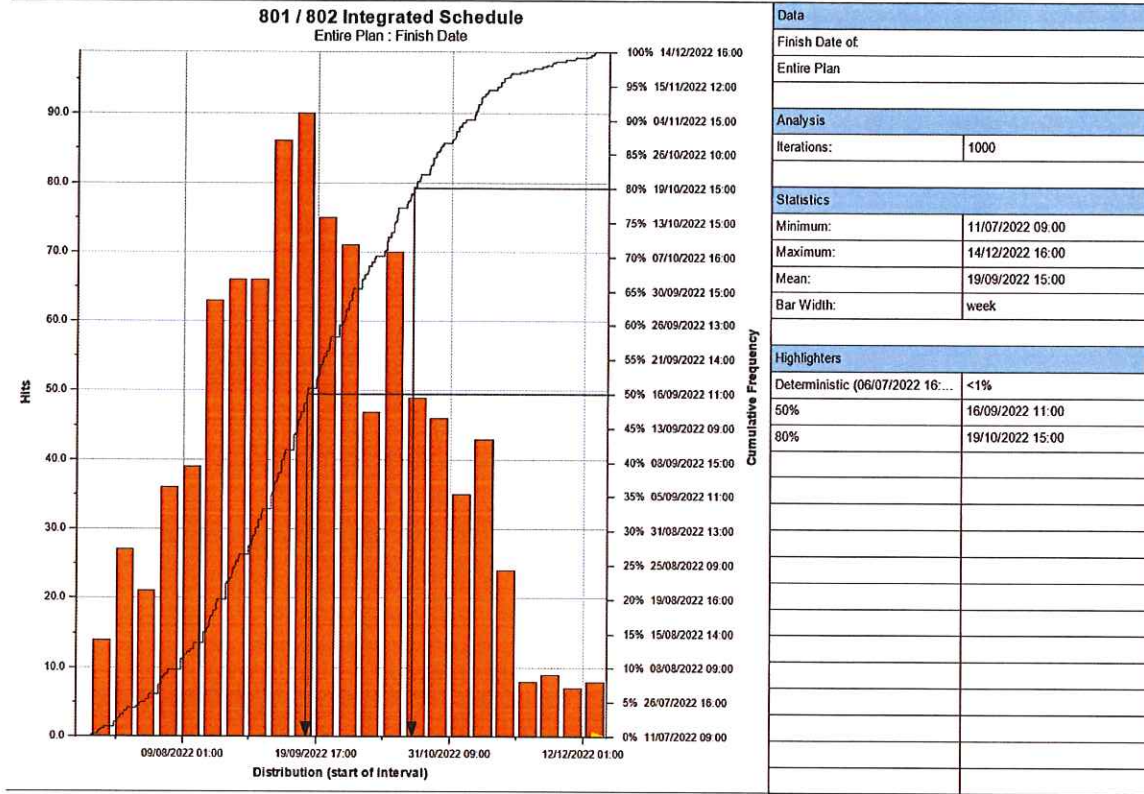
The outcome for ship 802 is shown below:

For Ship 802, the range of probability is **July and October 2022** (80% probability)

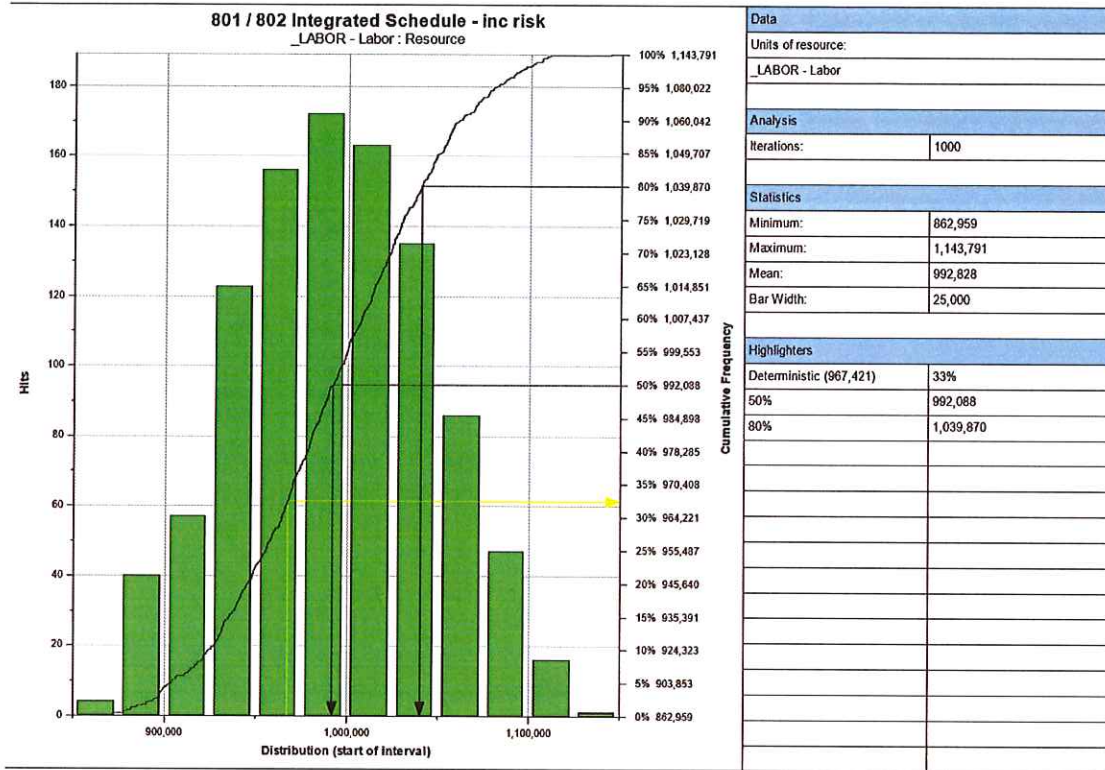
The output is:

The range of risk is between deterministic (967,421 manhours) and 80% probability (1,039,870 manhours). The percentage increase is therefore 7.5%.

Prior to undertaking the CRA we had already made an assumption of adding in a risk contingency of £8.8m to the costs to complete the vessels (£95.1m). This represents a 9% increase to the cost. The CRA output shows that this assessment is still considered adequate.
